Freedom Park (Little Sugar Creek) Final Monitoring Report Year 3 of 5 (2007)

Mecklenburg County, North Carolina

Project ID No. 141

February 2008

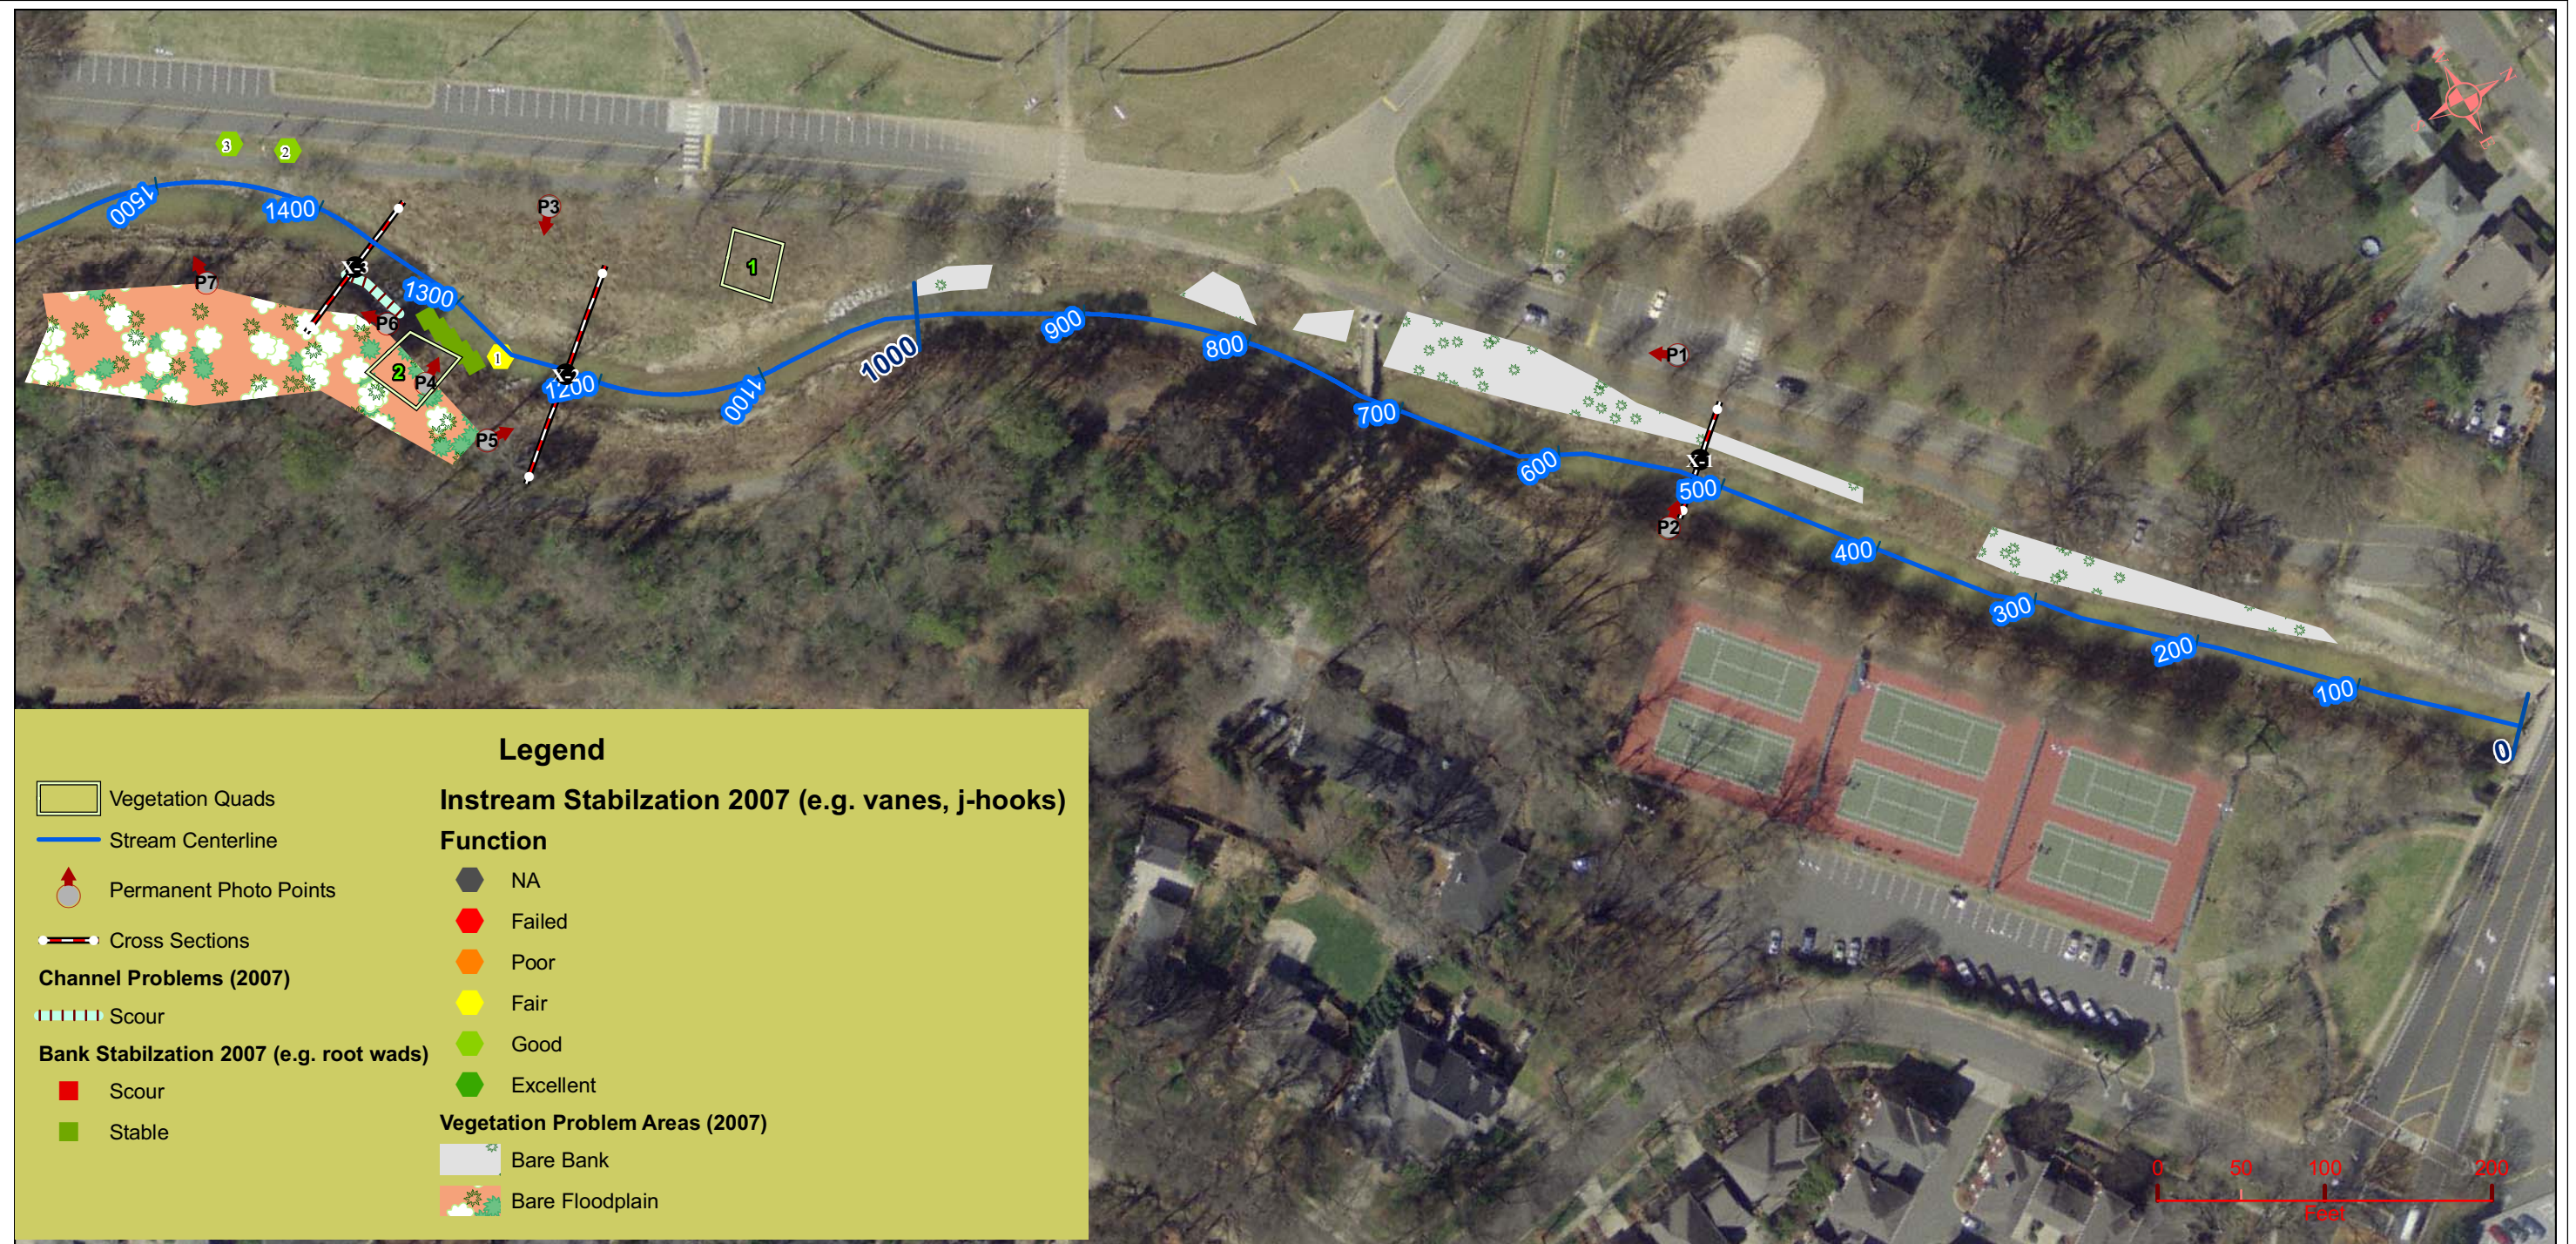
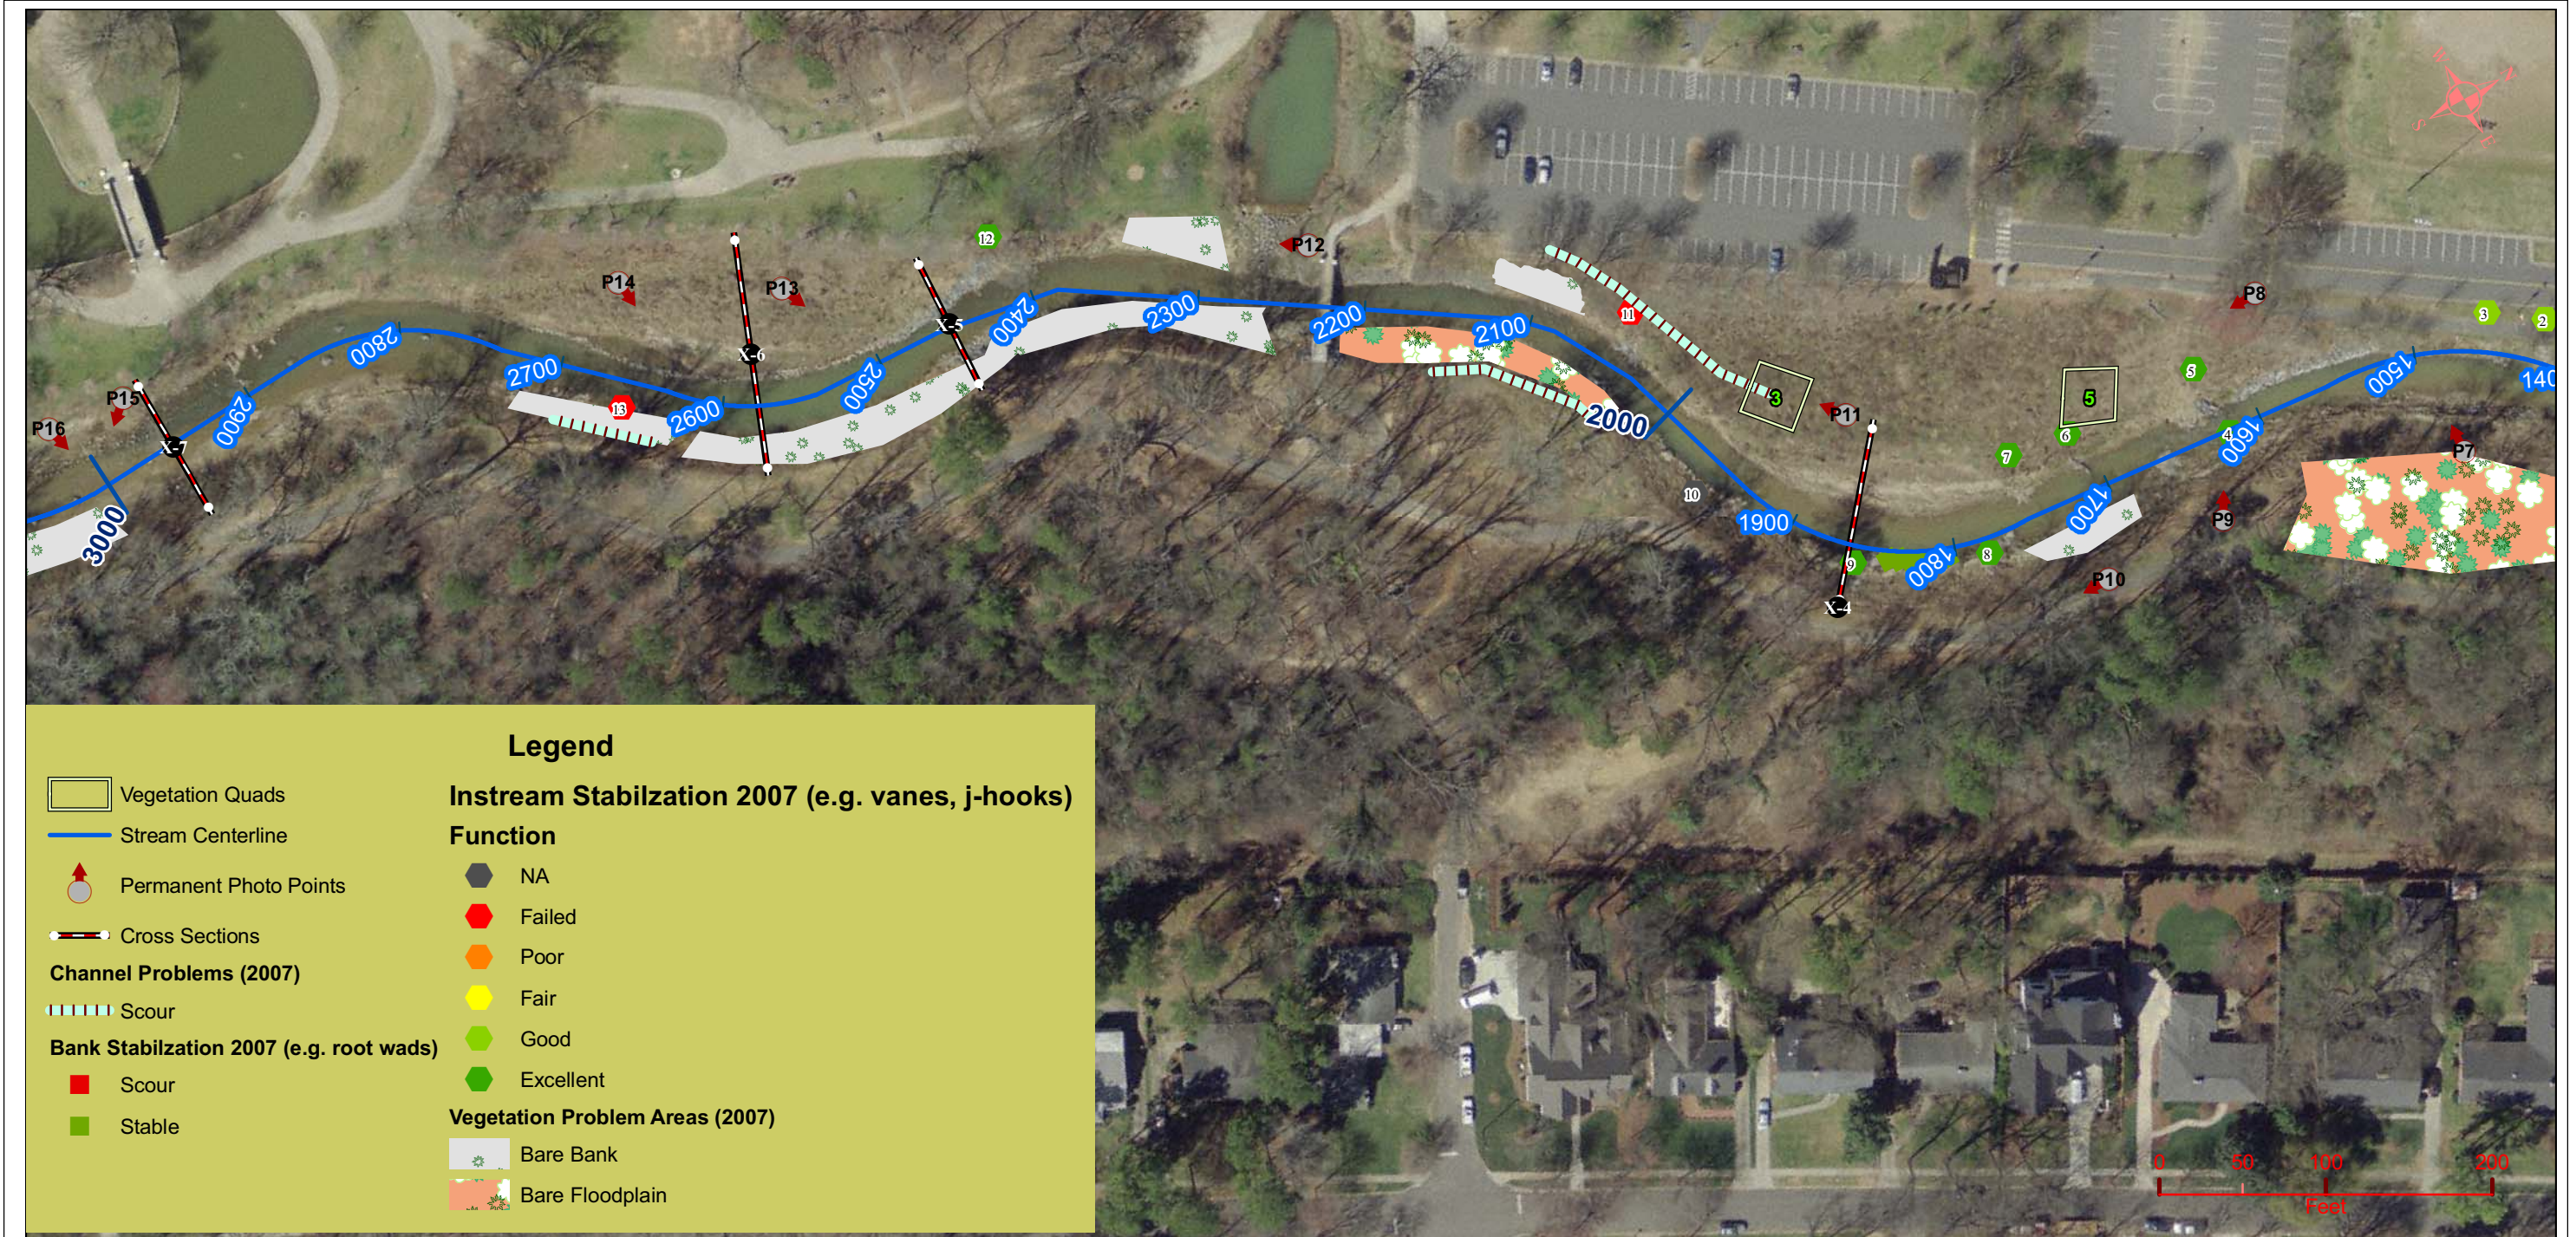
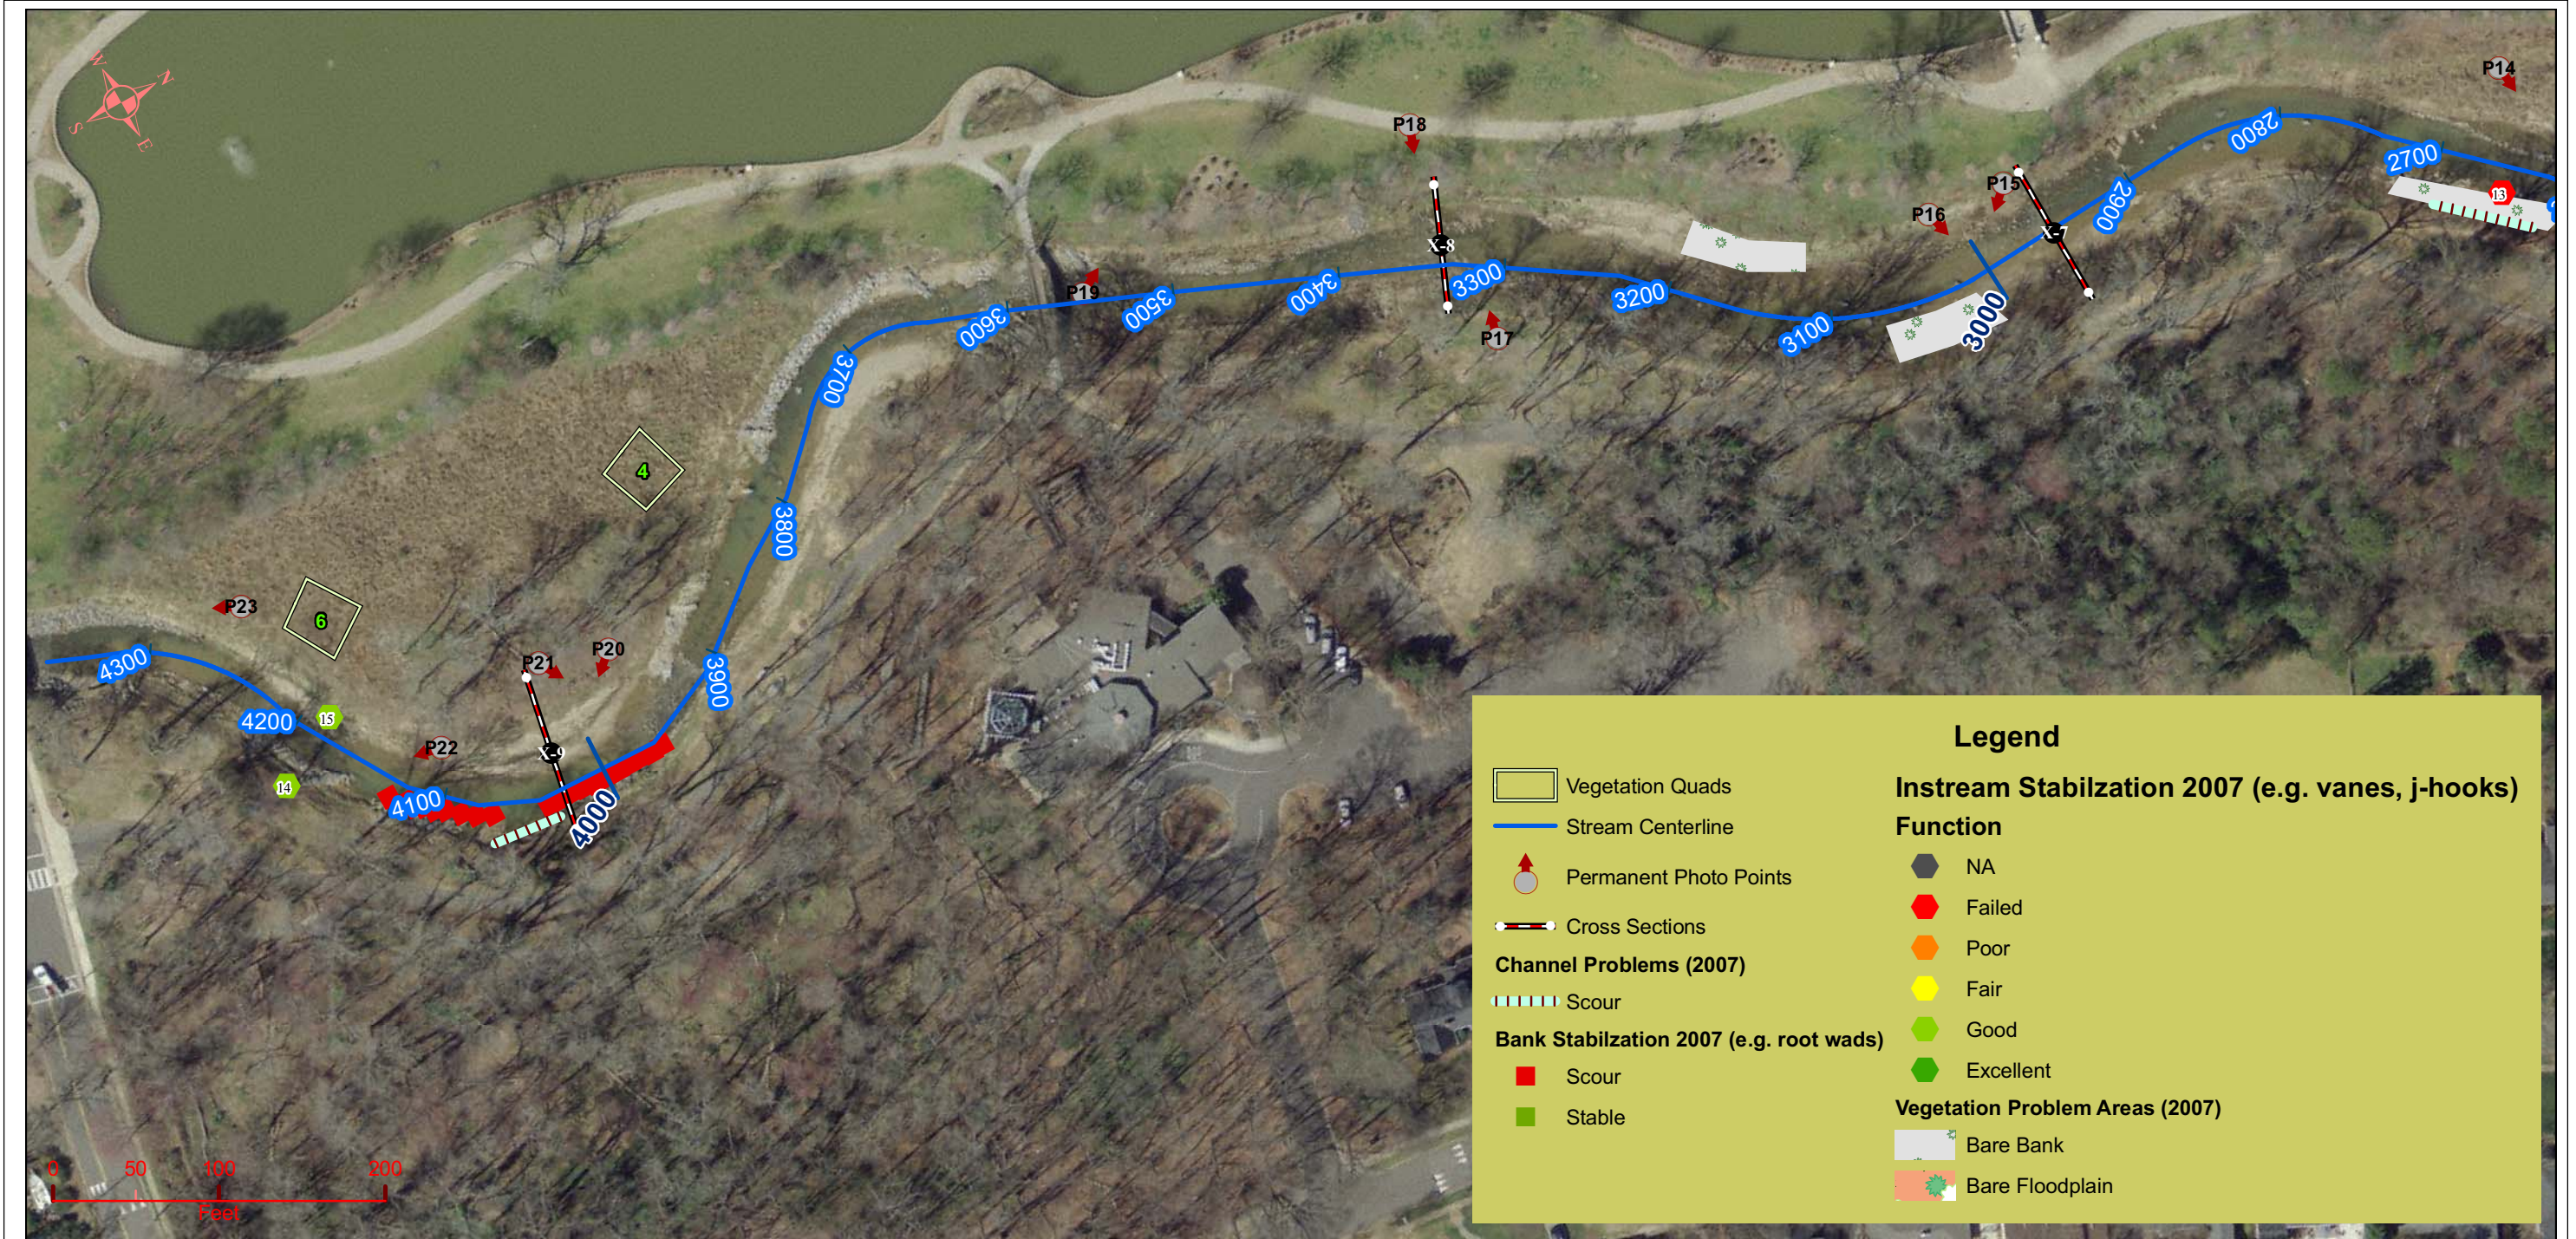
KHA assessed site vegetation in September and October, 2007. Kudzu had invaded much of the site in 2006, but was less evident in 2007. Several sections continue to exhibit bare banks. As noted in previous monitoring reports, the cause of the bare banks may be due to a lack of root development capable of withstanding stresses to during flood flows and/or compacted soils inhibiting vegetation growth. Two sections of floodplain appear to have been cleared (prior to 2006) to establish or maintain a mix of natural and ornamental vegetation. Some evidence of invasives was observed in the upper, larger cleared area. Appendix A provides a summary of vegetative problem areas. Figures 2-4 show the problem areas.

KHA assessed the stream channel during the spring and fall of 2007. Several isolated sections exhibited bank scour. Causes of scour may include lack of vegetative establishments; frequent flooding flows; unstable soils; and failed short-term protection such as coir fiber matting. Two areas utilizing boulder toe protection had pools developing behind them. Most structures seemed to remain in place and functional. One structure appeared to be missing completely; one structure appeared to be missing a header rock; and one structure had a collapse of boulders making up the arm. A set of root wads near the bottom of the reach showed severe scour behind the root balls. Large boulders have been placed at the base of these root wads. The boulders have held the root wads in place. Monitoring Plan View Sheets 1 through 3 show the location of the stream problem areas and table B1 in appendix B summarizes the stream problem areas.

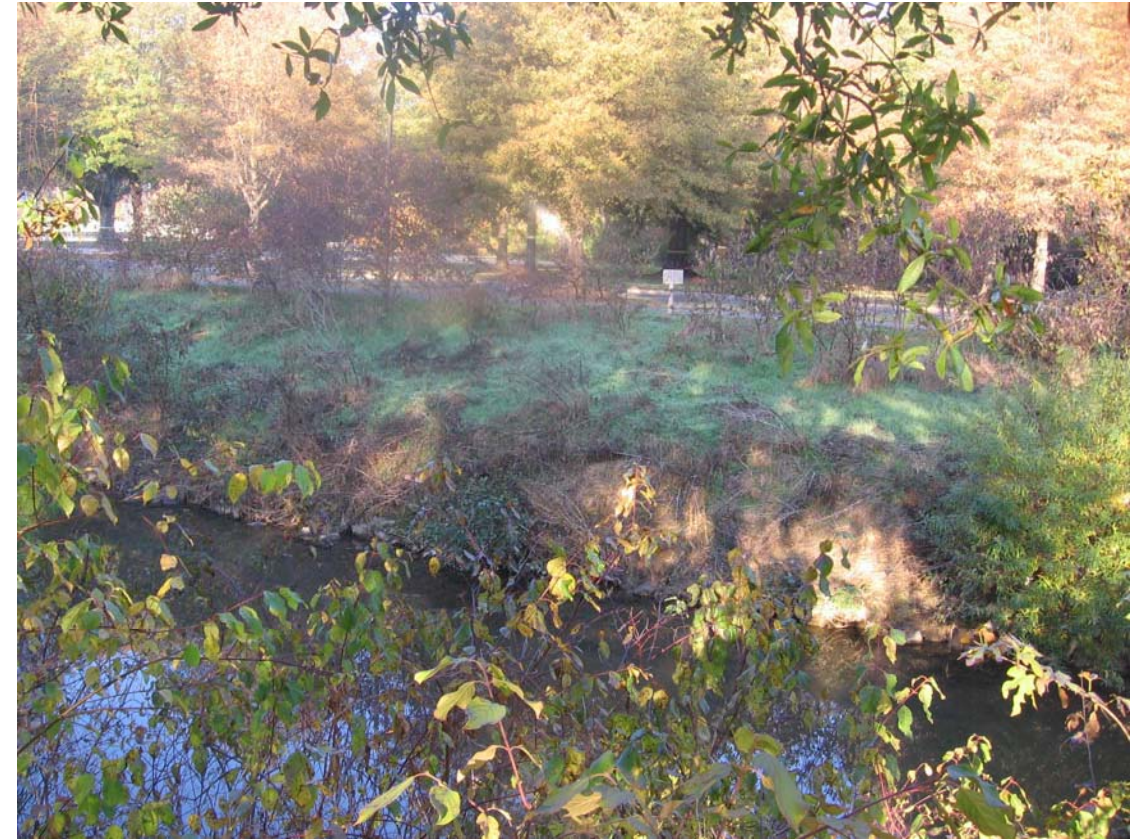
VP 1: Looking at right bank, bare bank

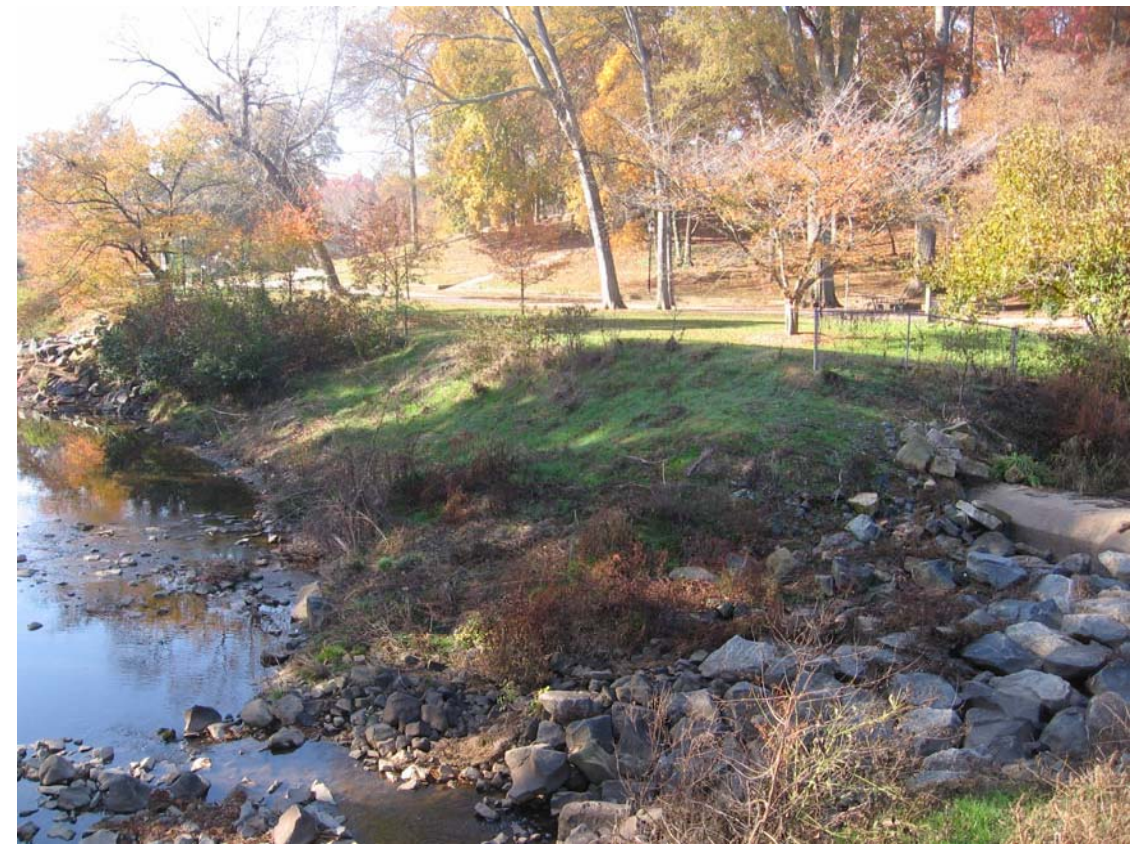
VP 3: Looking at right bank, bare bank

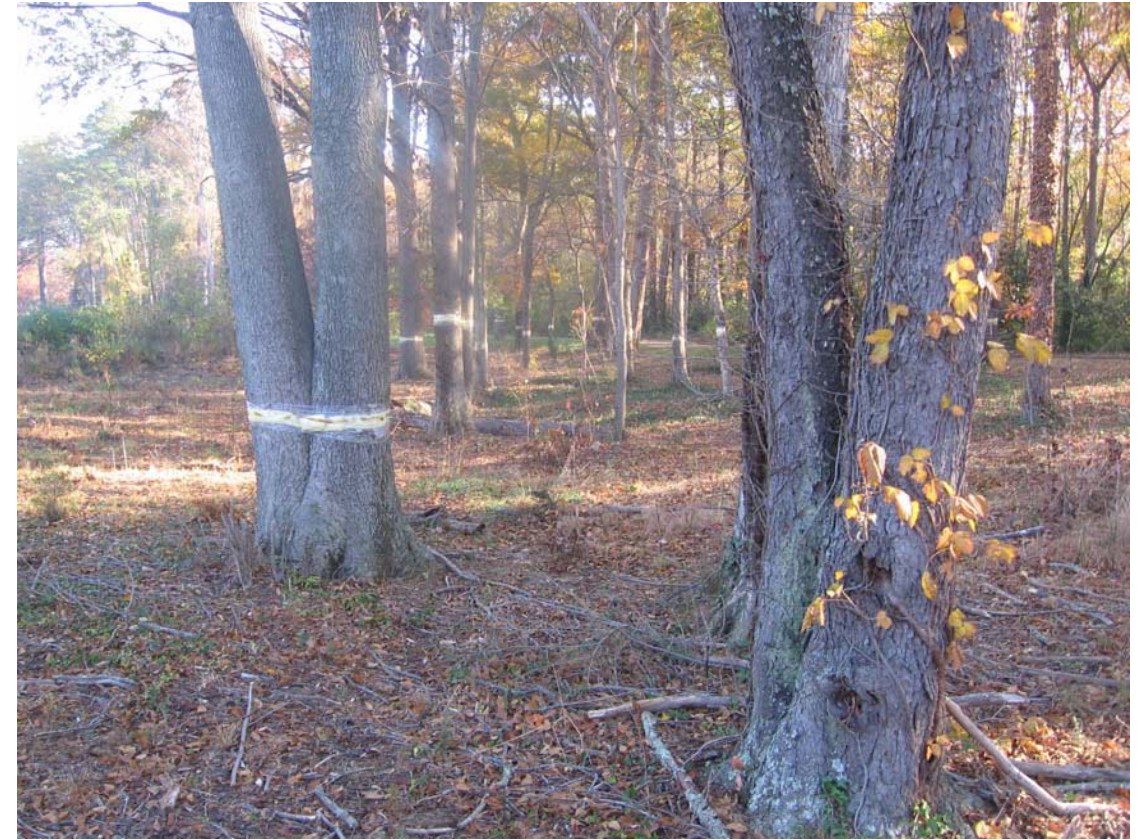
VP 5: Looking downstream at left bank, bare bank

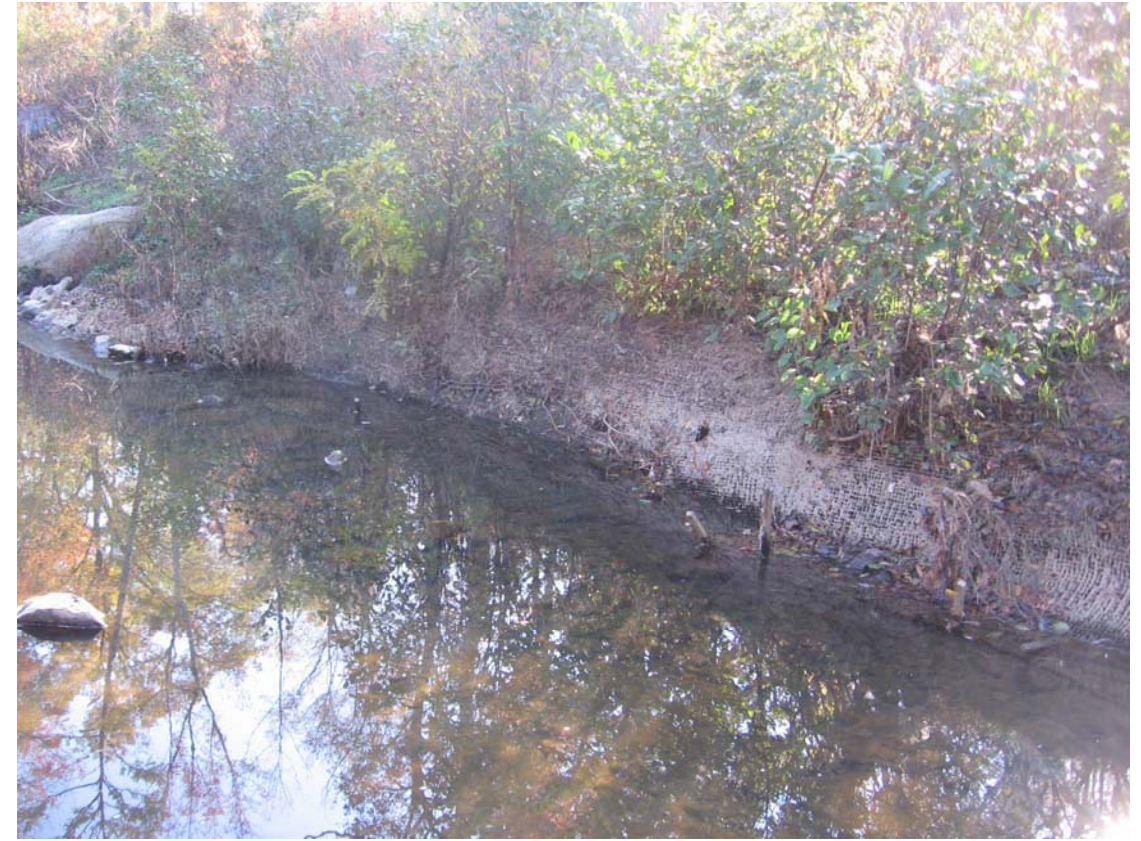
SP 1: Looking at left bank, collapsed structure

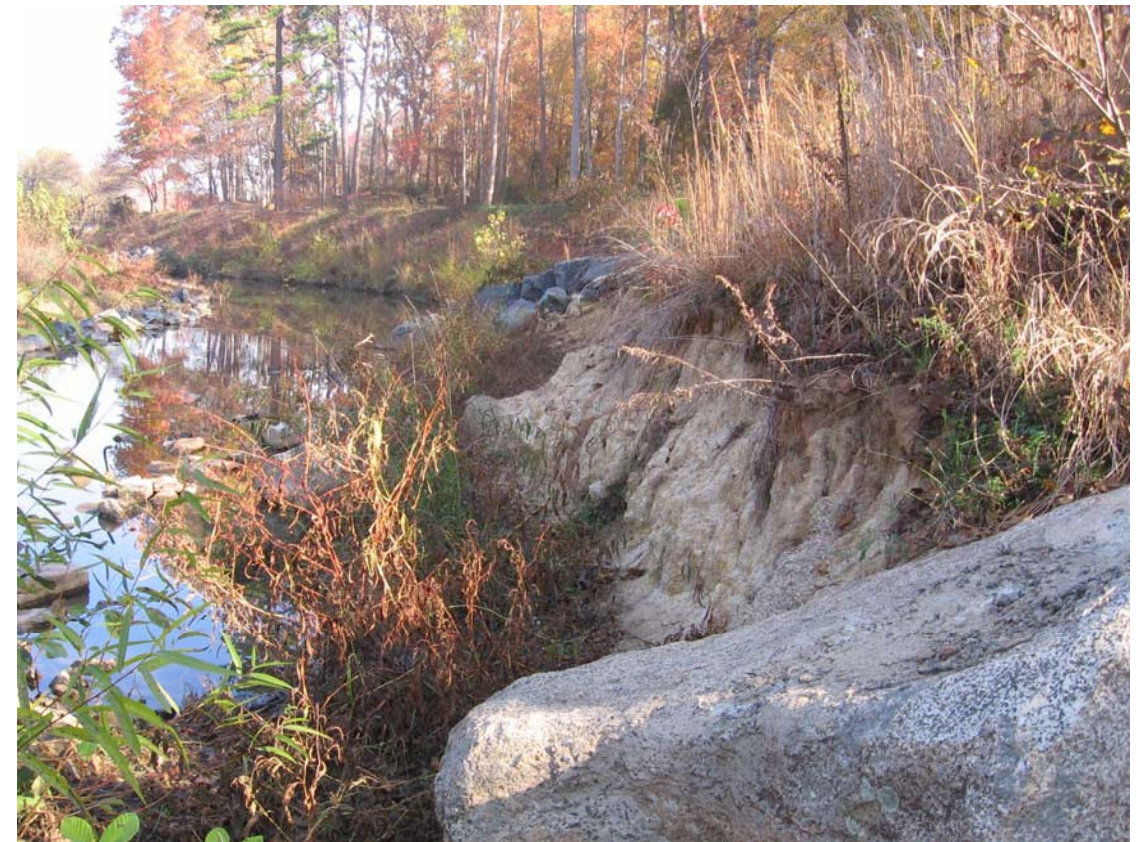
SP 3: Looking downstream at left bank, scour

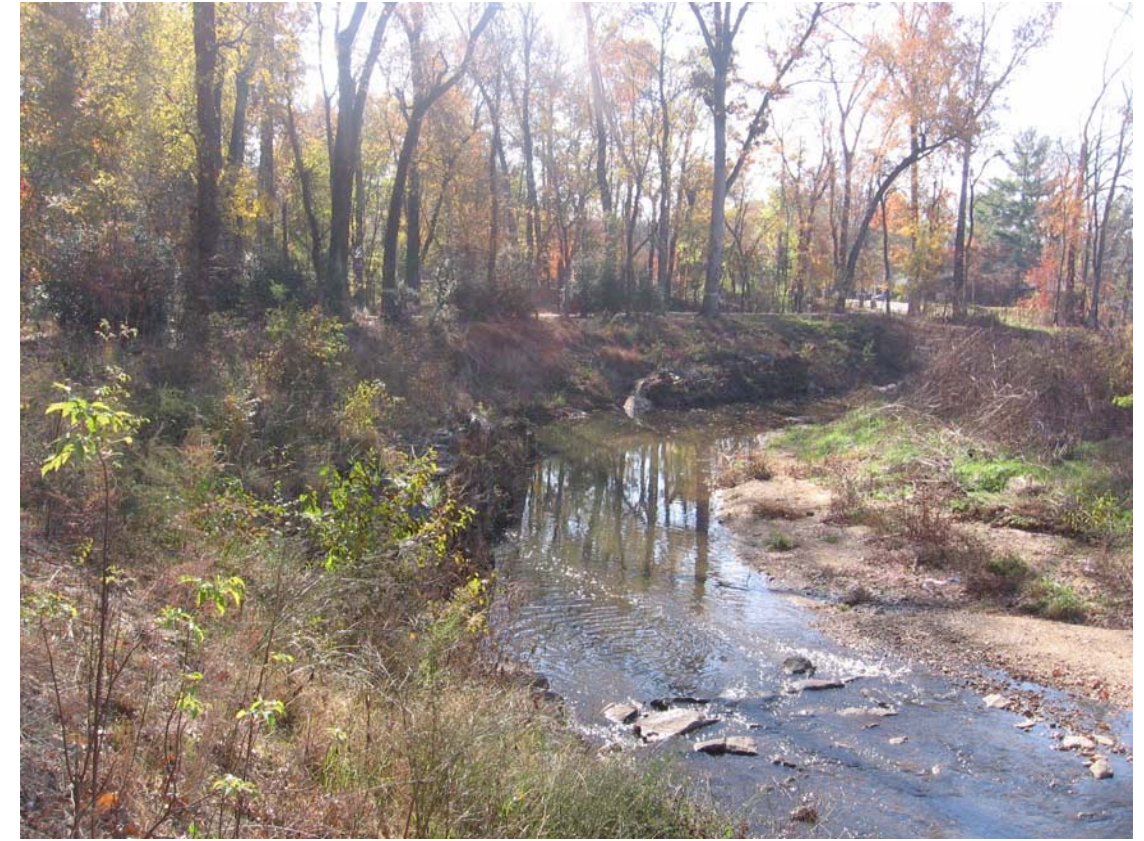
SP 5: Looking at right bank, scour behind boulder toe protection
