# Freedom Park (Little Sugar Creek) Monitoring Report Year 4 of 5 (2008)

Mecklenburg County, North Carolina

Project ID No. 141

May 2009

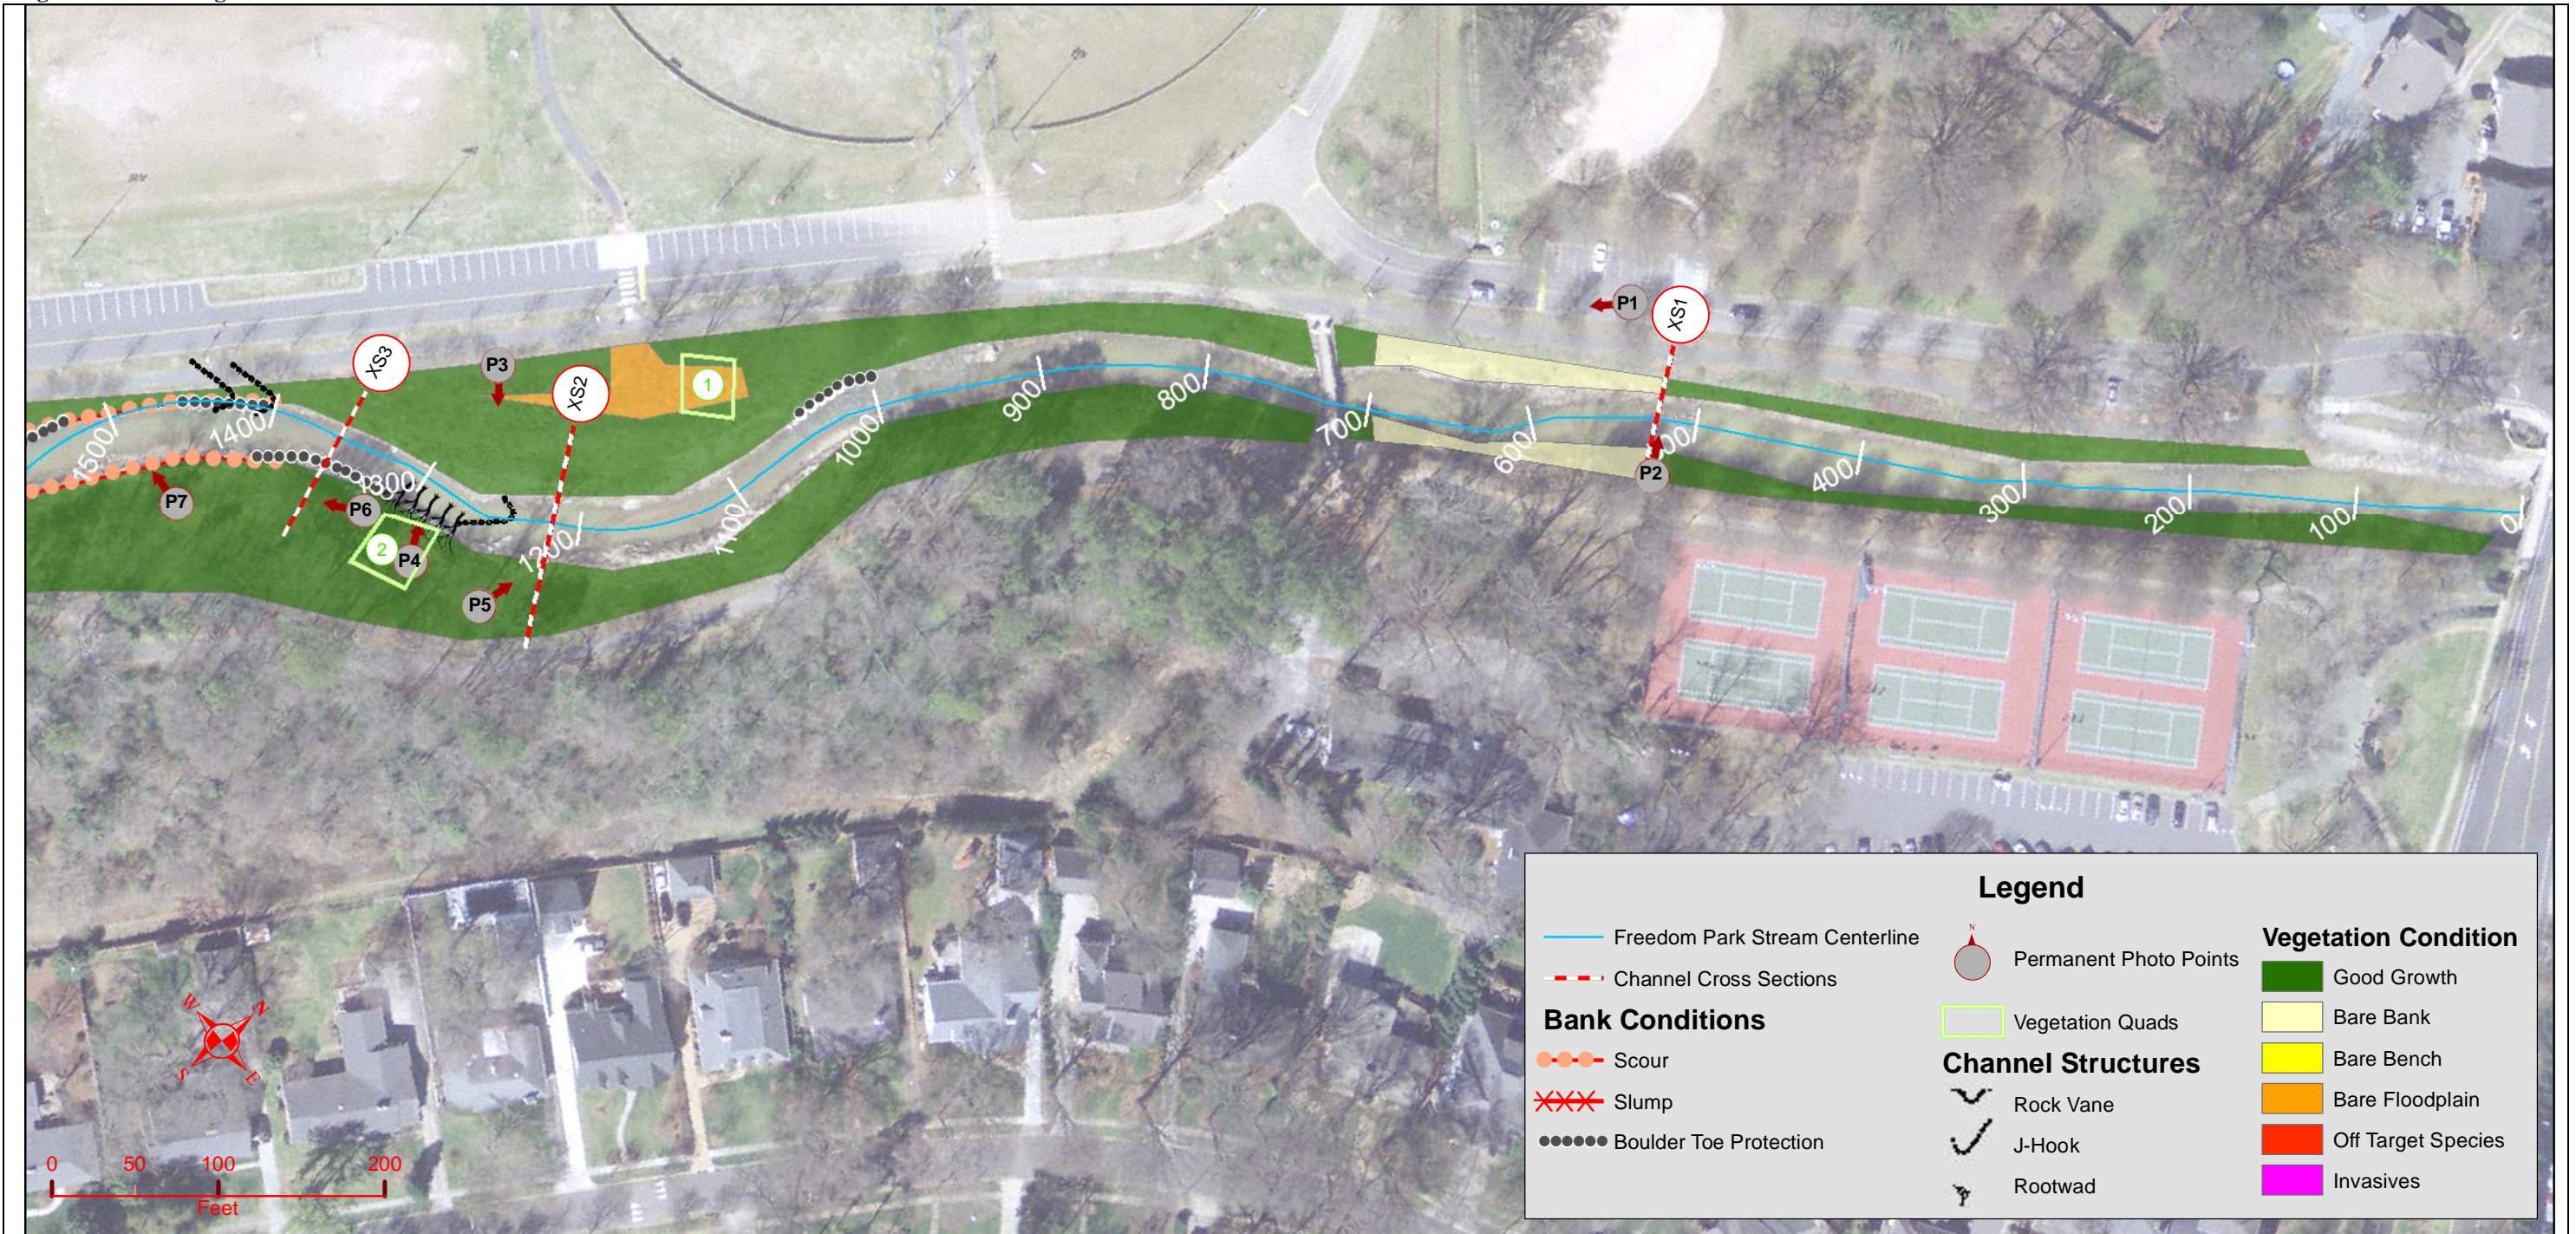
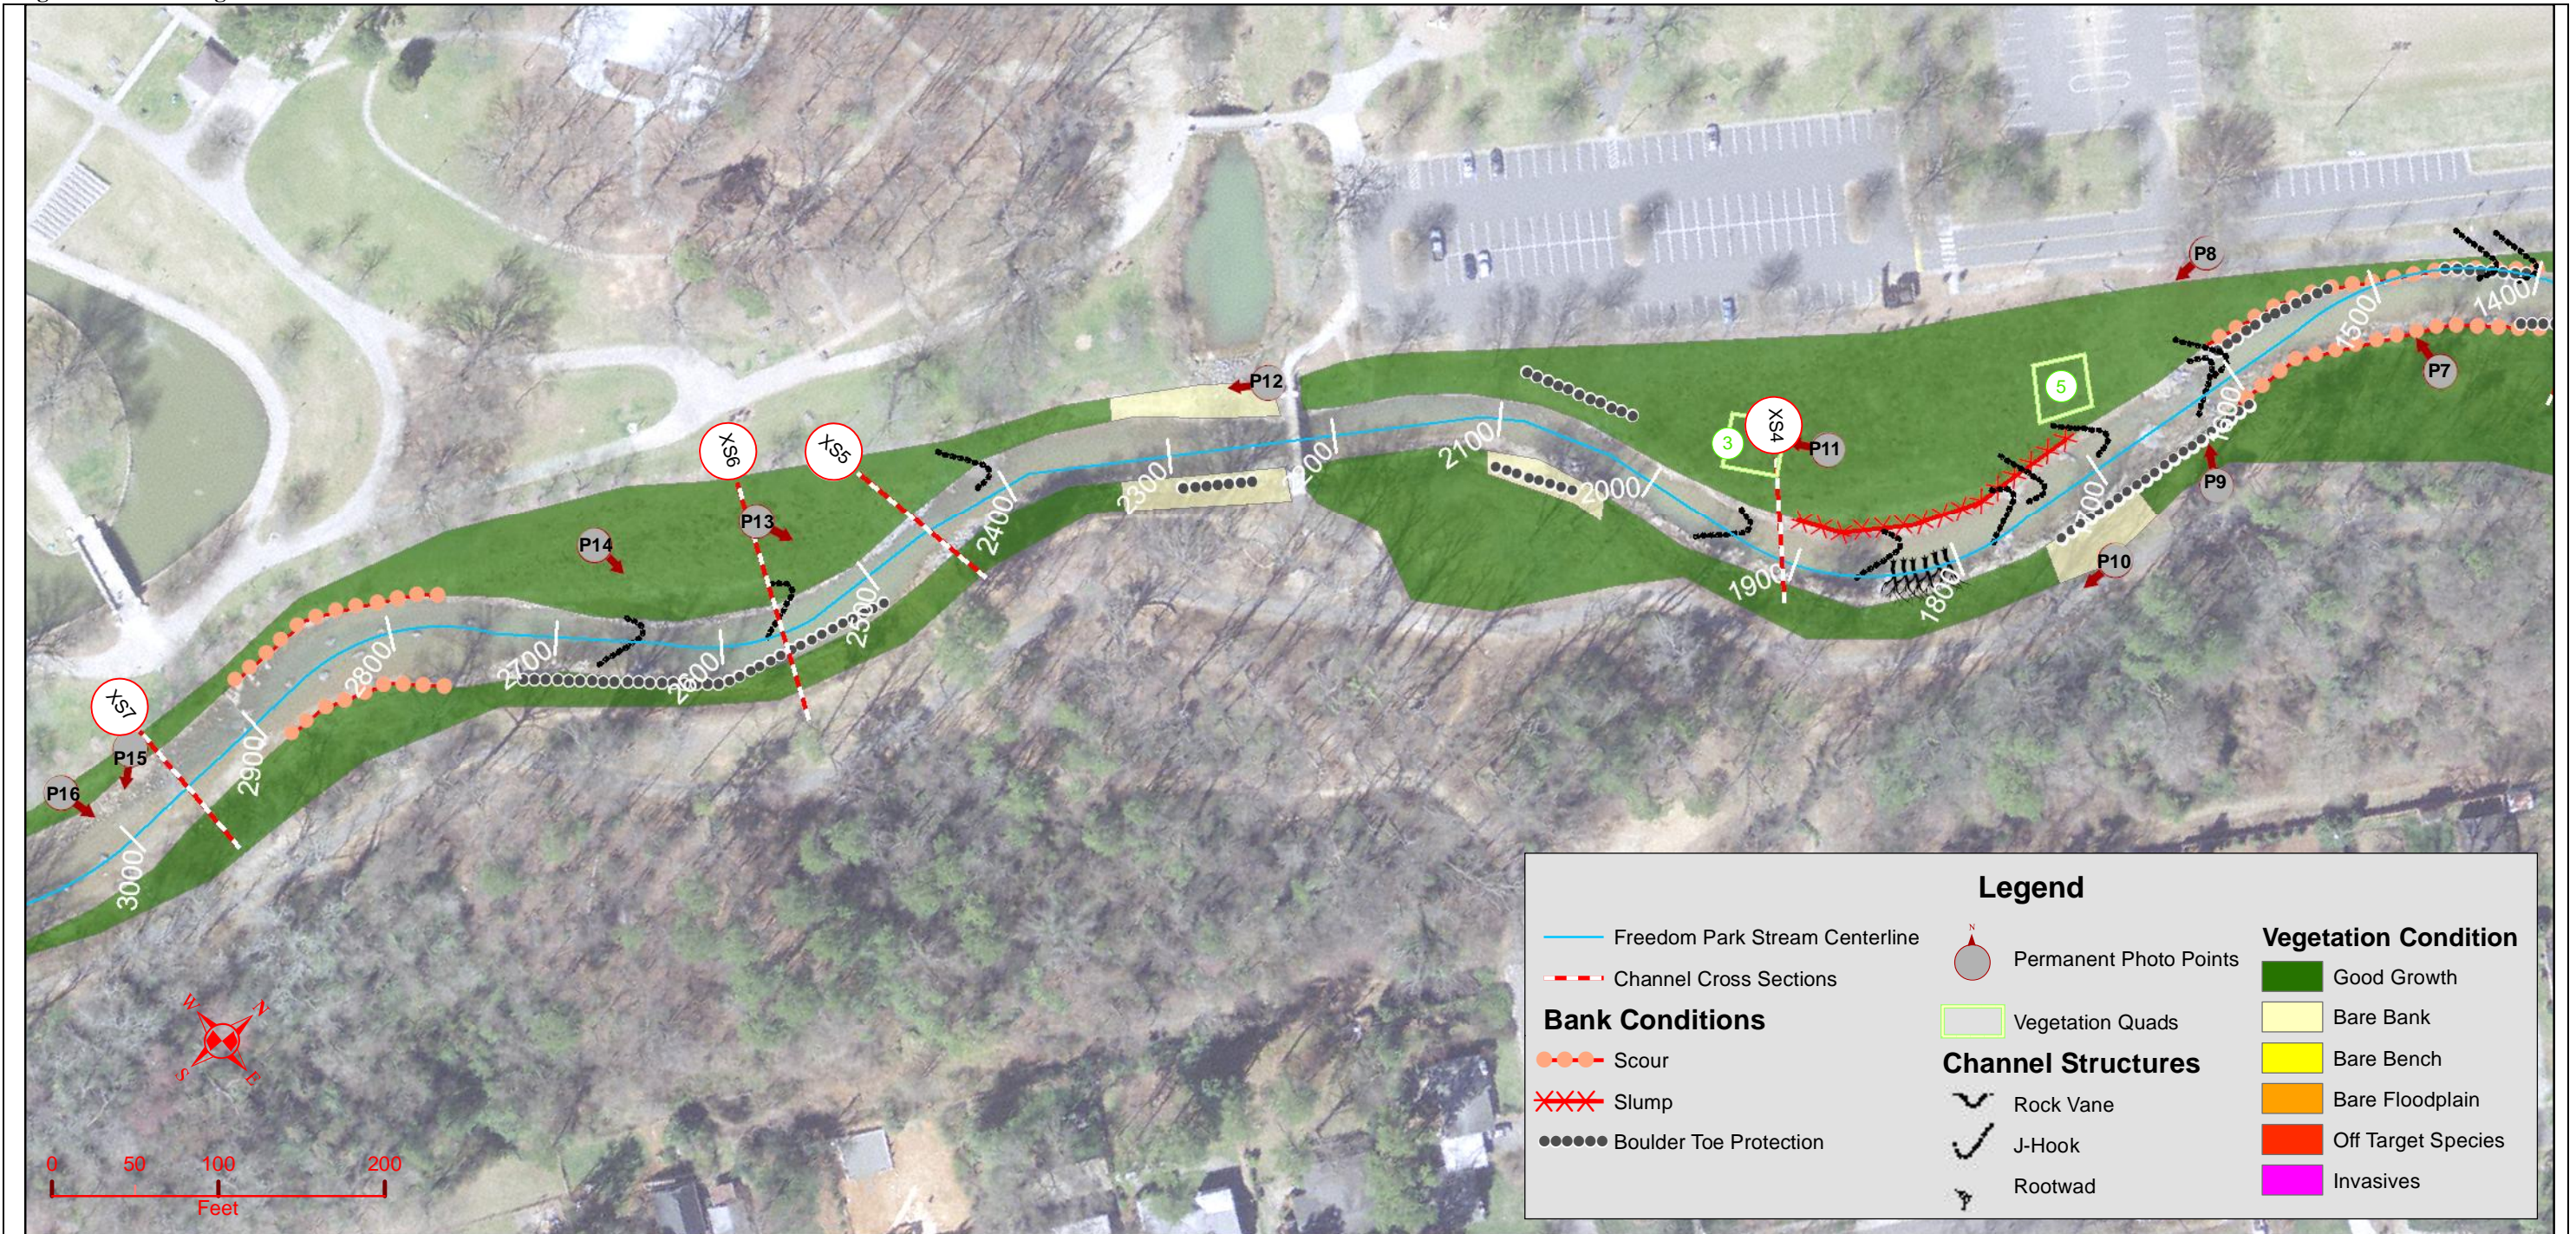
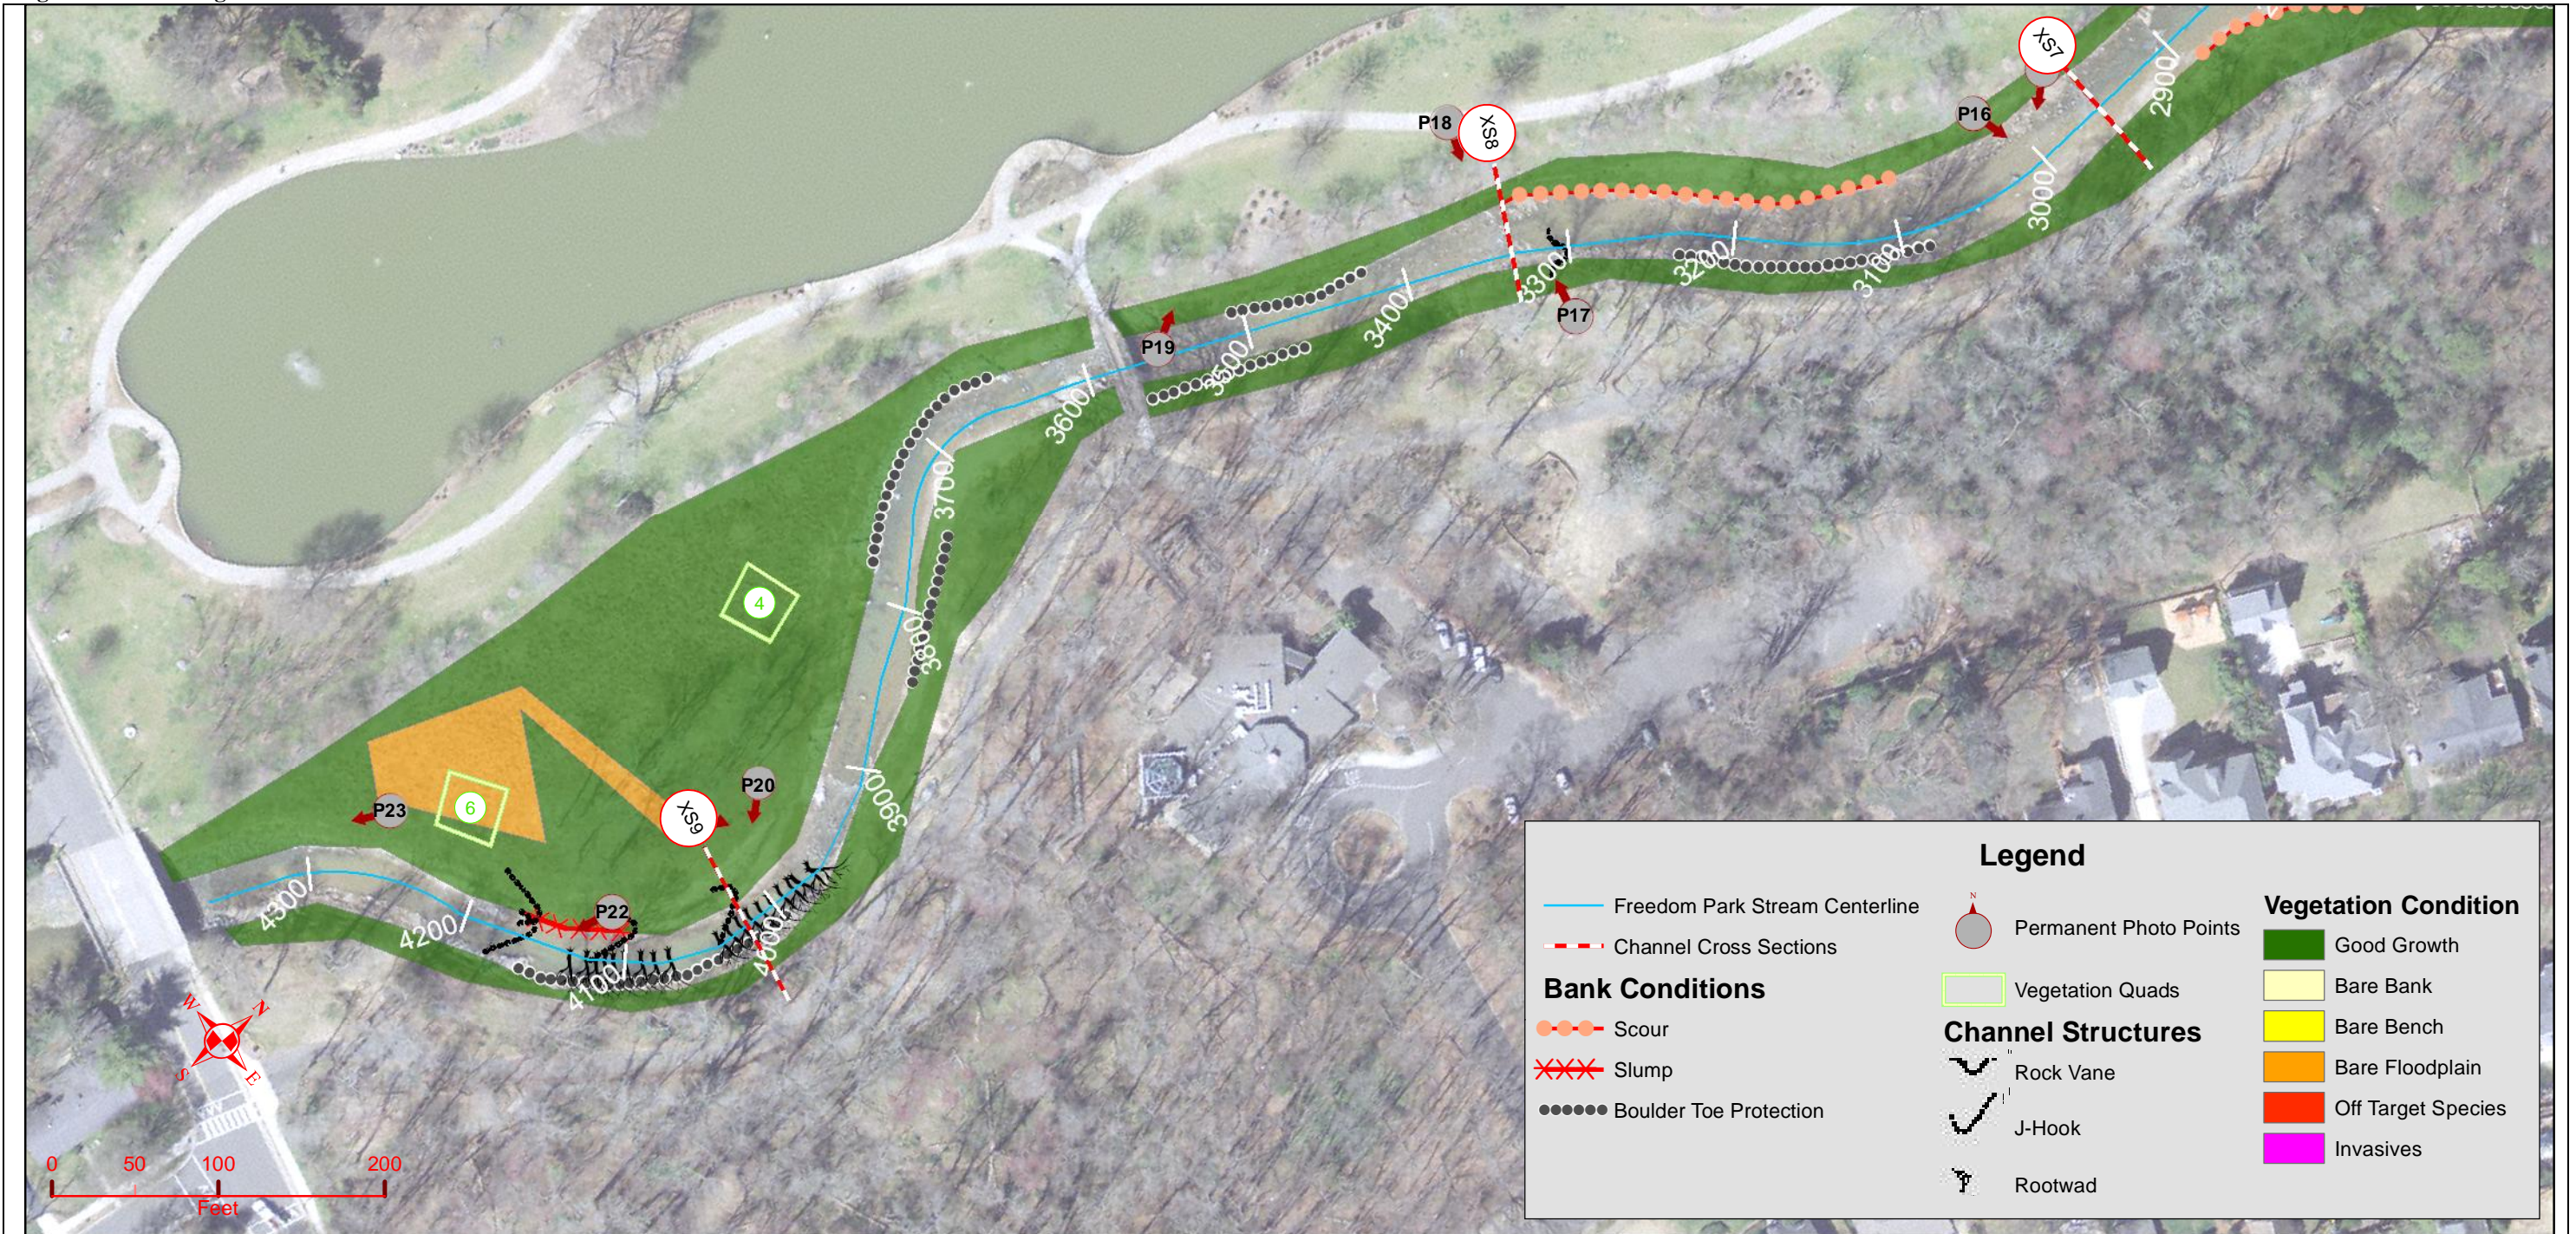
KHA assessed site vegetation in September and October, 2008. Several sections continue to exhibit bare banks. As noted in previous monitoring reports, the cause of the bare banks may be due to a lack of root development capable of withstanding stresses to during flood flows and/or compacted soils inhibiting vegetation growth. Two sections of floodplain appear to have been cleared for maintenance work. Appendix A provides a summary of vegetative problem areas. Figures 2-4 show the problem areas.

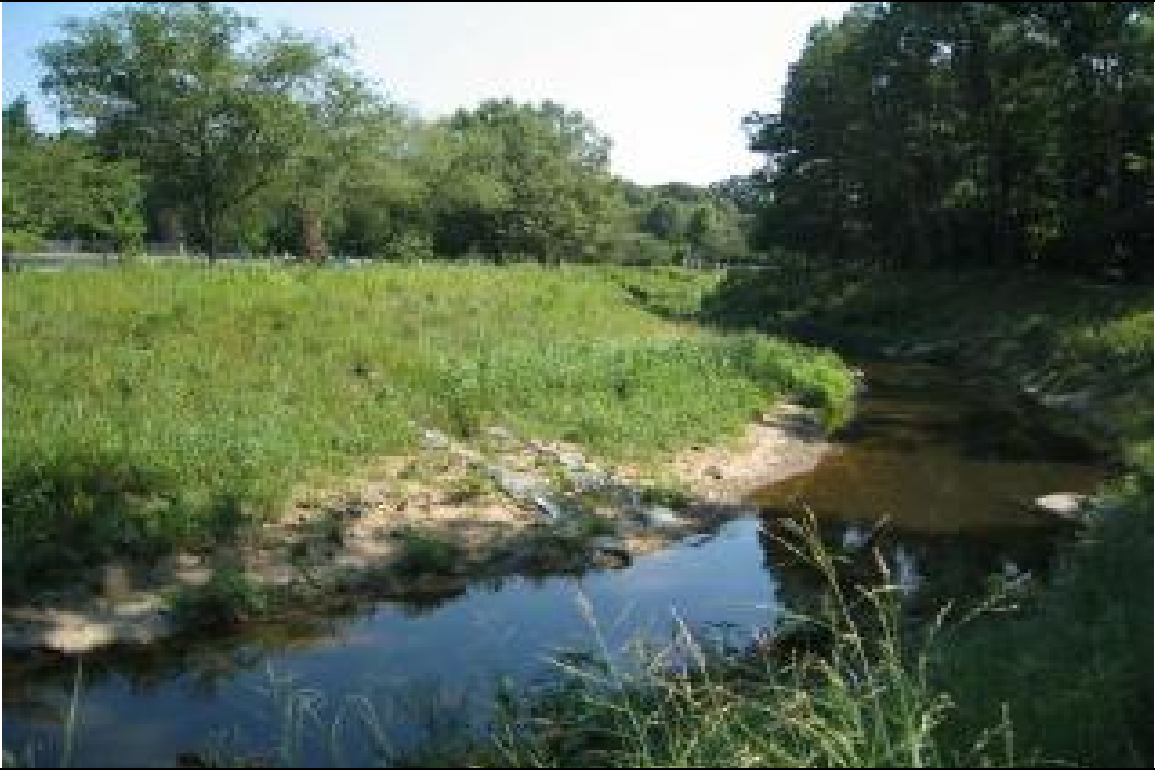
Permanent Photo PS04  
Taken: 10/13/2008

Project Table V provides a listing of probable bankfull events based on site observations and limited gage data. Photographic evidence and eye witness accounts indicate at least one (1) bankfull event occurred in 2008.
