# Buffalo Creek Watershed Phase I Stream Mitigation Plan Greensboro, North Carolina

North Carolina Department of Environment and Natural Resources  
Ecosystem Enhancement Program

February 2005

Mitigation Plan Prepared By Buck Engineering PC

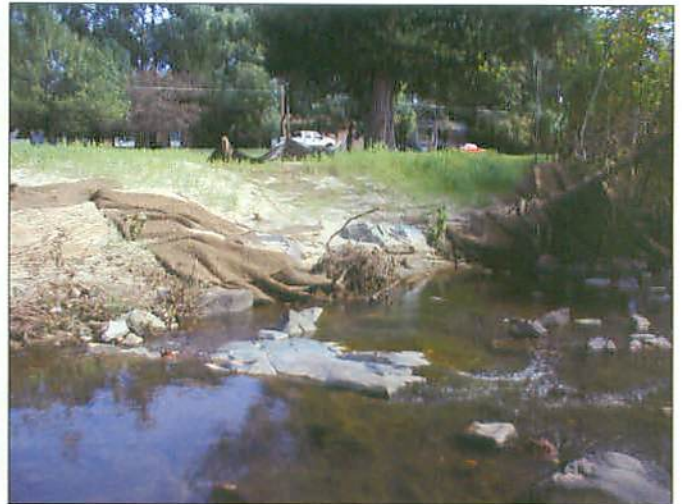
PP30B Reach 2 Step Pool #1 Before Repairs

Hillsdale Reach 1A and B: minor grading, seeding and matting. Reach 2: minor grading, seeding and matting successfully repaired all damage.

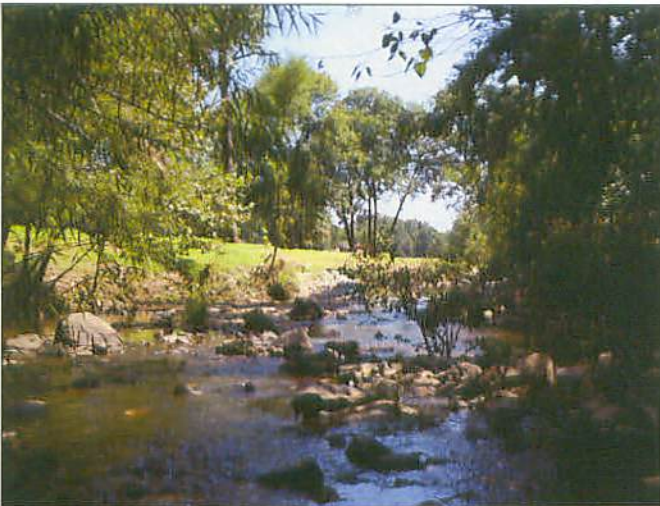
PP30C Reach 2 Rootwad #1 Before Repairs

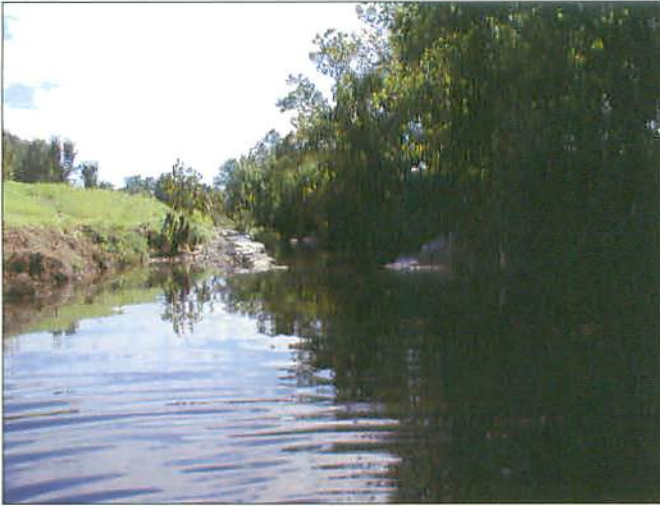
PP33B Reach 2 Rootwad #2 Before Repairs

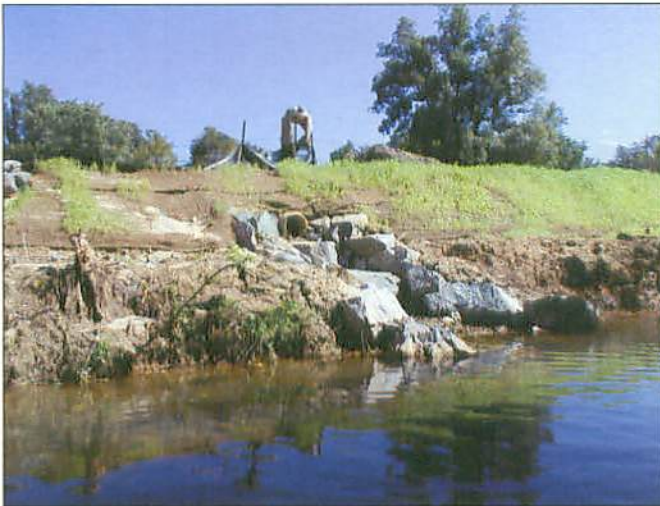
PP34B Reach 2 Rootwad #3 Before Repairs

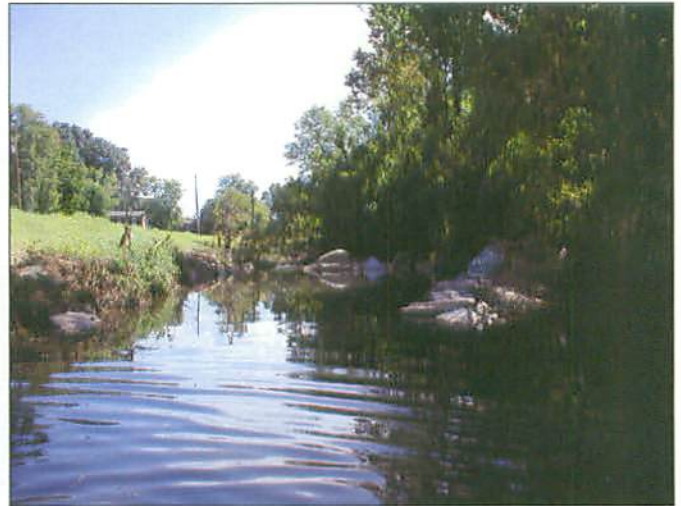
PP34C Reach 2 Step Pool #2 Before Repairs
