**Gillespie Golf Course (Mile Run Creek)  
Stream Restoration  
Greensboro, North Carolina**

**Annual Monitoring Report**

**Monitoring Year 2006**

**Monitoring Year: 2006  
Measurement Year 3  
As-Built Date: 2004  
NCEEP Project Number 144**

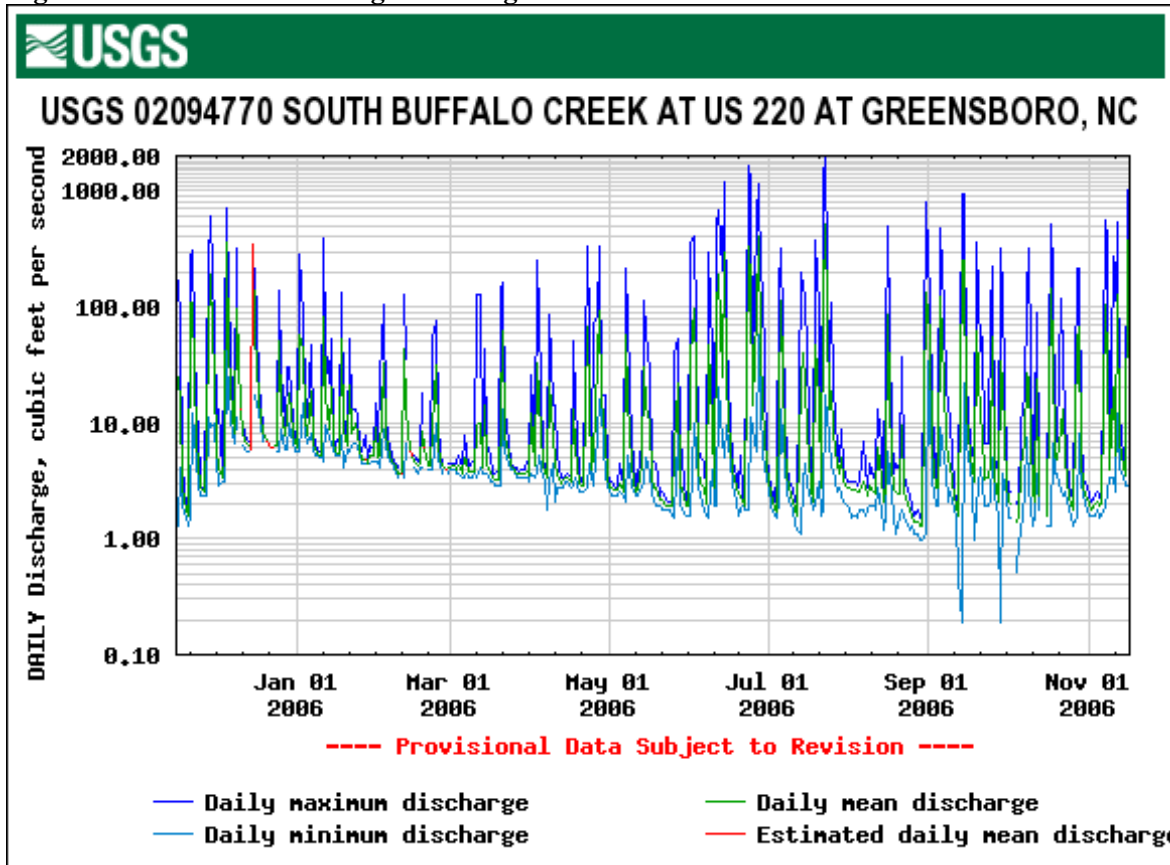
**Figure 3. USGS Stream Gauge Discharge Data for South Buffalo Creek at US 220.**

No crest gauges are installed at this site to document bankfull flow events. The following USGS stream gauge had been used in past reports to verify bankfull events. If this proximal gauge is the only alternative, there is no recourse except to make assumptions about out-of-bank events based on the gauge record. However, there are multiple reasons why this is not a good practice. First, the gauge represents the hydrology at one point in the watershed and not anywhere upstream or downstream with any certainty. There are multiple tributaries entering the stream between the gauge and the project site. Second, there are likely differences in cross-sectional geometry and

slope between the two sites- especially given that the project site was rebuilt. Even if the discharge could be accurately determined with this method, we still don't know for sure that there were not more or less out-of-bank events at the project reach than at the gauge reach. In short, gauge-height is not transferable. The accepted USGS procedure would be to transfer the discharge to the project reach from the gauge site, and then run a step-backwater or other flow model to predict slope and water surface elevation. Given the substantial shortcomings in this method, our recommendation is that a crest gage be installed at the project site.

It is highly recommended that crest gauges be installed at Gillespie Golf Course in order to measure bankfull flows if they occur onsite.
