**Gillespie Golf Course (Mile Run Creek) Stream Restoration
Greensboro, North Carolina**

Annual Monitoring Report

Monitoring Year 2007

**Monitoring Year: 2007
Measurement Year 4
As-Built Date: 2004
NCEEP Project Number 144**

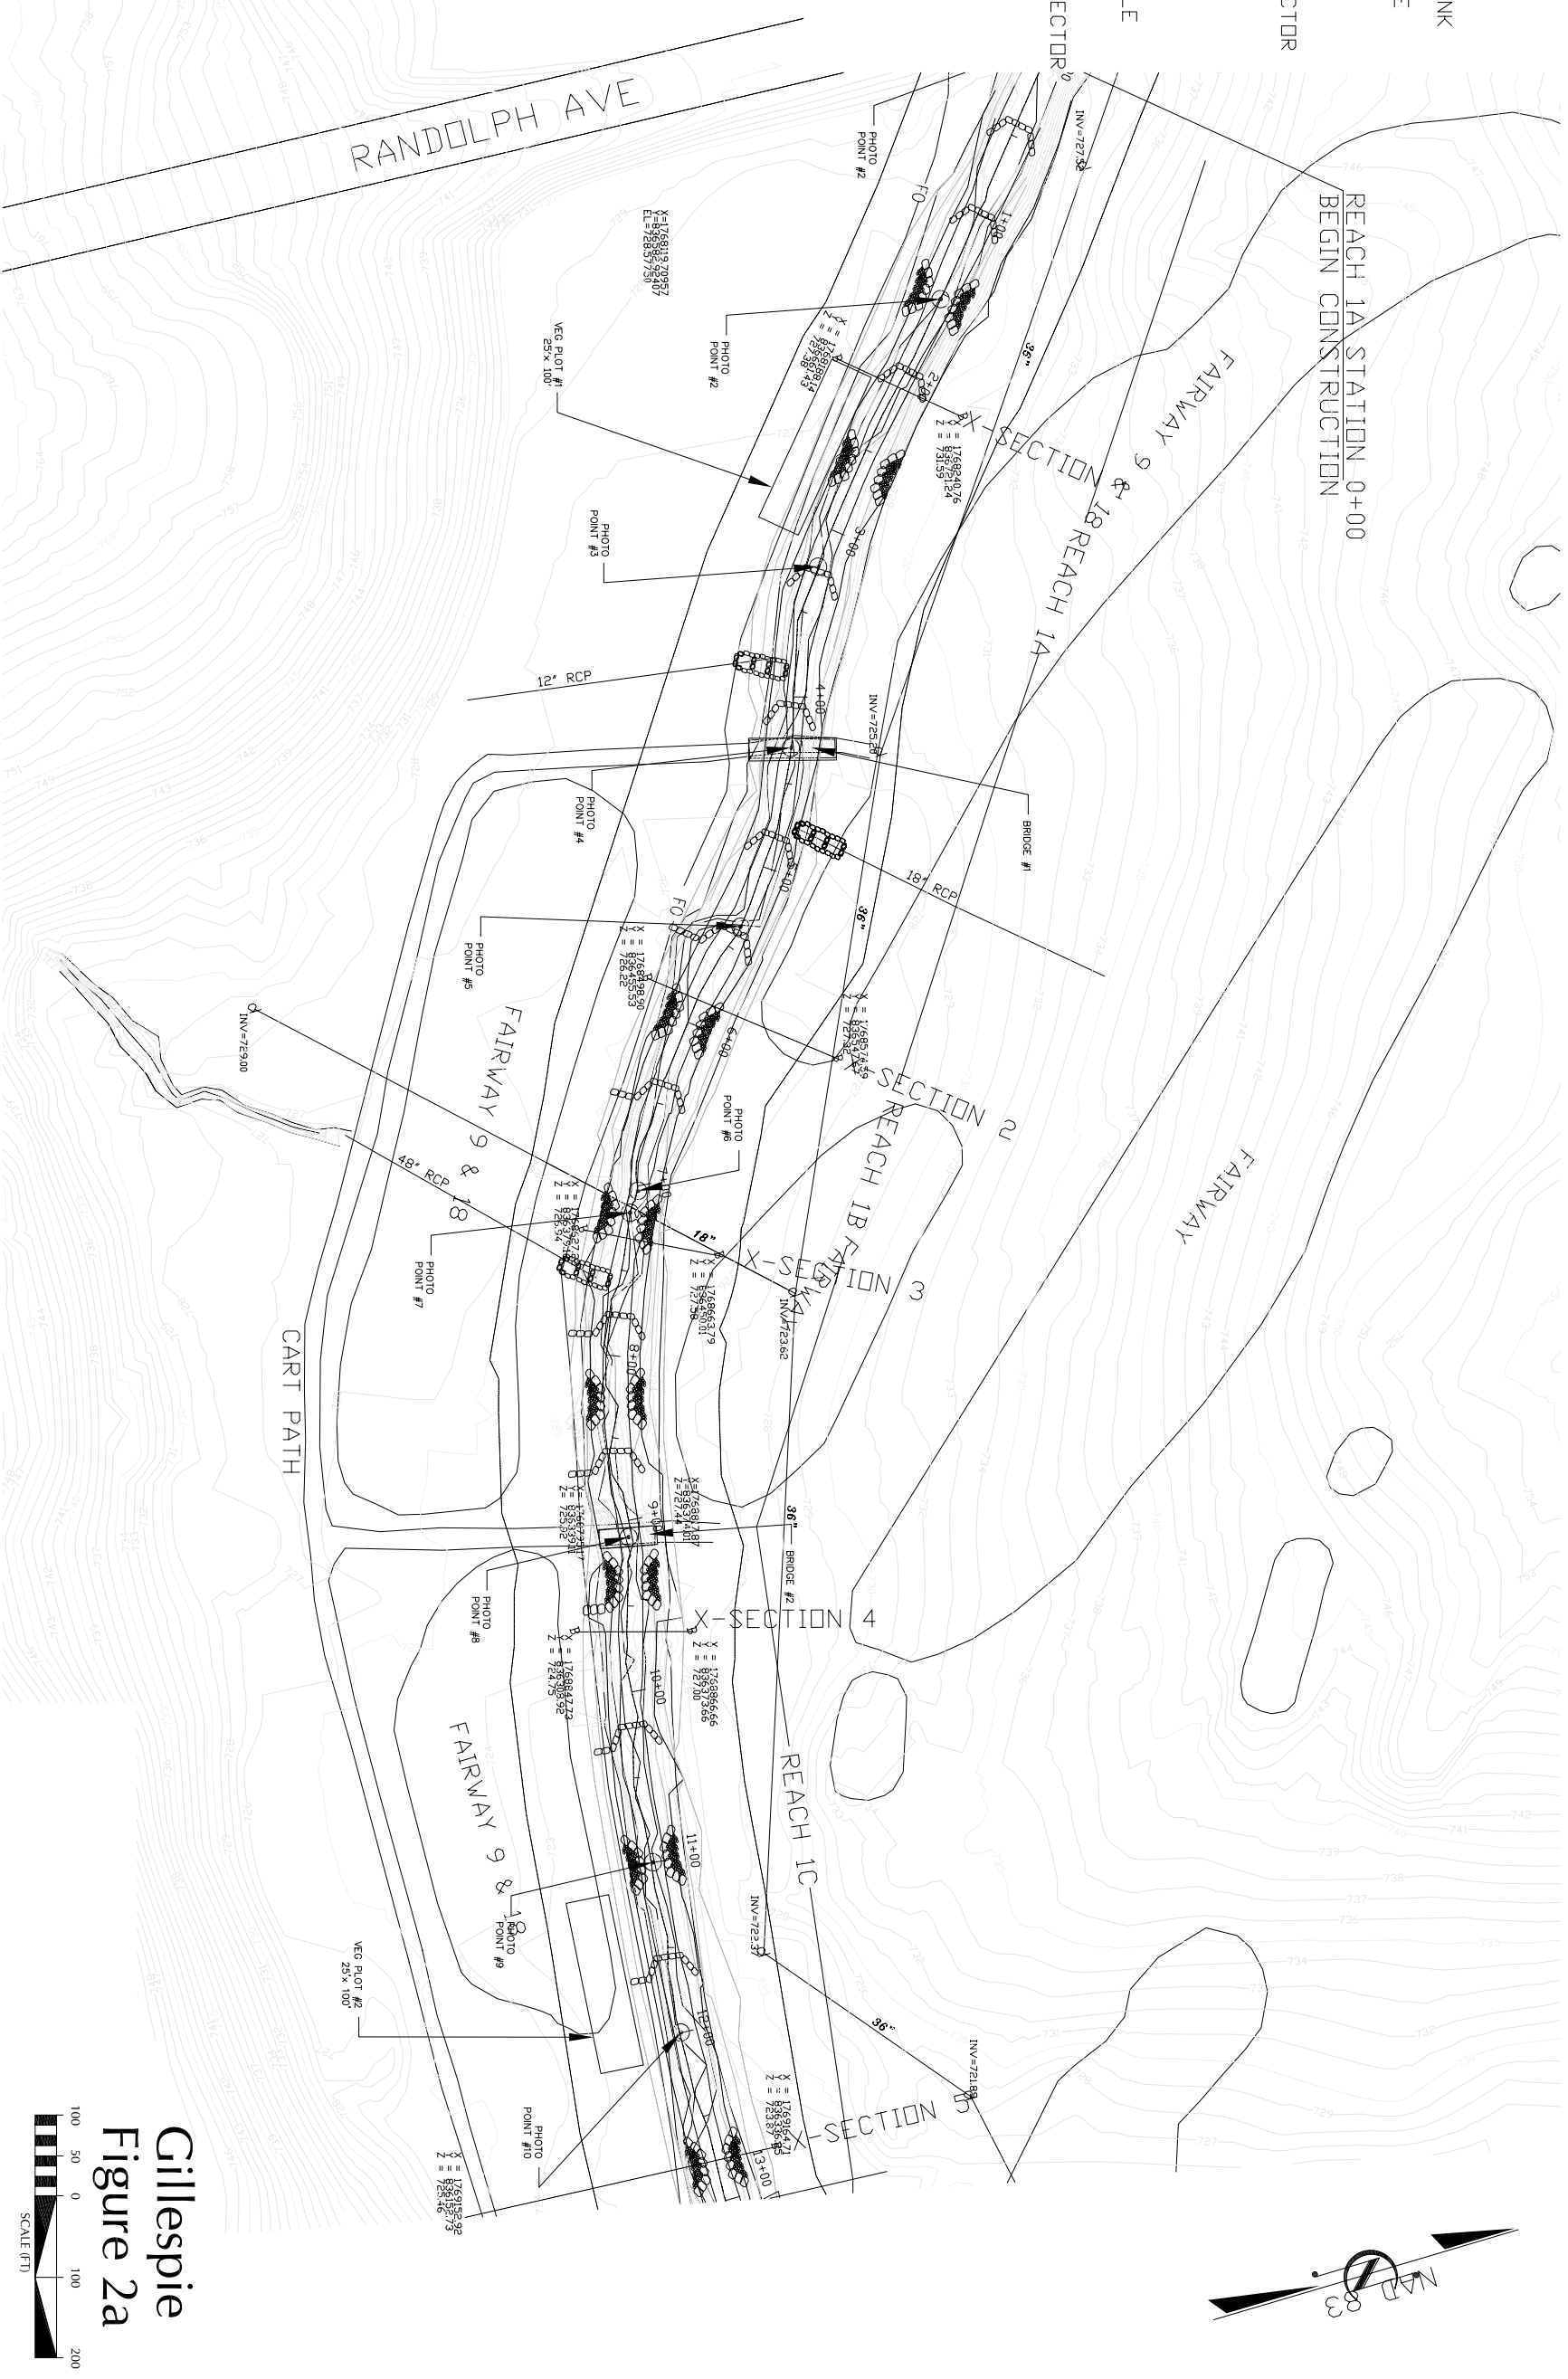
Gillespie
Figure 2a

An assessment of the channel stability was performed on April 27, 2007 by WK Dickson and Co., Inc. Several areas of concern were observed and documented, including localized bank scour, aggradation, and failure occurring with the engineered structures. These problem areas are shown in Figure 2.

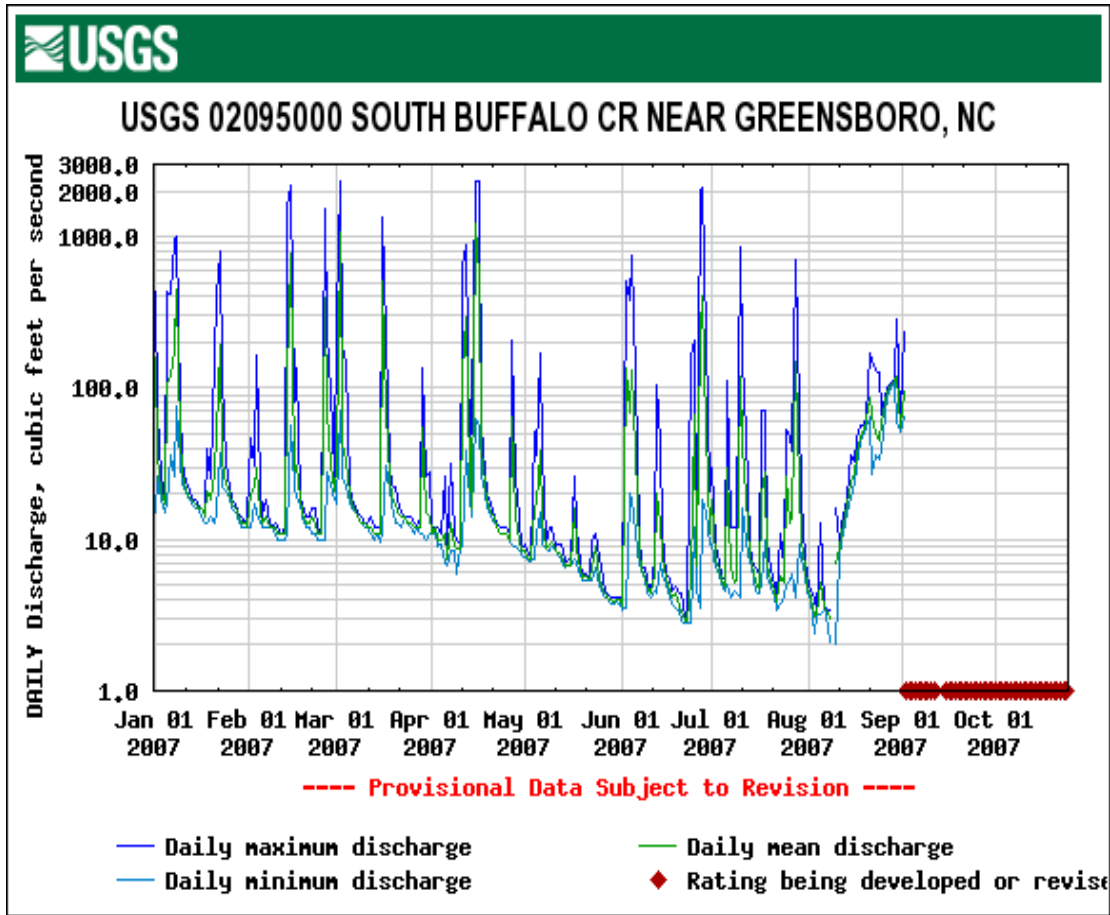
Figure 3. USGS Stream Gauge Discharge Data for South Buffalo Creek at US 220.

No crest gauges are installed at this site to document bankfull flow events. The following USGS stream gauge data had been used in past reports to verify bankfull events (Figure 3). Although this technique has been used to establish the occurrence of bankfull events for the history of this project, it is not scientifically valid. The accepted USGS procedure would be to transfer the discharge to the project reach from the gauge site, and then run a step-backwater or other flow model to predict slope and water surface elevation. Given the substantial short-comings in this method, our recommendation is that a crest gauge be installed at the project site.
