**Gillespie Golf Course (Mile Run Creek) Stream Restoration  
Greensboro, North Carolina**

**Final Annual Monitoring Report**

**Monitoring Year 2008**

**March 2009**

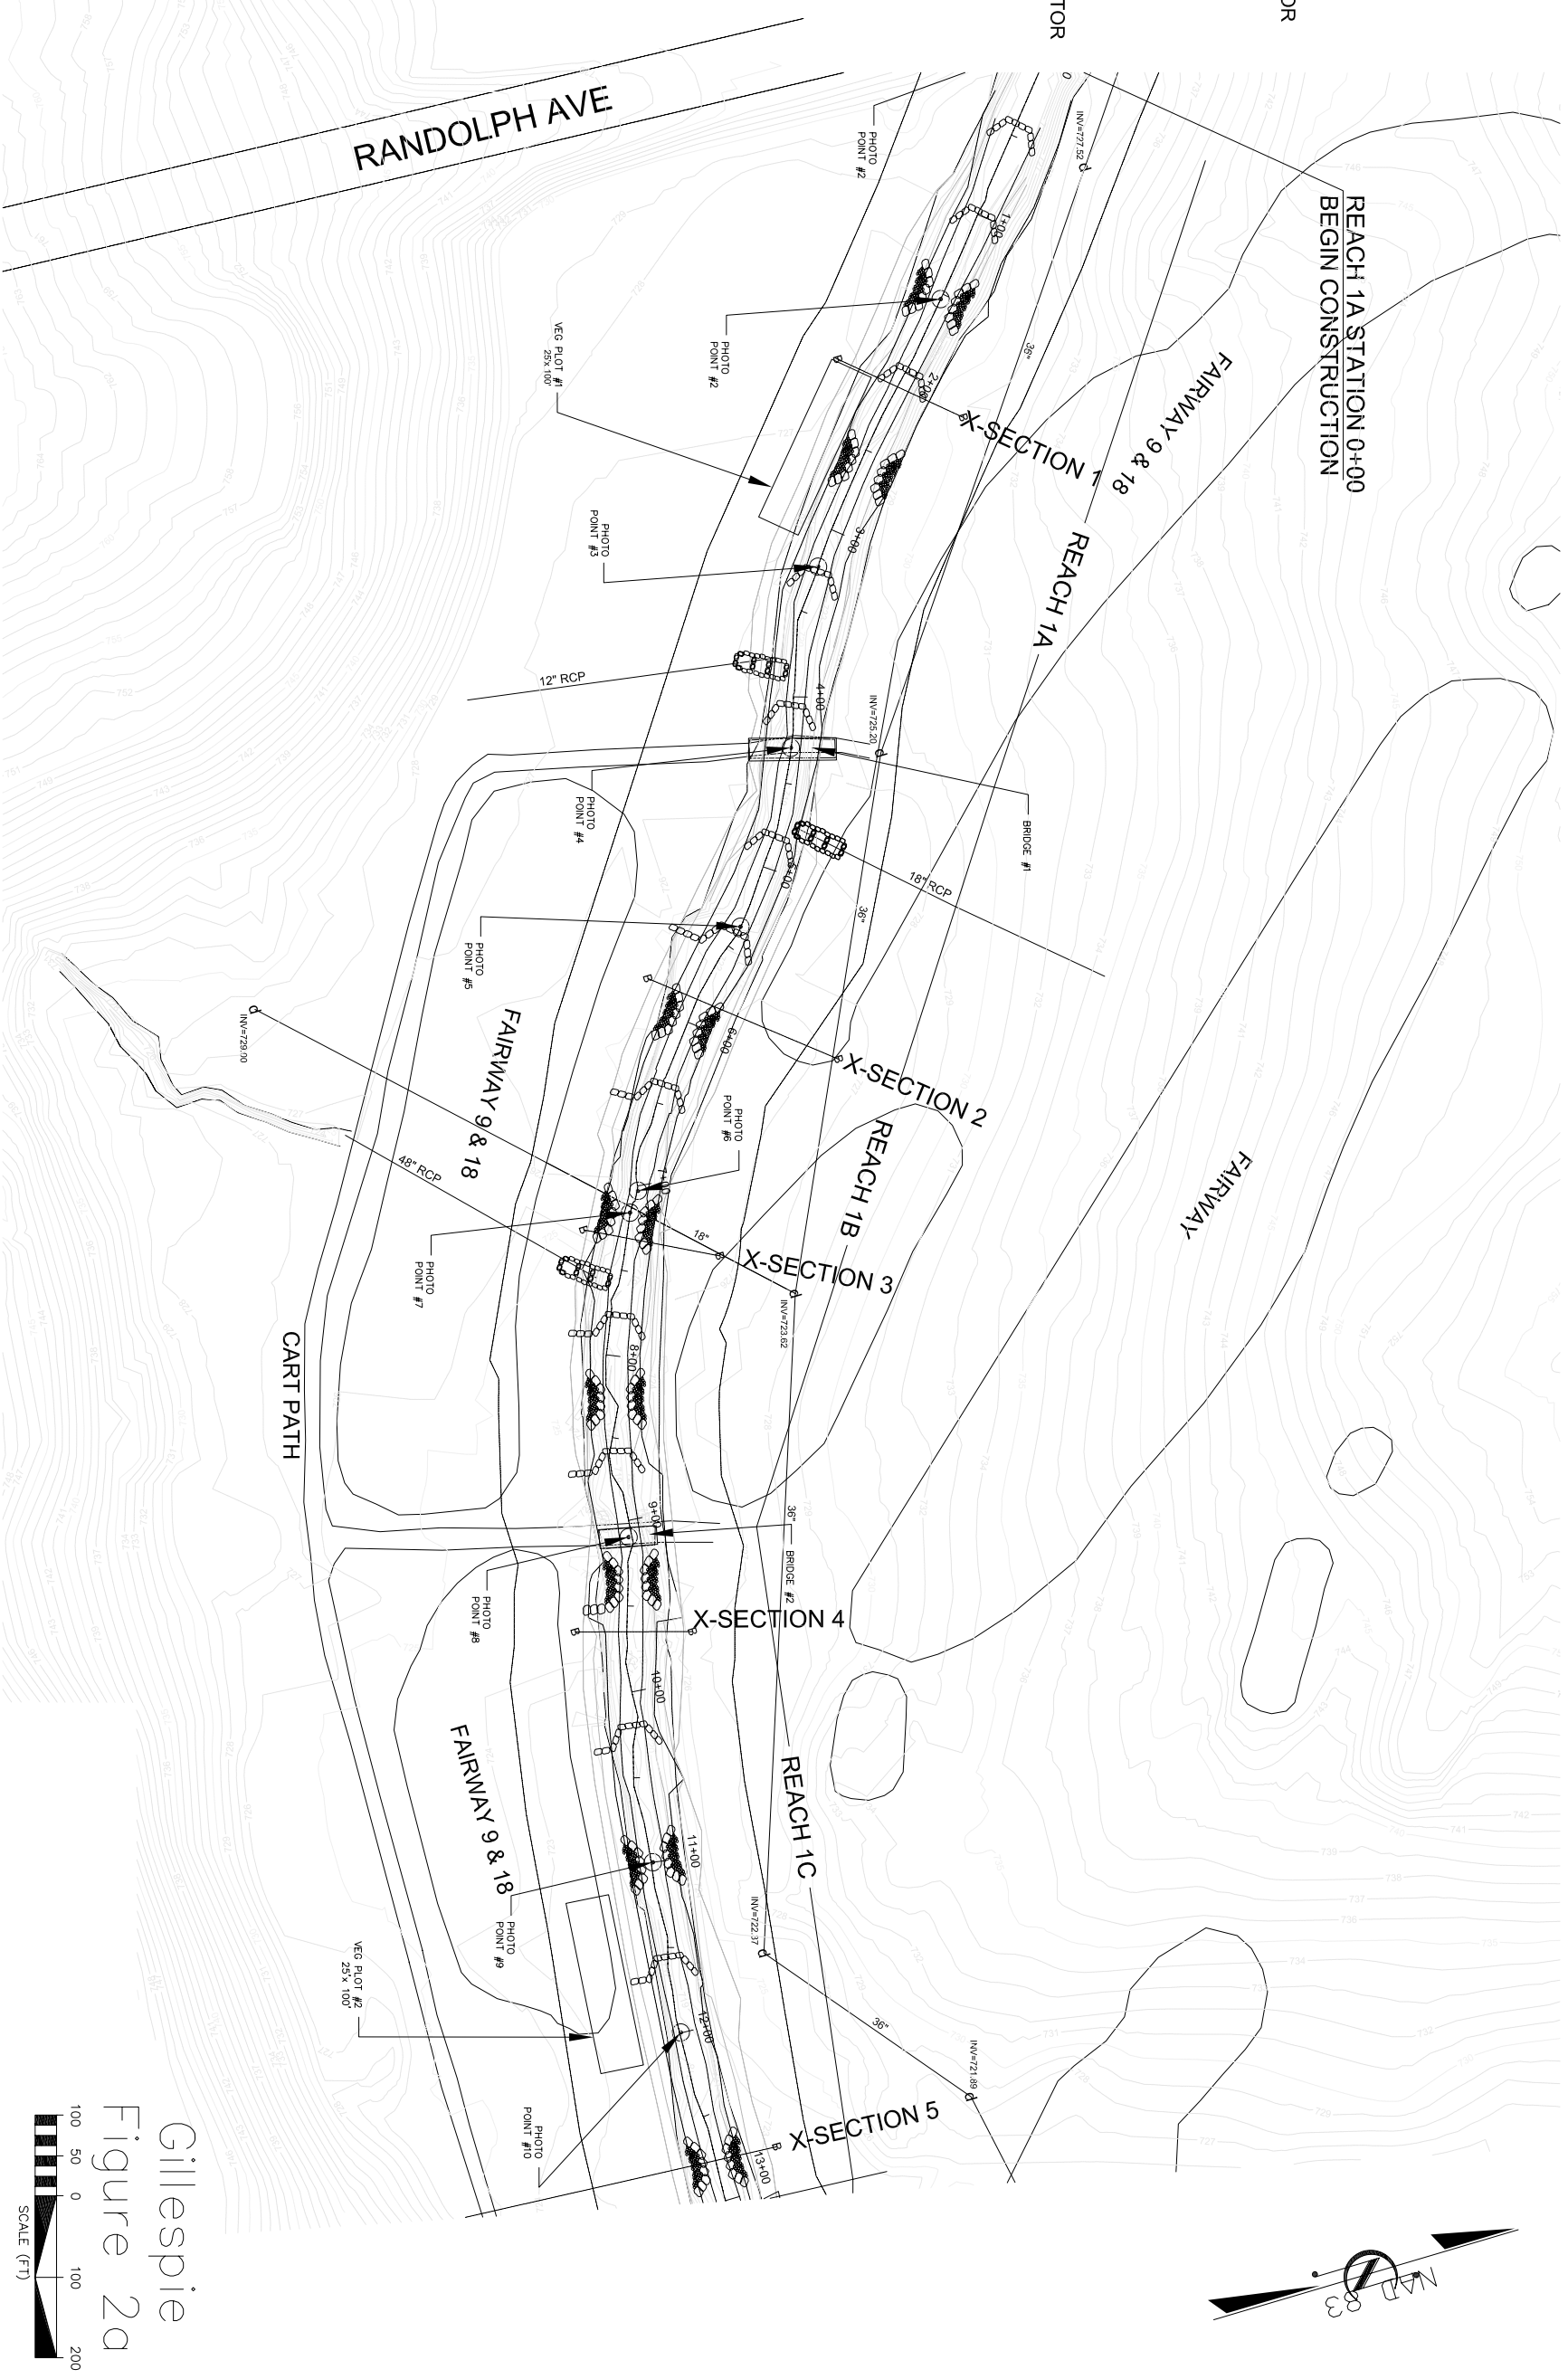
Gillespie  
Figure 2a  
SCALE (FT)  
100 50 0 100 200

An assessment of the channel stability was performed on July 9, 2008 by WK Dickson and Co., Inc. Several areas of concern were observed and documented, including localized bank scour and aggradation. These problem areas are shown in Figure 2.

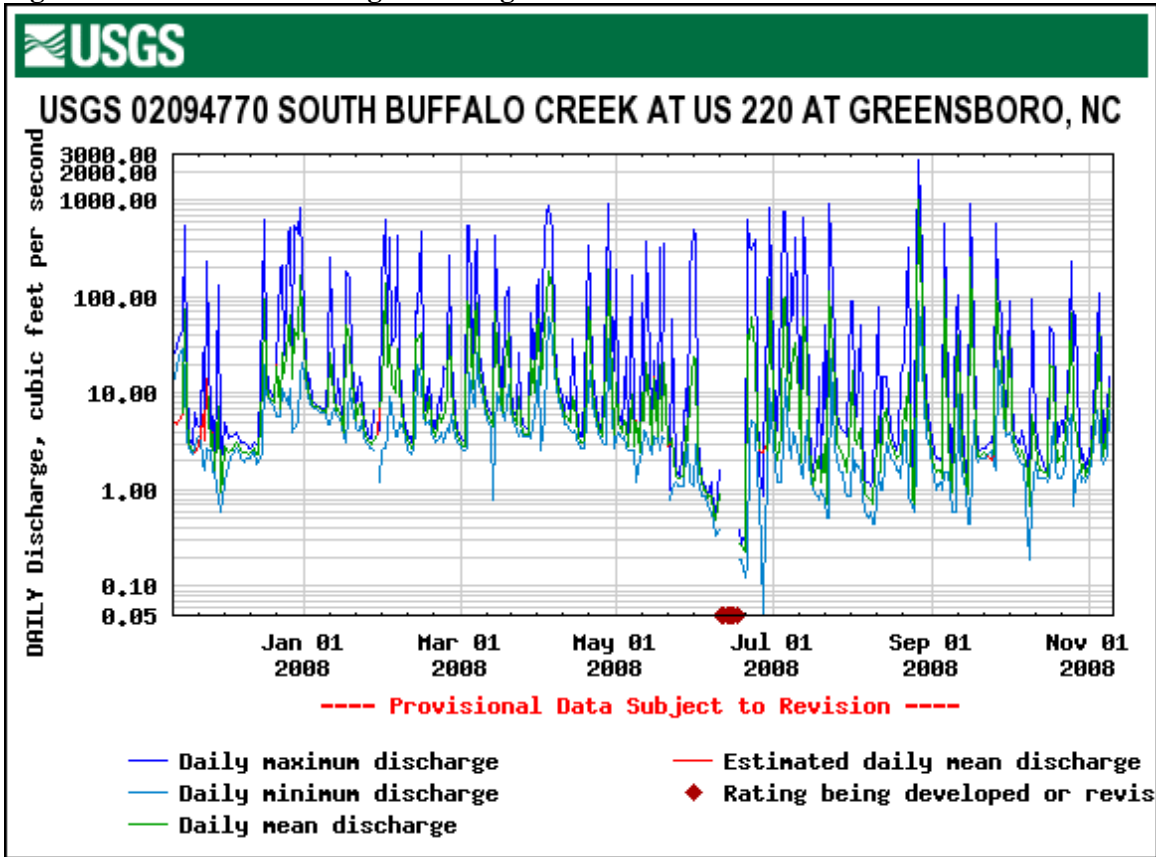
Figure 3. USGS Stream Gauge Discharge Data for South Buffalo Creek at US 220.

Potential occurrences were extrapolated based on USGS stream gauge discharge data for South Buffalo Creek at US 220 (approximately 2 miles downstream of the project site), which has a drainage area of 15.4 square miles (Figure 3). Bankfull events were determined by comparing the stream discharge cubic feet per second (cfs) against the drainage area on the urban Piedmont regional curve. According to the urban Piedmont regional curve, a bank full event occurs on a stream with a 15.4 mi<sup>2</sup> drainage area when the discharge is between 1,538 and 1,704 cfs. Based on USGS data and the Piedmont urban regional curves, one bankfull event occurred in 2008. Table V lists bankfull events as they occurred in 2008.

Although this technique has been used to establish the occurrence of bankfull events for the history of this project, it should be used as a proxy estimator. The idealized approach would be to transfer the discharge to the project reach from the gauge site, and then run a step-backwater or other flow model to predict slope and water surface elevation. The event captured by the USGS gauge was the result of Tropical Storm Fay, which produced 6-10 inches of rain in central Guilford County, and at least 6 inches throughout the Buffalo Creek drainage basin, with reports of widespread flooding in Greensboro.
