**Glade Creek
Stream Restoration
NCEEP Project Number: 854
Monitoring Contract Number: D08033S
Monitoring Year 2
2012 Final Report**

**Submitted to
North Carolina Ecosystem Enhancement Program
North Carolina Department of Environment and Natural Resources
November 2012**

Glade Creek Stream Restoration 2012 Monitoring Report (MY 2)

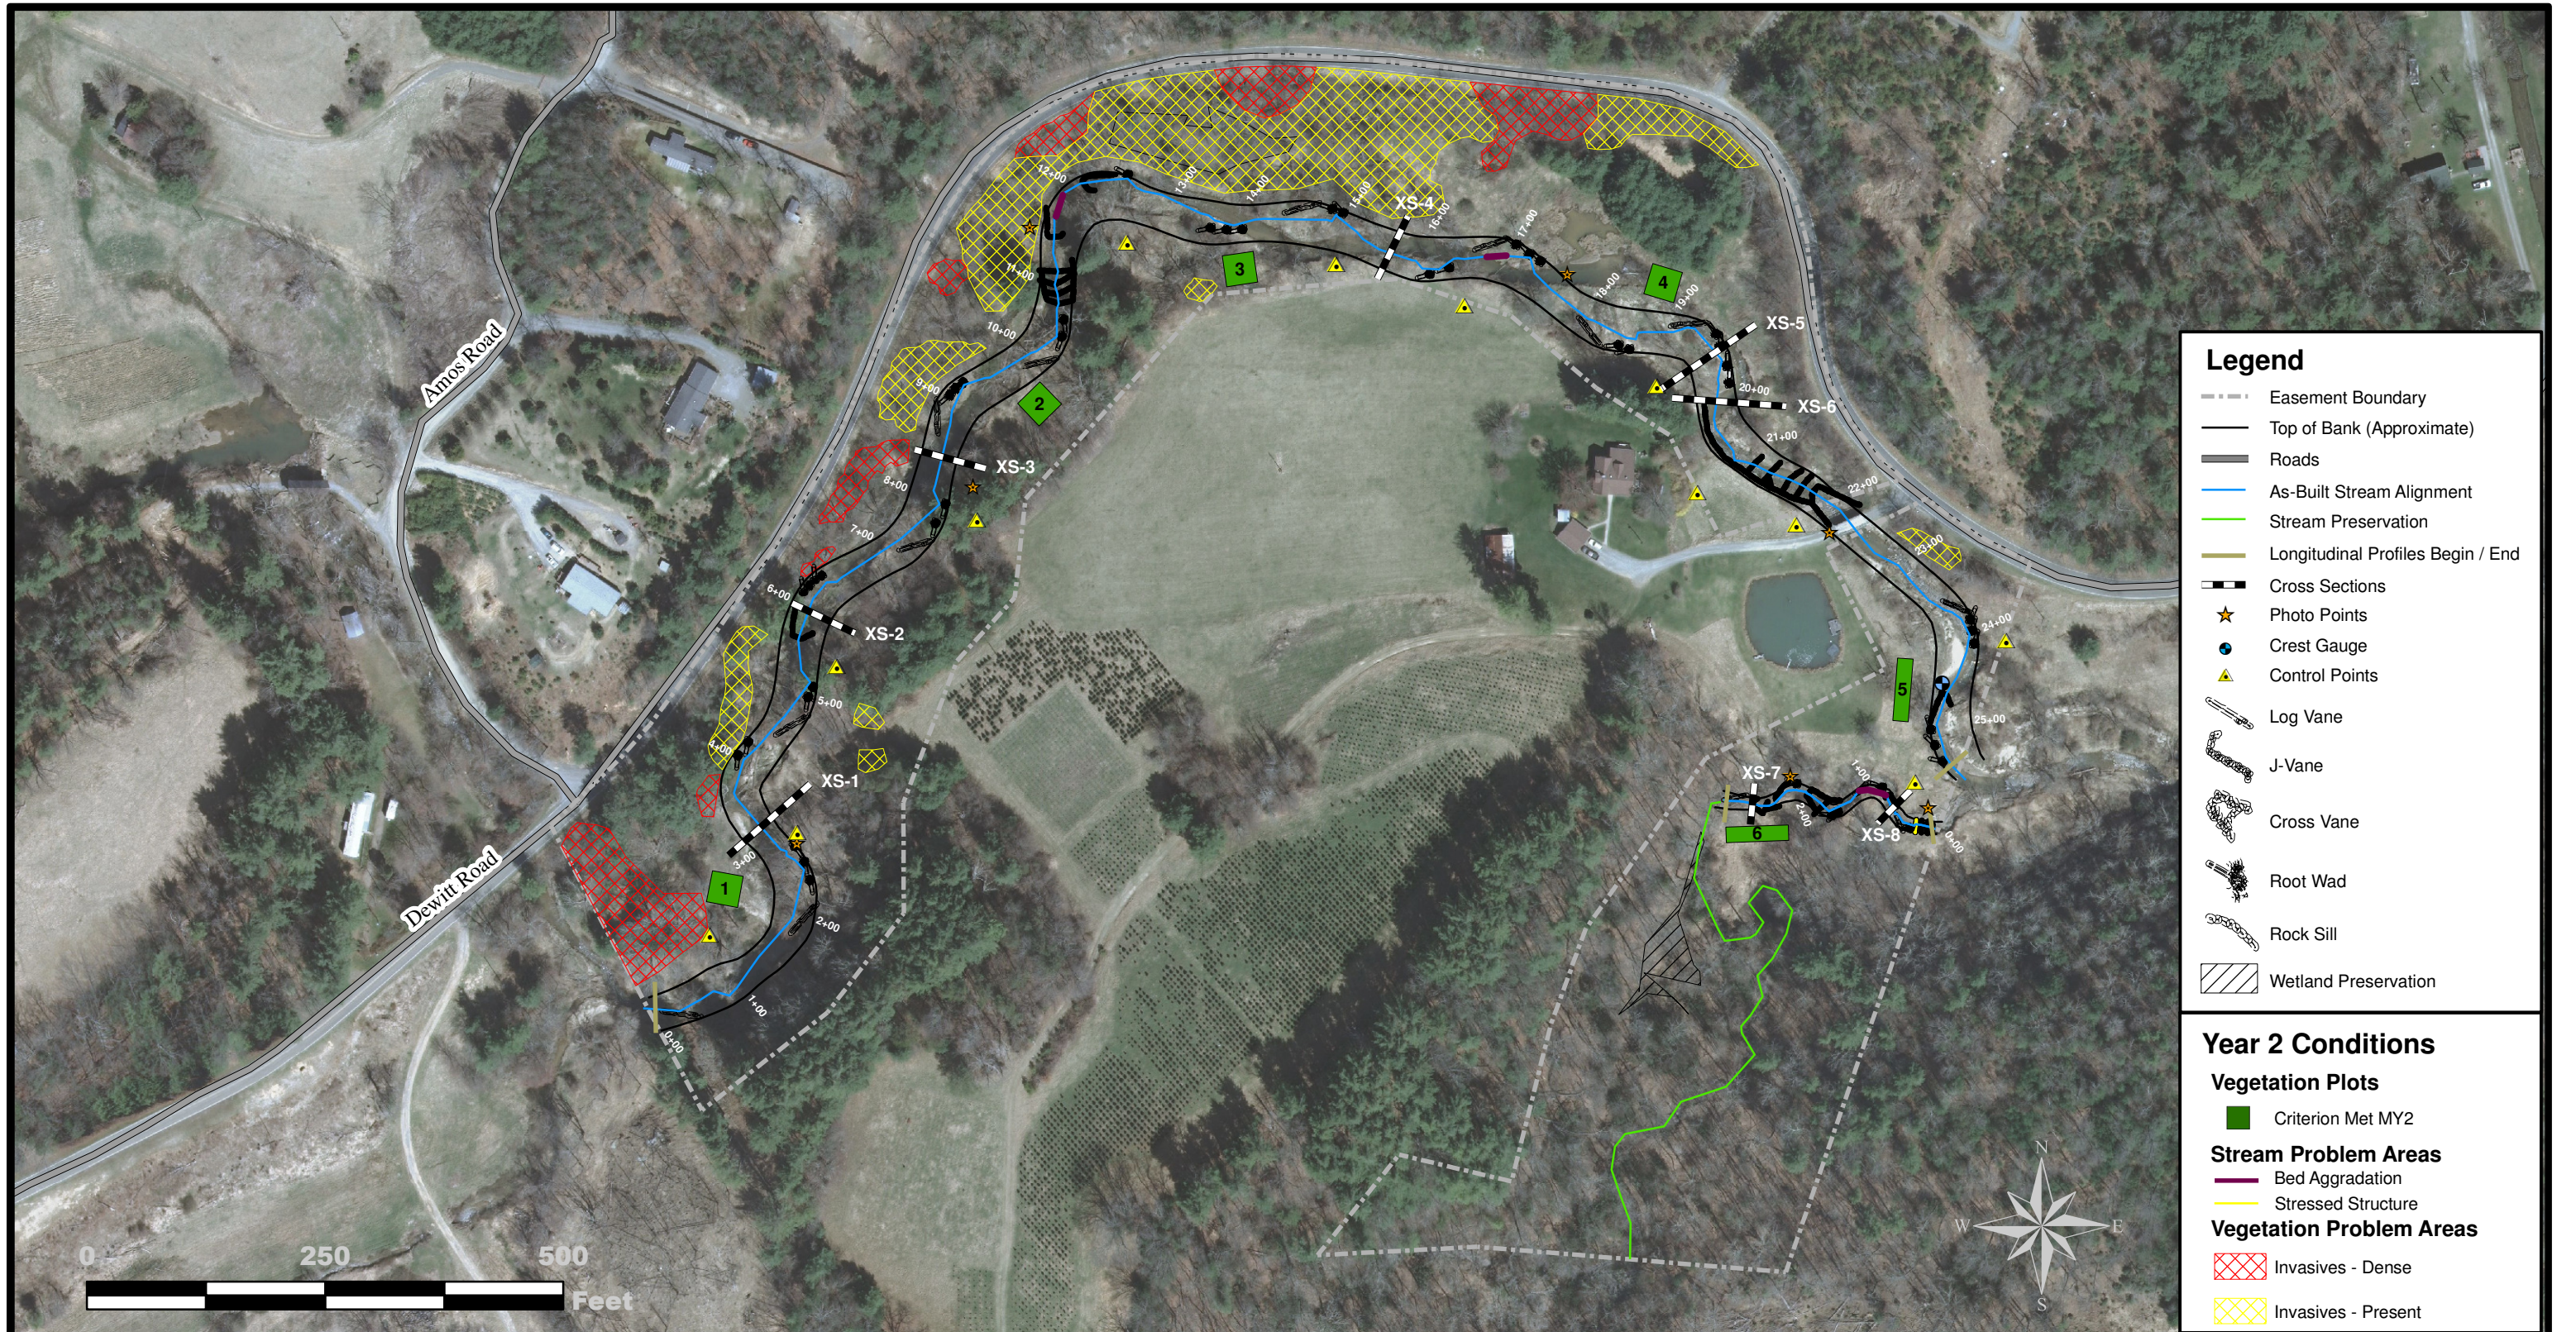
Figure 2. Integrated Current Condition Plan View - Final

Stream longitudinal profiles remained stable between monitoring years. While three areas of bed aggradation were present, no other significant instability in the stream channel were identified. No bankfull events have been documented since construction was completed.
