**Glade Creek
Stream Restoration
NCDMS Project Number: 854
Monitoring Contract Number: D08033S
Monitoring Year 5
2015 Final Report**

**Submitted to
North Carolina Division of Mitigation Services
North Carolina Department of Environmental Quality
December 2015**

Glade Creek Stream Restoration 2015 Monitoring Report (MY 5)

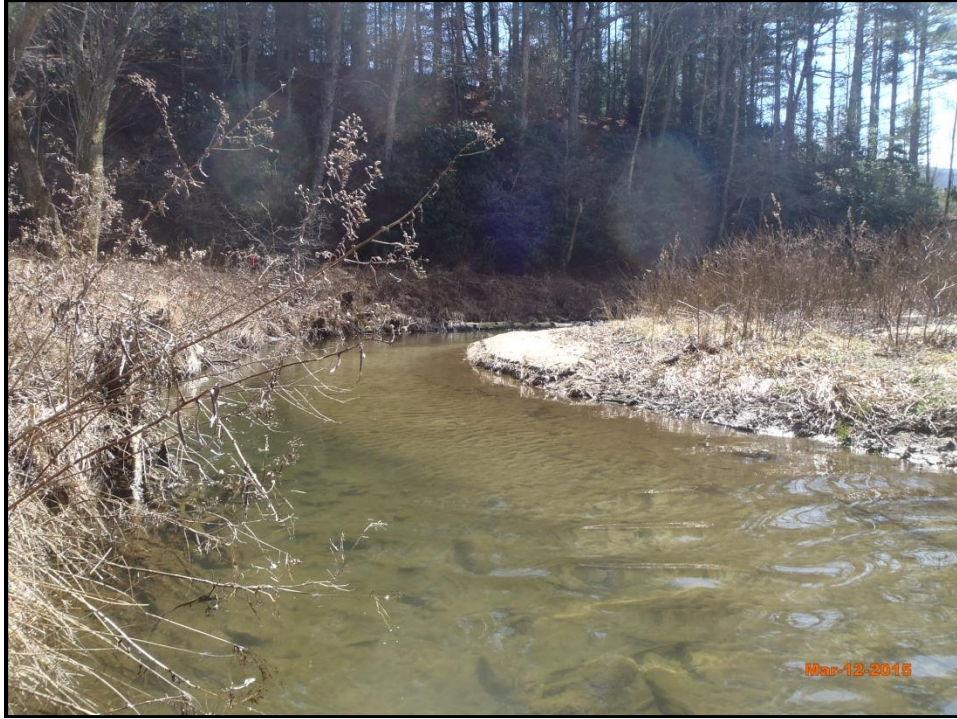
Glade Creek – Permanent Photo Station 1
Upstream

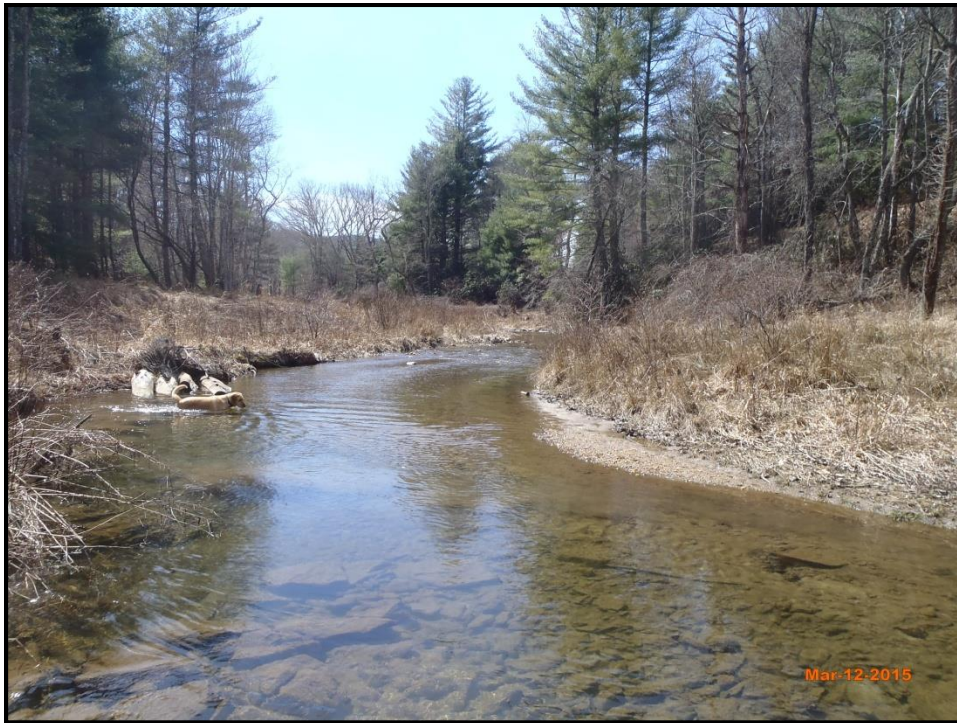
Glade Creek – Permanent Photo Station 2
Upstream

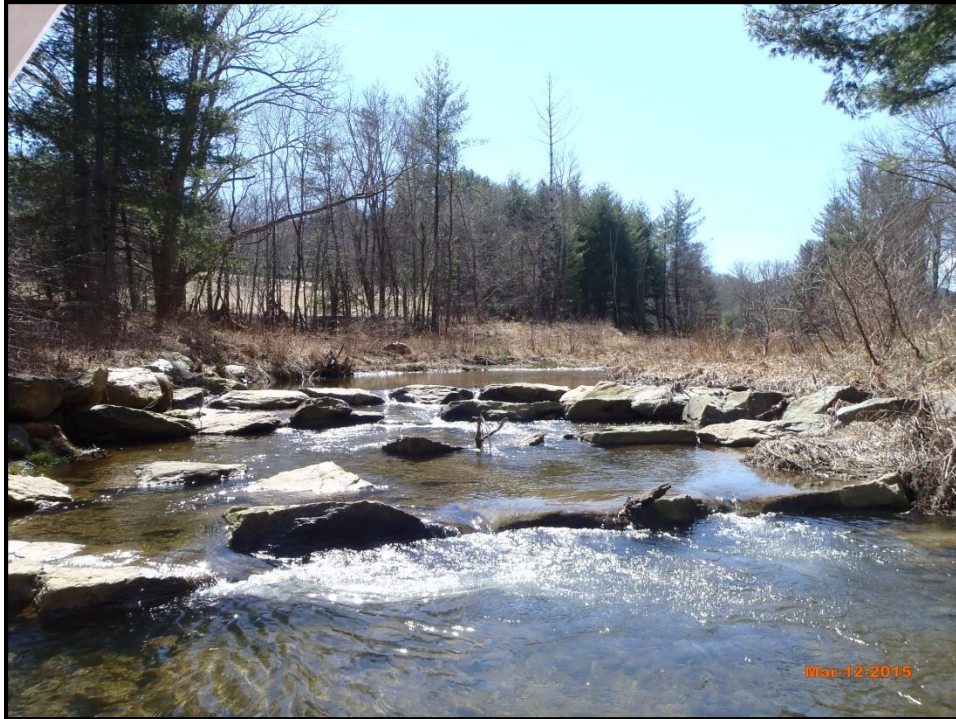
Glade Creek – Permanent Photo Station 3
Upstream

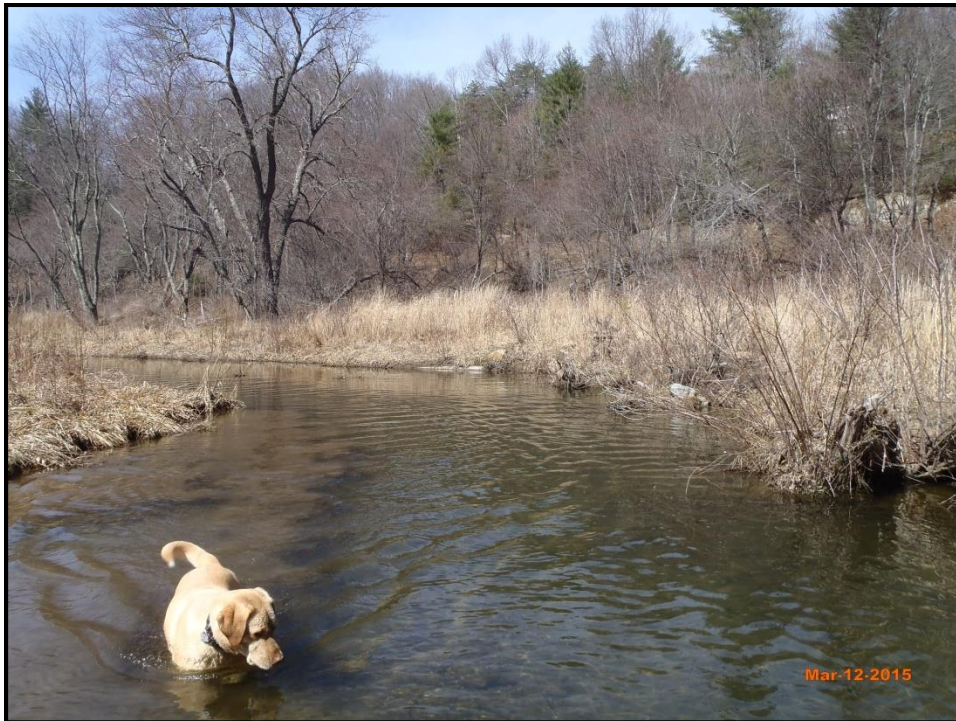
Glade Creek – Permanent Photo Station 4
Upstream

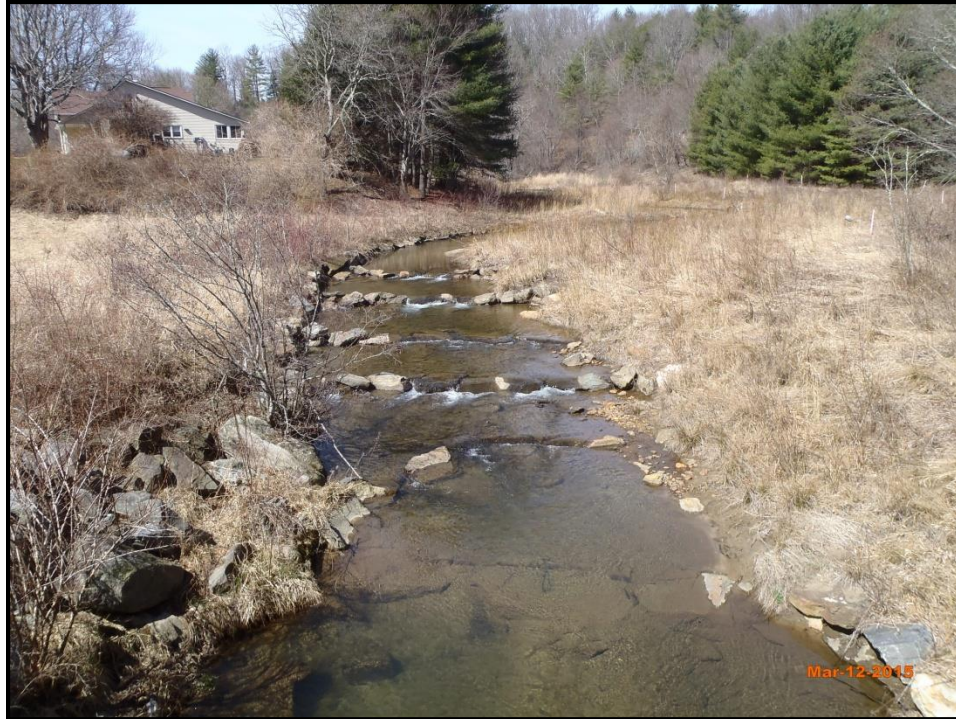
Glade Creek – Permanent Photo Station 5
Upstream

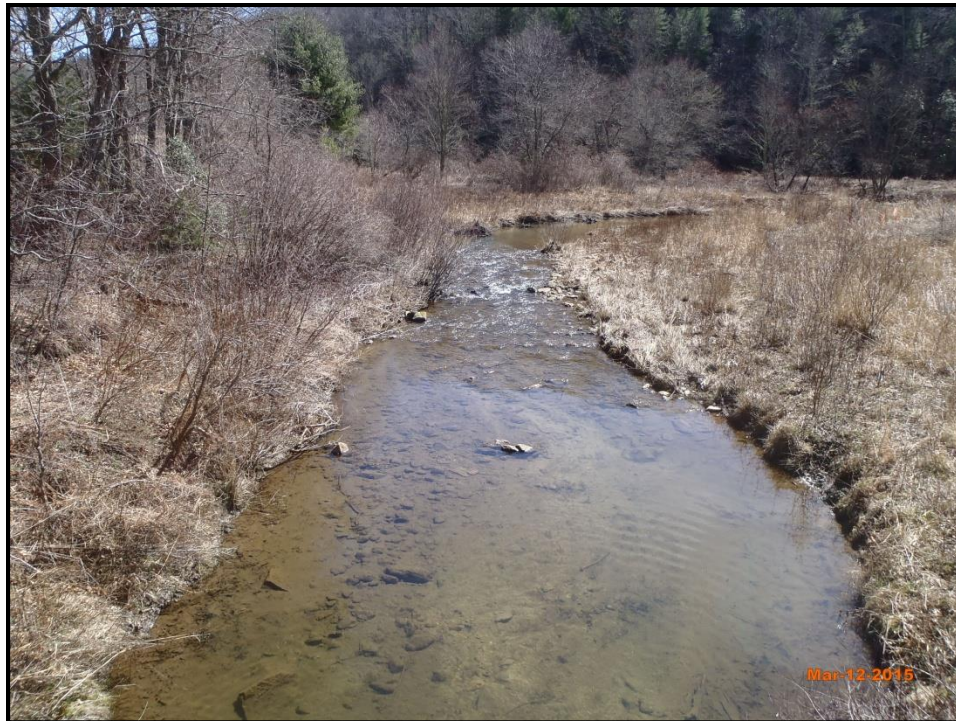
Glade Creek – Permanent Photo Station 5
Downstream

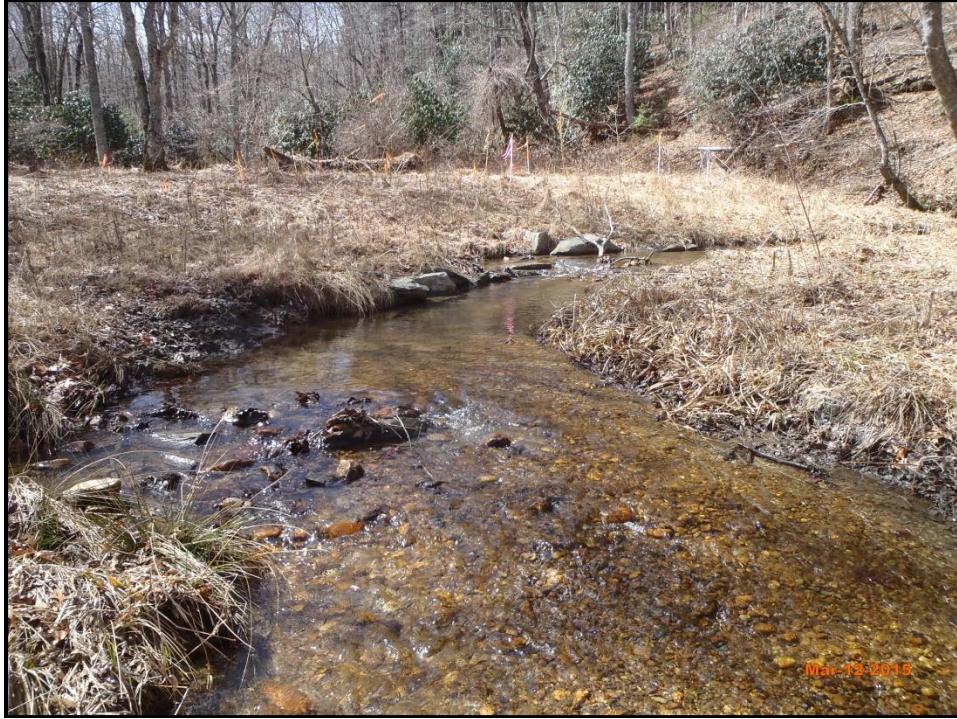
Unnamed Tributary Lower – Permanent Photo Station 6
Upstream

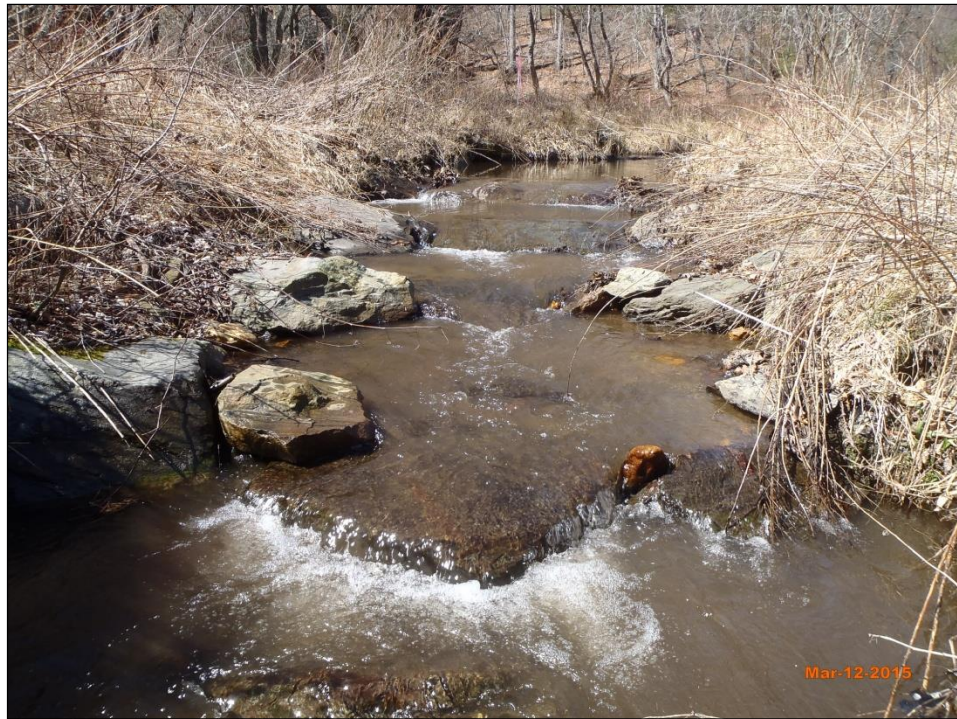
Unnamed Tributary Lower – Permanent Photo Station 7
Upstream

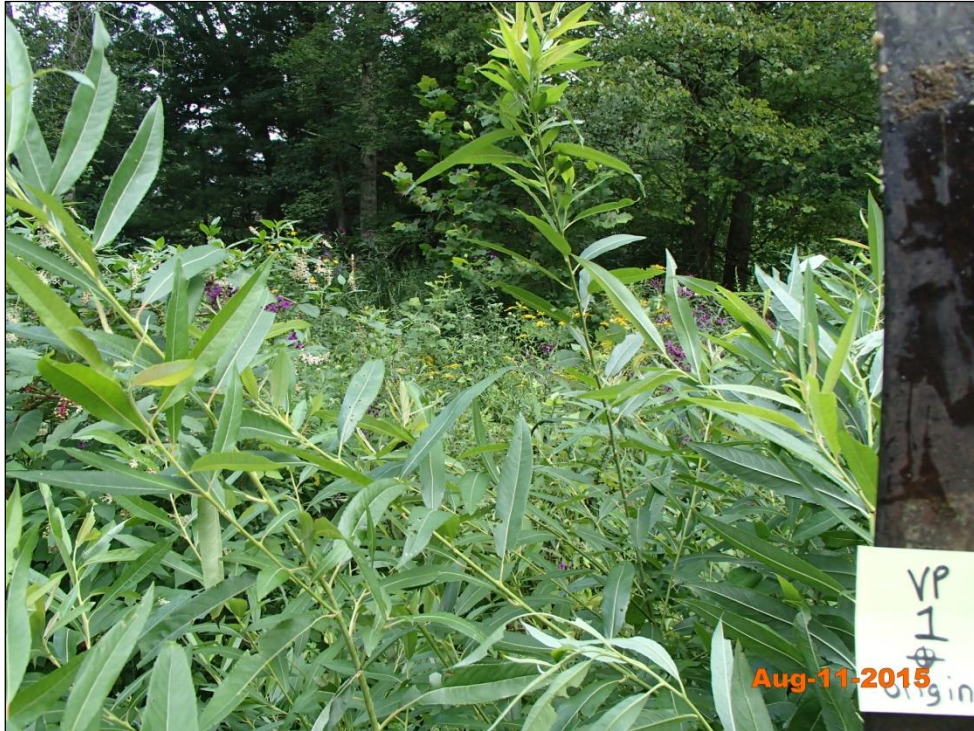
Vegetation Monitoring Plot 1
Monitoring Year 5 – August 11, 2015

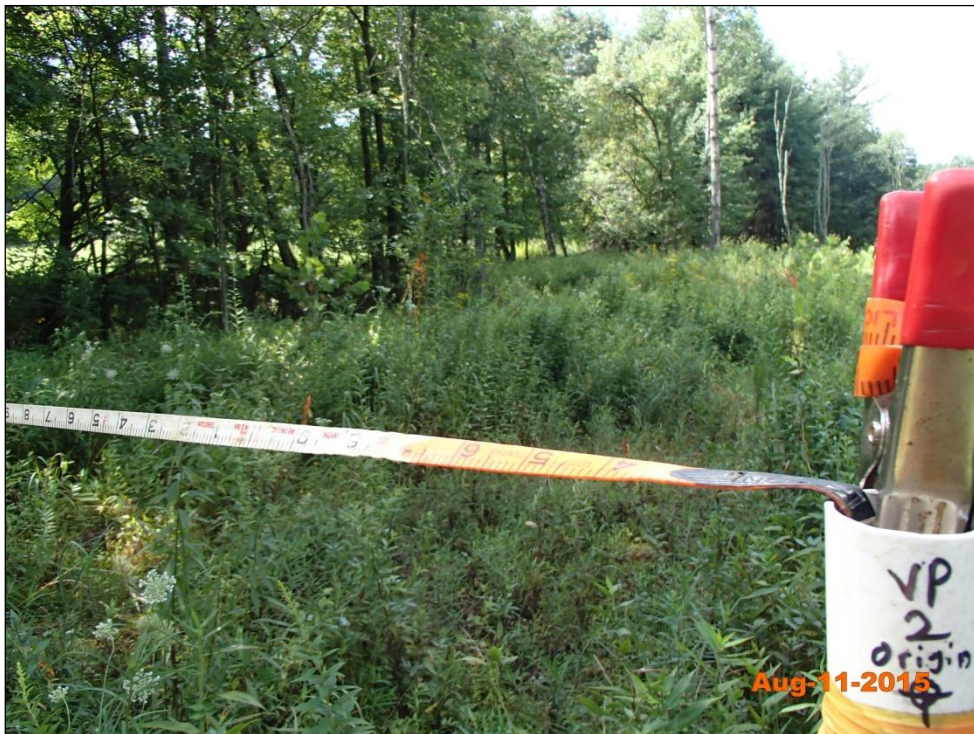
Vegetation Monitoring Plot 2
Monitoring Year 5 – August 11, 2015

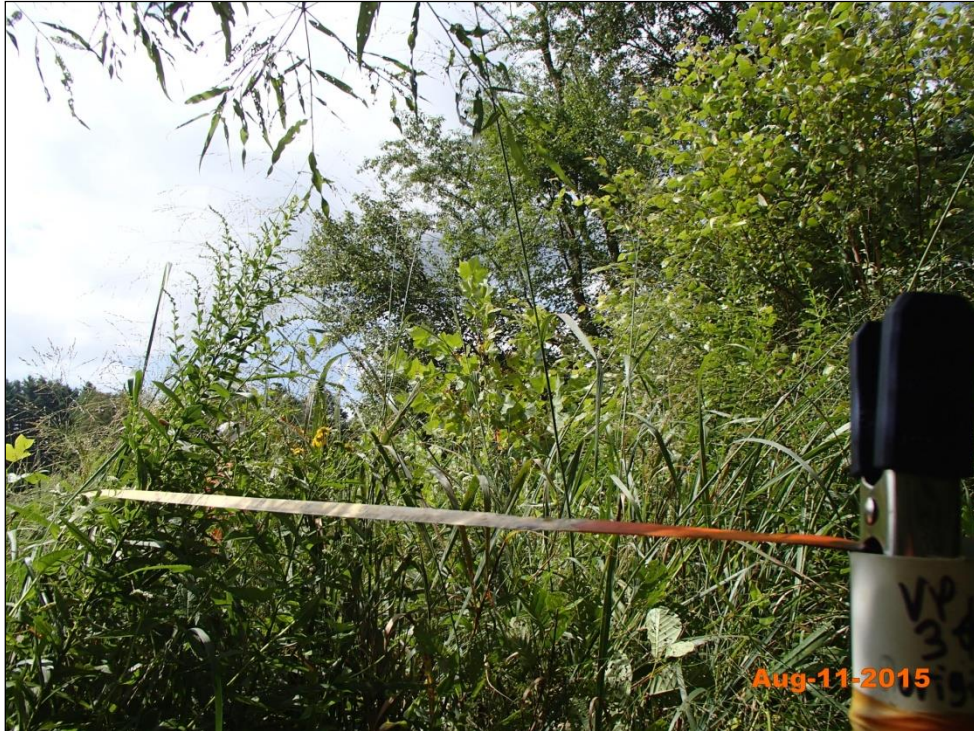
Vegetation Monitoring Plot 3
Monitoring Year 5 – August 11, 2015

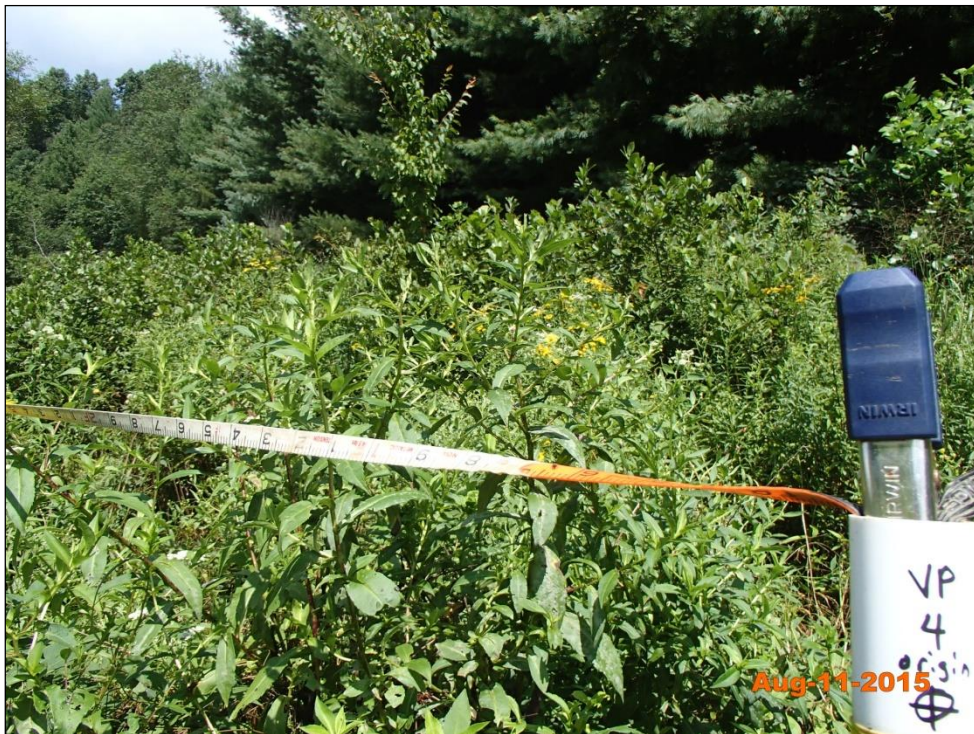
Vegetation Monitoring Plot 4
Monitoring Year 5 – August 11, 2015

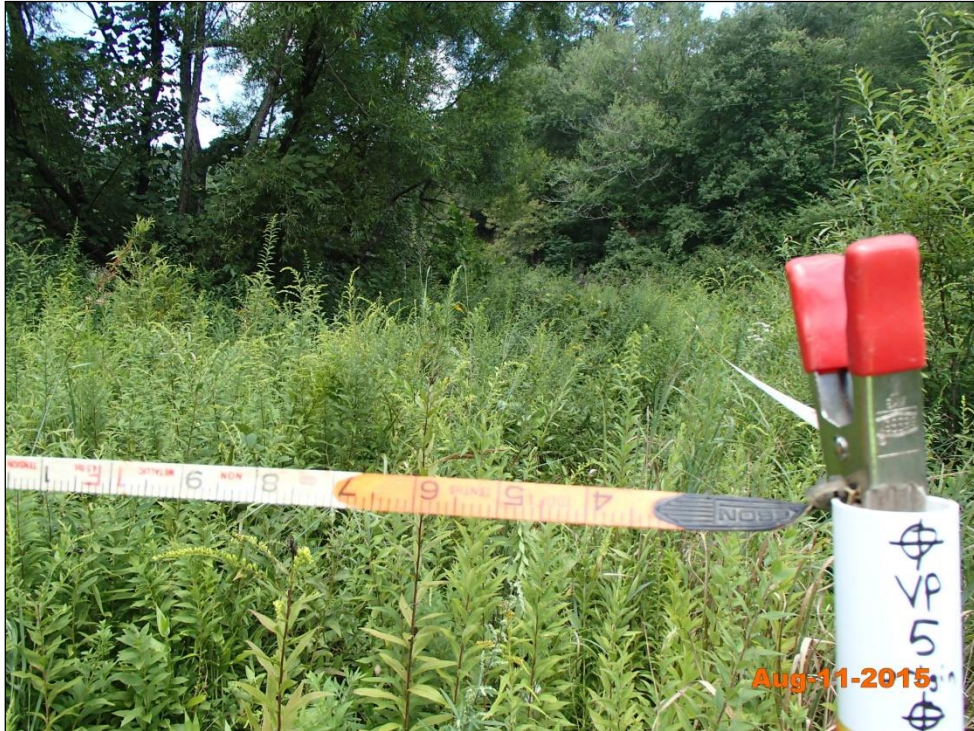
Vegetation Monitoring Plot 5
Monitoring Year 5 – August 11, 2015

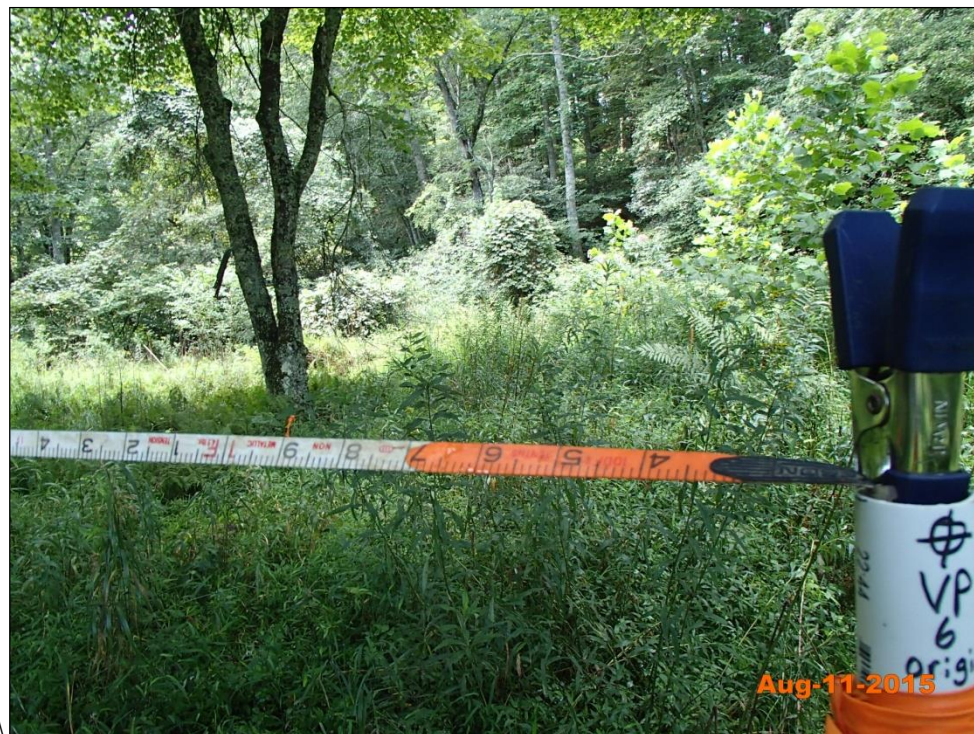
Vegetation Monitoring Plot 6
Monitoring Year 5 – August 11, 2015

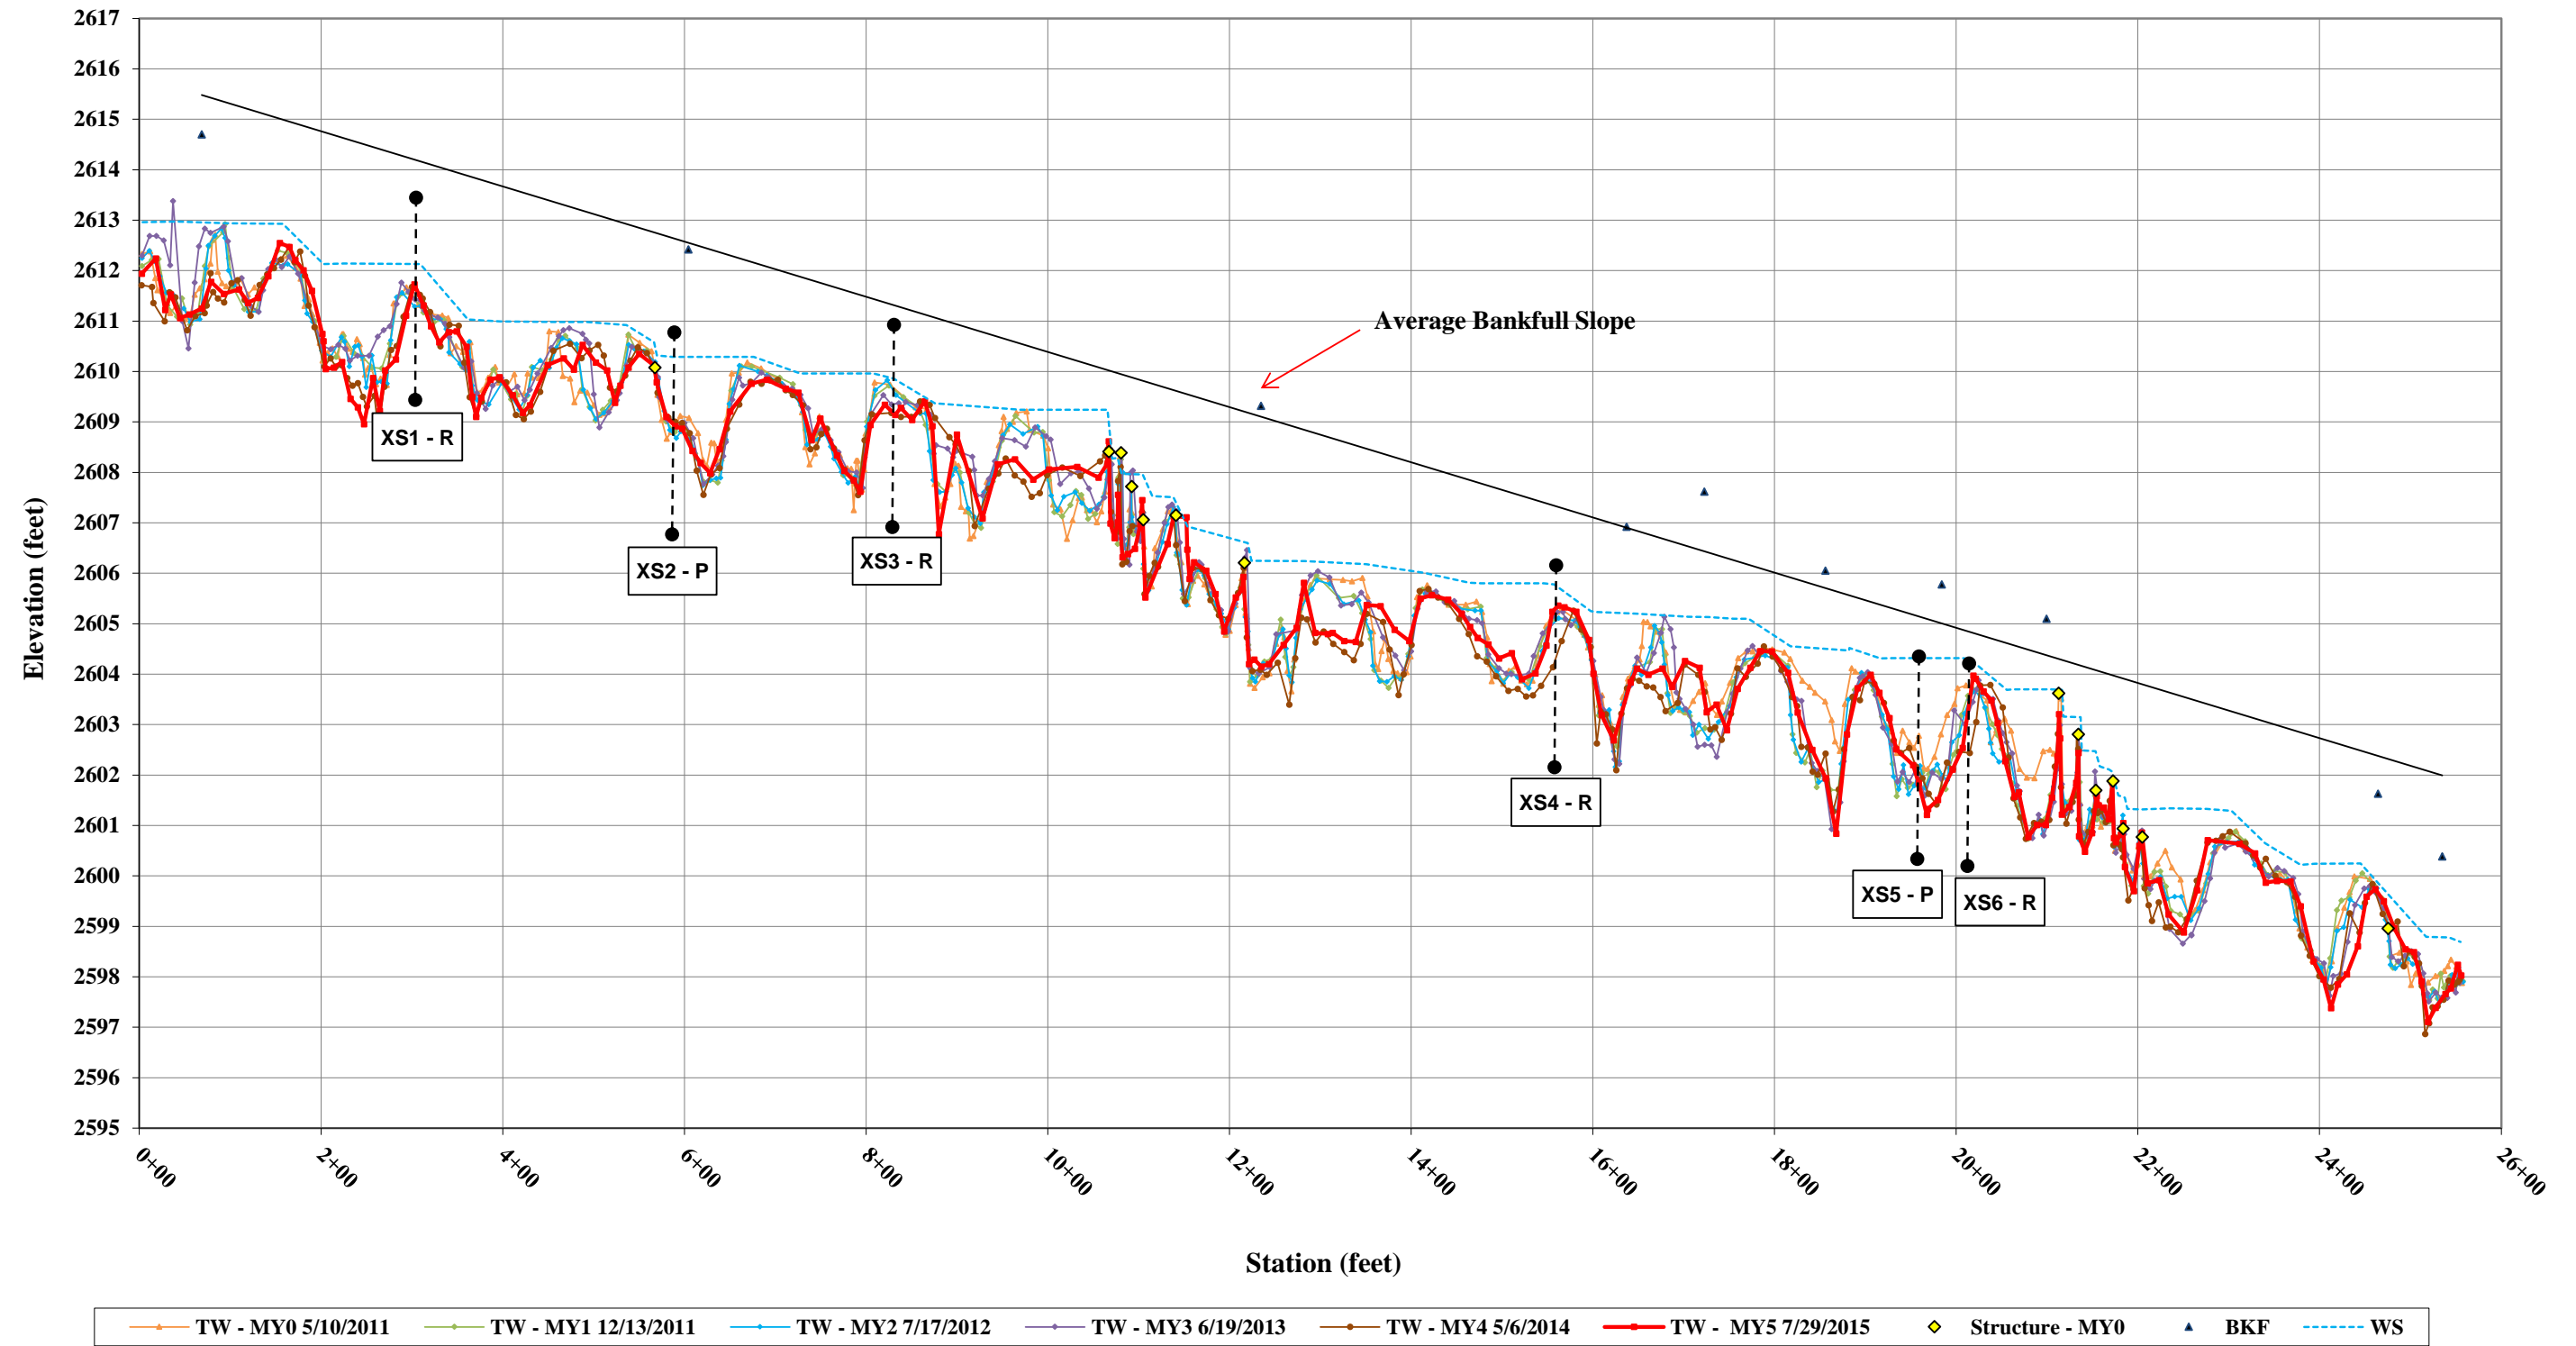
**Glade Creek Mainstem
Longitudinal Profile
Staioning 0+03 - 25+58**

The stream longitudinal profile along the mainstem has remained relatively stable between MY4 and MY5. Bed scour from 9+75 to 9+99 and subsequent deposition in the pool has resulted in a flattening of the bed profile in the approach to the first rock vane/rock step structure series at station 10+67. This has reduced the number of pools in the reach from 28 to 27 and is noted in Table 11b and illustrated in the profile in Appendix D. Downstream of this series, the stream adjustments that occurred between stations 12+79 and 13+69 from MY3 and MY4 have stabilized and show no further signs of degradation. Data at XS-4 (riffle) indicates that downcutting along the left-descending bank presented in MY4 has not progressed. Fine sediment deposition along the bankfull bench has increased the bankfull bank height ratios on cross-sections 1, 4, and 6 from 1.0 to 1.2, 1.2, and 1.1 respectively. Although, adjustment in the channel are apparent within the reach, no signs of significant instability, such as sloughing banks or failing structures, have been documented. The stream longitudinal profile along the unnamed tributary has also remained relatively stable between MY4 and MY5. Scour in the riffle at station 1+90 and deposition in the subsequent pool at station 1+80 increased the riffle slope from 0.010 to 0.017. As in the mainstem, deposition of fine sediment has increased the bankfull bank height ratios from 1.0 to 1.3 in cross-sections 7 and 8 on the unnamed tributary. While these changes represent change from the baseline calculations, they are considered insignificant. In
