AS-BUILT BASELINE MONITORING REPORT

GLADE CREEK II RESTORATION PROJECT

Alleghany County, NC
SCO Project ID 07-07088-01
DMS Project Number 92343
DWR Number 09-0049
USACE Action ID 2009-00589

Data Collection Period: May 2016
Draft Submission Date: June 30, 2016
Final Submission Date: August 12, 2016

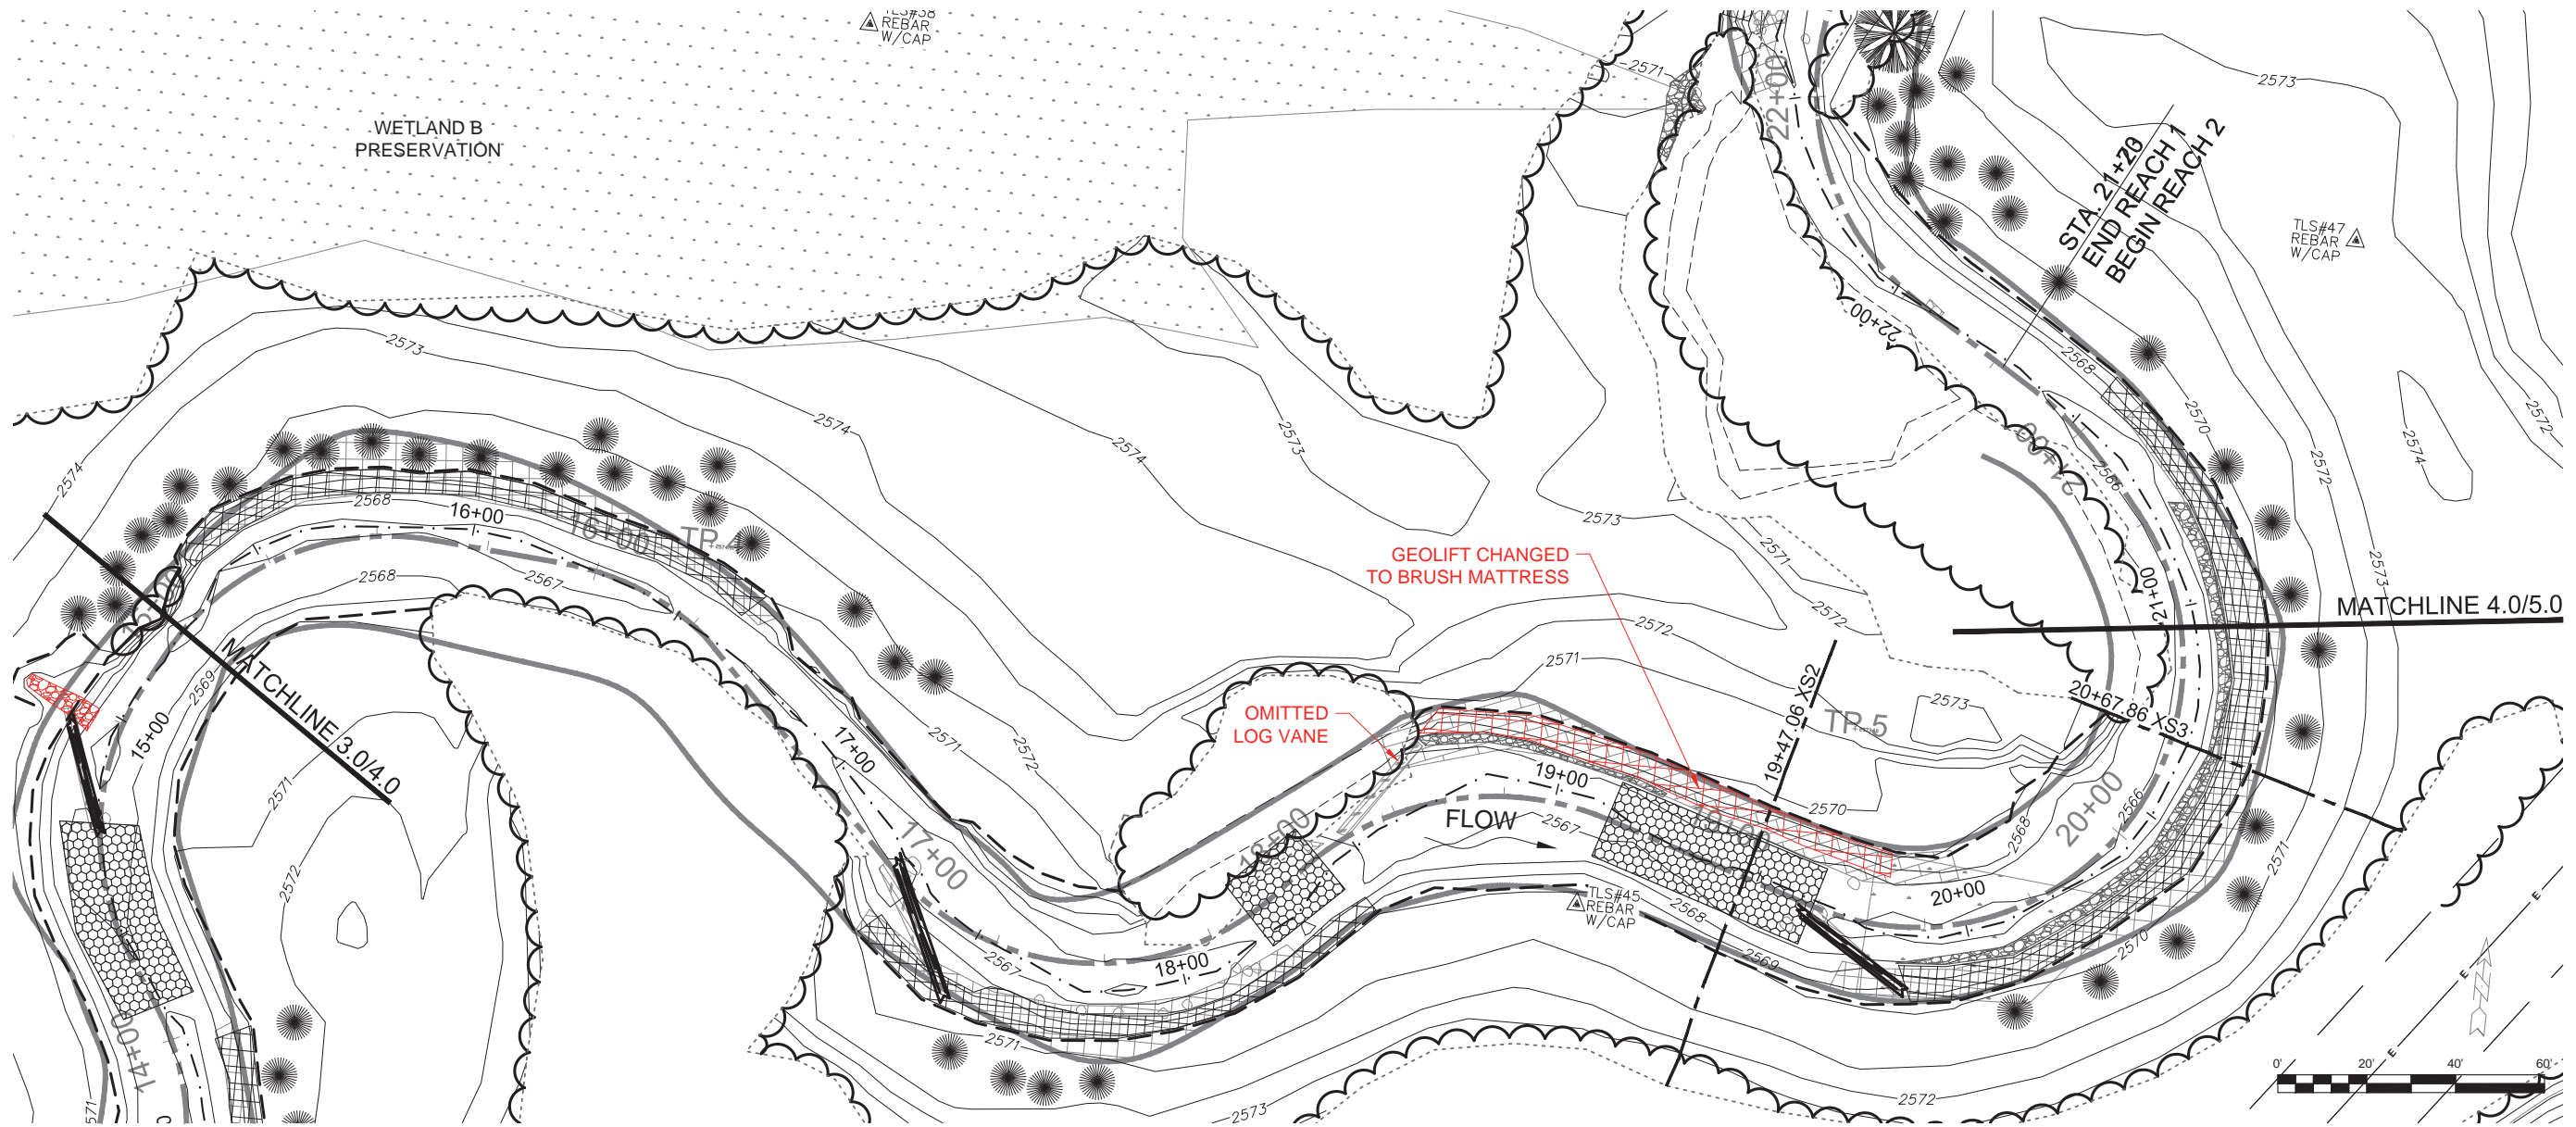
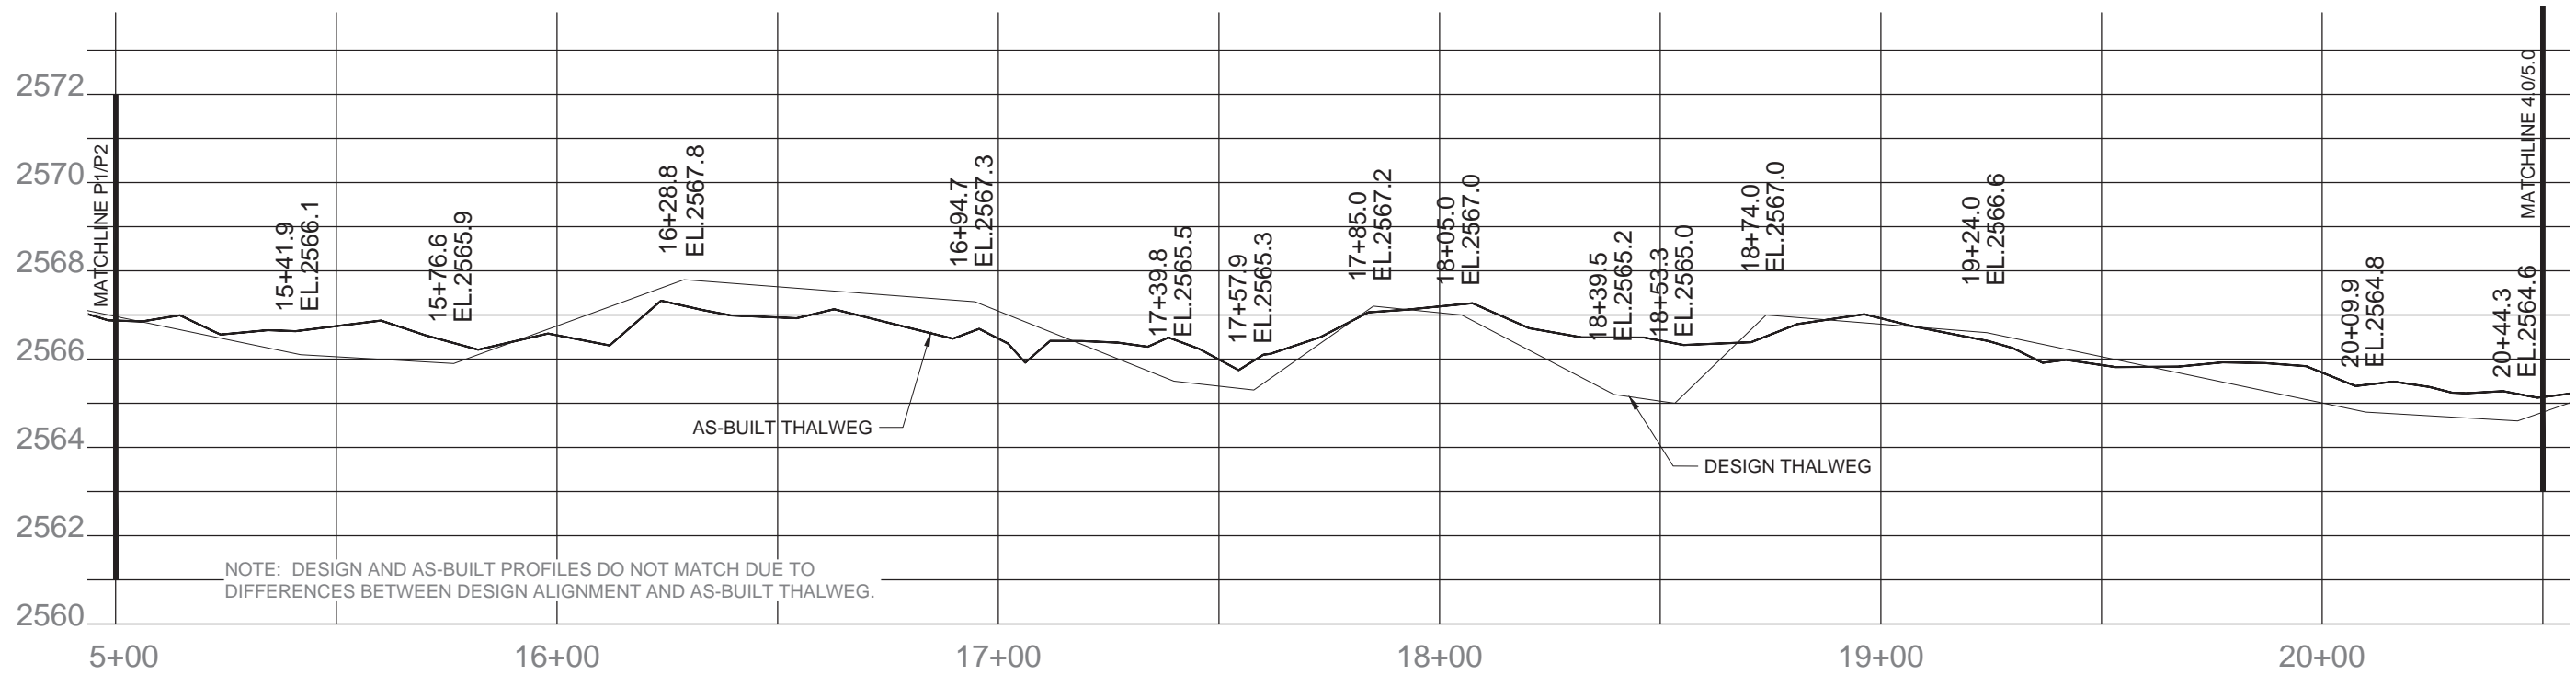
NOTE: DESIGN AND AS-BUILT PROFILES DO NOT MATCH DUE TO DIFFERENCES BETWEEN DESIGN ALIGNMENT AND AS-BUILT THALWEG.

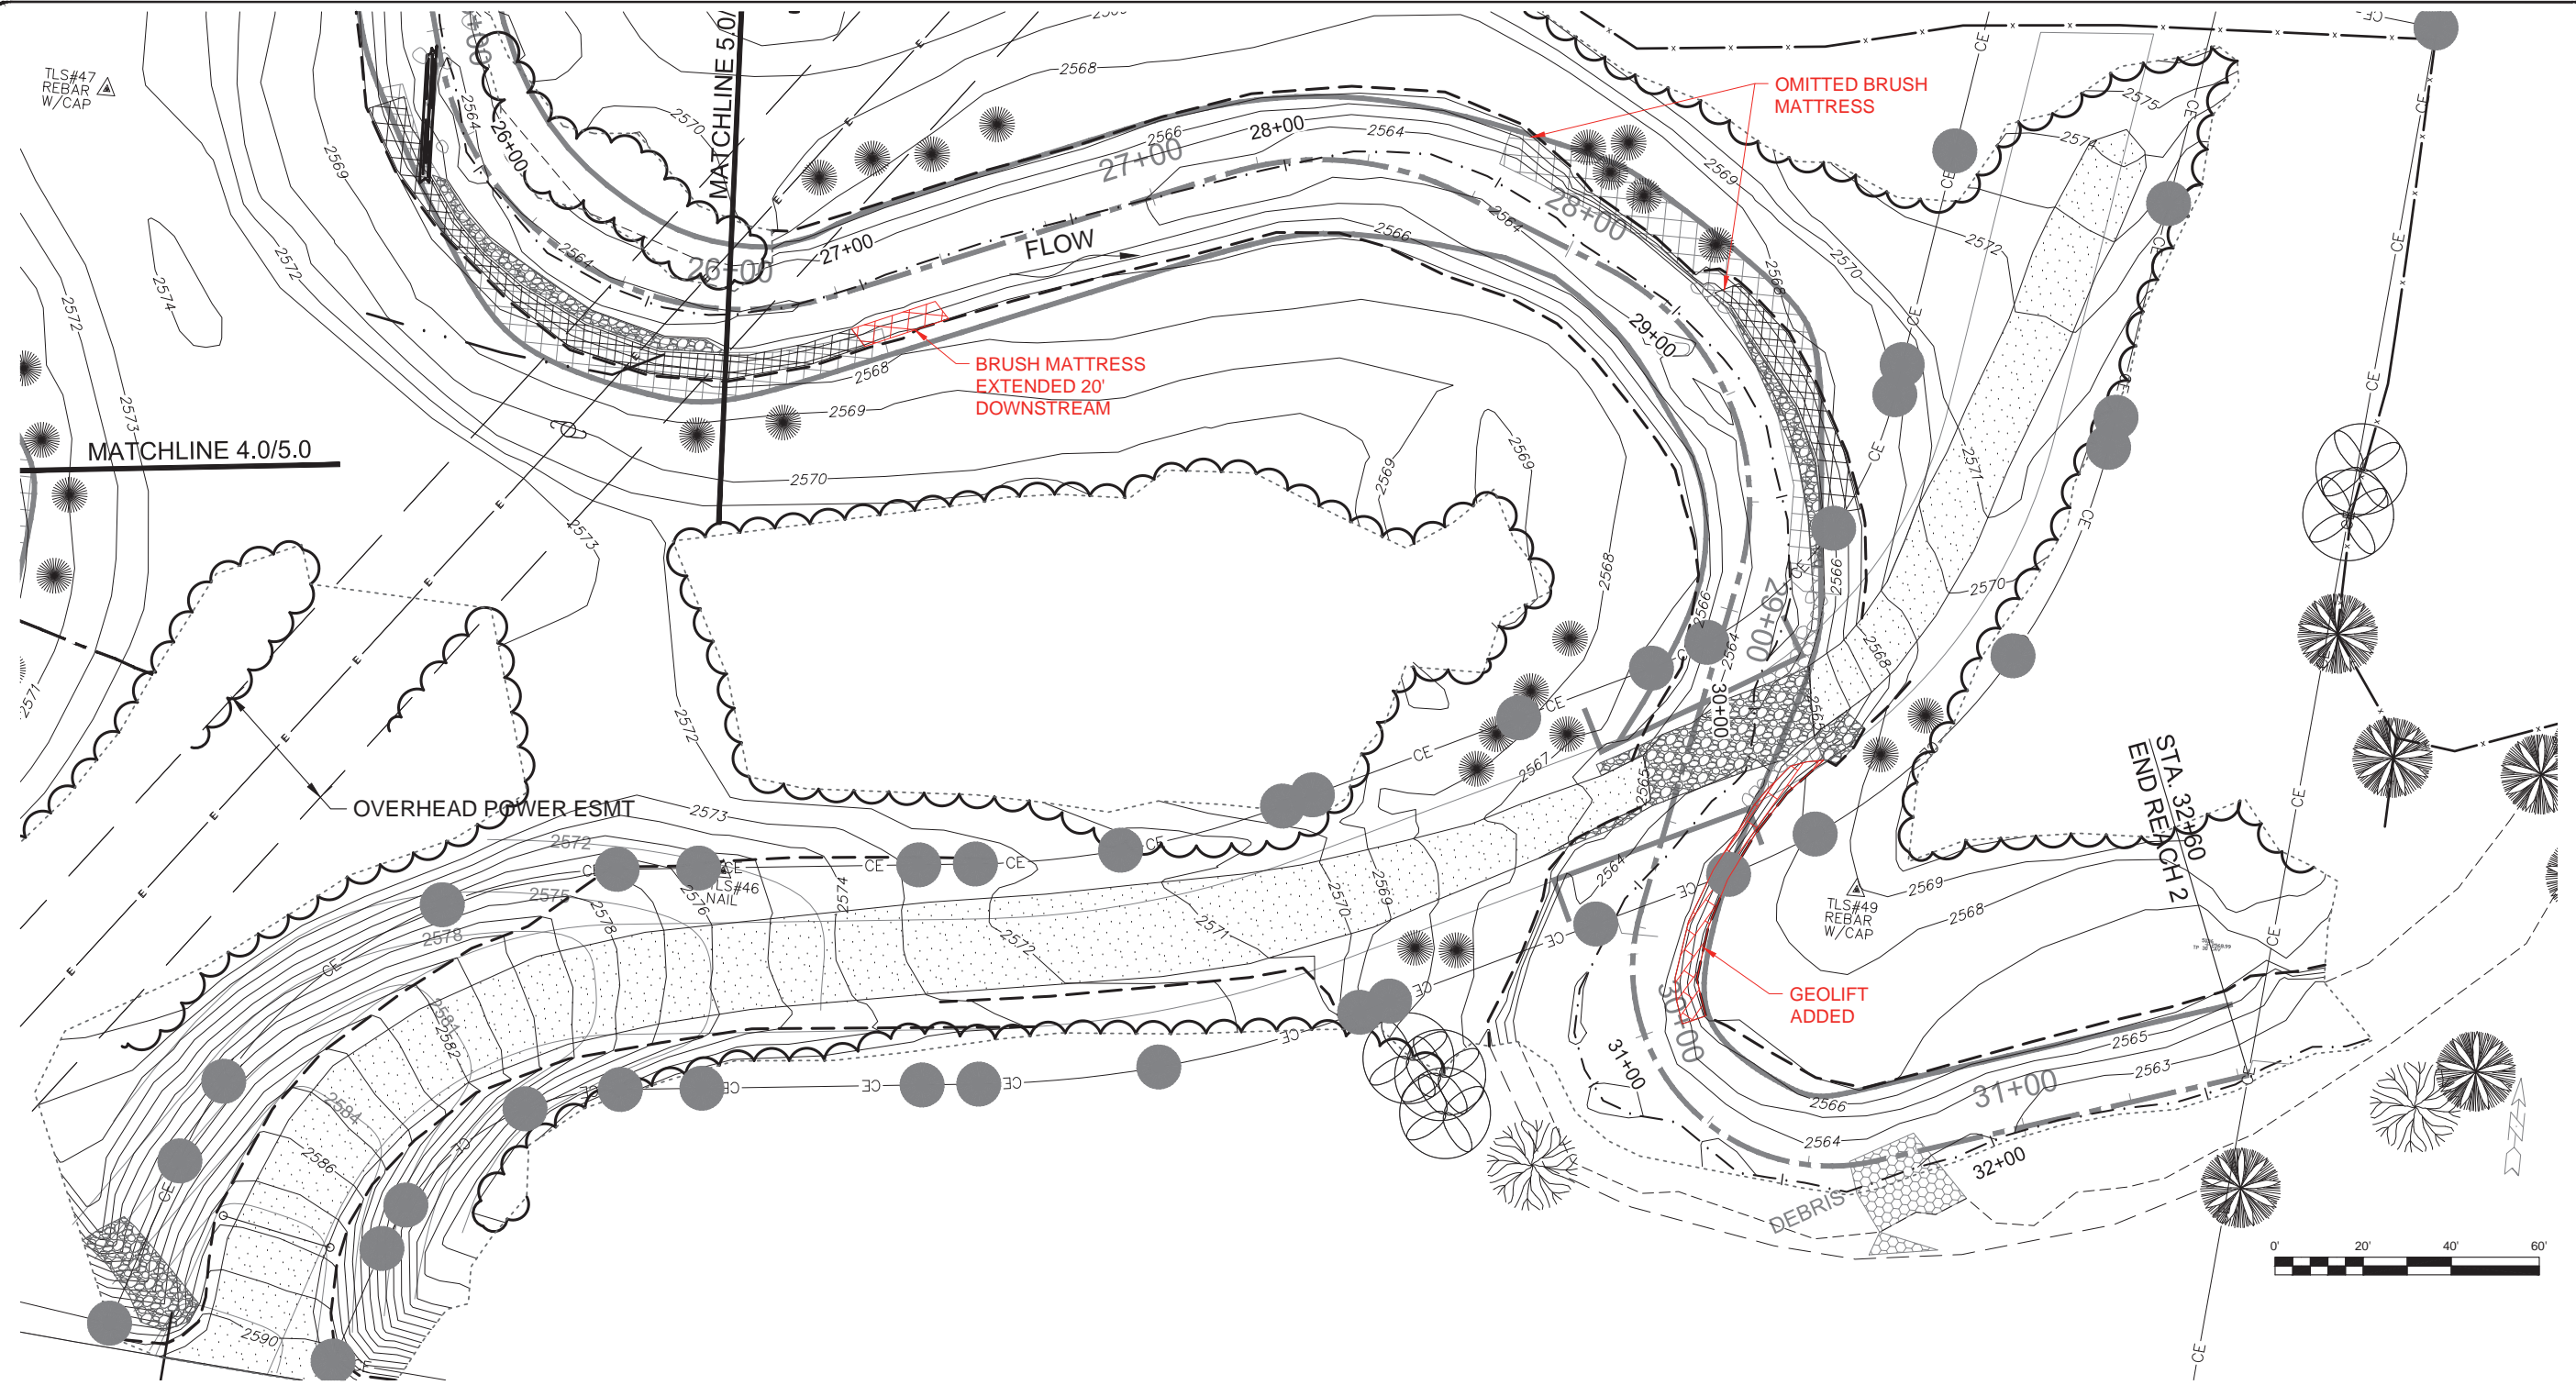
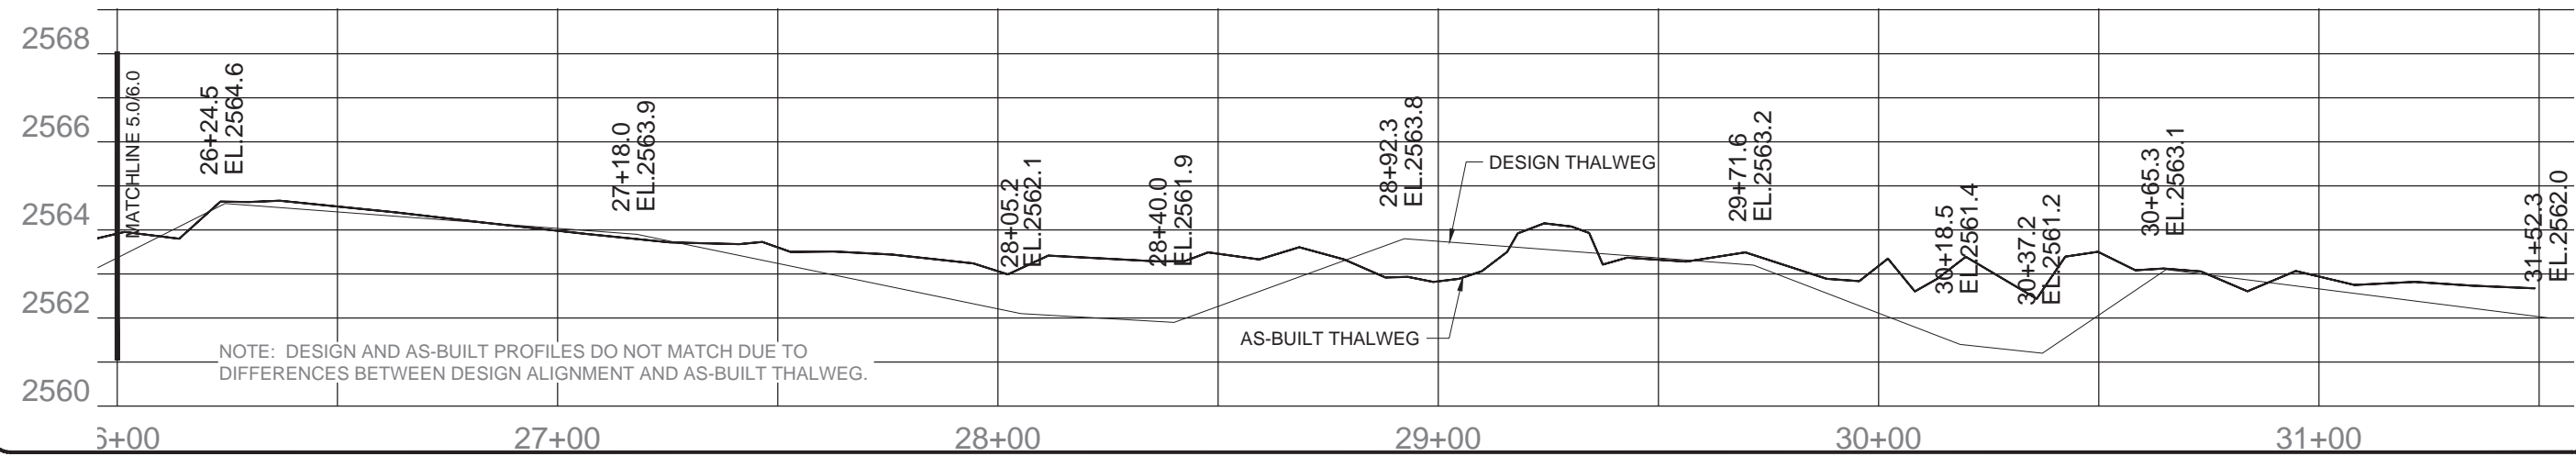
NOTE: DESIGN AND AS-BUILT PROFILES DO NOT MATCH DUE TO DIFFERENCES BETWEEN DESIGN ALIGNMENT AND AS-BUILT THALWEG.

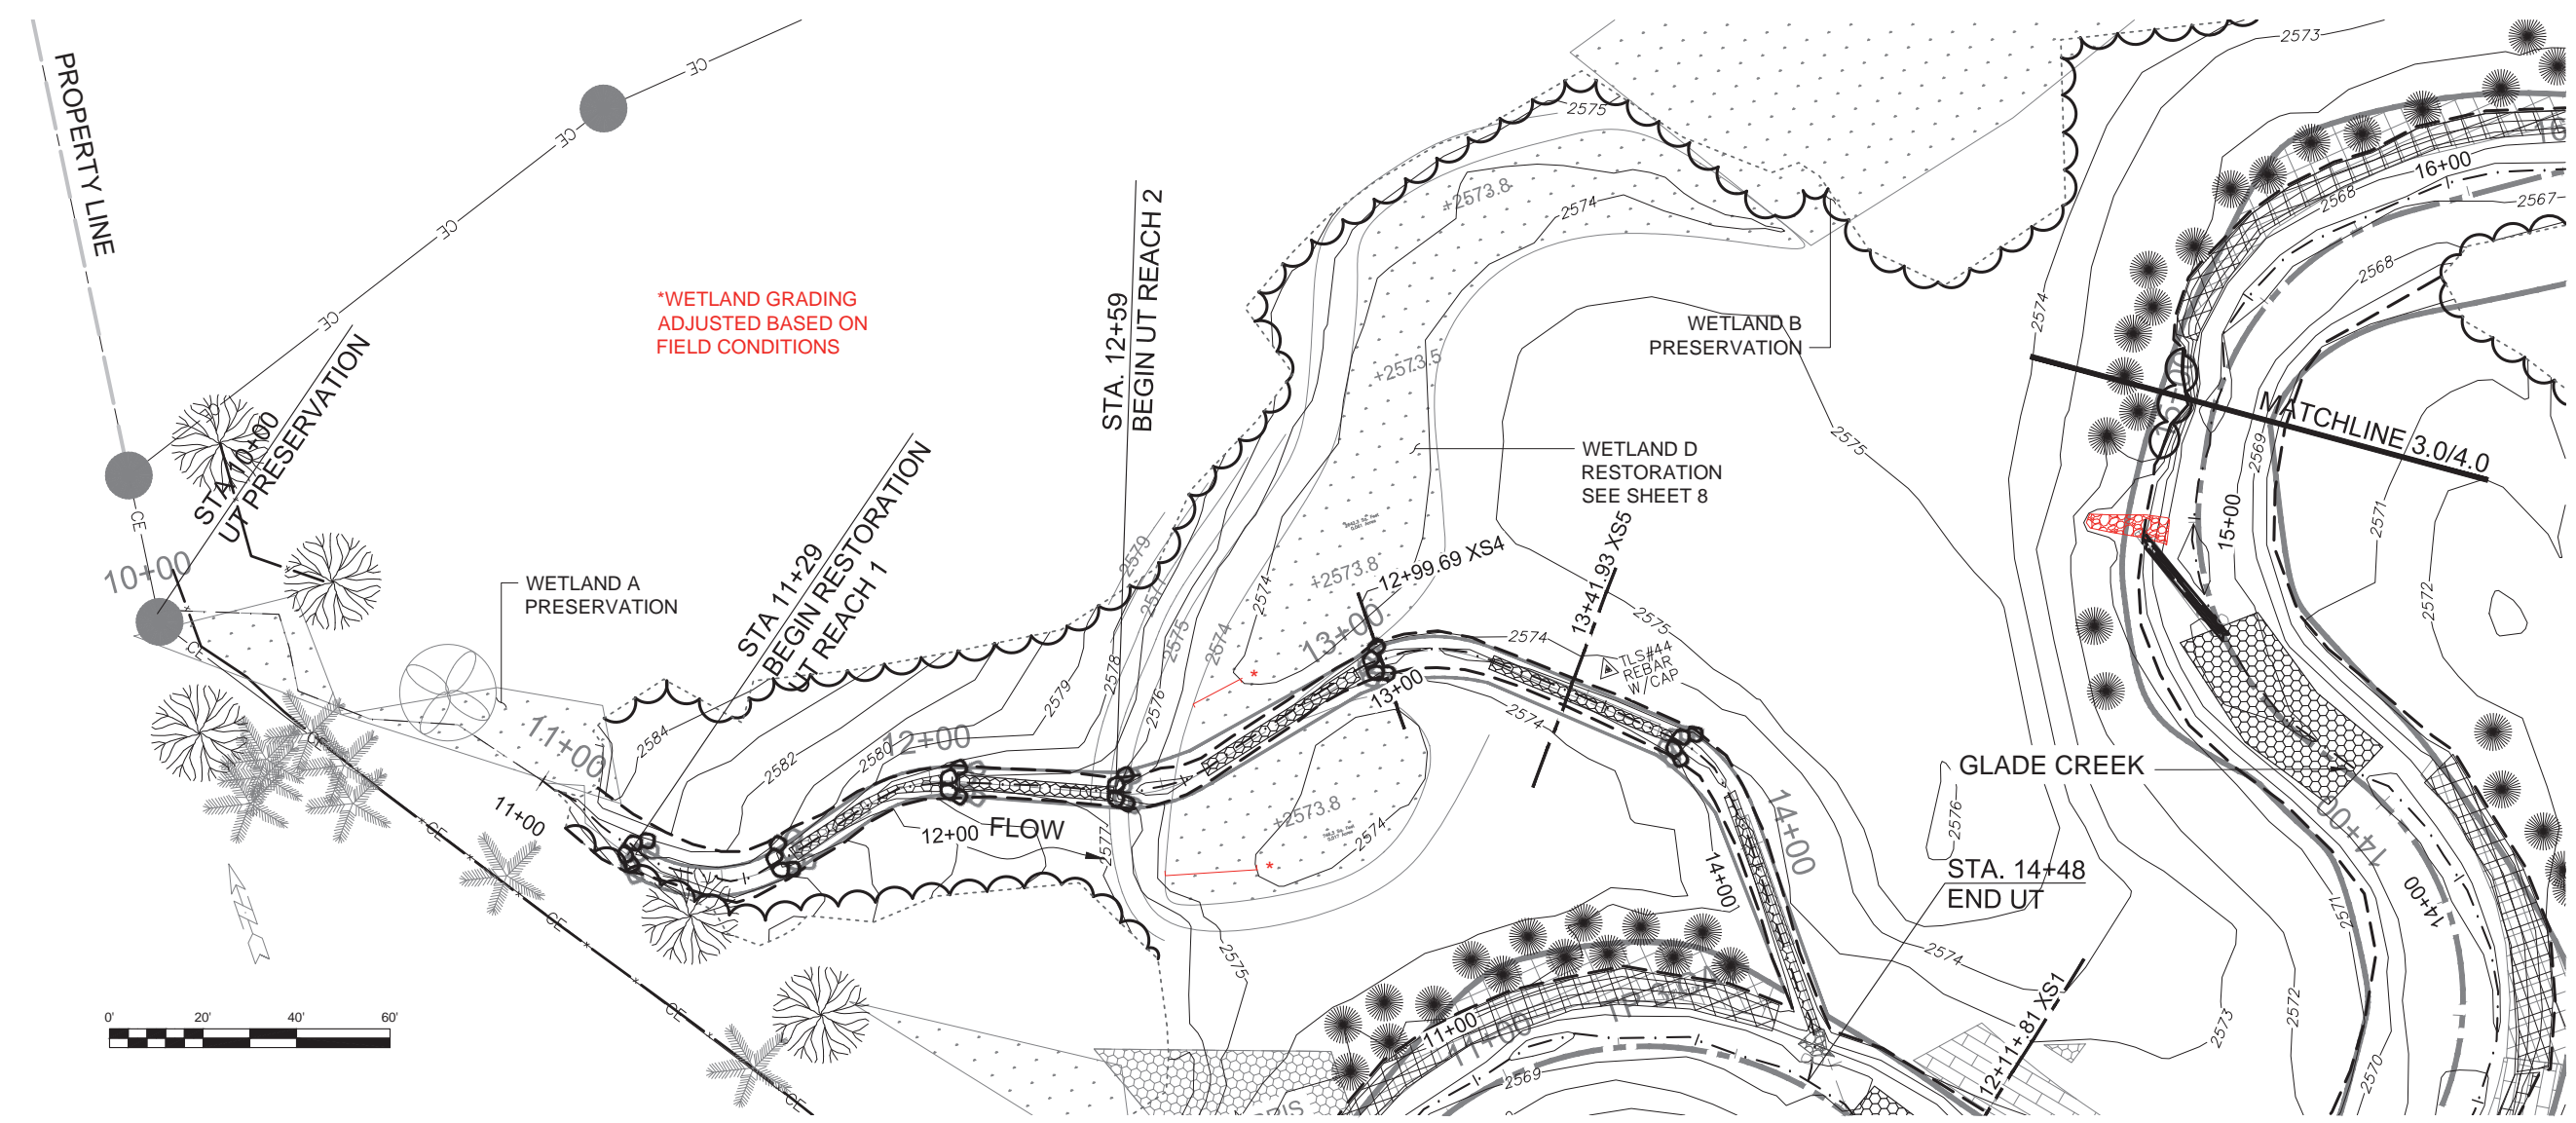
NOTE: DESIGN AND AS-BUILT PROFILES DO NOT MATCH DUE TO DIFFERENCES BETWEEN DESIGN ALIGNMENT AND AS-BUILT THALWEG.

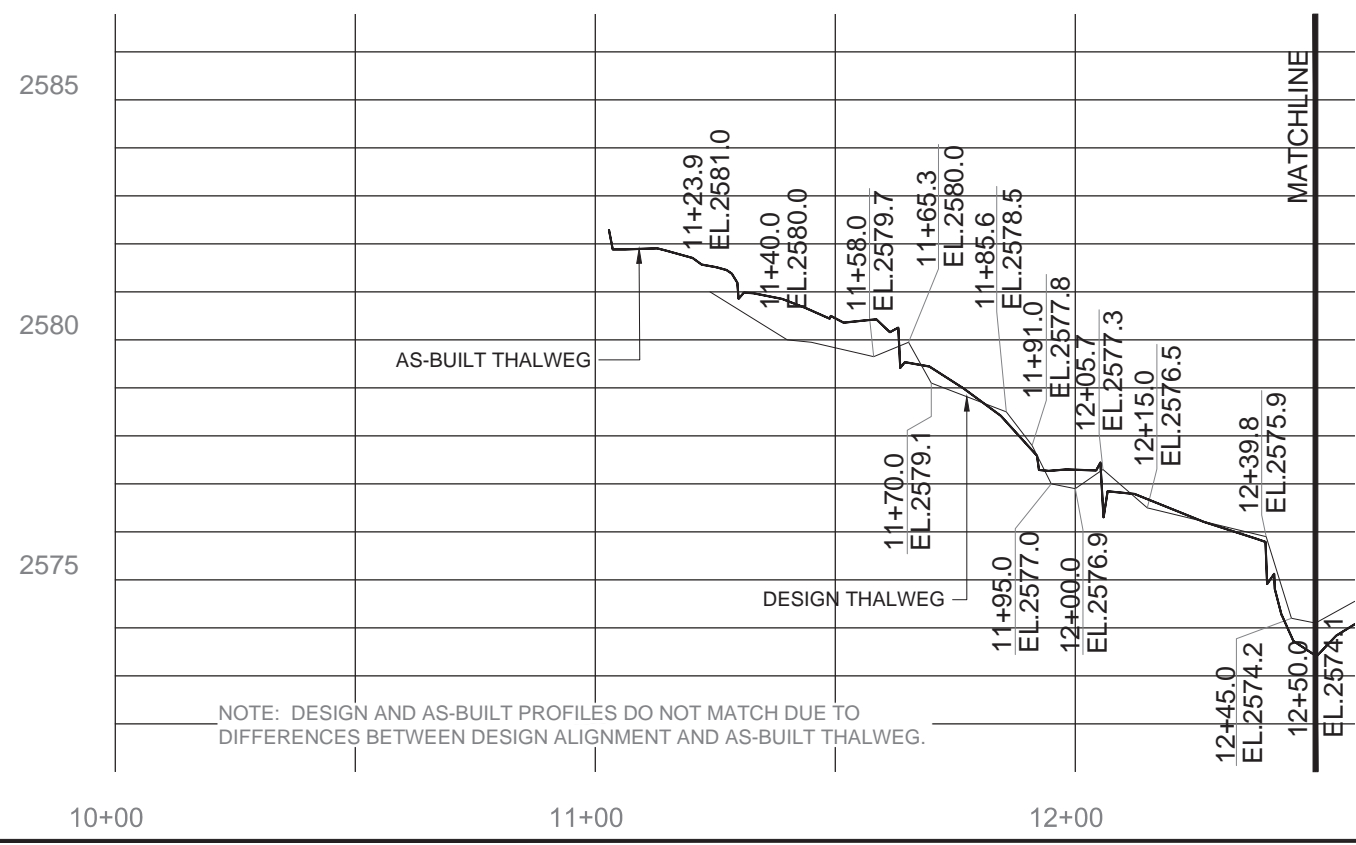
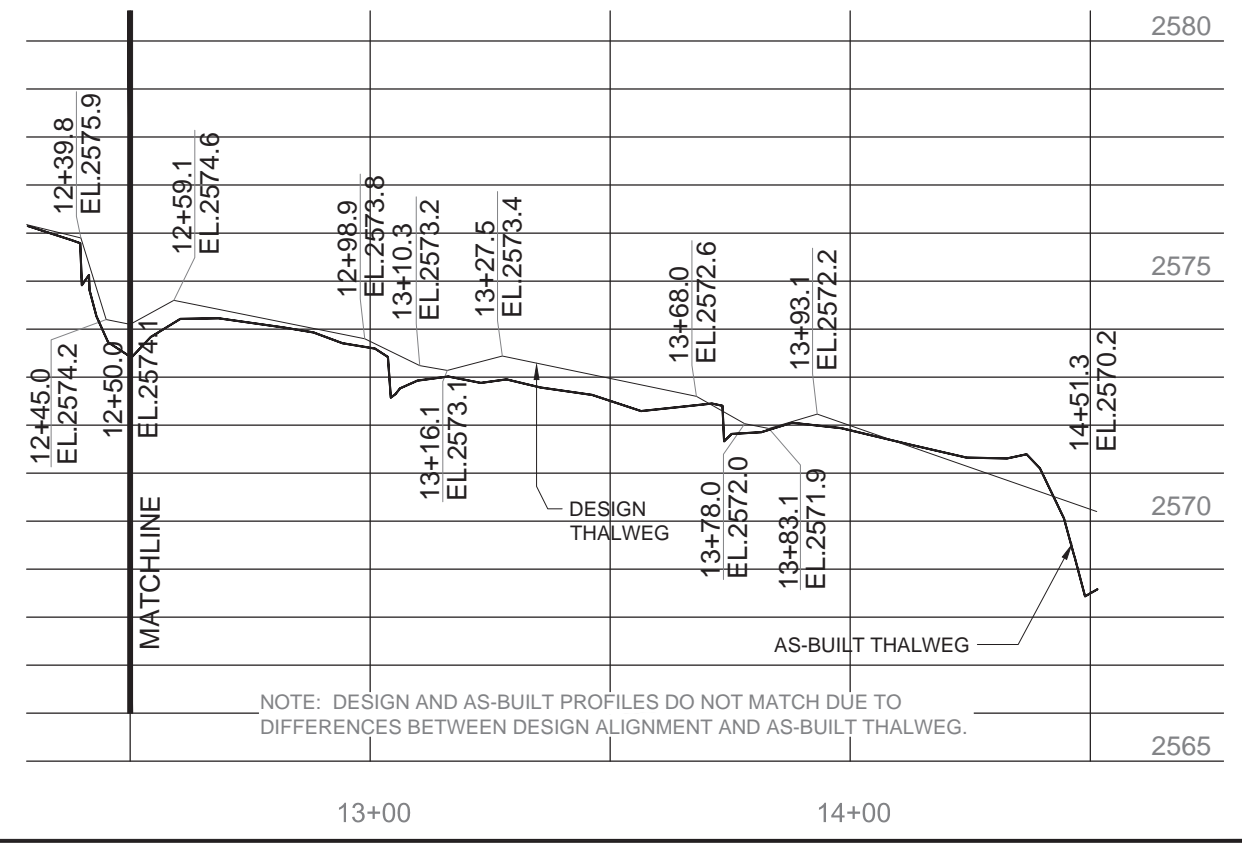
NOTE: DESIGN AND AS-BUILT PROFILES DO NOT MATCH DUE TO DIFFERENCES BETWEEN DESIGN ALIGNMENT AND AS-BUILT THALWEG.

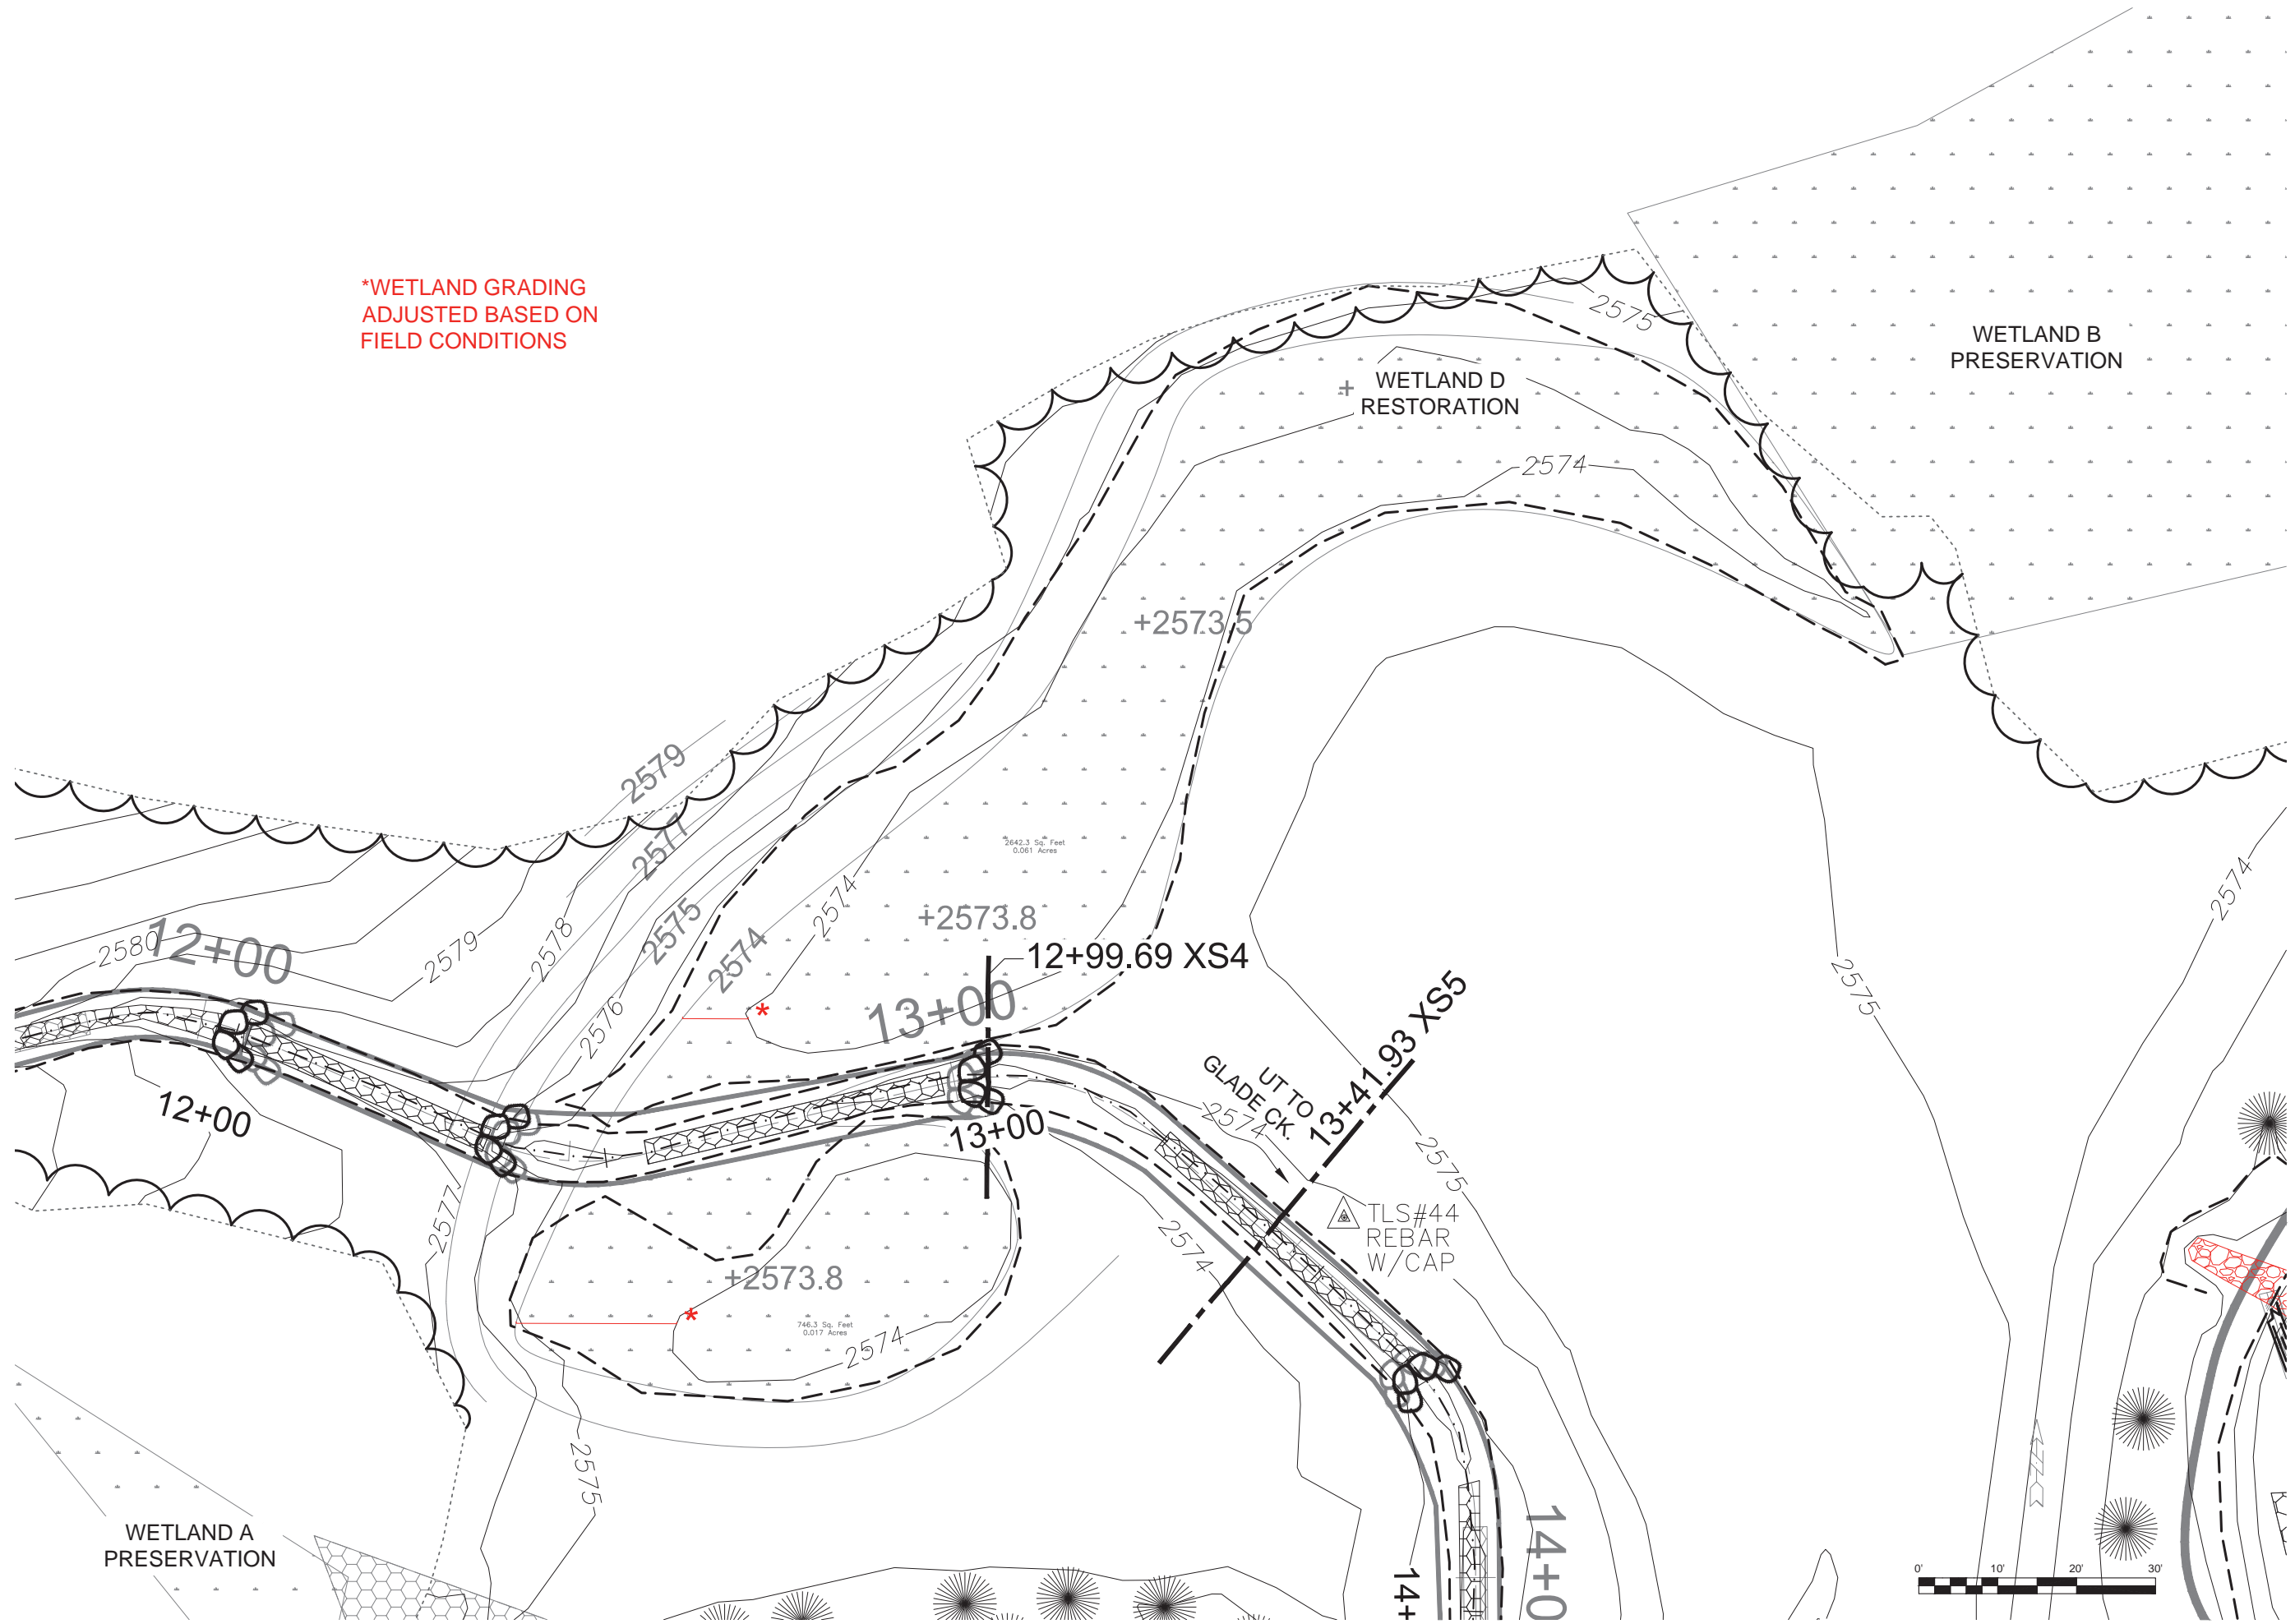
Wetland D
Wetland Grading

- Wetland grading was adjusted based on field conditions (moved the lip of the wetland slightly up valley to match the top of bank of UT to Glade Creek).

*WETLAND GRADING
ADJUSTED BASED ON
FIELD CONDITIONS
