**MONITORING YEAR 1
ANNUAL REPORT**
Final

GLADE CREEK II RESTORATION PROJECT

Alleghany County, NC

NCDMS Project Number 92343

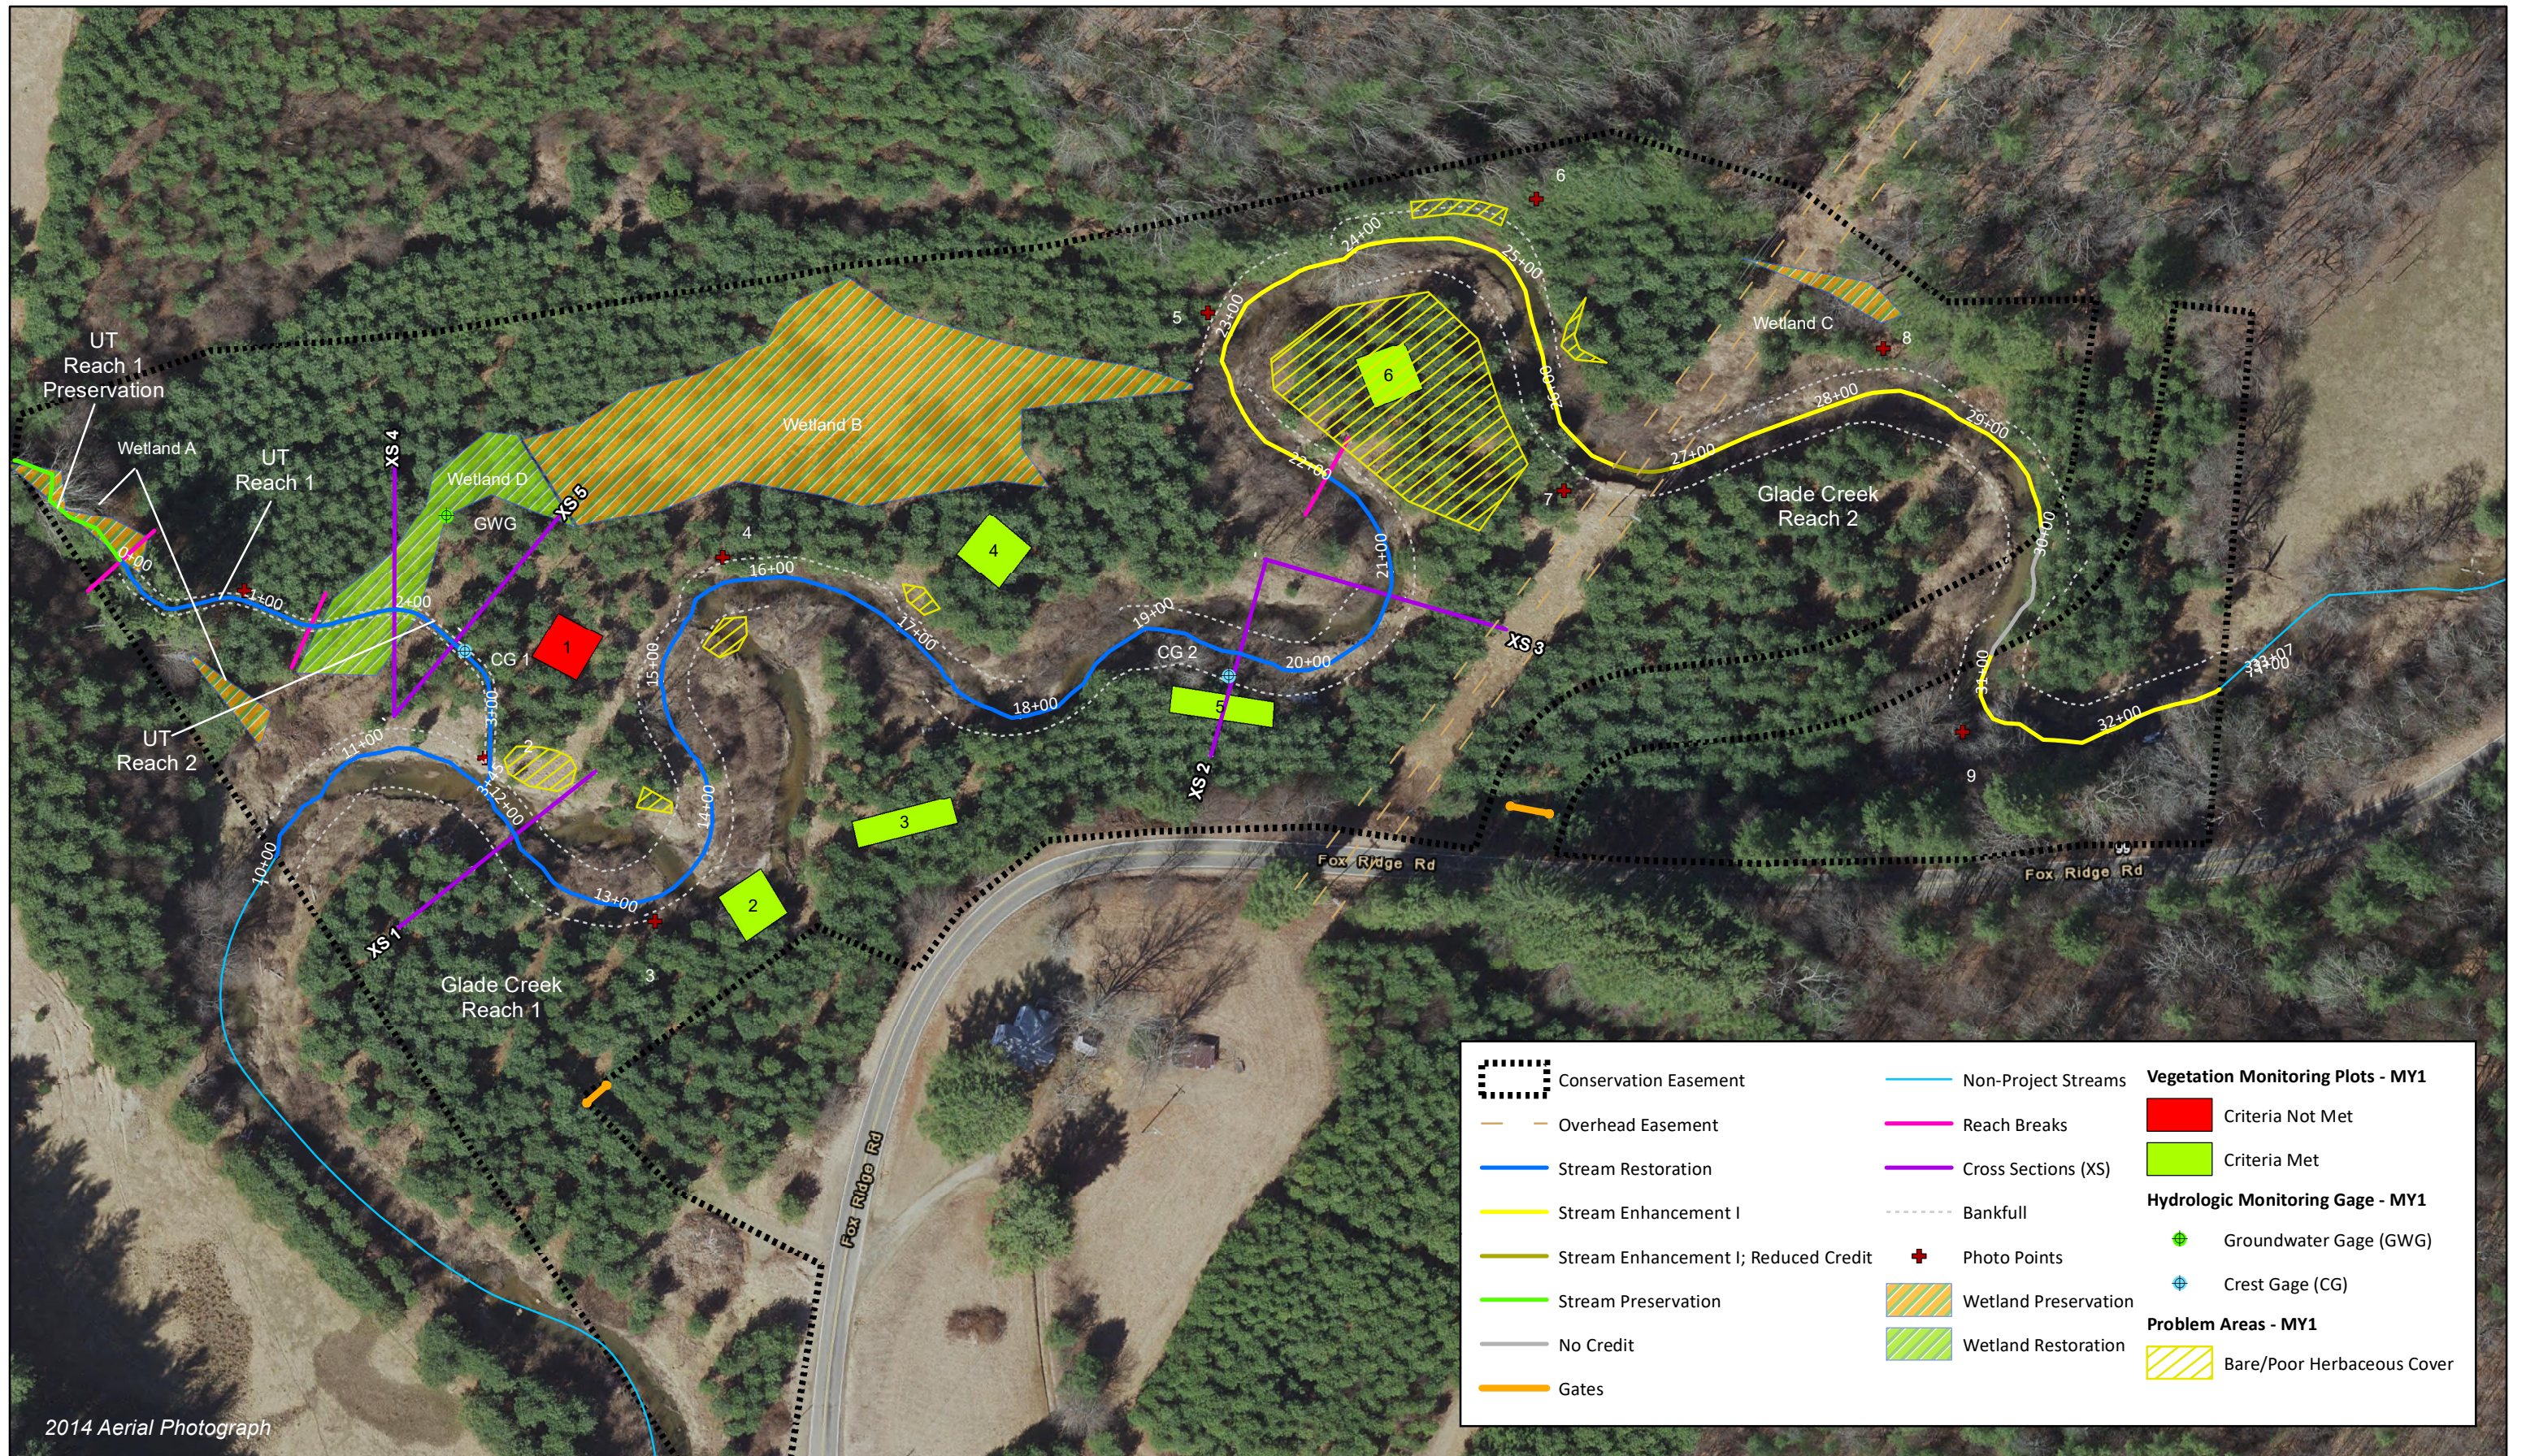
Figure 3 Integrated Current Condition Plan View
 Glade Creek II Restoration Project
 DMS Project No. 92343
 Monitoring Year 1 - 2016

The MY1 vegetation monitoring and visual assessment revealed few vegetation areas of concern. Small patches of bare or poor herbaceous cover in the riparian area of Glade Creek Reach 1 and 2 were observed, as shown in Figure 3 in Appendix 2.
