MONITORING YEAR 2 ANNUAL REPORT

GLADE CREEK II RESTORATION PROJECT

Alleghany County, NC
DEQ Contract 6843
DMS Project Number 92343
USACE Action ID 2009-00589

Data Collection Period: March 2017 – November 2017
Final Submission Date: February 1, 2018

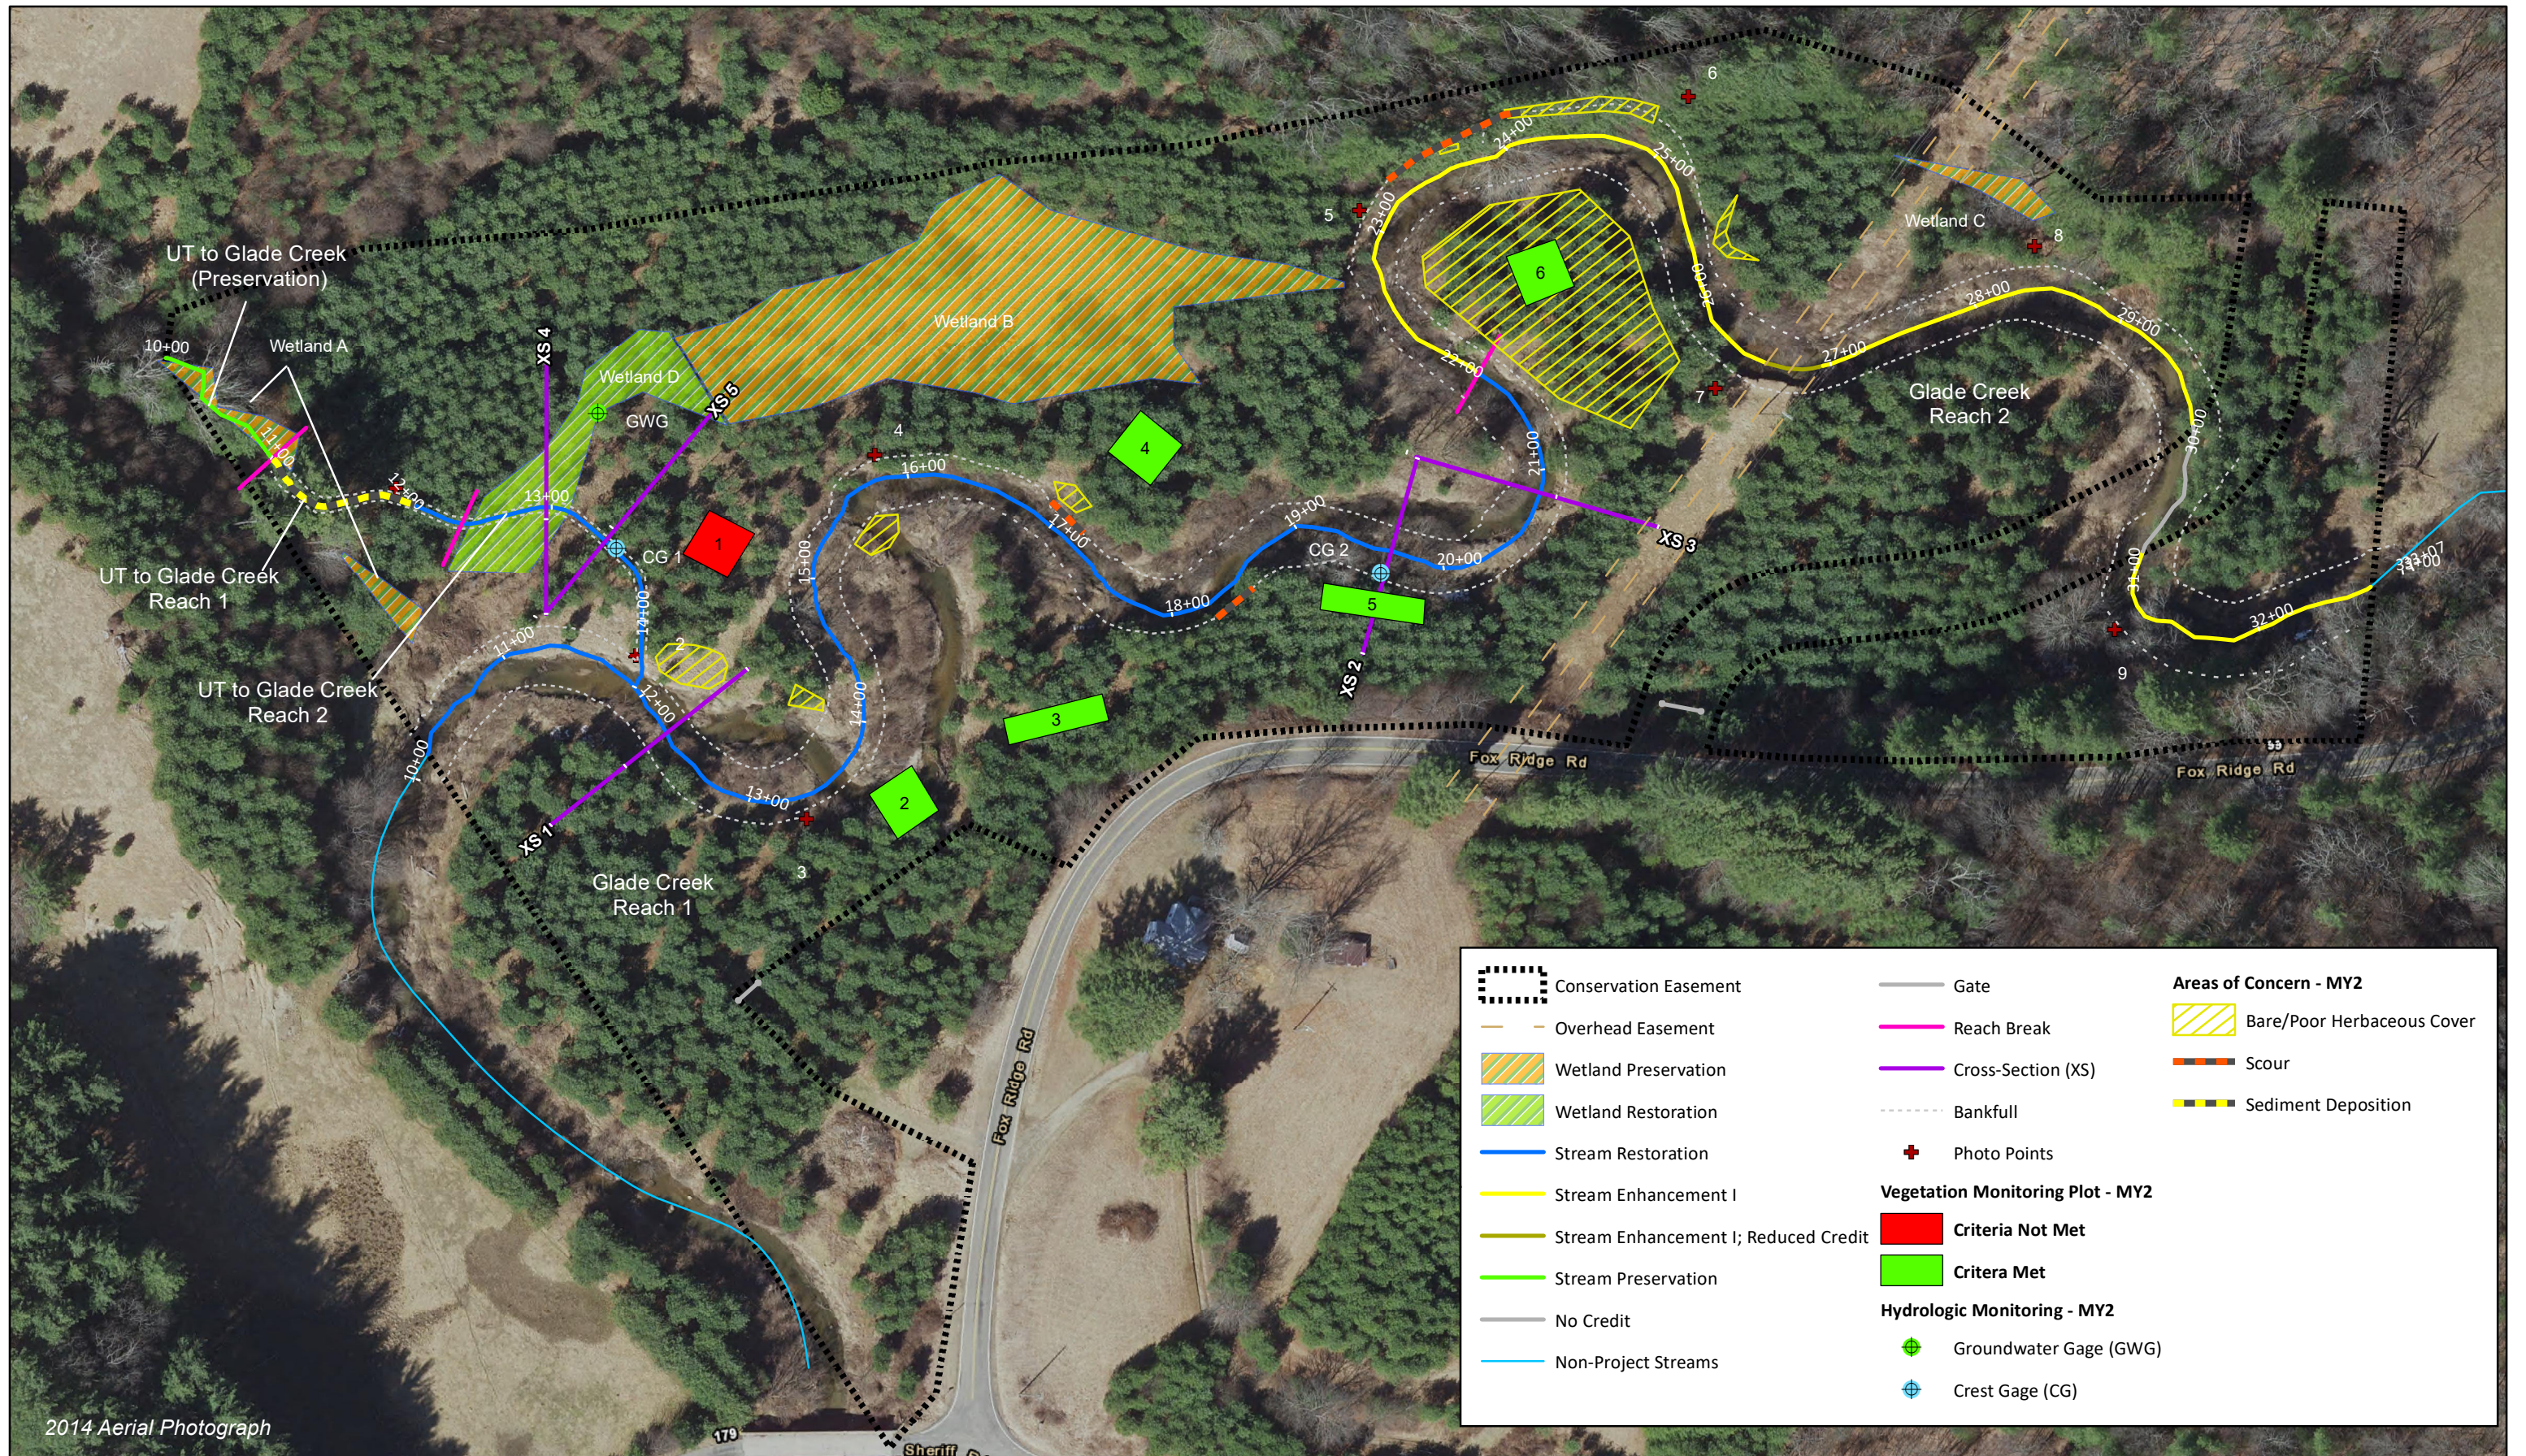
Figure 3 Integrated Current Condition Plan View
 Glade Creek II Restoration Project
 DMS Project No. 92343
 Monitoring Year 2 - 2017

The MY2 vegetation monitoring and visual assessment revealed few vegetation areas of concern. Small patches (approximately 6.3%) of bare or poor herbaceous cover in the riparian area of Glade Creek Reach 1 and 2 were observed. Supplemental planting is recommended in vegetation plot 1 and throughout the entire Site since the overall vigor of planted and surrounding stems have declined. Refer to Figure 3 in Appendix 2.

Minor adaptive management is recommended along UT to Glade Creek and Glade Creek. Within the upstream section of UT to Glade Creek Reach 1, hand removal of the sediment deposit and hand removal of the herbaceous material within the channel are recommended to temporarily improve stream function and reduce the active braiding. Where the tree has fallen across the UT to Glade Creek, removal of the fallen tree is recommended to prevent future blockage. Wildlands recommends replacing the brush mattresses on Glade Creek where bank erosion is occurring, and the brush mattress is no longer intact with the bank. Adding live stakes on the left bank between stations 23+00 and 25+00 is also recommended for bank stabilization.

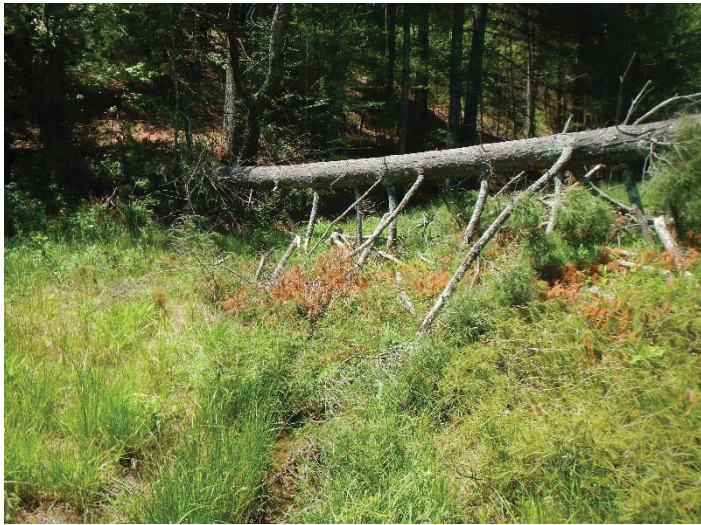
Photo Point 1 – view upstream UT Glade Creek (5/10/2017)

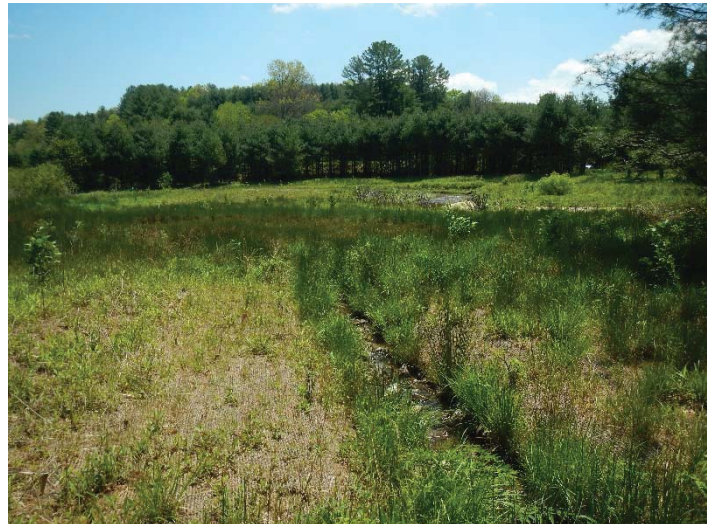
Photo Point 1 – view downstream UT Glade Creek 5/10/2017)
