MONITORING YEAR 3 ANNUAL REPORT

GLADE CREEK II RESTORATION PROJECT

Alleghany County, NC
DEQ Contract 6843
DMS Project Number 92343
USACE Action ID 2009-00589

Data Collection Period: March 2018 – November 2018
Submission Date: December 12, 2018

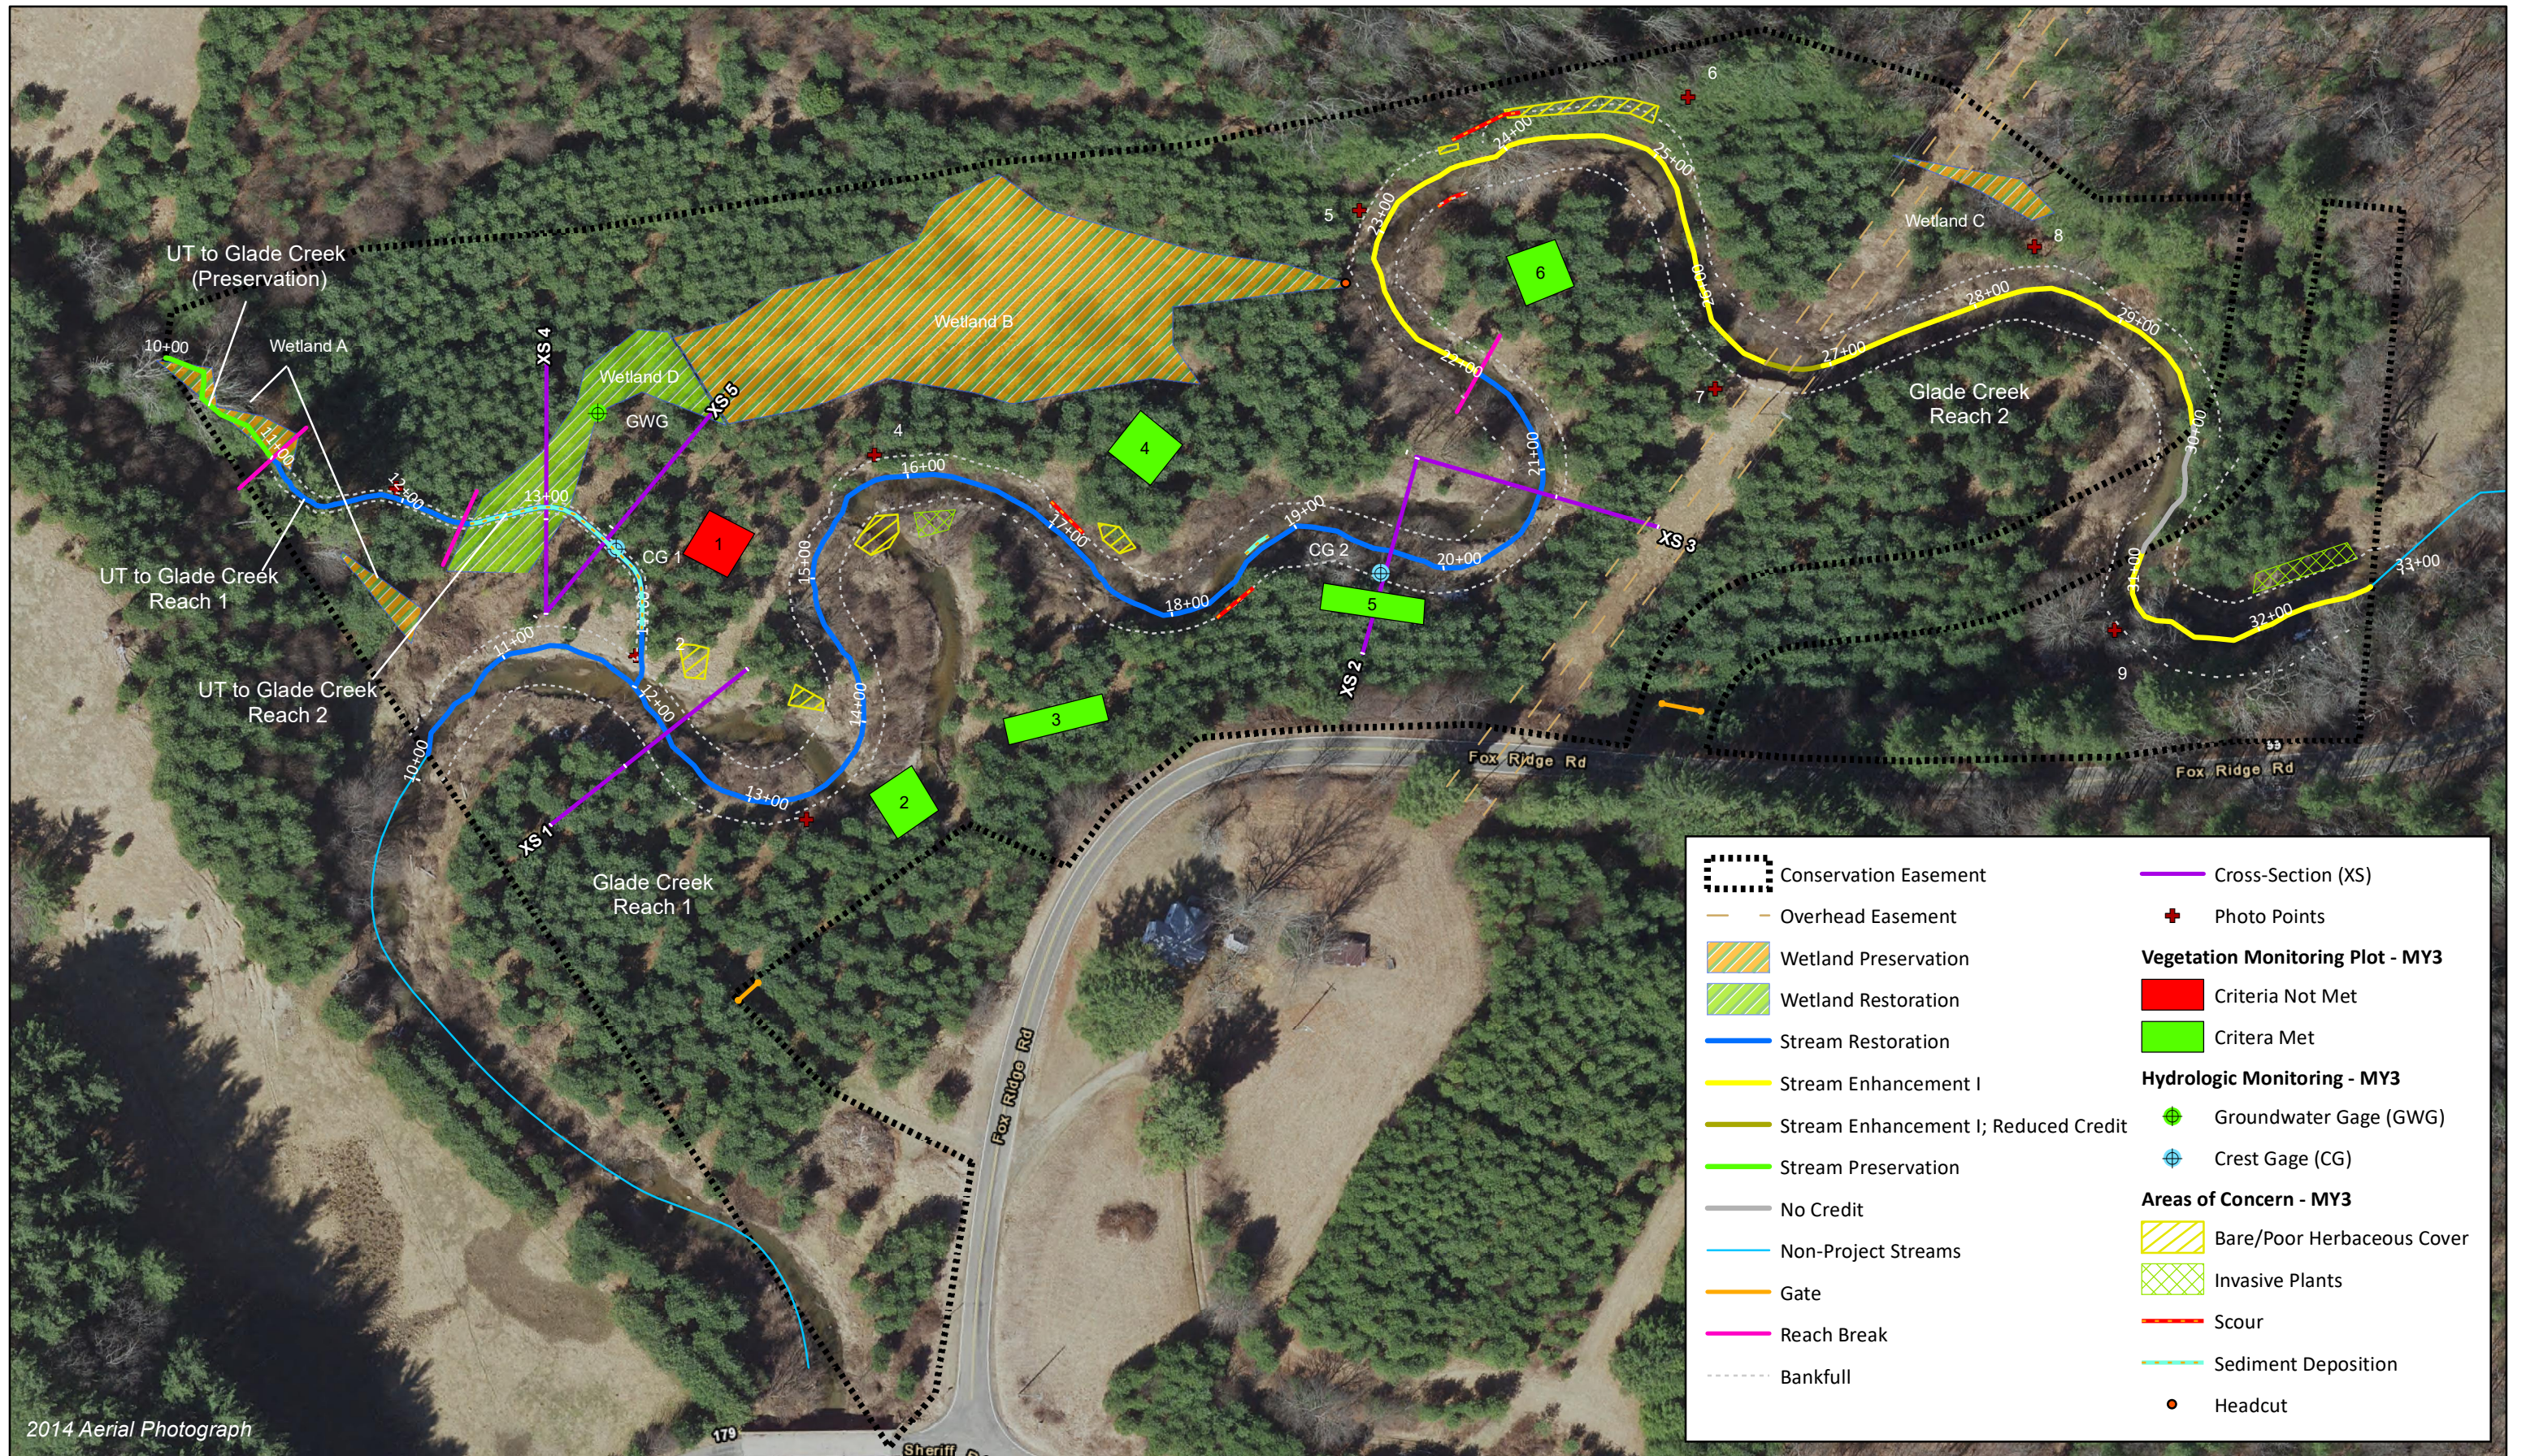
UT to Glade Creek has continued to experience an increase in fine sediment throughout MY3. Sedimentation has continued despite the adaptive management was performed in March 2018 on UT to Glade Creek to improve stream function and reduce active braiding. At the start of UT to Glade Creek Reach 2, sediment deposition has directed flow through Wetland D on the left floodplain of the channel. This was observed after two large storm events that occurred in September and October 2018. Land management activities and cattle pasture upstream of the project are most likely contributing excessive sediment on UT to Glade Creek.

There are a few areas of minor scour and erosion along Glade Creek. In MY2 it was observed that the brush mattress around station 18+00 had been displaced; therefore, exposing the bank and minor scouring continues to be present. In addition, the left bank between stations 23+00 and 25+00 still show signs of scour under the brush mattress and behind the boulders. In MY3, the right bank around station 23+50 is showing signs of bank instability. Replacing brush mattresses and adding live stakes on Glade Creek where bank erosion is occurring is recommended for bank stabilization. These stream areas of concern are indicated in Table 6 and on Figure 3 in Appendix 2.

One headcut has formed at the outflow of Wetland B where it meets Glade Creek Reach 2 (around station 22+80). This area will be monitored in future years for signs of accelerated instability. Please refer to the CCPV Figure 3 in Appendix 2.

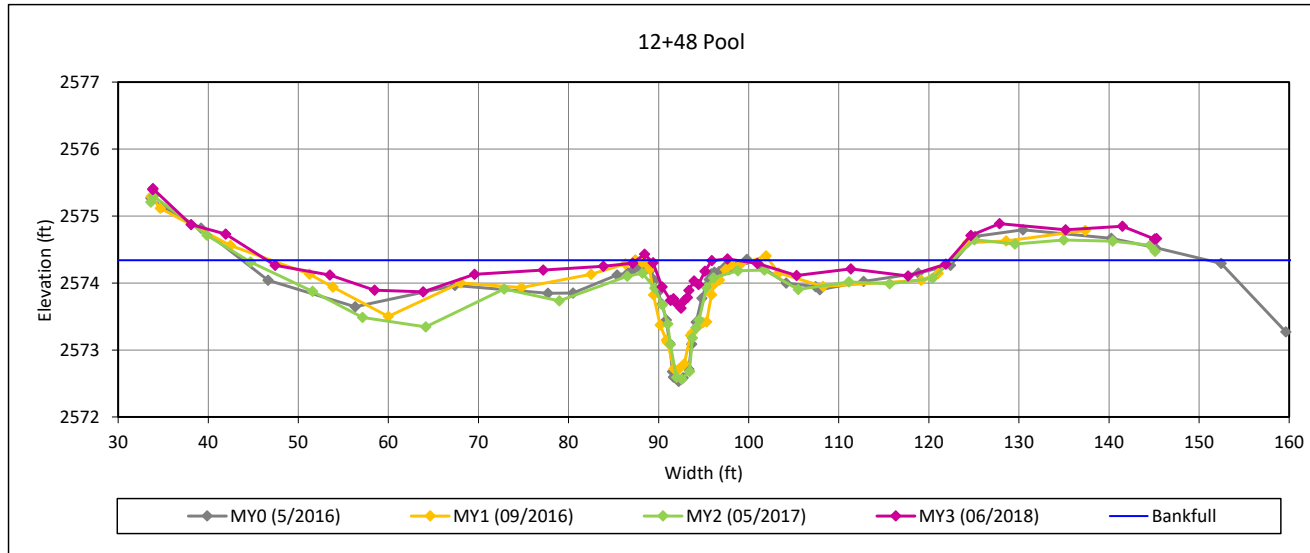
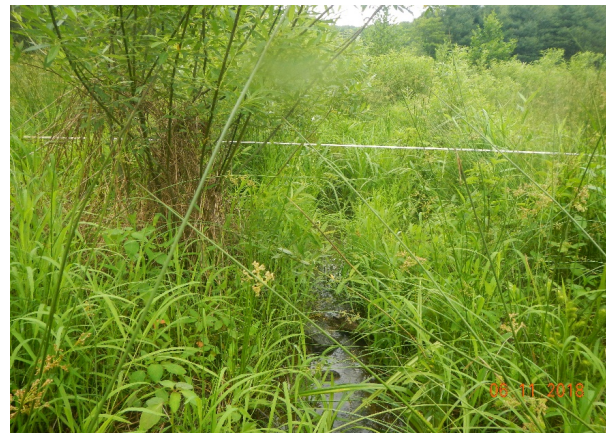
Cross-Section 4 - UT to Glade Creek

Morphological surveys for MY3 were conducted in May 2018. Results indicate that the channel dimensions are stable and functioning as designed on Glade Creek. However, UT to Glade Creek cross-section 4 and cross-section 5 plots show significant sediment deposition that has increased the width-to-depth ratios. In general, the reachwide pebble counts on Glade Creek show coarser materials in the riffles and fines in the pools. The UT to Glade Creek reachwide channel materials resulted in a D_{50} of 0.2 mm (sand) during MY3. This fining of sediment materials was observed in MY2 and continues in MY3 for UT to Glade Creek.
