# MONITORING YEAR 4 ANNUAL REPORT

## GLADE CREEK II RESTORATION PROJECT

Alleghany County, NC  
DEQ Contract 6843  
DMS Project Number 92343  
USACE Action ID 2009-00589

Data Collection Period: March – October 2019  
Submission Date: December 13, 2019

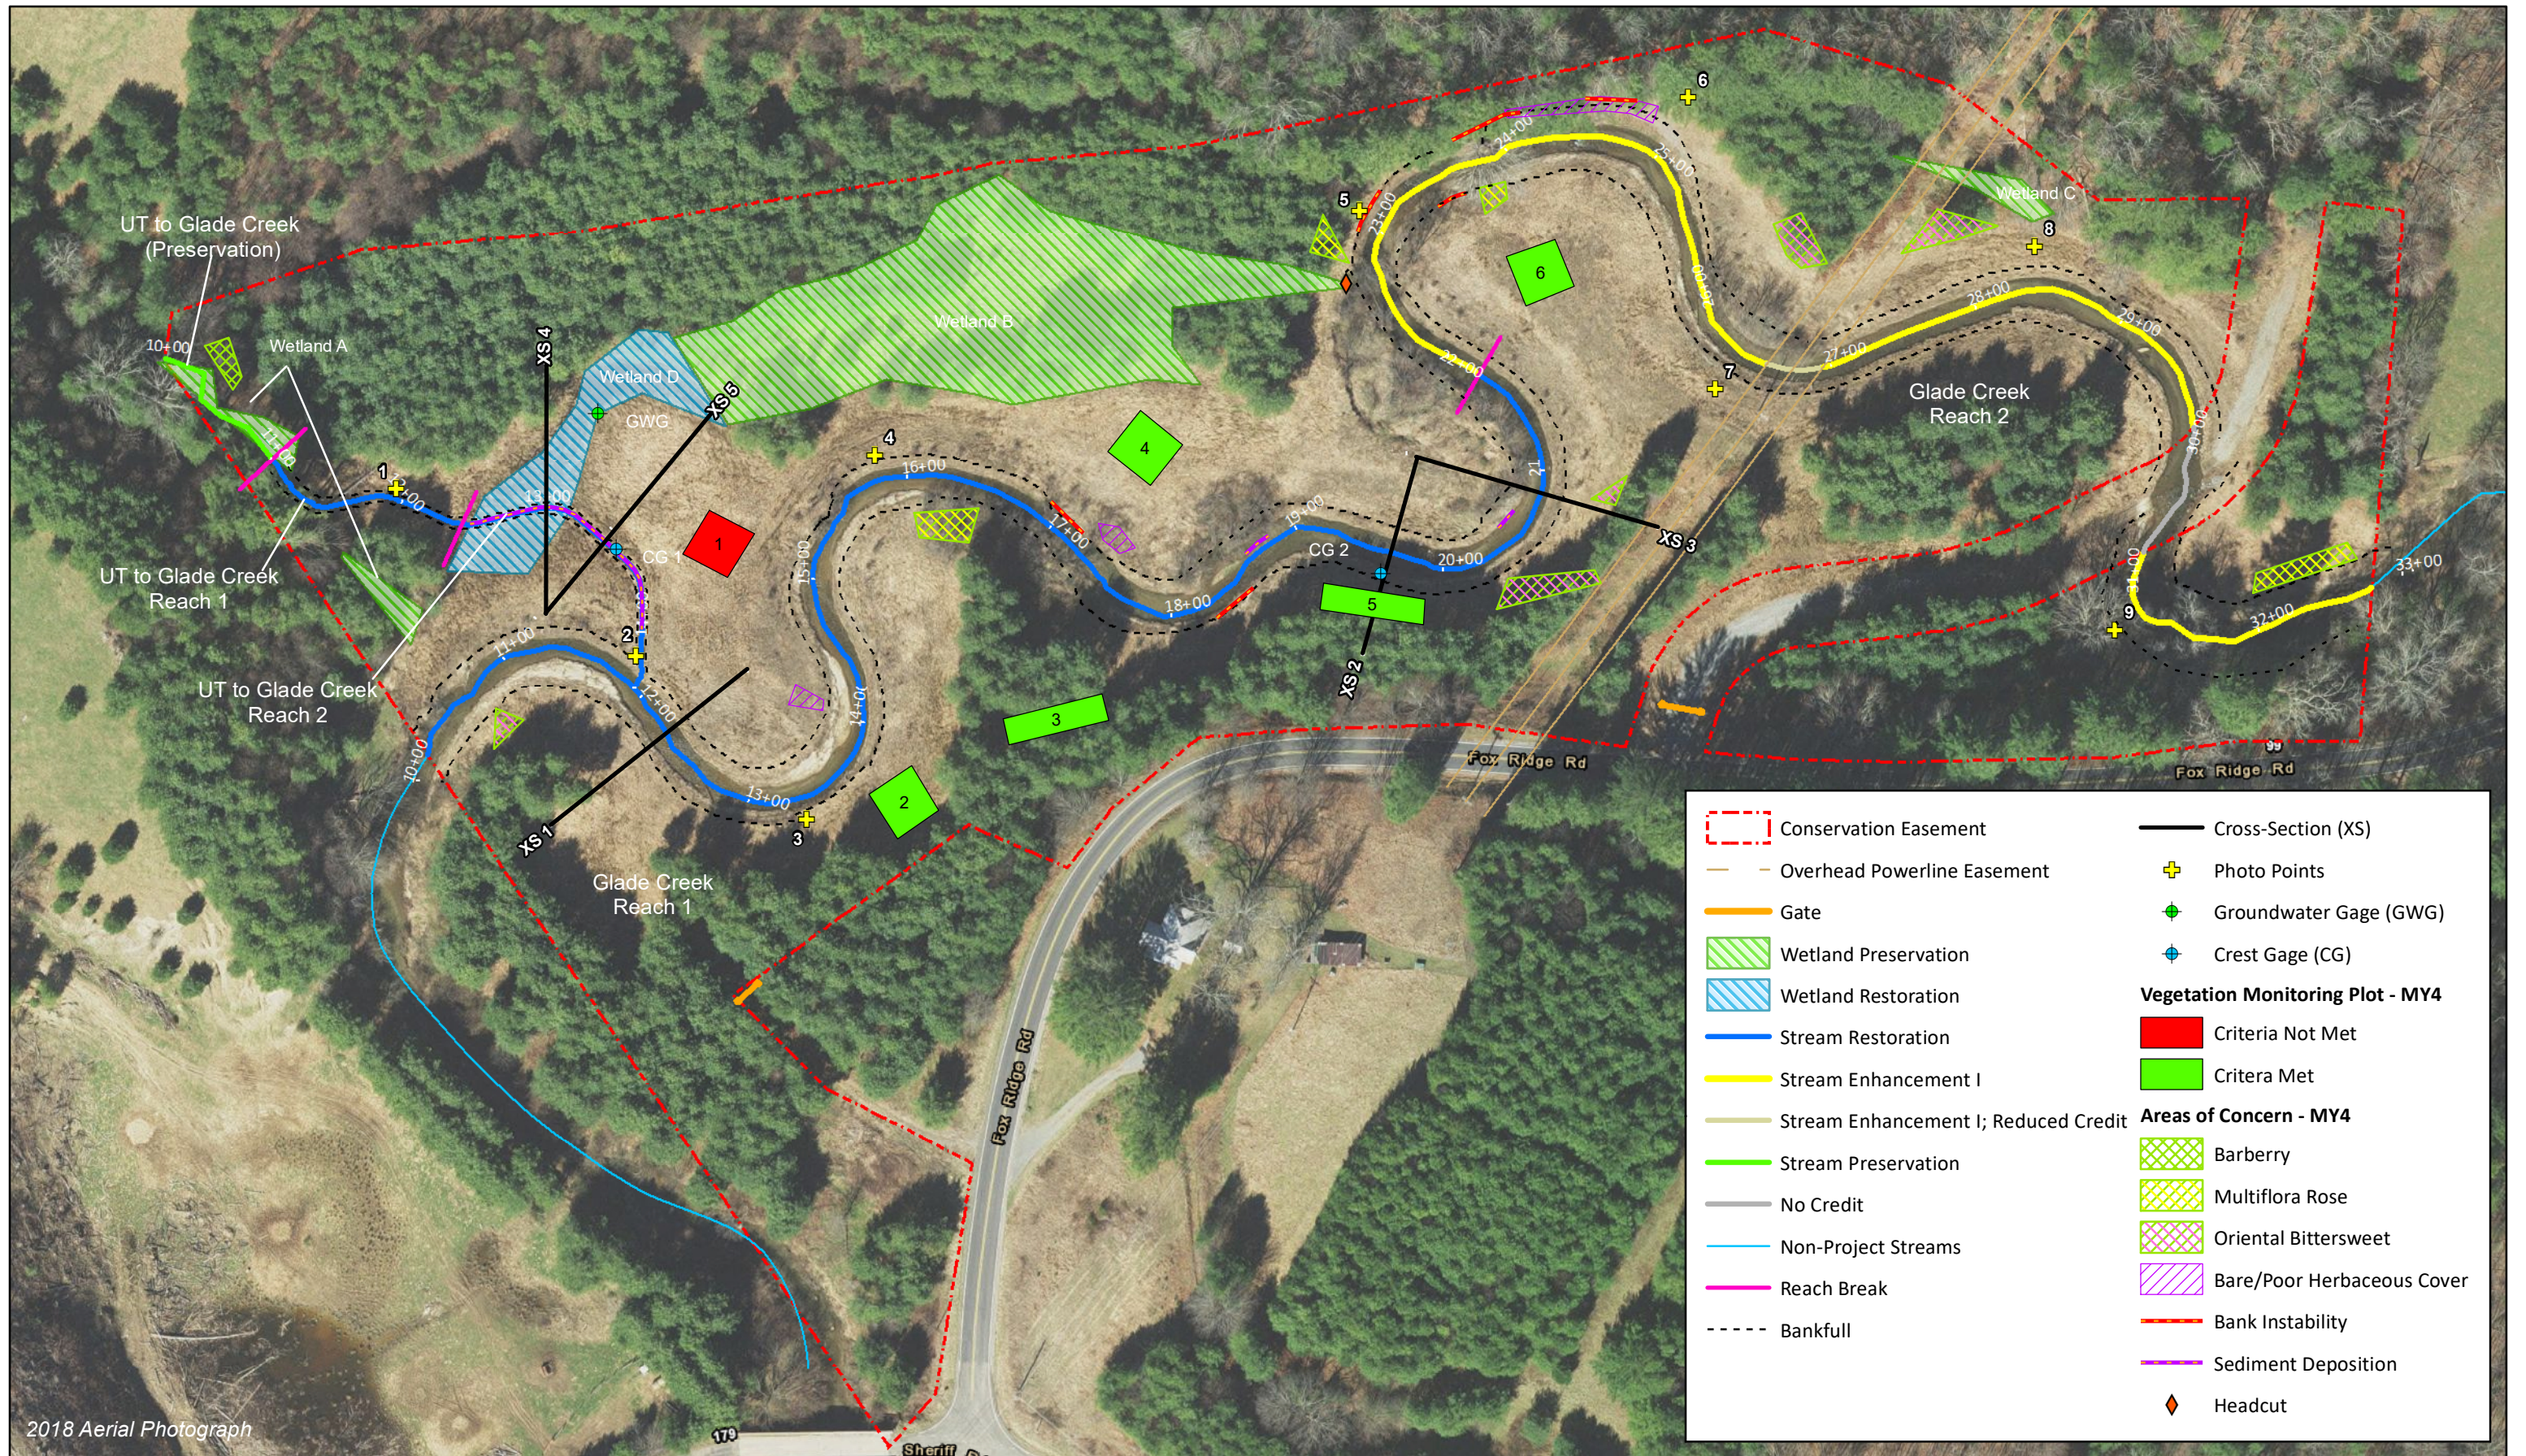
Along Glade Creek, there are a few isolated areas with minor to moderate bank erosion occurring along with loose coir matting. Previously noted in MY2, areas of scour near station 23+00 to 24+50 were planted with live-stakes in April 2019 to help stabilize the bank. Areas of concern are depicted on the CCPV Figure 3 and Table 6 in Appendix 2.

One headcut that was noted in MY3 at the outflow of Wetland B where it meets Glade Creek Reach 2 (around station 22+80), continues to be visible in MY4. This headcut is likely to migrate further into the wetland without maintenance. Based on visual assessments in MY4, the area within Wetland D that is normally observed to have standing water is also lacking woody vegetation. Please refer to the CCPV Figure 3 in Appendix 2.
