MONITORING YEAR 5 ANNUAL REPORT

GLADE CREEK II RESTORATION PROJECT

Alleghany County, NC
DEQ Contract 6843
DMS Project Number 92343
USACE Action ID 2009-00589

GLADE CREEK II RESTORATION PROJECT
Monitoring Year 5 Annual Report

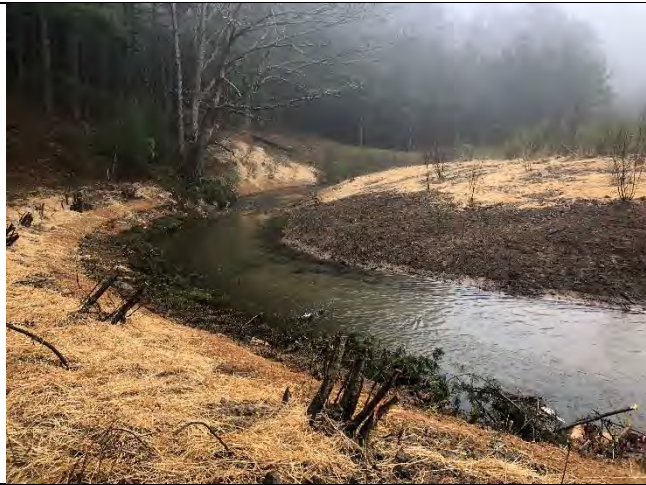
Brush toe geolift repair, left bank looking downstream

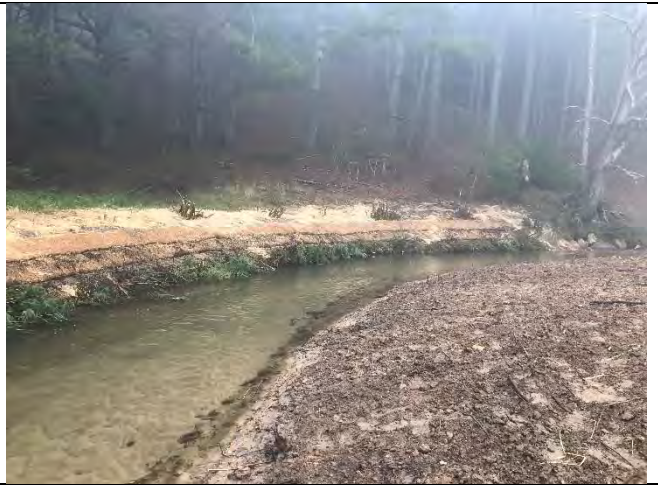
Brush toe geolift repair area from right bank, looking downstream

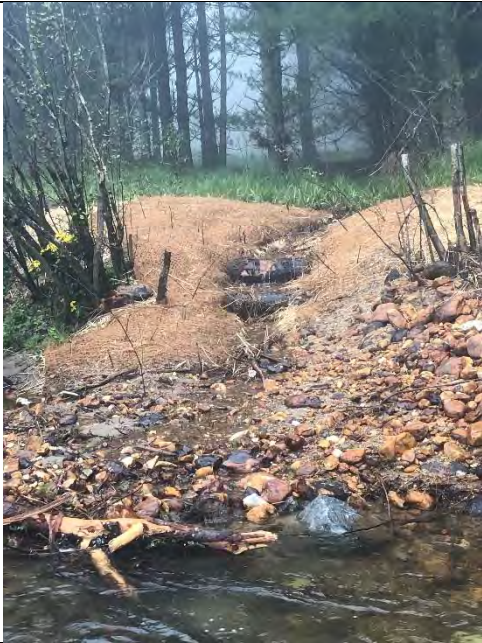
Wetland B outlet steps

One headcut was previously noted beginning in MY3 at the outflow of Wetland B where it meets Glade Creek Reach 2 (near station 22+75). DMS contracted with a provider to complete repairs in April 2020 which included the installation of log sills for grade control at the wetland outflow. As discussed in section 1.2.2, Wetland B had previously been noted to have poor woody stem growth and therefore supplemental planting occurred in April 2020 with appropriate wetland tree and shrub species. Please refer to the repair as-built plan in Appendix 6.

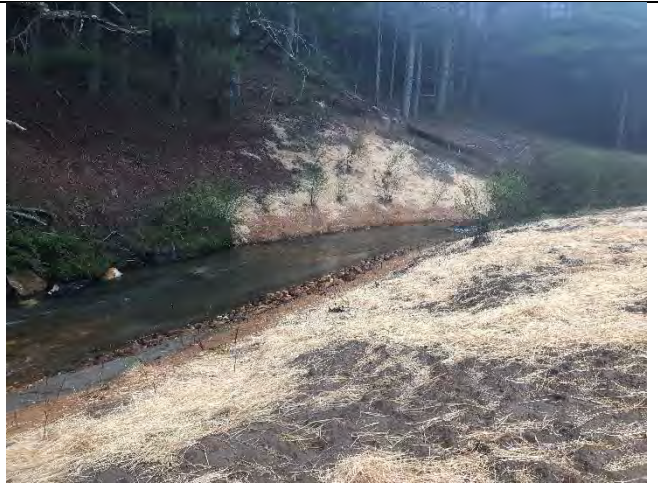
Point bar grading and hillslope repair

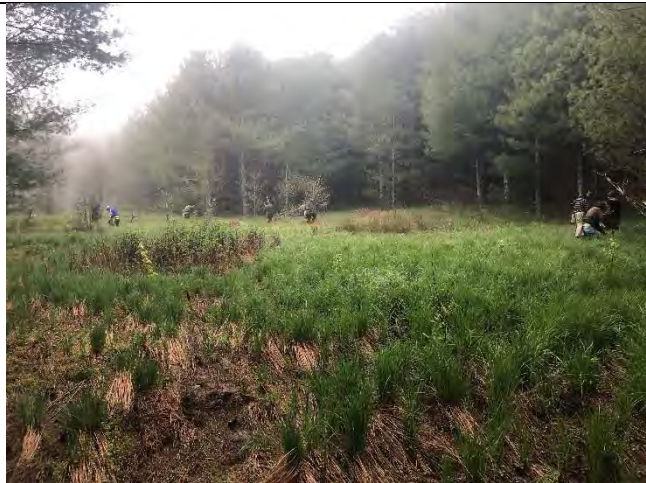
Wetland B planting

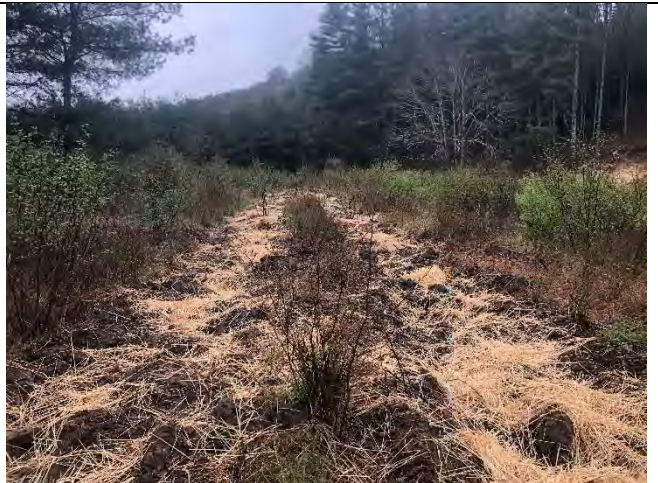
Construction access route stabilization

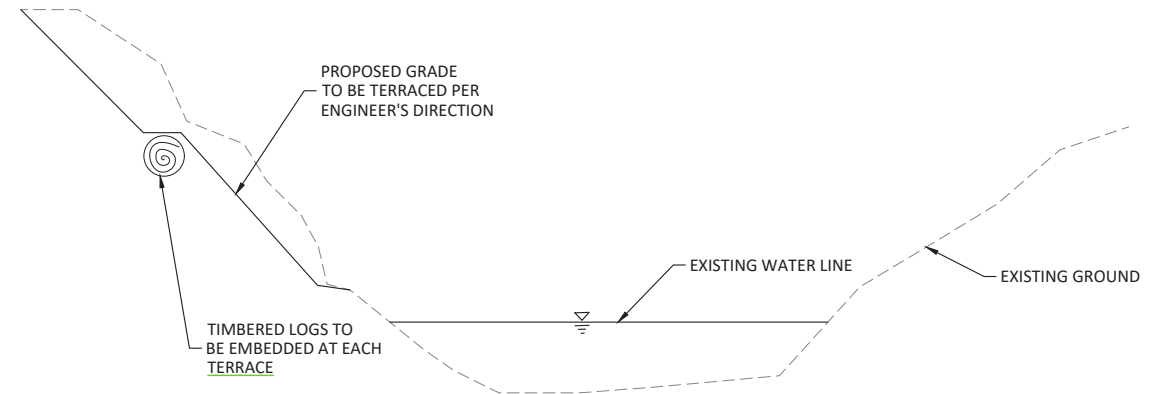
2 Terrace Slope
2 Not to Scale

Row of alder transplants installed along top.
