**Glen Raven Stream Restoration
Monitoring Report – MY01
Alamance County, NC
Basin 03030002 - Contract # D05011-1**

November 2007

**Project Manager: Joseph J. Pfeiffer, P.W.S.
Email: jpfeiffer@kci.com**

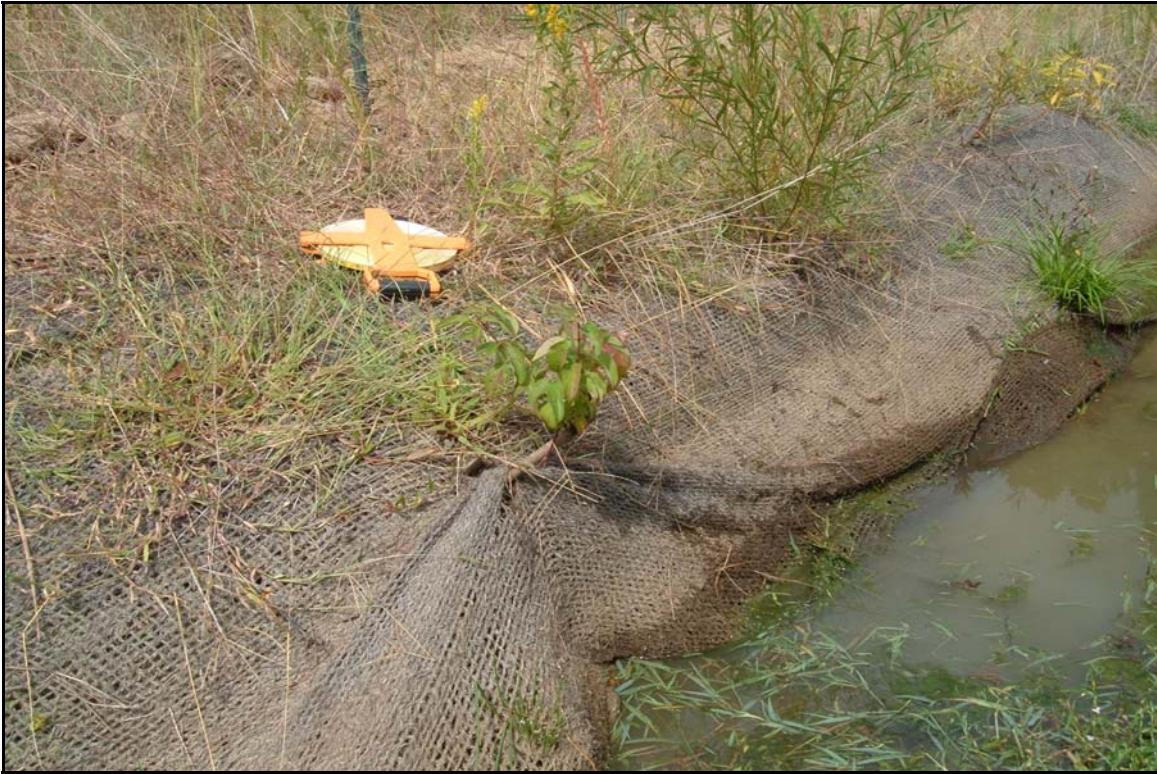
SP1 – Problem area #1. Erosion on toe of bank beneath matting. 10/3/07 - MY 01

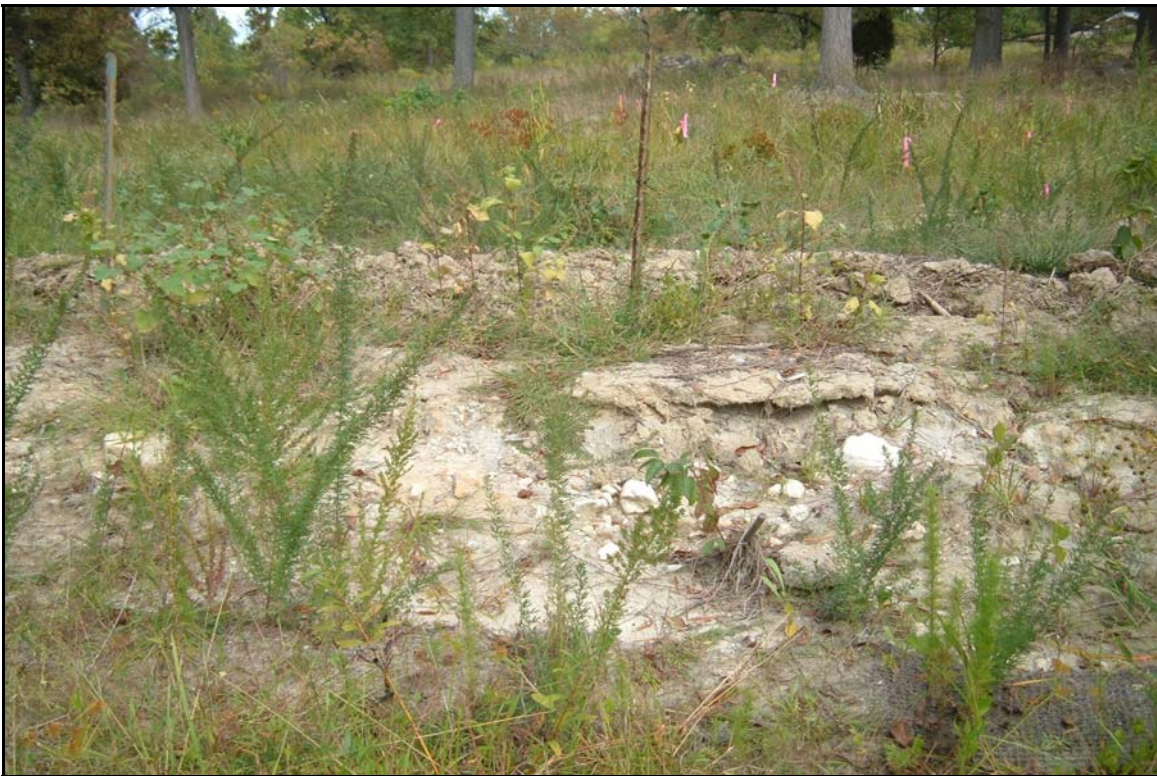
SP2 – Problem Area #4. Bank erosion beneath washed away matting. 10/3/07 - MY 01

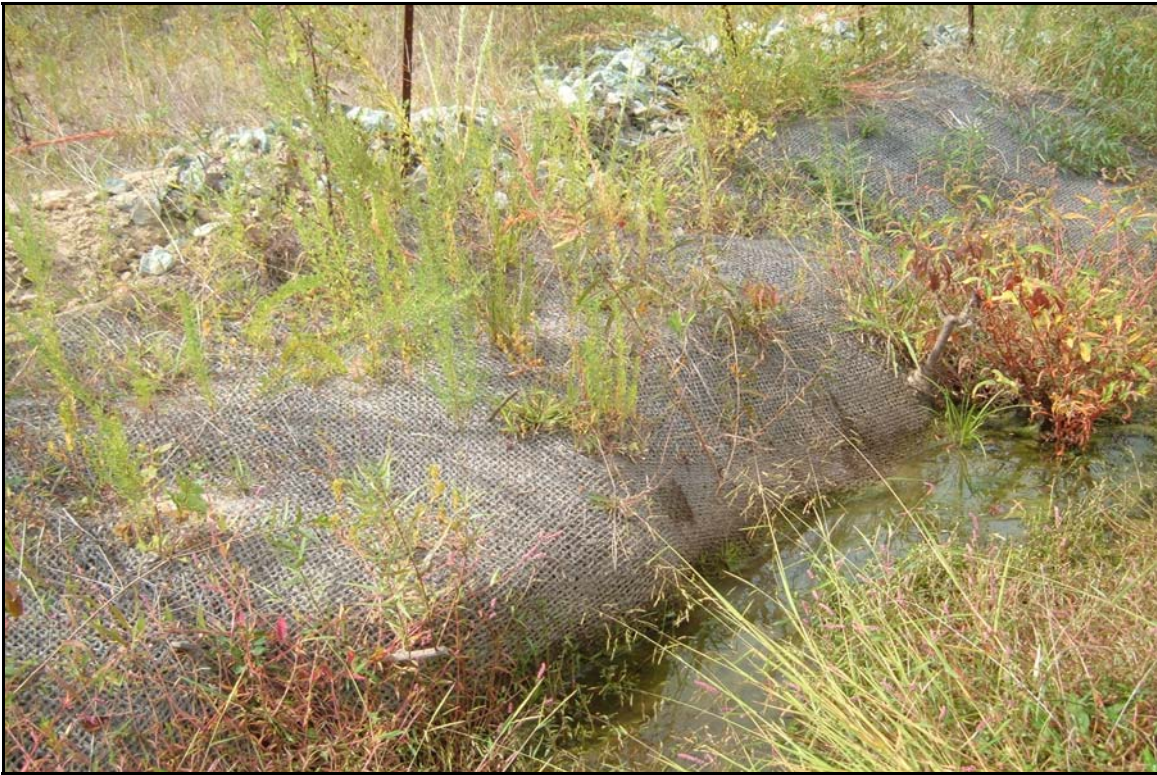
SP3 – Problem Area #11. Bank erosion on toe of bank beneath matting. 10/3/07 - MY 01

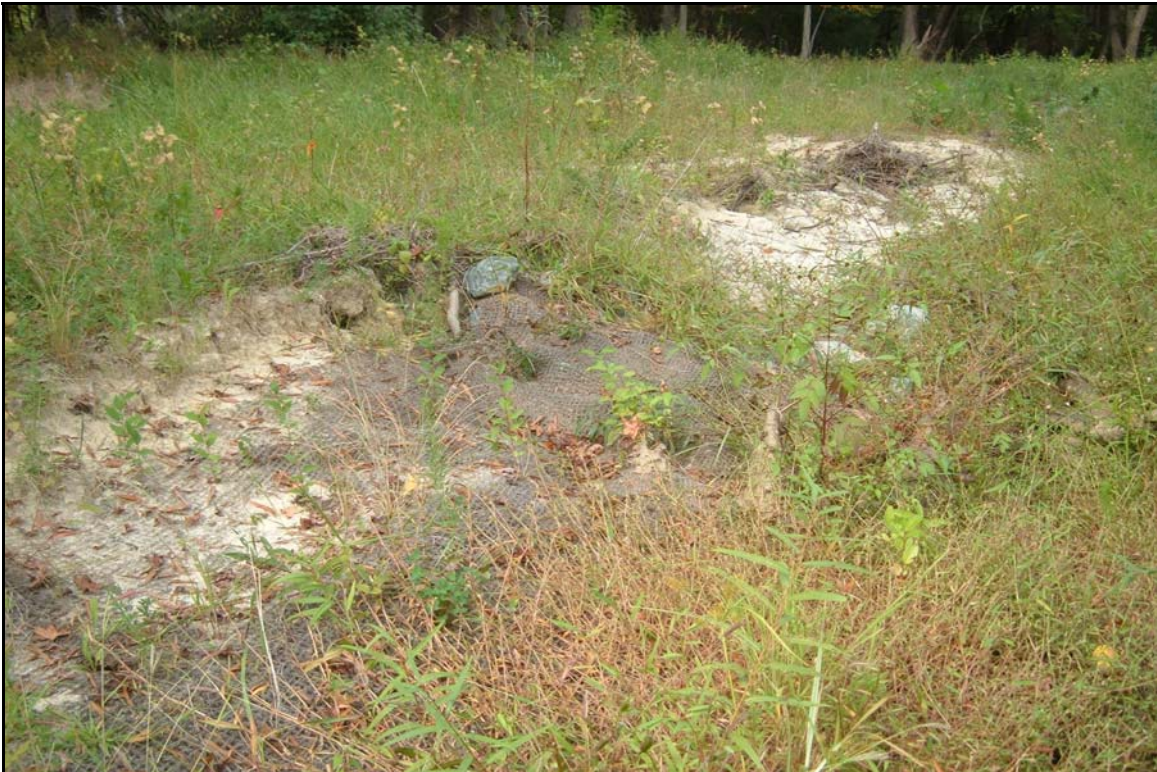
SP4 – Problem Area #17. Bank and floodplain erosion beneath washed away matting and remaining matting. 10/3/07 - MY 01
