**Glen Raven Stream Restoration
Monitoring Report – MY02
Alamance County, NC
Basin 03030002 - Contract # D05011-1**

October 2008

**MONITORING
PLAN VIEW**

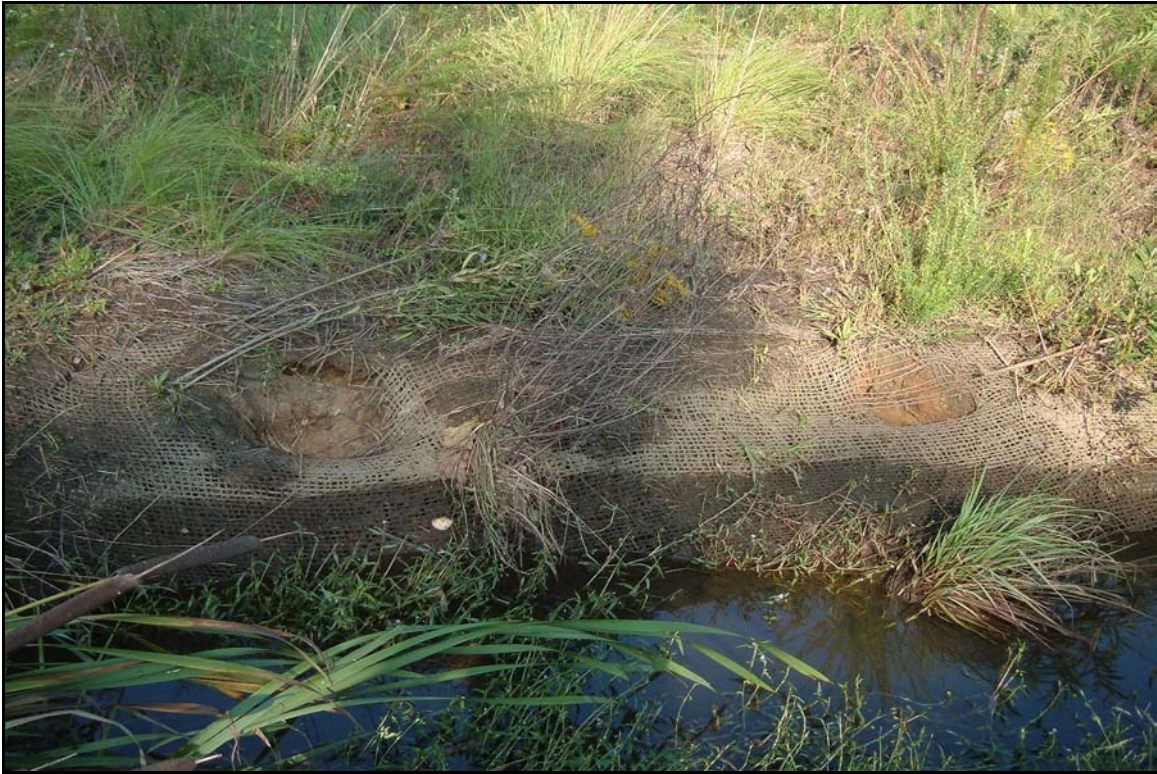
Bank Erosion – Erosion on toe of bank beneath matting. Stationing 11+10 – 11+25 09/29/08 - MY 02

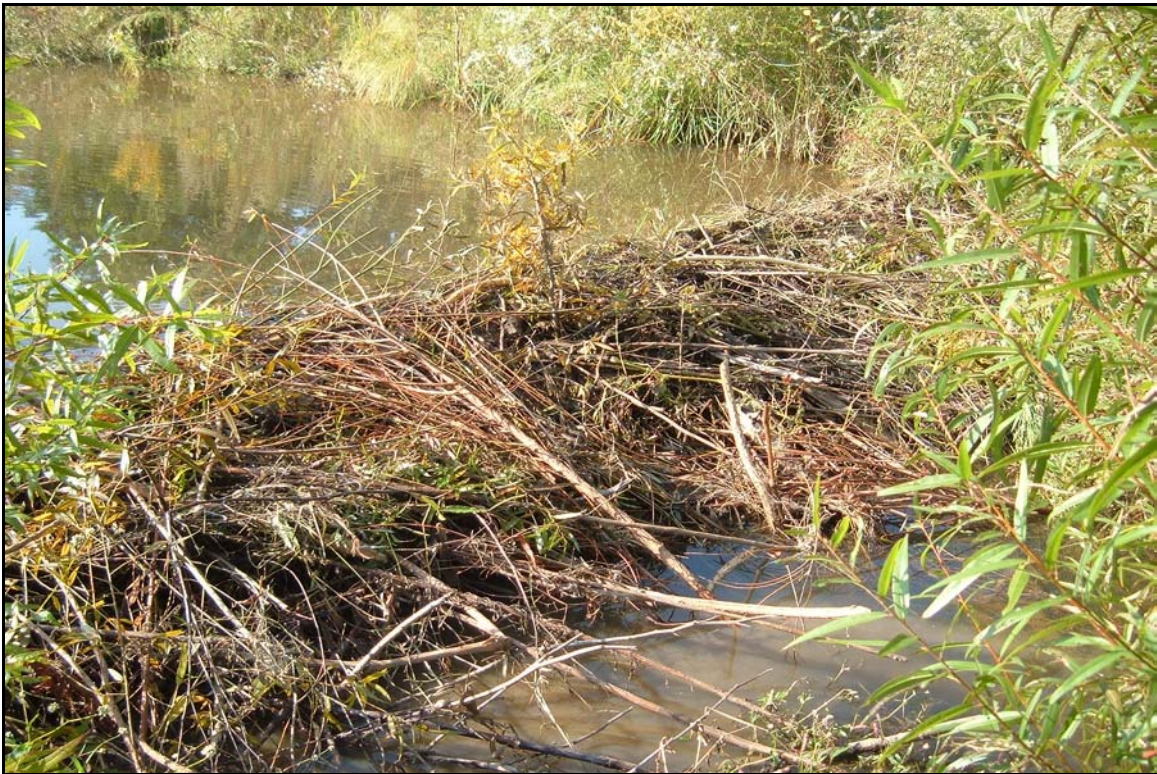
Beaver Dam – First of two beaver dams at the site. Station 19+50 09/29/08 - MY 02

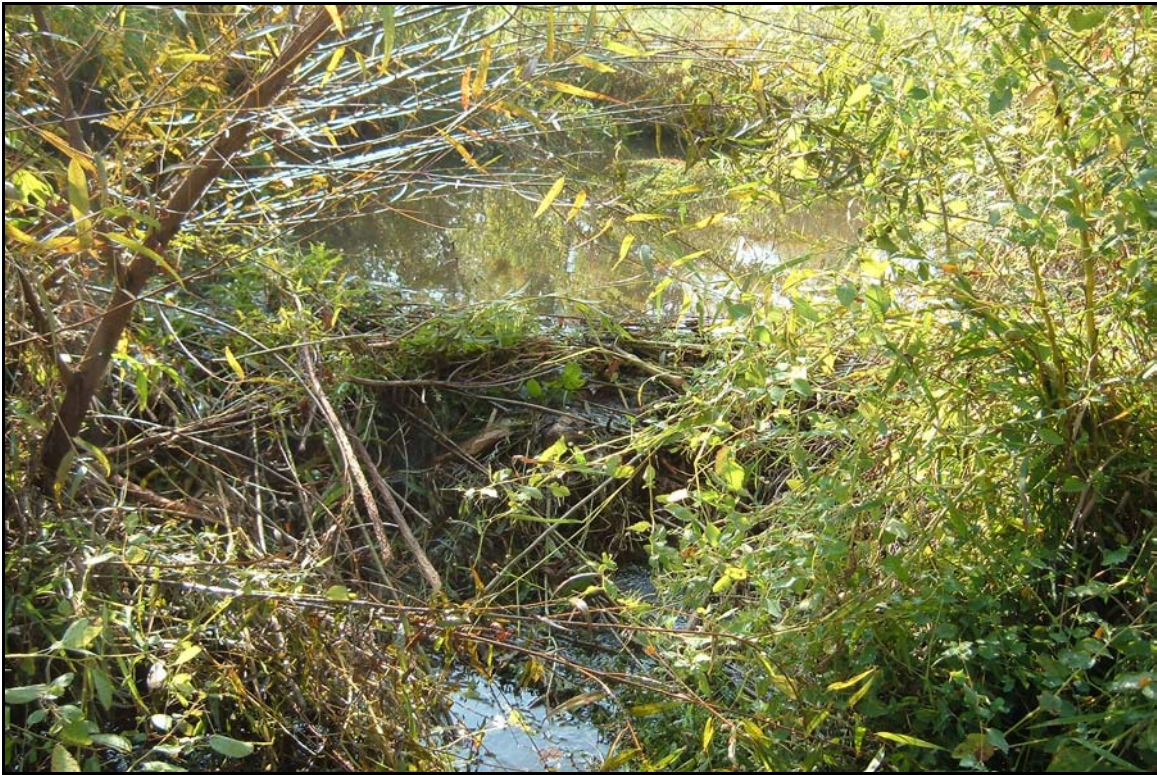
Beaver Dam – Second of two beaver dams at the site. Station 20+50 09/29/08 - MY 02

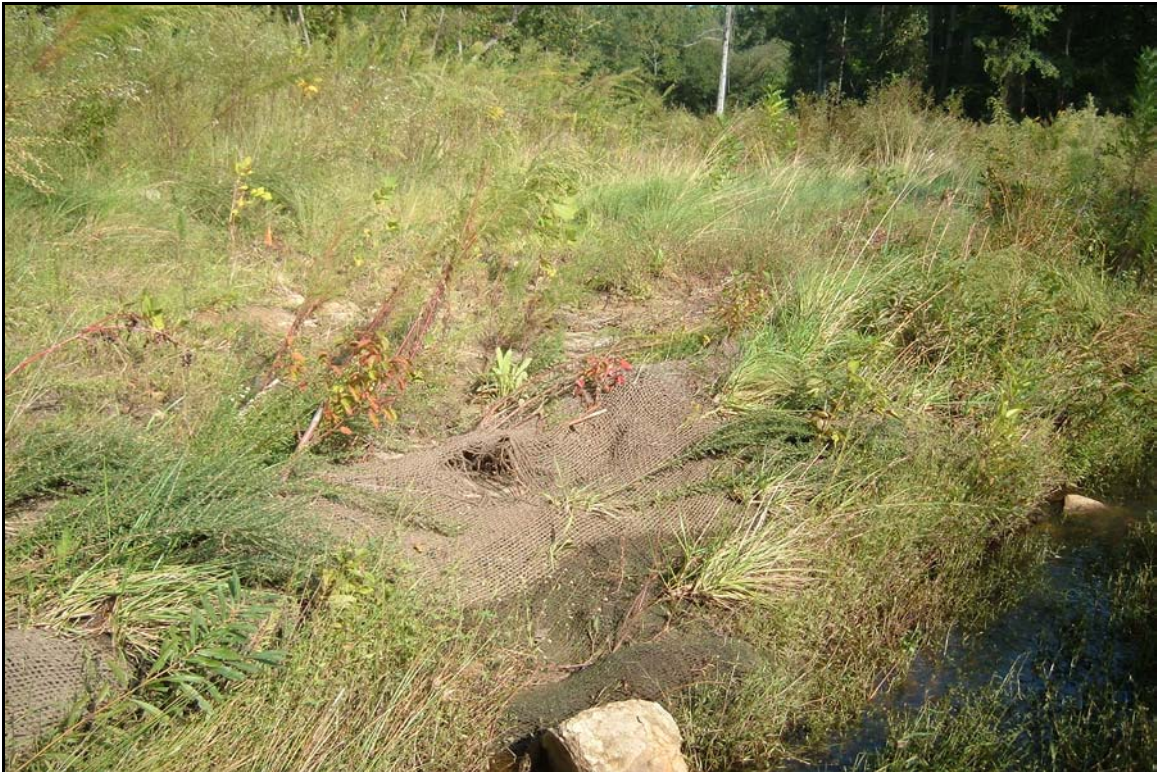
Bank/Floodplain Erosion – Bank erosion under matting and upper bank and floodplain erosion. Stationing 28+80 – 28+95 09/29/08 - MY 02

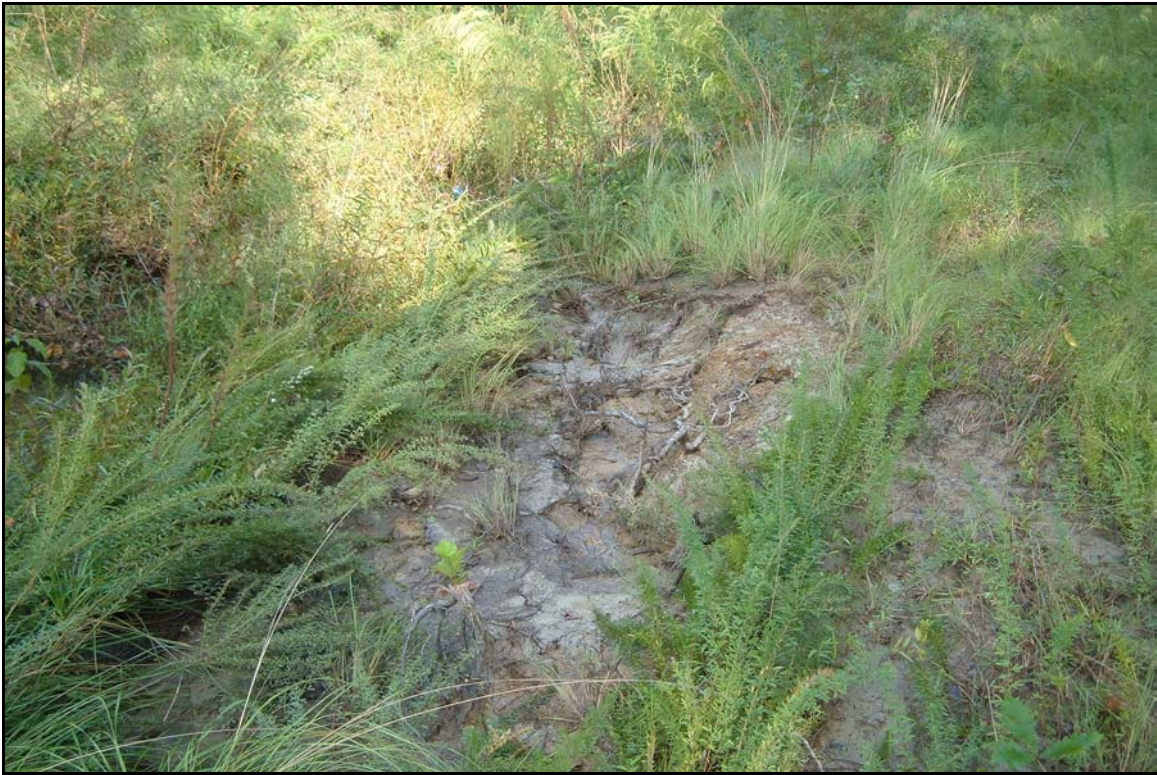
Floodplain Erosion – Upper bank and floodplain erosion. Stationing 31+85 – 32+05 09/29/08 - MY 02

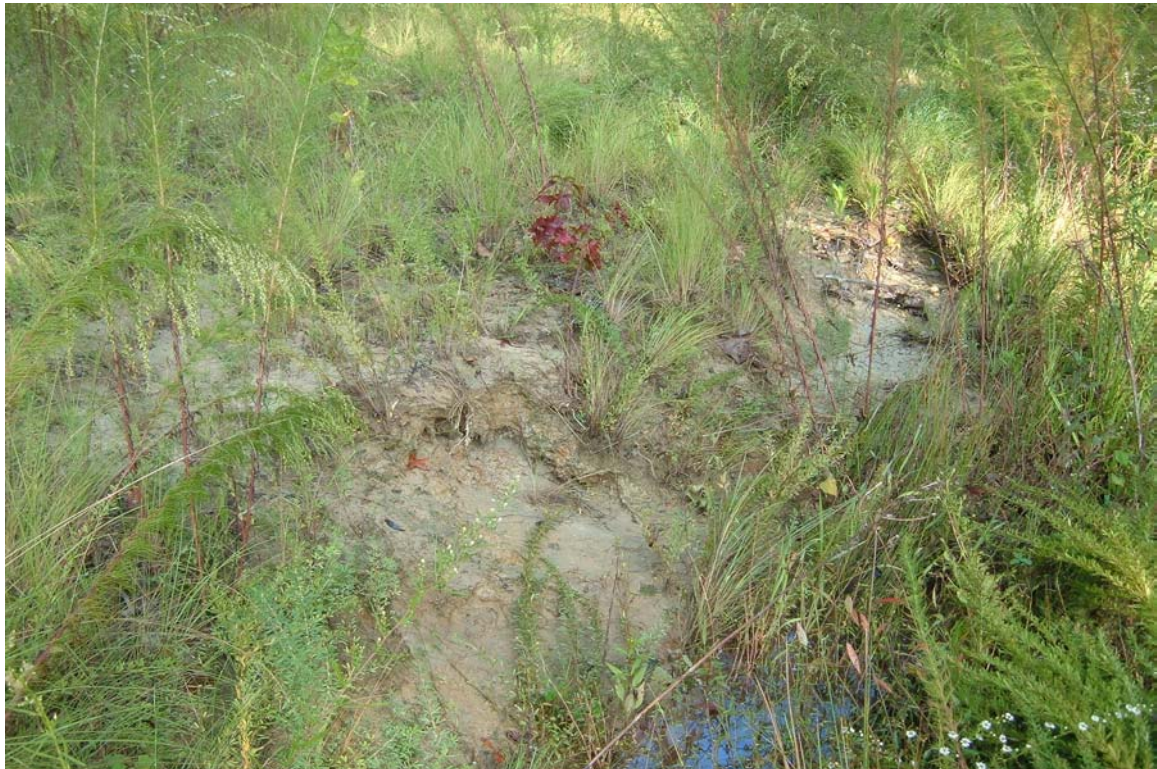
Floodplain Erosion – Stationing 34+40 – 34+60 09/29/08 - MY 02

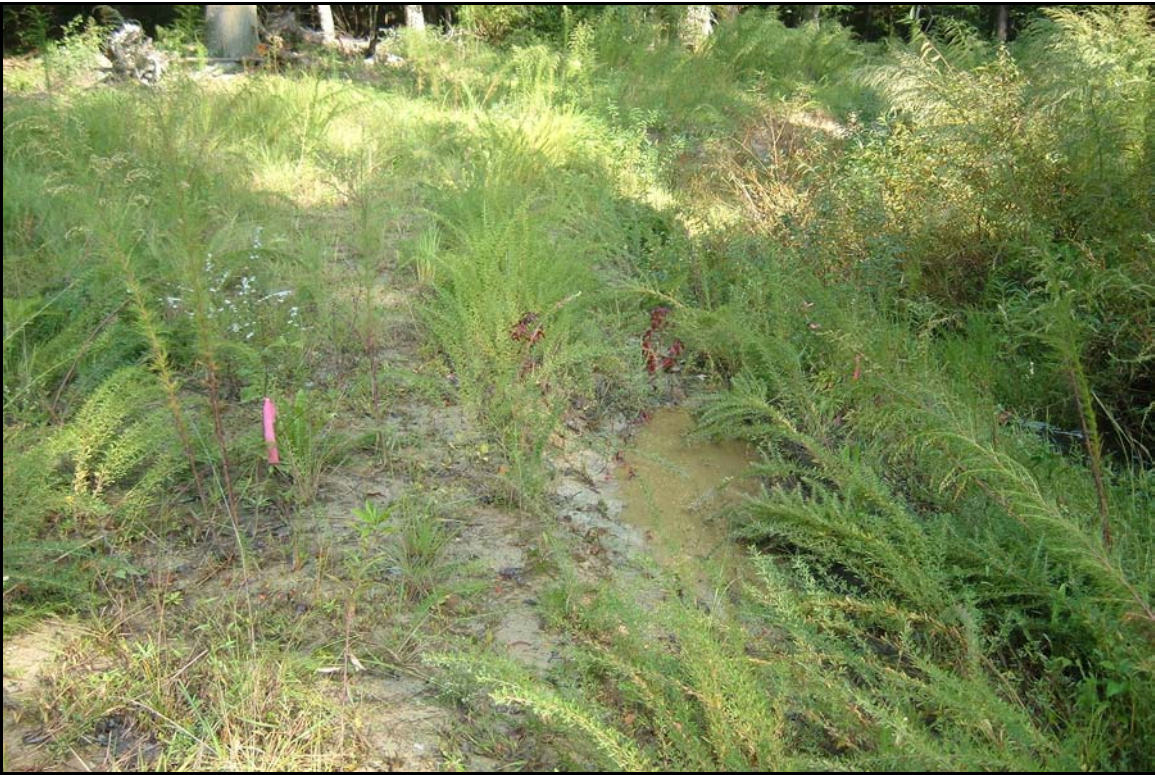
Floodplain Erosion – Upper bank and floodplain erosion. Stationing 36+00 – 36+10 09/29/08 - MY 02

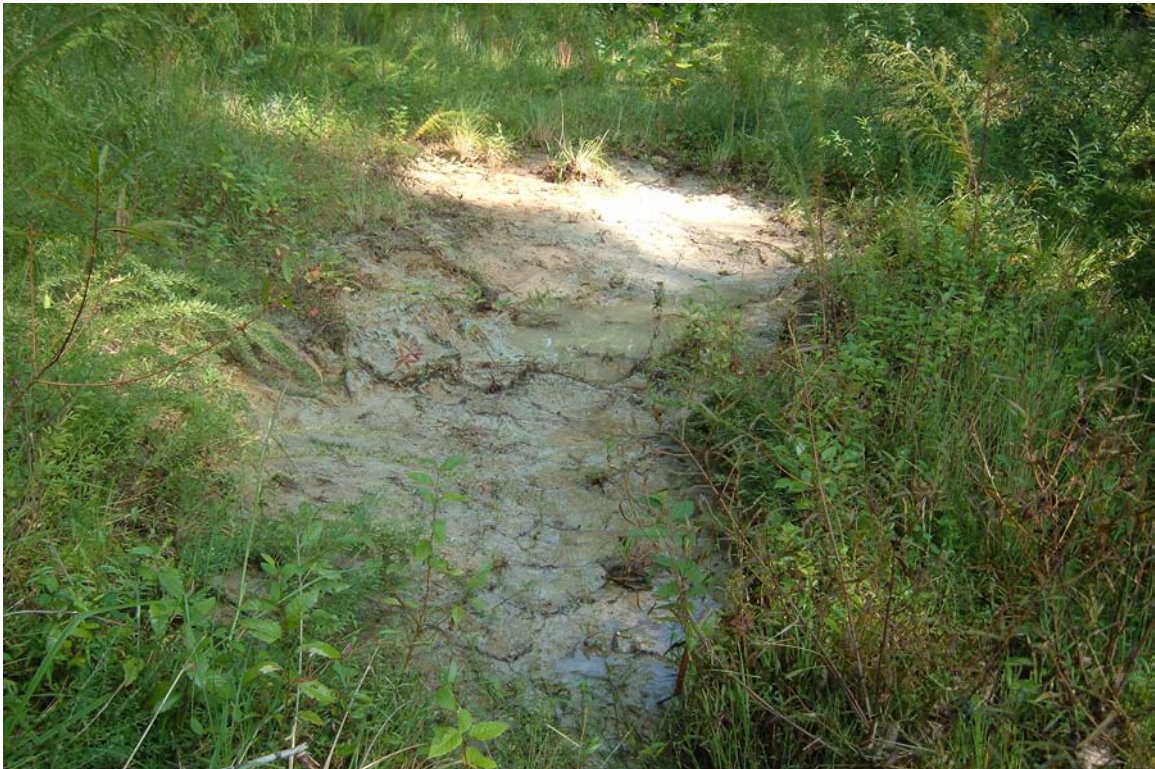
Floodplain Erosion – Stationing 36+20 – 36+40 09/29/08 - MY 02

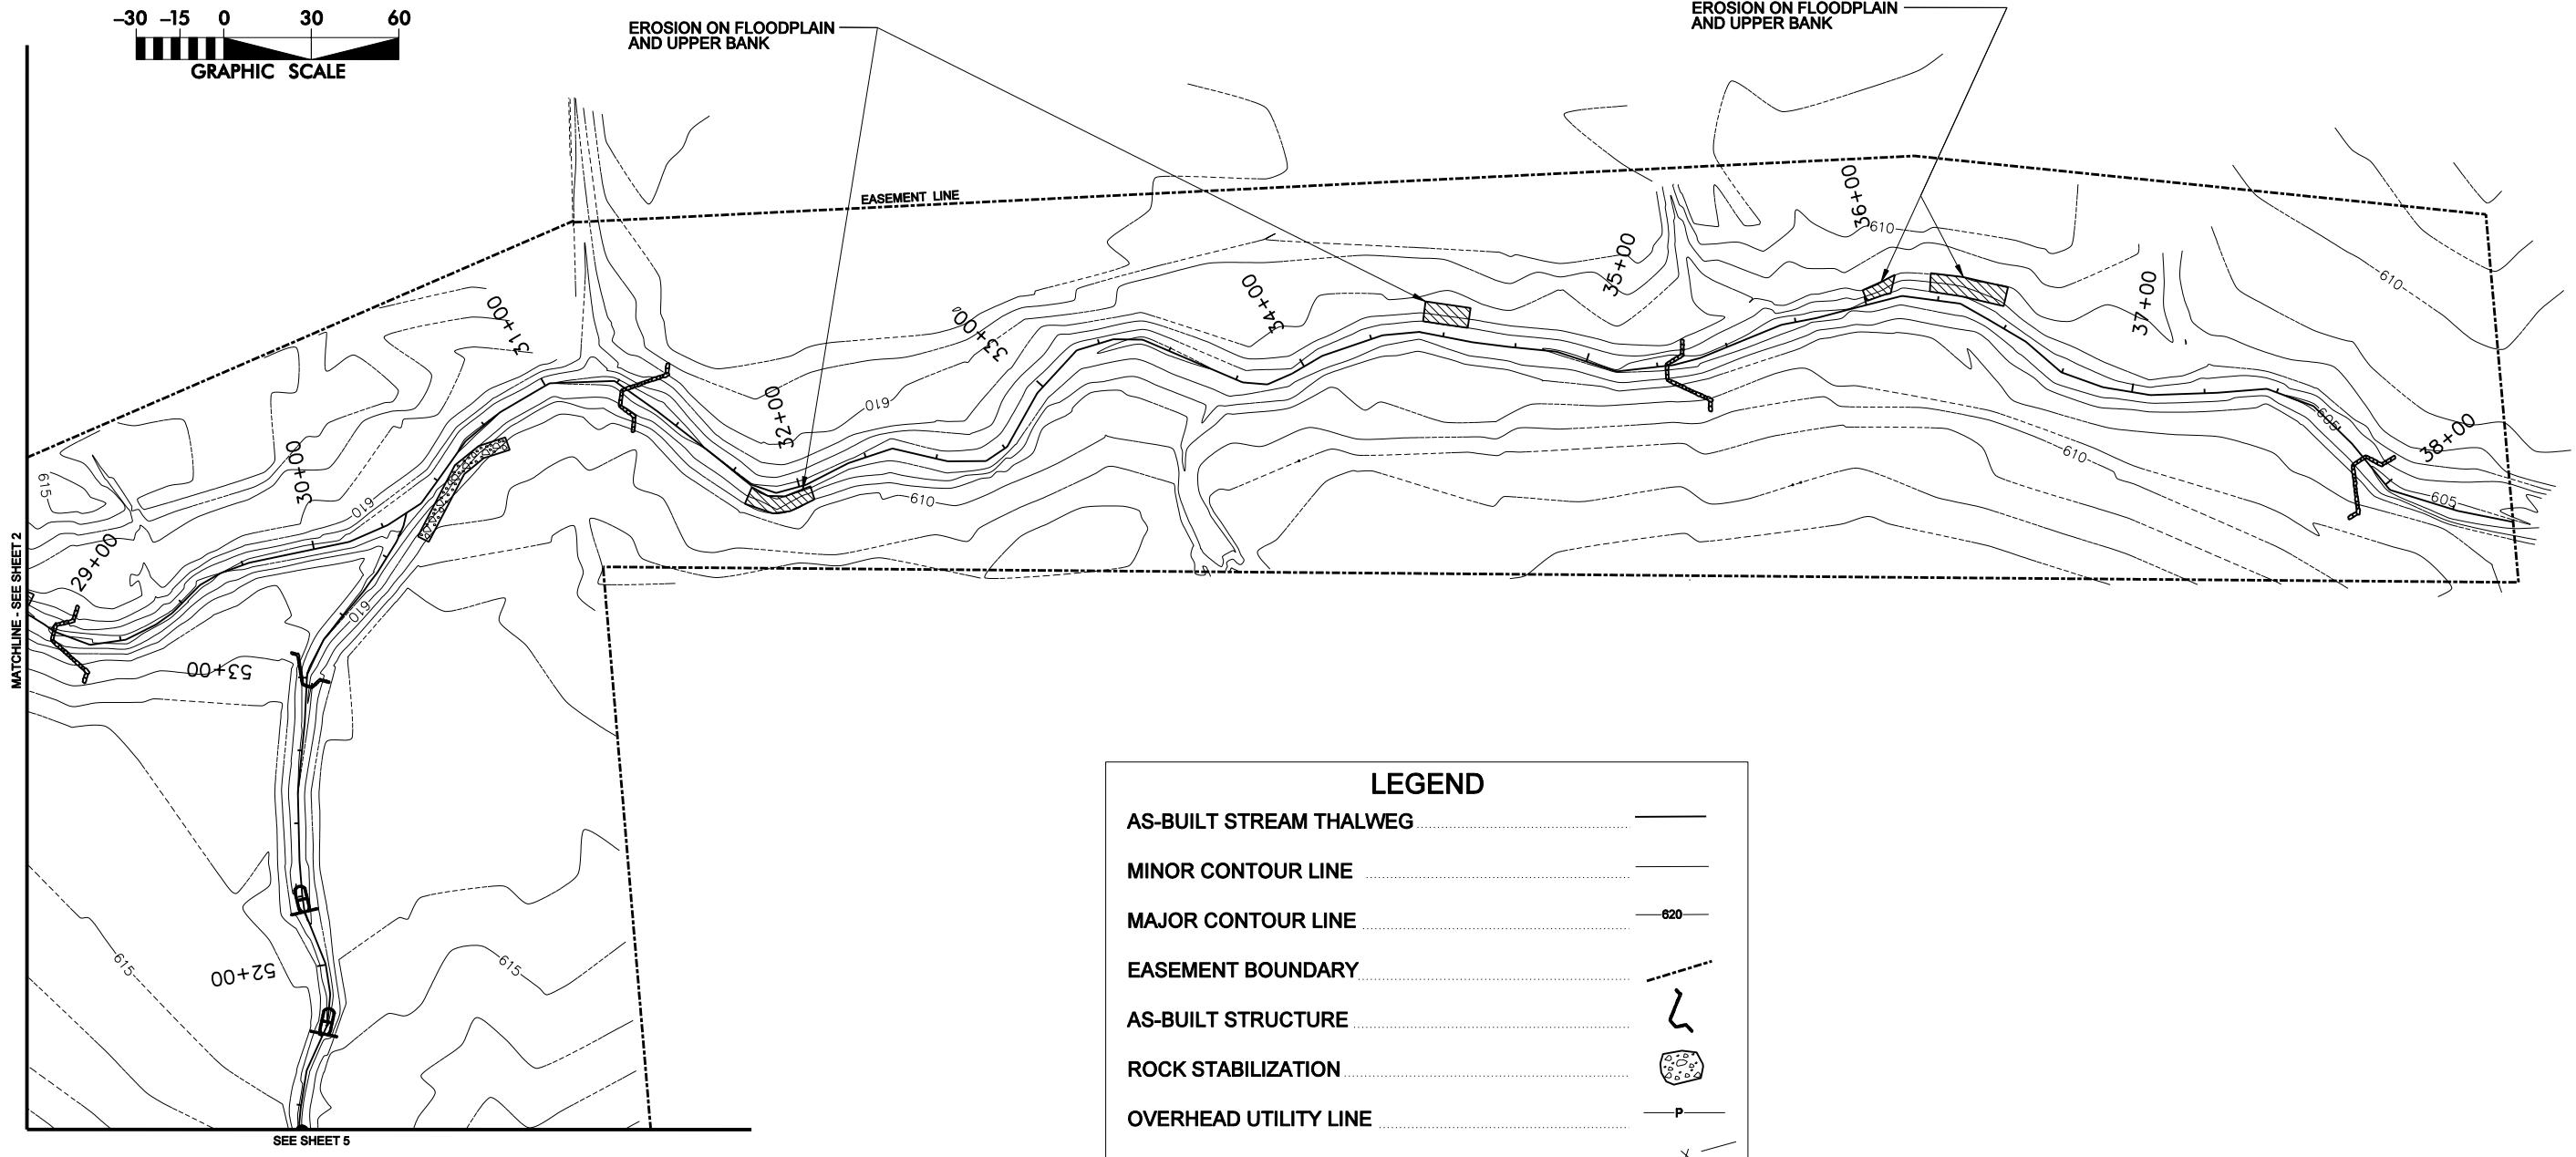
EROSION ON FLOODPLAIN AND UPPER BANK
