**Glen Raven Stream Restoration
Monitoring Report – MY03
Alamance County, NC
Basin 03030002 - Contract # D05011-1**

December 2009

EXECUTIVE SUMMARY

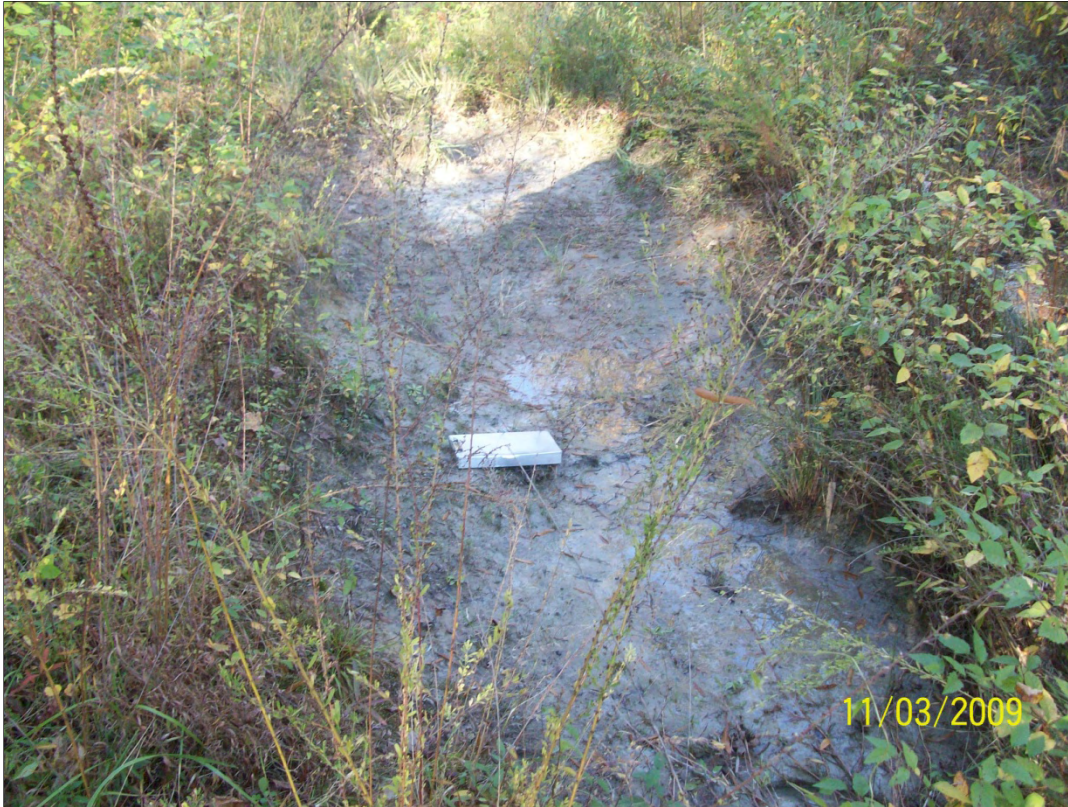
The stream assessment completed during third-year monitoring found the stream to be stable and functioning properly. Channel dimensions have not changed significantly from second-year monitoring conditions. Small portions of localized floodplain erosion were noted during the third year of monitoring and the beaver dams reported during the second year of monitoring have been removed. These areas have been documented in the Current Conditions Plan View. The on-site stream gauges have recorded thirteen bankfull events since the beginning of 2008. This includes the over three-inch rain event from by Tropical Storm Hanna, which caused the stream stage to crest at almost three feet above bankfull.

SP1 – Upper bank and floodplain erosion. Stationing 36+20 – 36+50 11/3/09 - MY 03
