**Glen Raven Stream Restoration  
Monitoring Report – MY04  
Alamance County, NC  
Basin 03030002 - Contract # D05011-1**

**2010**

Figure 1.	Vicinity Map .....	2
Figure 2.	Current Condition Plan View.....	6

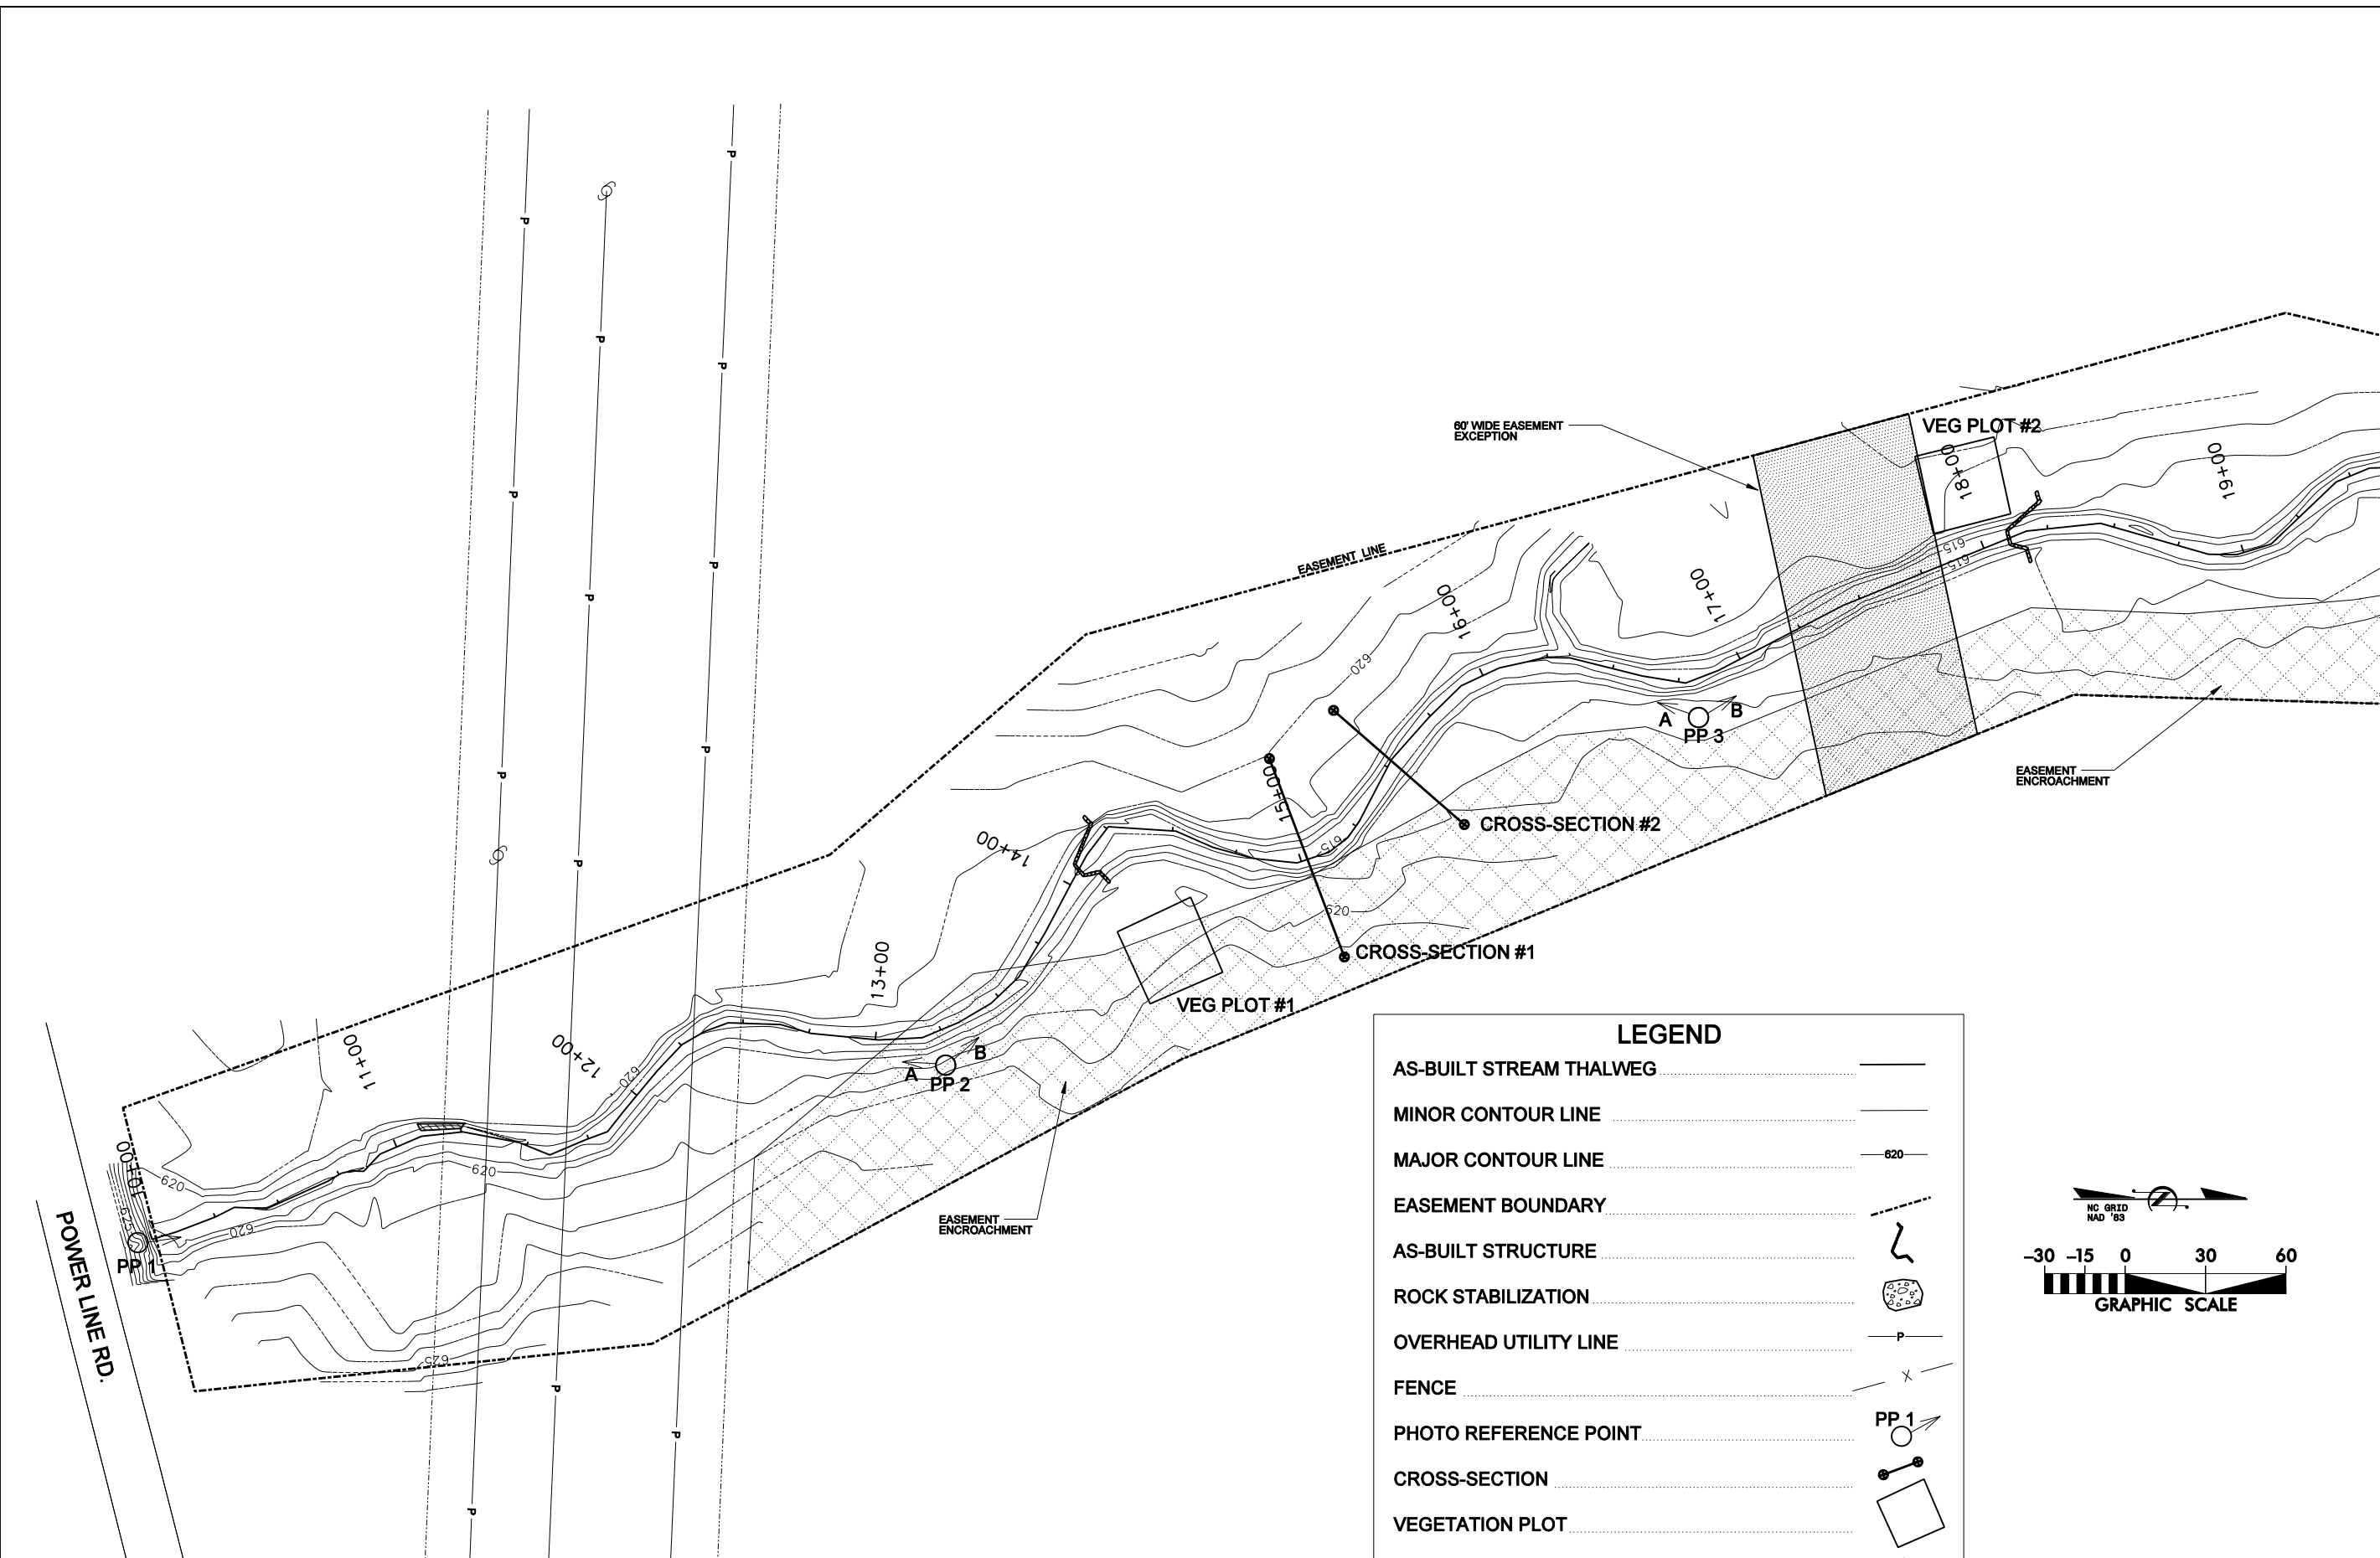
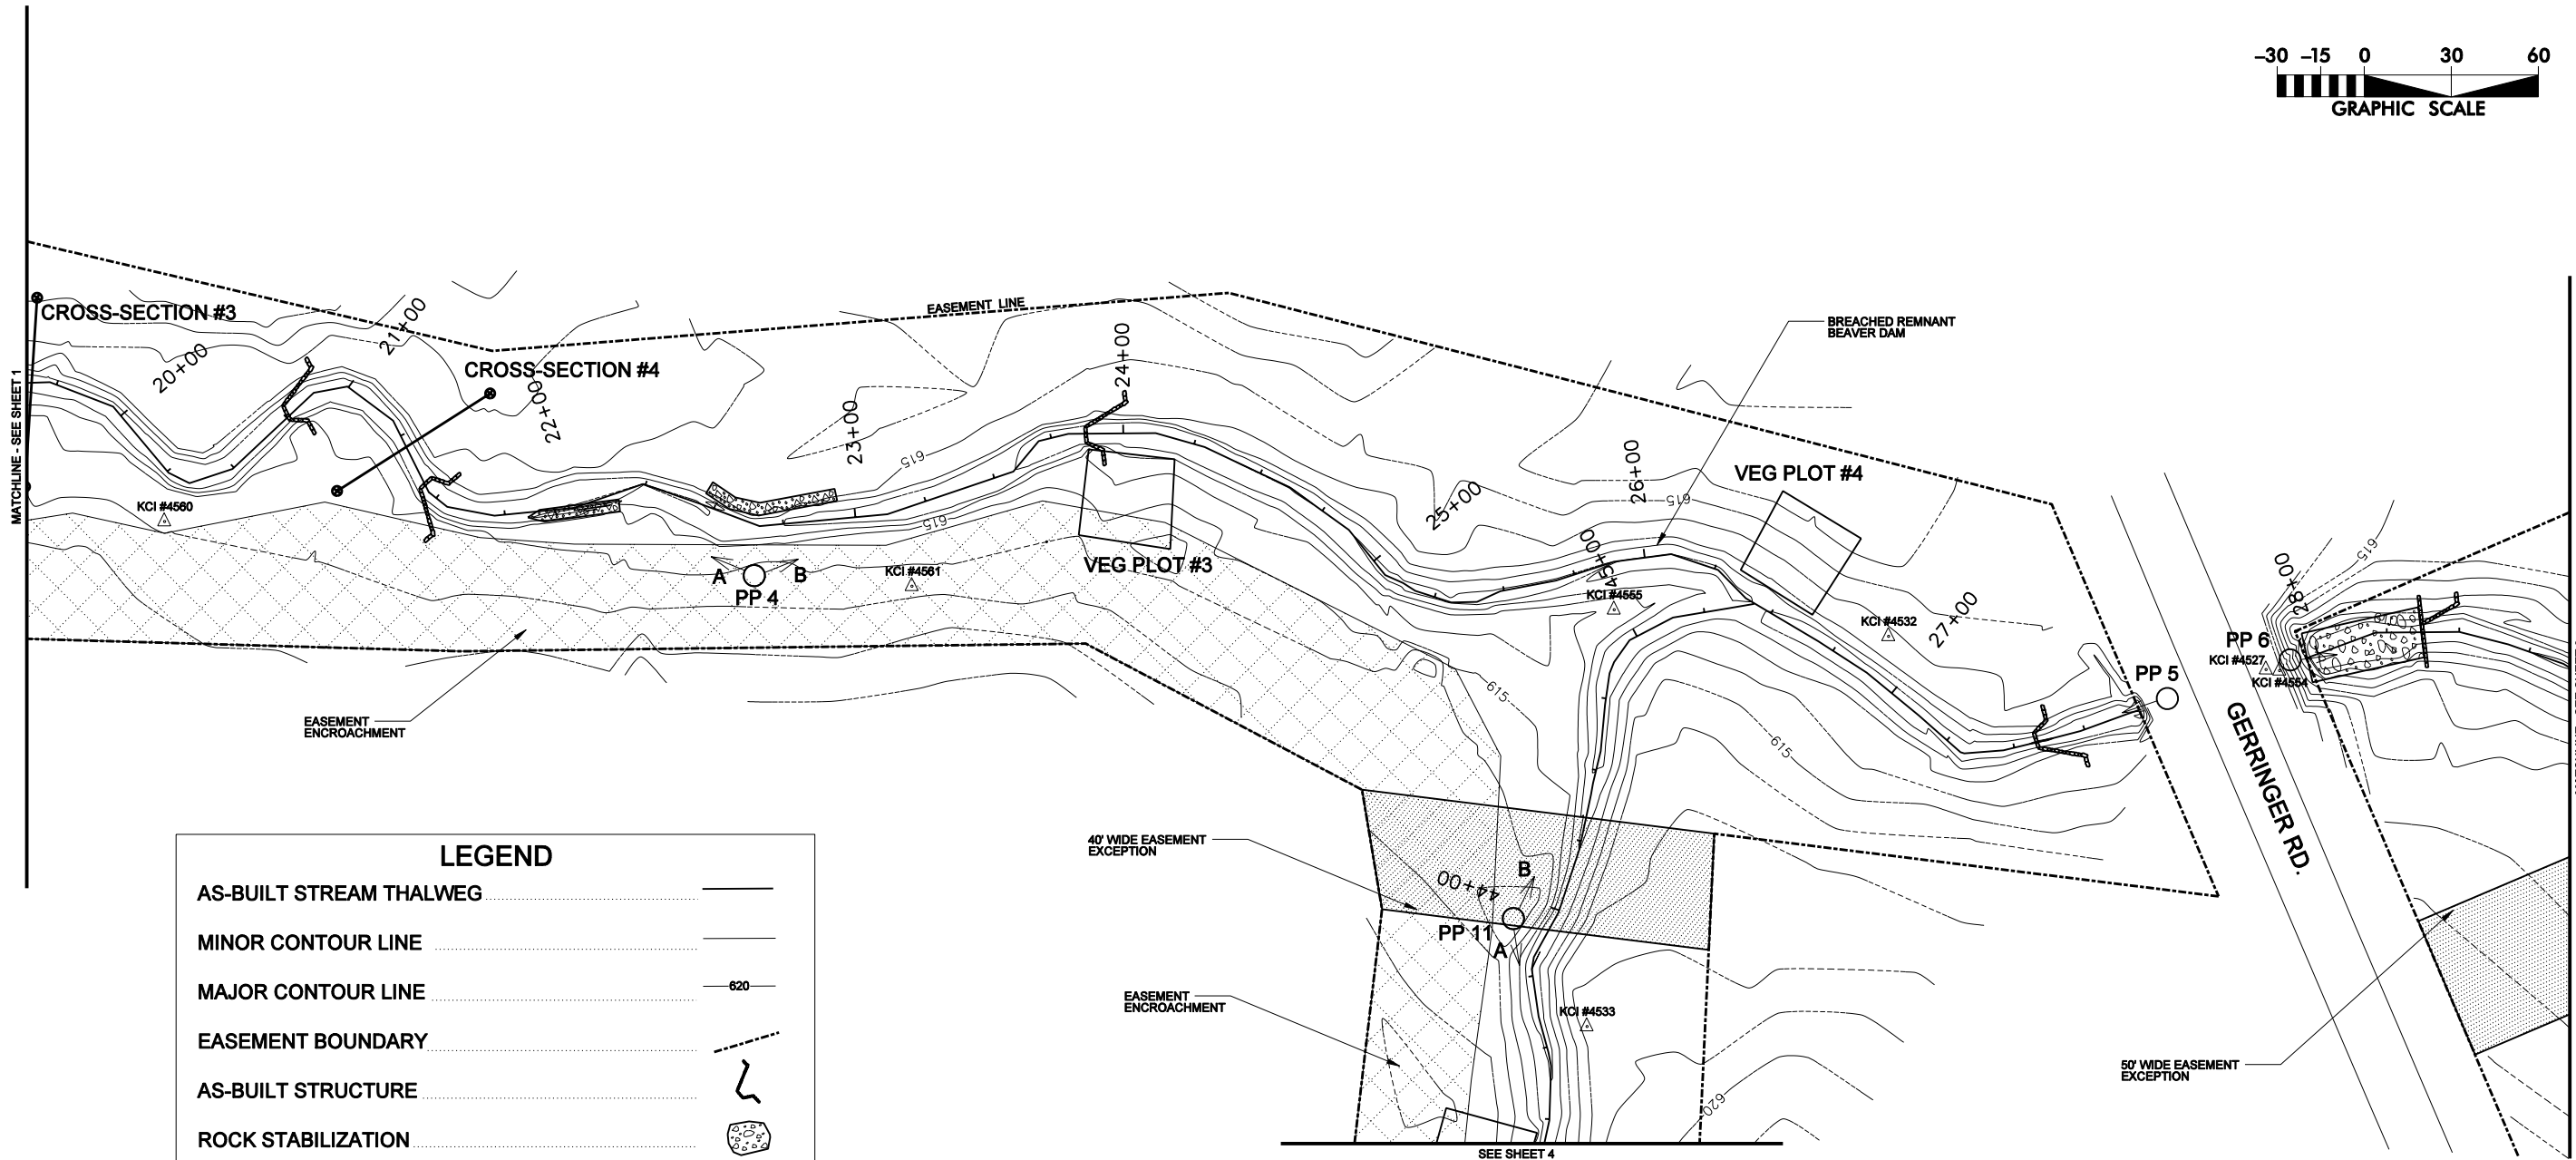
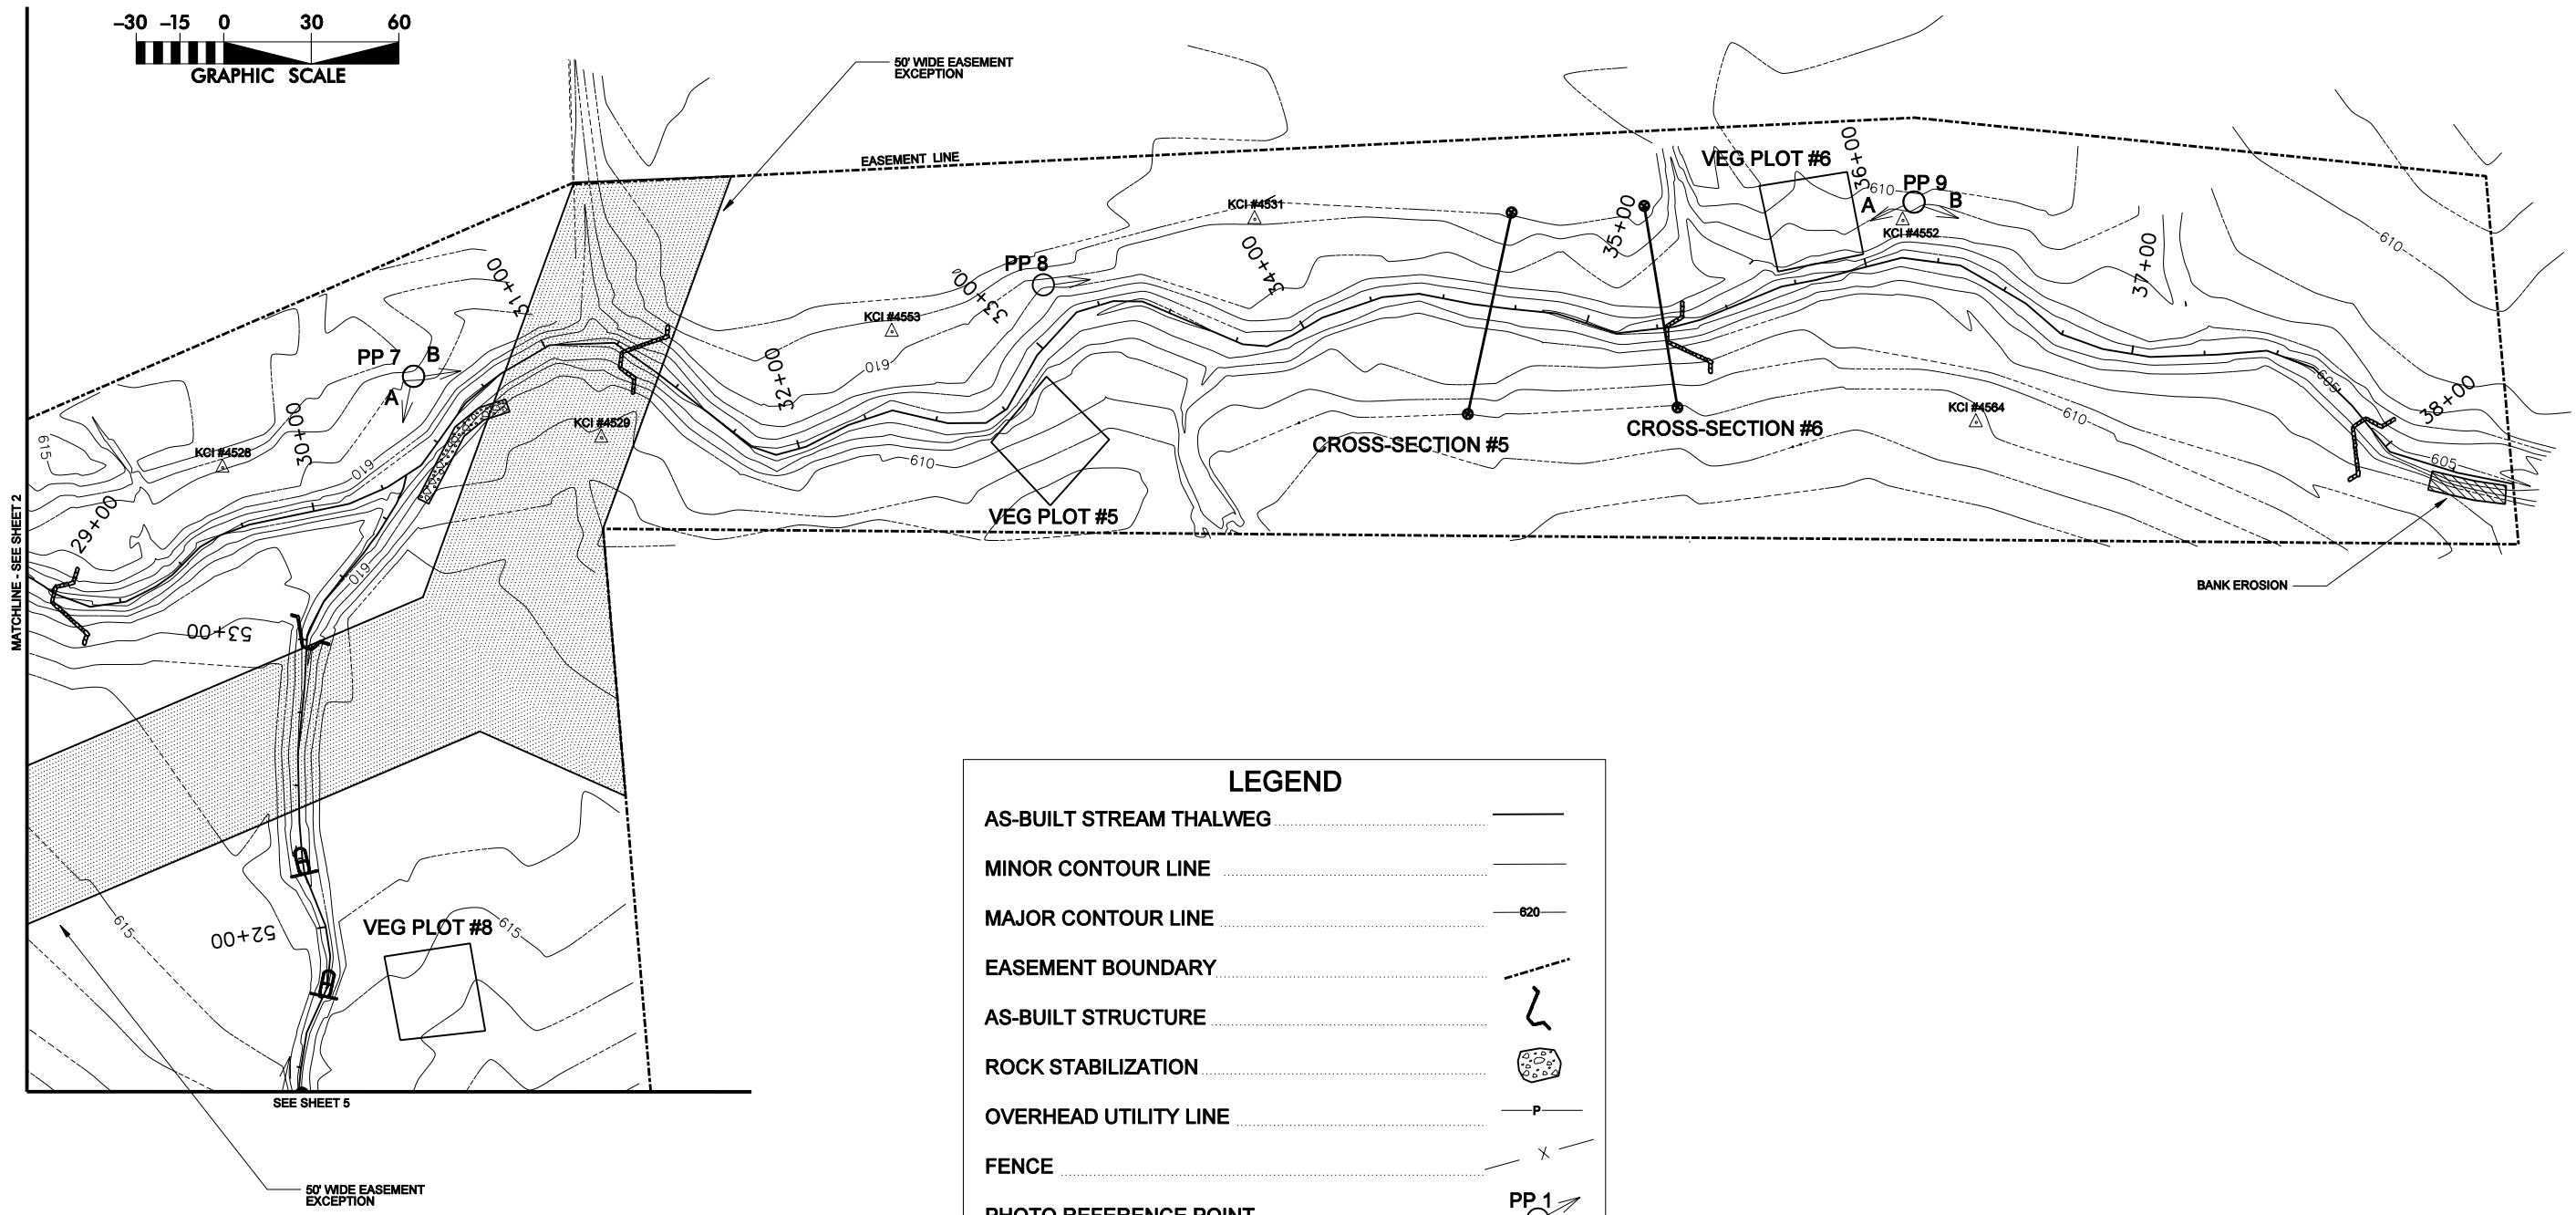
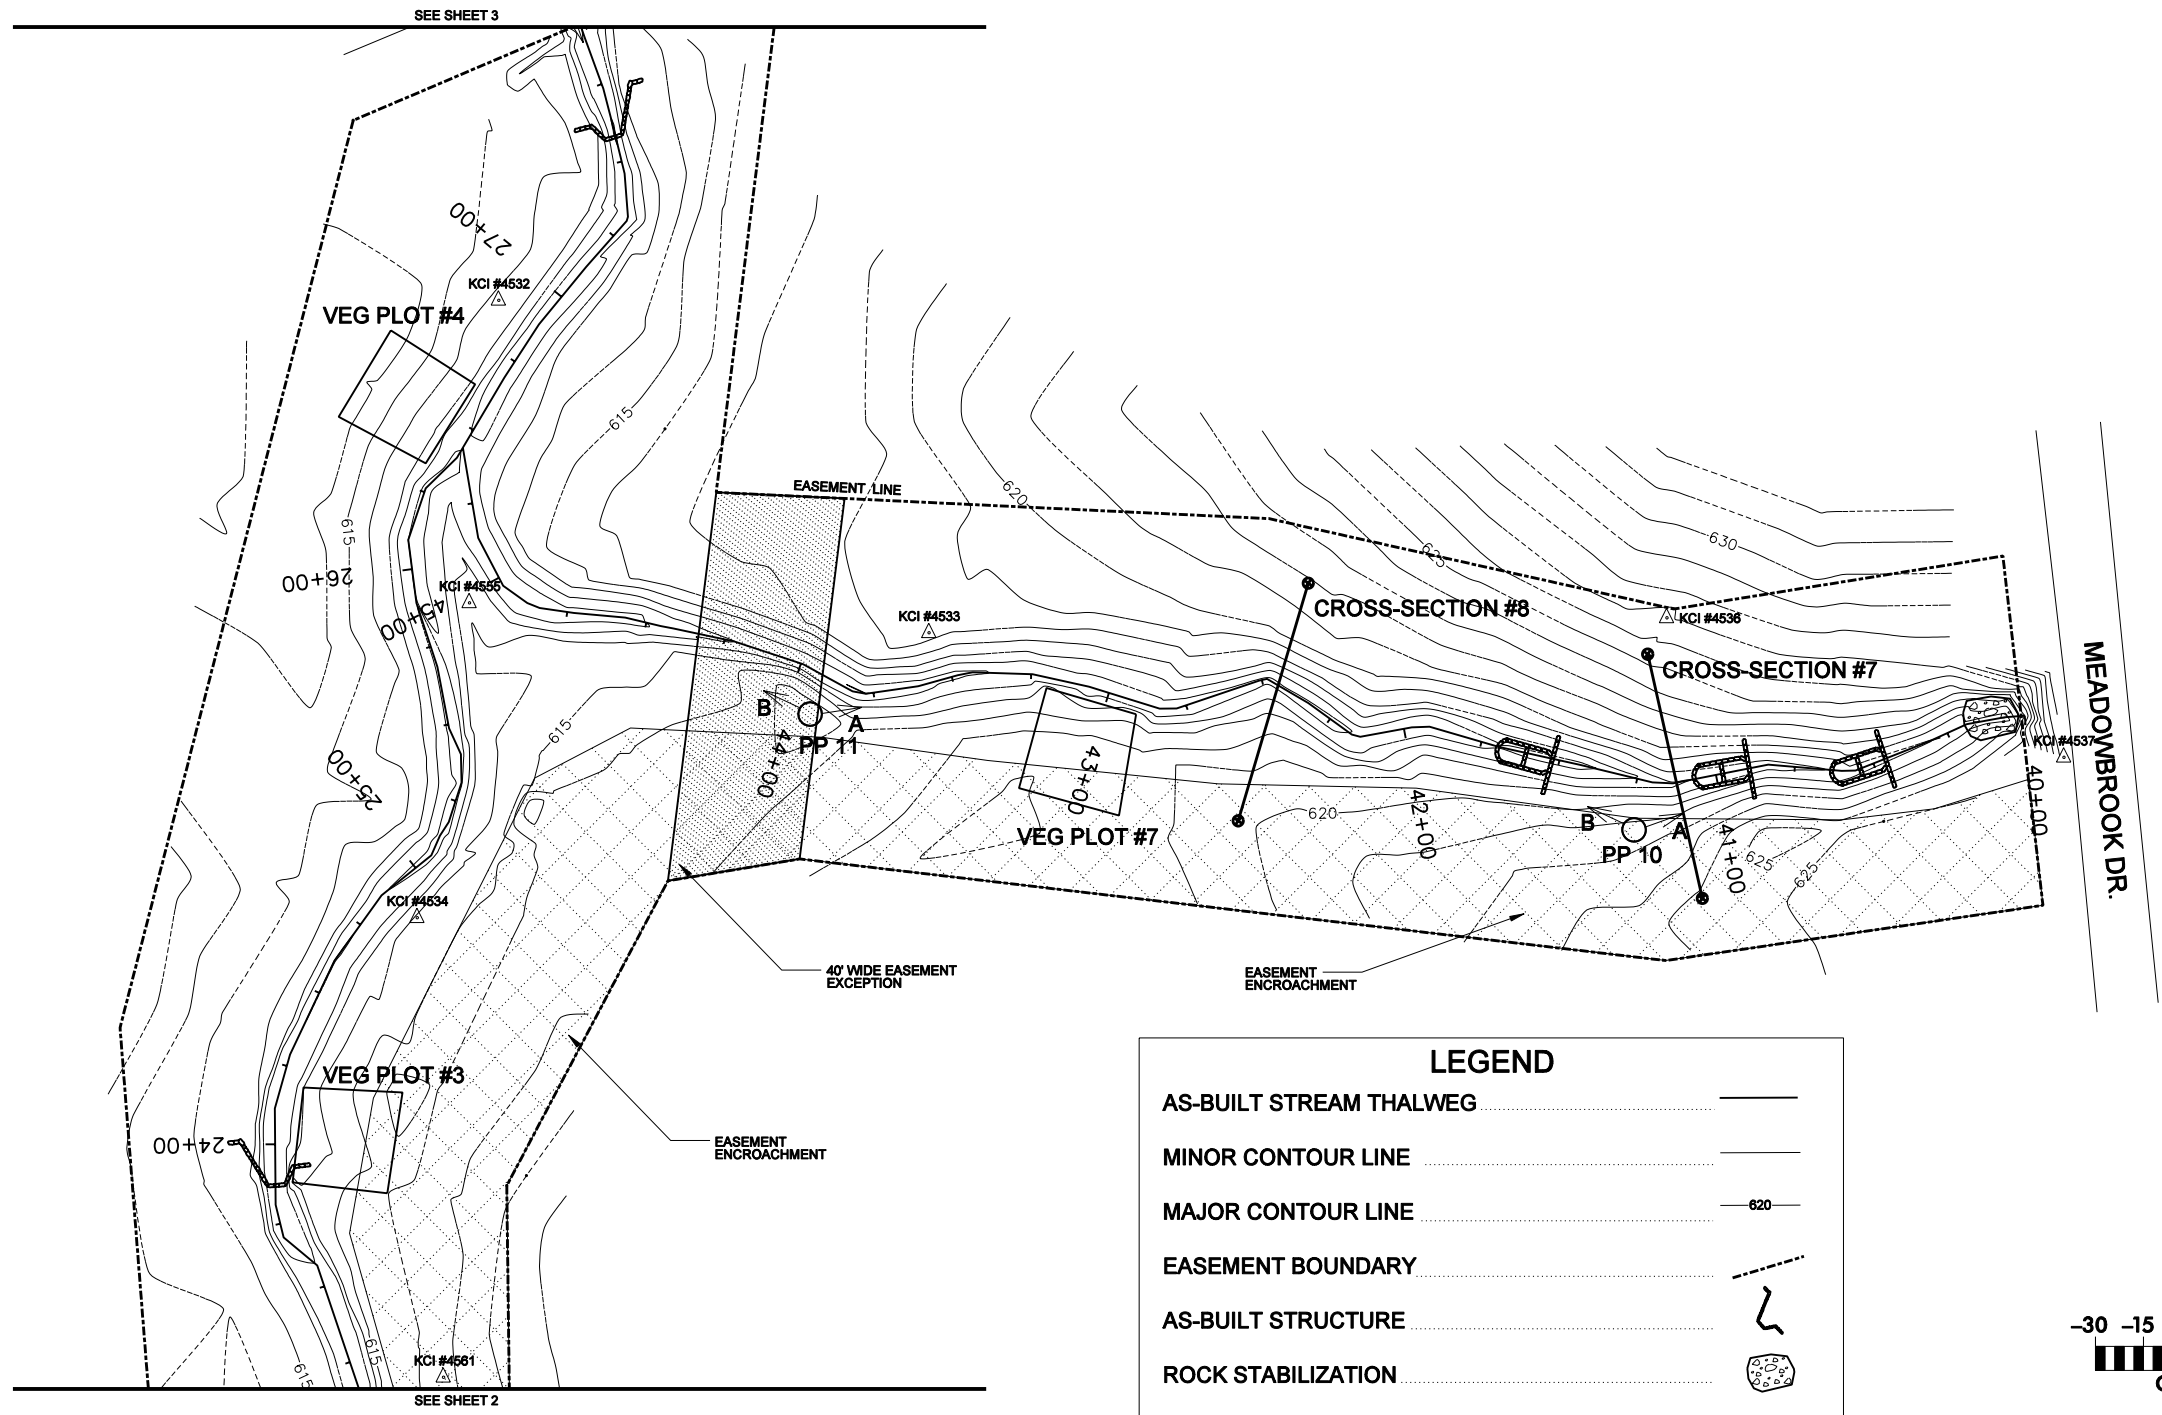
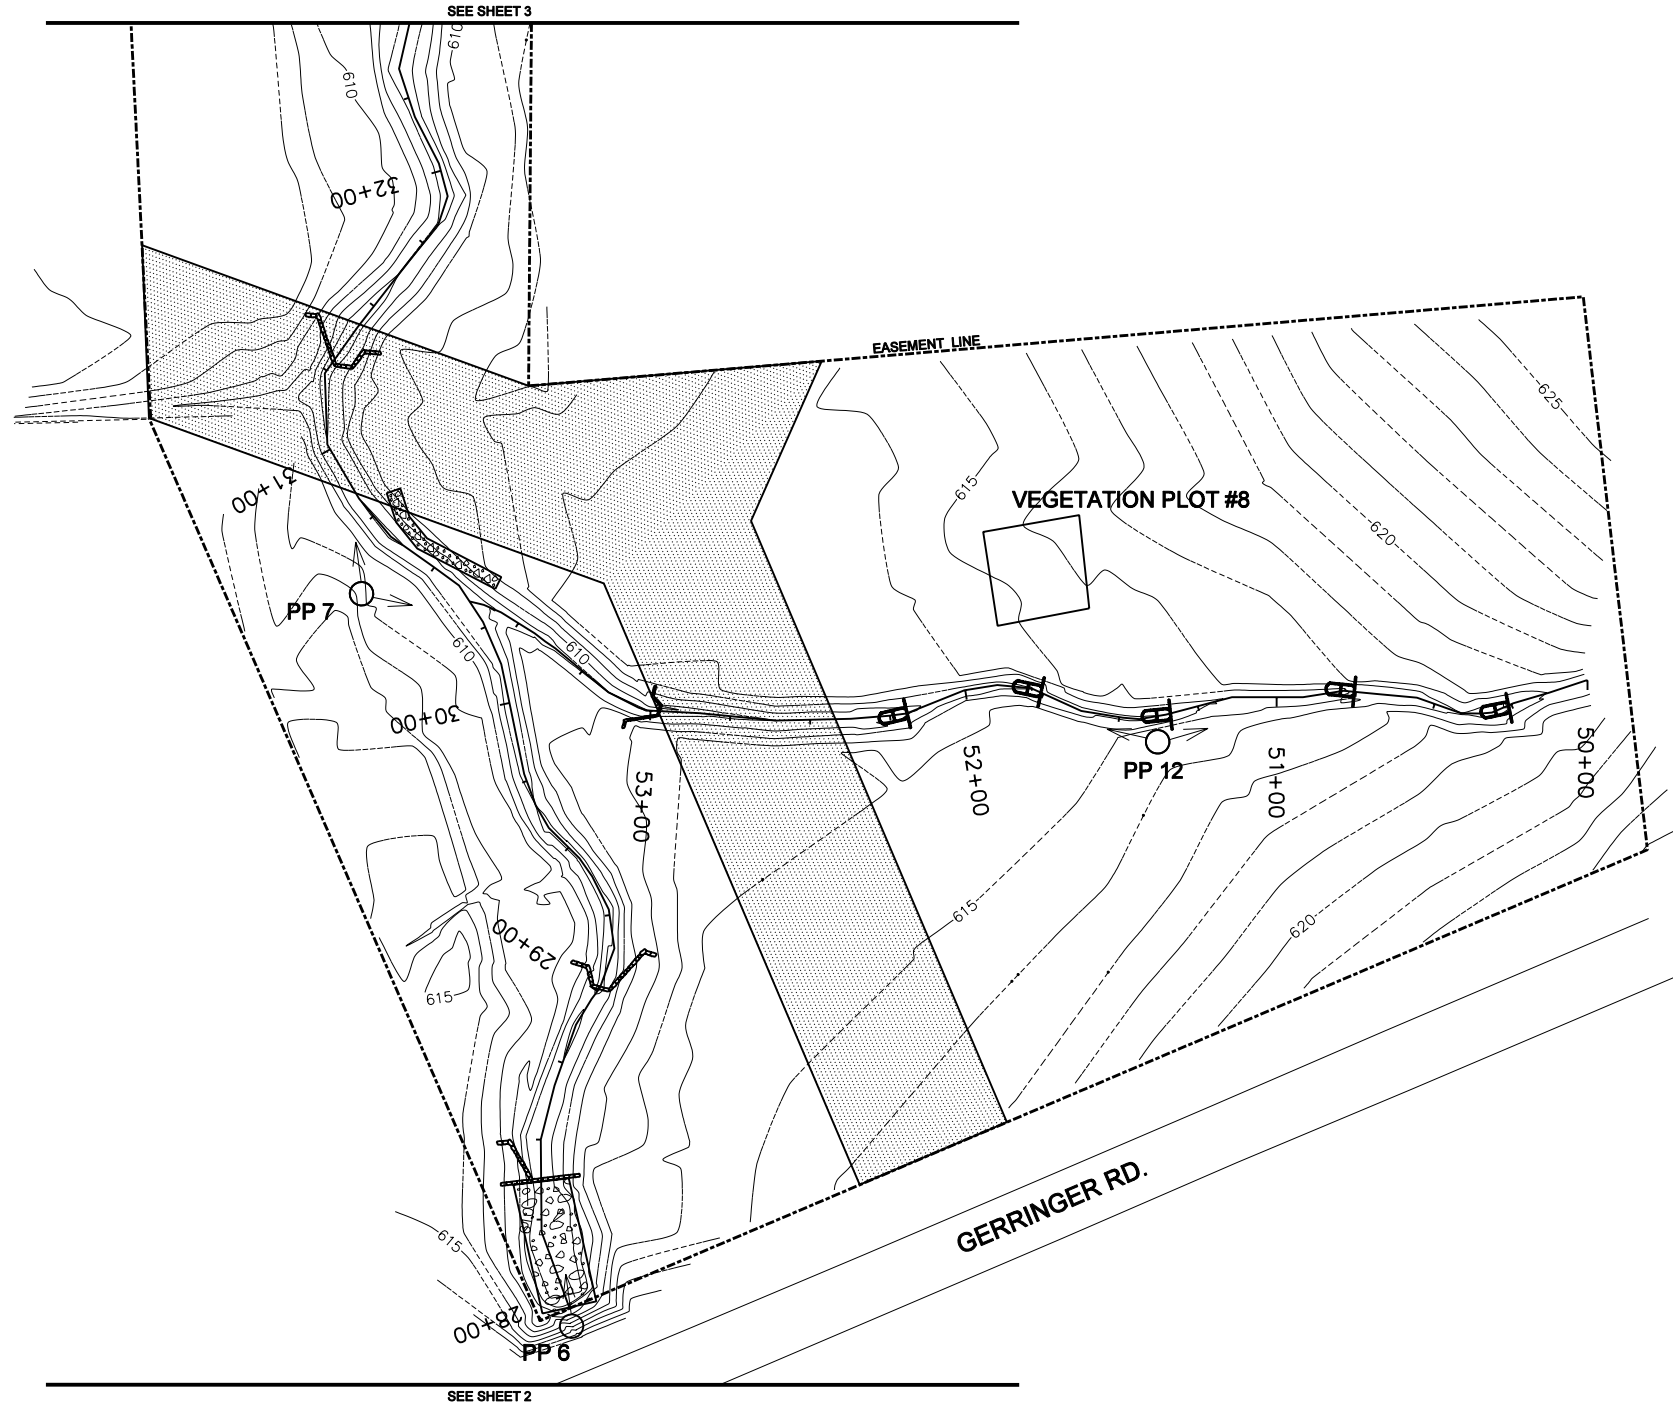
DATE: DECEMBER 2010  
 SCALE: 1"=60'  
**CURRENT  
 CONDITION  
 PLAN VIEW**  
 SHEET 1 OF 5

The fourth year of monitoring found the physical components of the stream to be stable. The morphological monitoring revealed that the cross-sections and the longitudinal profile have changed only minimally since the third-year monitoring. The changes that have occurred do not indicate a trend toward an unstable condition. A small portion of bank erosion has been labeled in the CCPV at the downstream limits of the project. This area will continue to be monitored. The beaver dams that were found during the previous year's monitoring have been removed, and as of December 2010 there were no beaver dams on the Glen Raven site. For more information on the monitored cross-sections and the longitudinal profile, see Appendix B.

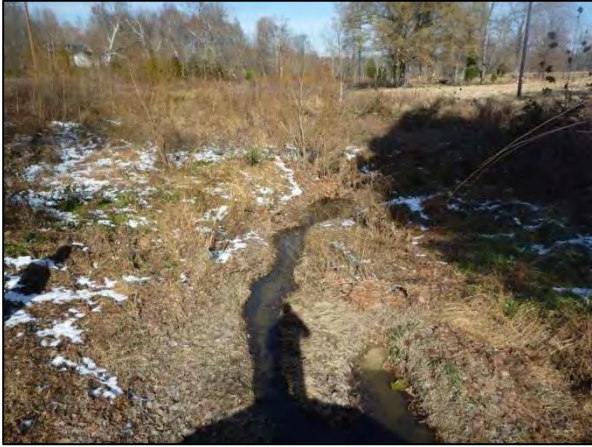
Photo Point 1: View looking north from Power Line Road. 12/10/10 – MY-04

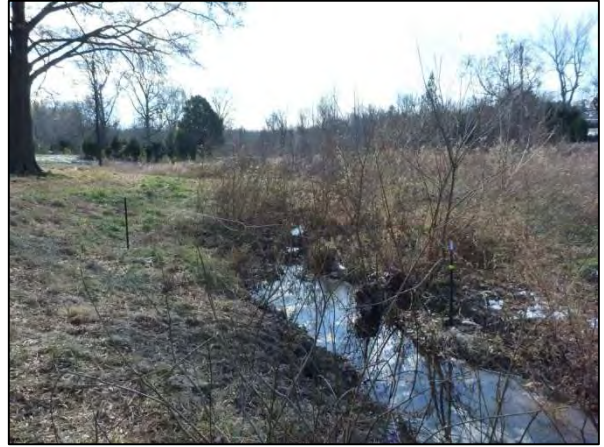
Photo Point 2a: View looking south near Station 13+25. 12/10/10 – MY-04

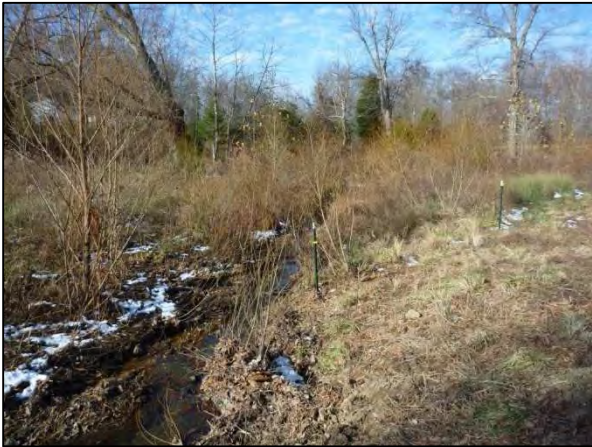
Photo Point 2b: View looking north near Station 13+25. 12/10/10 – MY-04

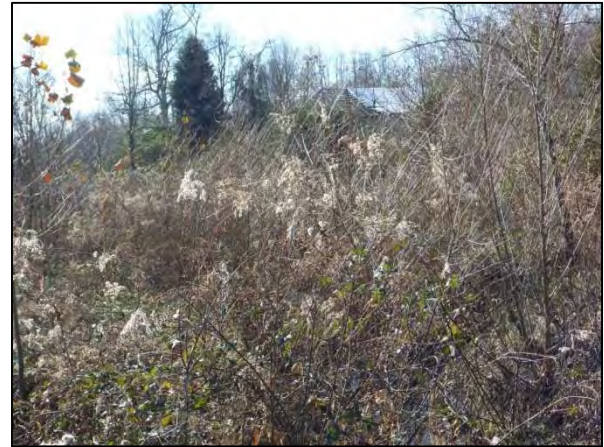
Photo Point 3a: View looking south near Station 16+75. 12/10/10 – MY-04

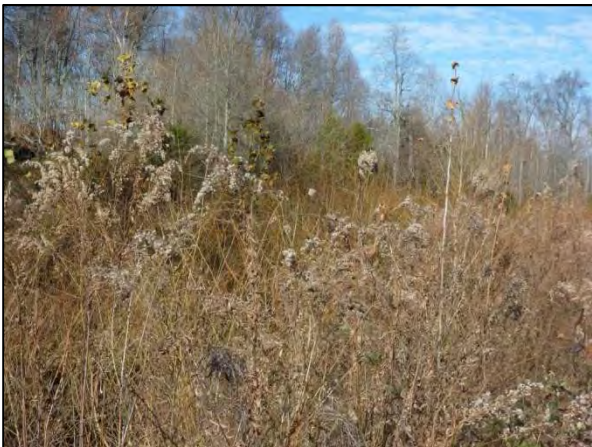
Photo Point 3b: View looking north toward Vegetation Plot #2. 12/10/10 – MY-04

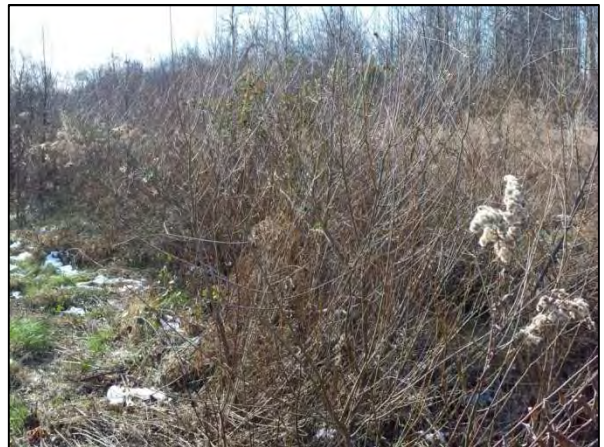
Photo Point 4a: View looking south near Station 22+75. 12/10/10 – MY-04

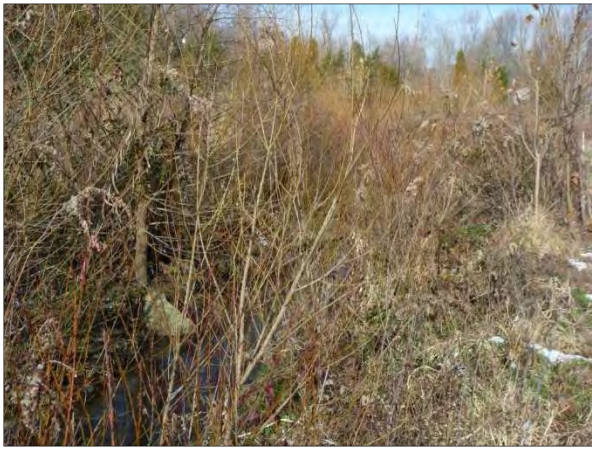
Photo Point 4b: View looking north toward Vegetation Plot #3. 12/10/10 – MY-04

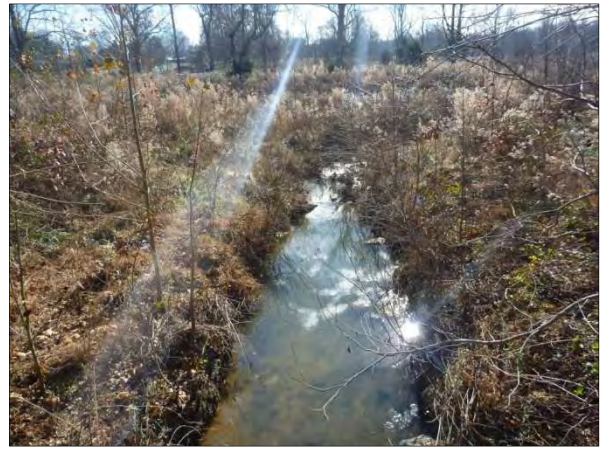
Photo Point 5: View looking south from Gerring Road culvert. 12/10/10 – MY-04

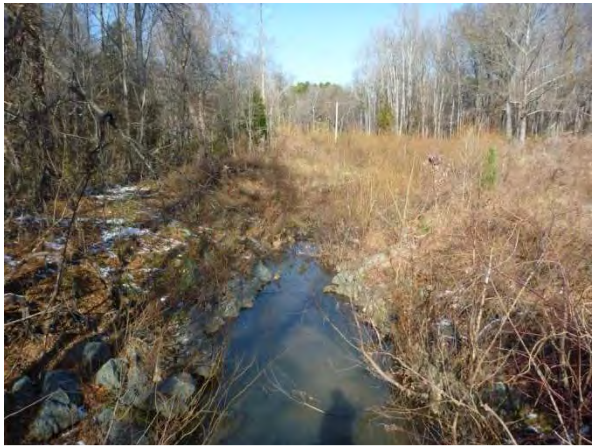
Photo Point 6: View looking north from Gerring Road culvert. 12/10/10 – MY-04

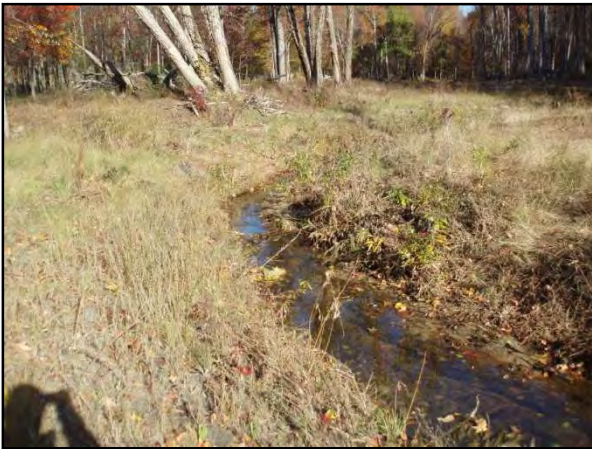
Photo Point 7b: View looking north near Station 31+15. 12/10/10 – MY-04

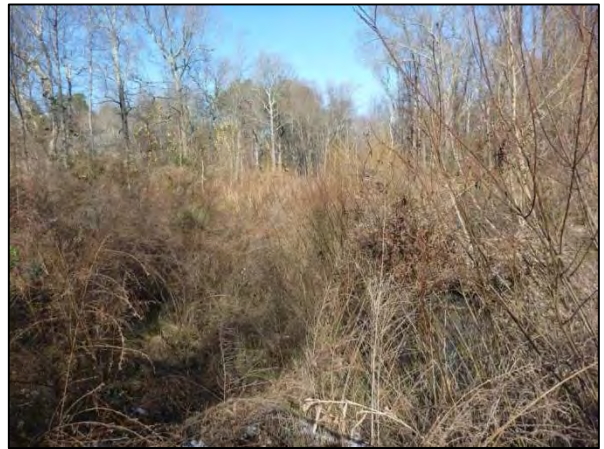
Photo Point 8: View looking south towards plot #7. 12/10/10 – MY-04

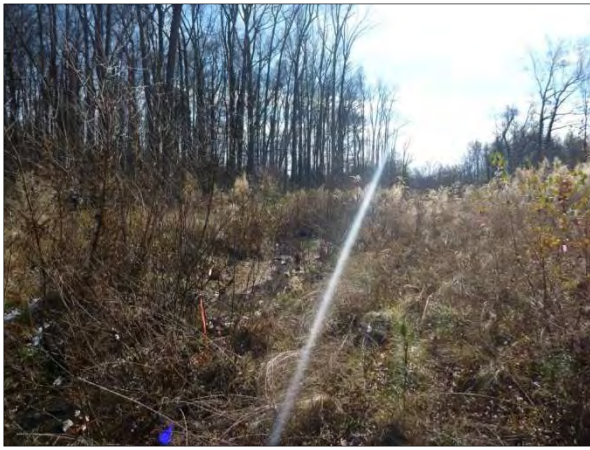
Photo Point 9a: View looking north toward vegetation plot #8. 12/10/10 – MY-04

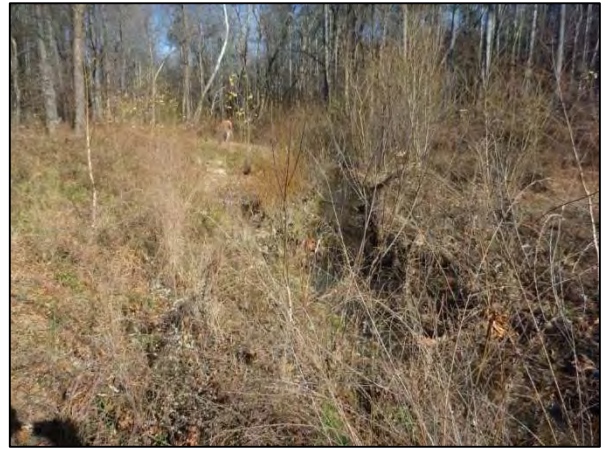
Photo Point 9b: View looking north toward end of project. 12/10/10 – MY-04

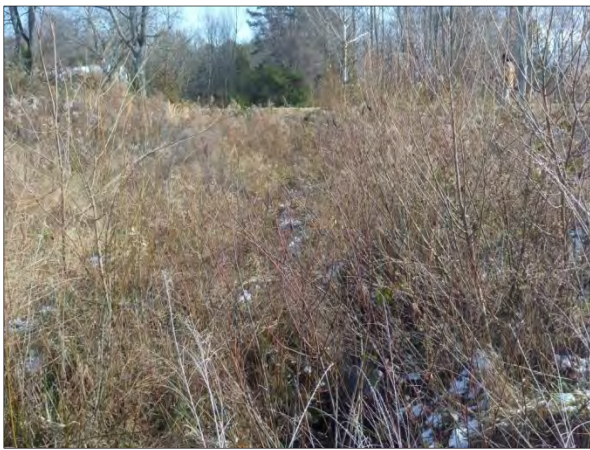
Photo Point 10a: View looking upstream on UT1 near Station 41+25. 11/16/07 – MY-04

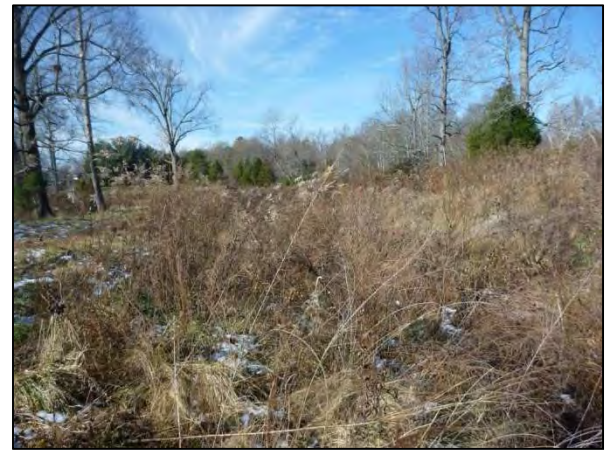
Photo Point 10b: View looking downstream on UT1 Station 41+25. 12/10/10 – MY-04

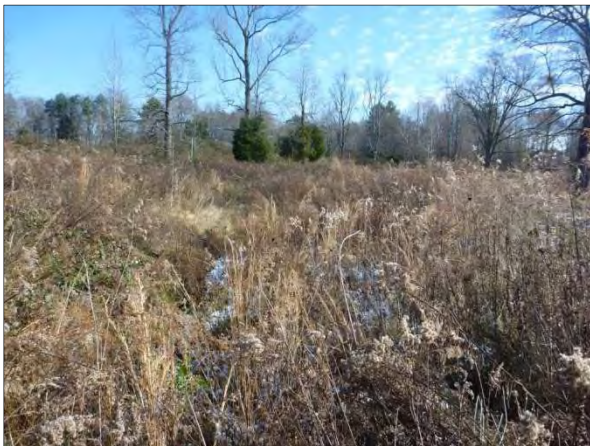
Photo Point 11a: View looking east on UT1 with vegetation plot #4 on right. 11/16/07 – MY-04

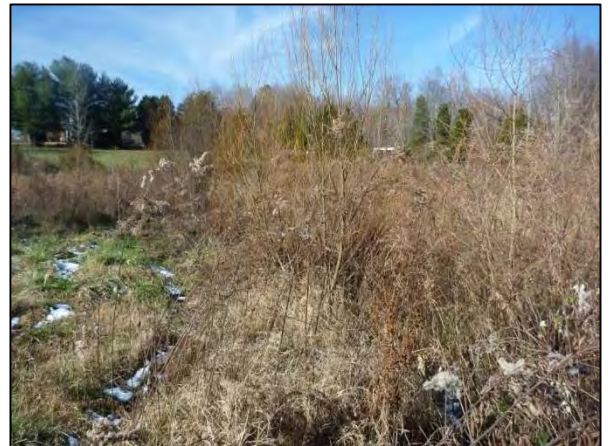
Photo Point 11b: View looking downstream UT1 before enters UTHR. 12/10/10 – MY-04

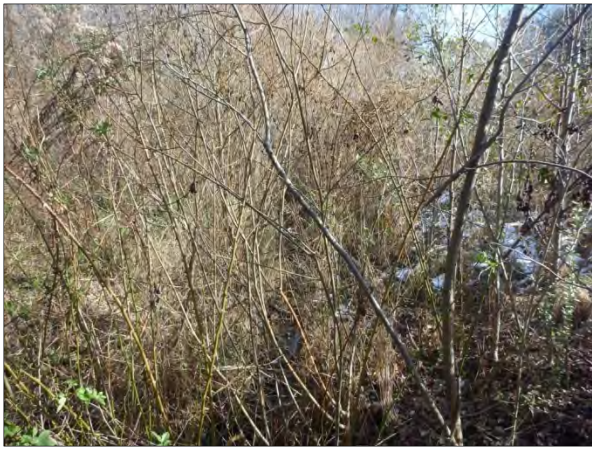
Photo Point 12a: View looking upstream on UT2.  
11/16/07 – MY-04

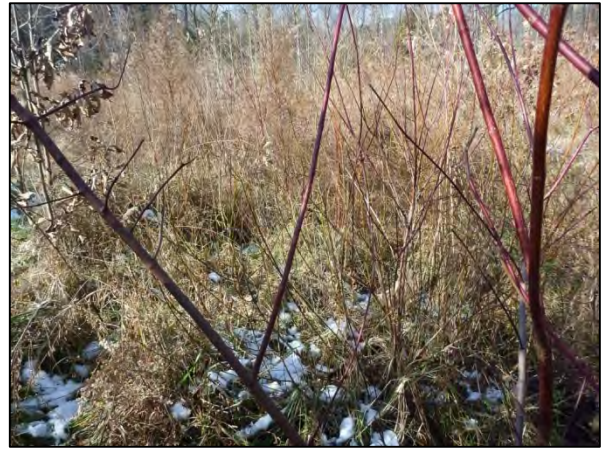
Photo Point 12b: View looking downstream  
UT2 before it enters UTHR.12/10/10 – MY-04
