**FINAL  
ANNUAL MONITORING REPORT  
GOLDSBORO HOUSING AUTHORITY**

**STREAM RESTORATION  
WAYNE COUNTY, NORTH CAROLINA  
(EEP Project Number 145)**

Monitoring Year 2 of 5 (2010)

Prepared by:  
Axiom Environmental, Inc.  
20 Enterprise Street, Suite 7  
Raleigh, North Carolina 27607

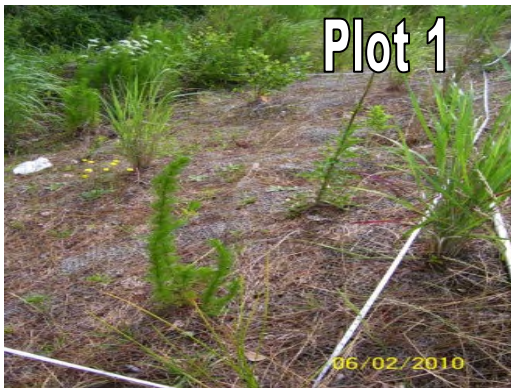
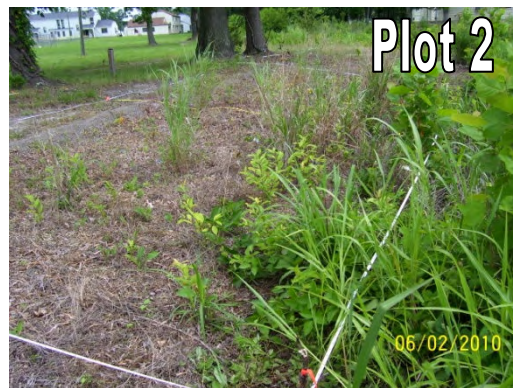
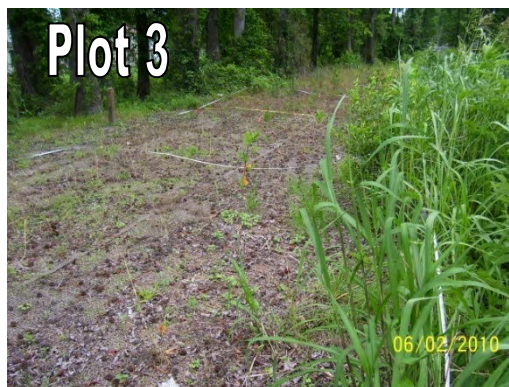
**Goldsboro Housing Authority  
 Year 2 (2010) Annual Monitoring  
 Vegetation Plot Photos (taken June 2010)**

Vegetation Plot ID	Vegetation Survival Threshold Met?	Tract Mean
1	Yes	67%
2	No	
3	Yes

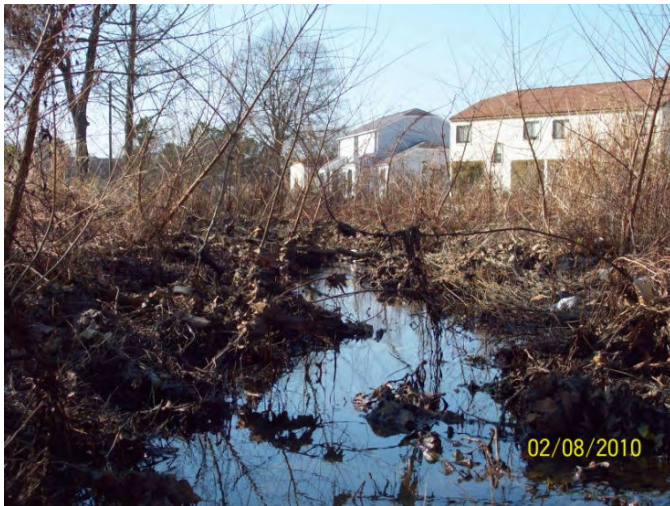
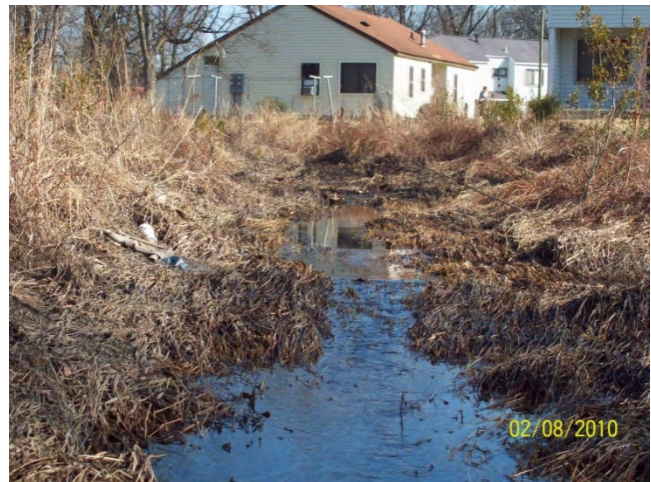
Bankfull Event Photos 1-2 showing evidence of a previous overbank event.
