**FINAL
ANNUAL MONITORING REPORT
GOLDSBORO HOUSING AUTHORITY**

**STREAM RESTORATION
WAYNE COUNTY, NORTH CAROLINA
(EEP Project Number 145)**

Monitoring Year 3 of 5 (2011)

Prepared by:
Axiom Environmental, Inc.
218 Snow Avenue
Raleigh, North Carolina 27603

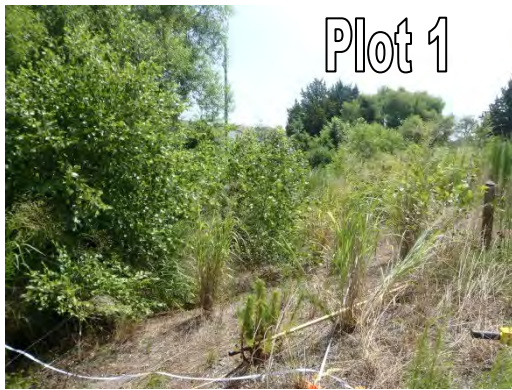
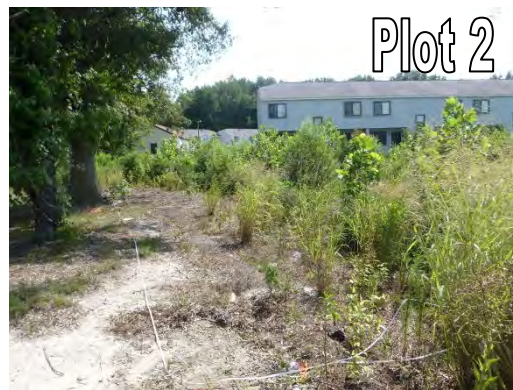
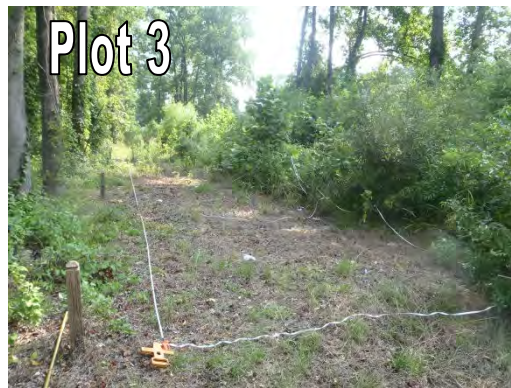
**Goldsboro Housing Authority
 Year 3 (2011) Annual Monitoring
 Vegetation Plot Photos (taken July 2011)**

Based on interagency guidelines (USACE 2003), success criteria dictate that survival of woody species planted at mitigation sites should be at a minimum density of 320 stems per acre at the end of the third monitoring year. Subsequently, 290 stems per acre must be surviving at the end of year 4 and 260 stems per acre at the end of year 5. Based on the number of stems counted, average densities were measured at 553 planted stems per acre surviving in year 3 (2011). Individual plots 1 and 3 met success criteria based

on planted stems alone while plot 2 was slightly below success criteria with 283 planted stems per acre. The dominant species identified at the Site were planted stems of river birch (*Betula nigra*) and sycamore (*Platanus occidentalis*). Supplemental planting of the Site is scheduled to occur in late 2011.

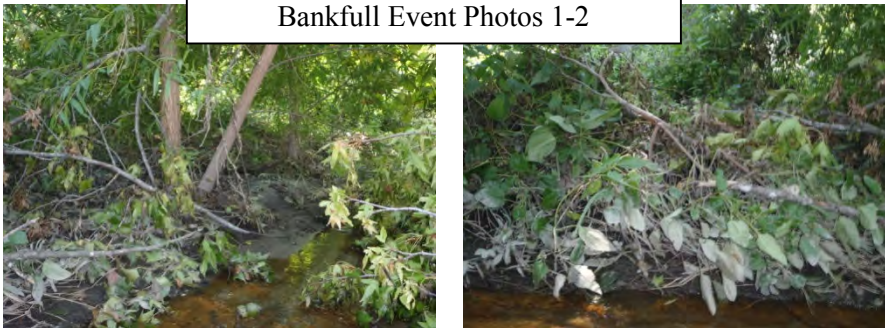
Bankfull Event Photos 1-2

Date of Data Collection	Date of Occurrence	Method	Photo (if available)
July 11, 2009	Between May 5-11, 2009	Total of 4.74 inches* of rain reported to fall over 7 days	--
November 12, 2009	November 12, 2009	Overbank resulting from a total of 4.47 inches* of rain reported to fall over 3 days as the result of Tropical Storm Ida	--
February 9, 2010	February 5, 2010	Visual observations of overbank event including crest gauge, wrack lines, and wrack in saplings from a 1.95-inch* rainfall event on February 5, 2009 that occurred after numerous rainfall events within the 3 weeks prior to that date that totaled 4.43 inches.	1-2
September 28, 2010	September 26-27, 2010	Rainfall data totaling 3.99 inches* over a period of two days.	--
February 2, 2011	February 2, 2011	Visual observations of overbank event including crest gauge, wrack lines, and wrack in saplings from a 2.58-inch* rainfall event on February 2, 2011 that occurred after a 1.89-inch rainfall event the week before.	3

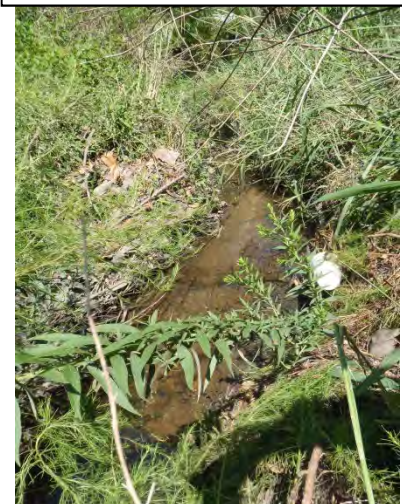
Bankfull Event Photo 4

July 21, 2011	April 16, 2011	Visual observations of overbank event including crest gauge, wrack lines, and wrack in saplings from a 2.25-inch* rainfall event on April 16, 2011 that occurred after a total of 2.25 inches of rain that fell the ten days before.	--
August 31, 2011	August 25, 2011	Visual observations of stream overbanking as a result from 6.12-inch* rainfall from Hurricane Irene	4

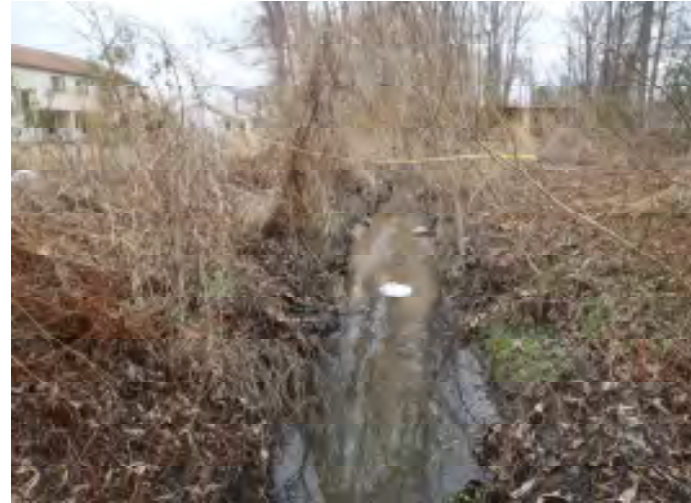
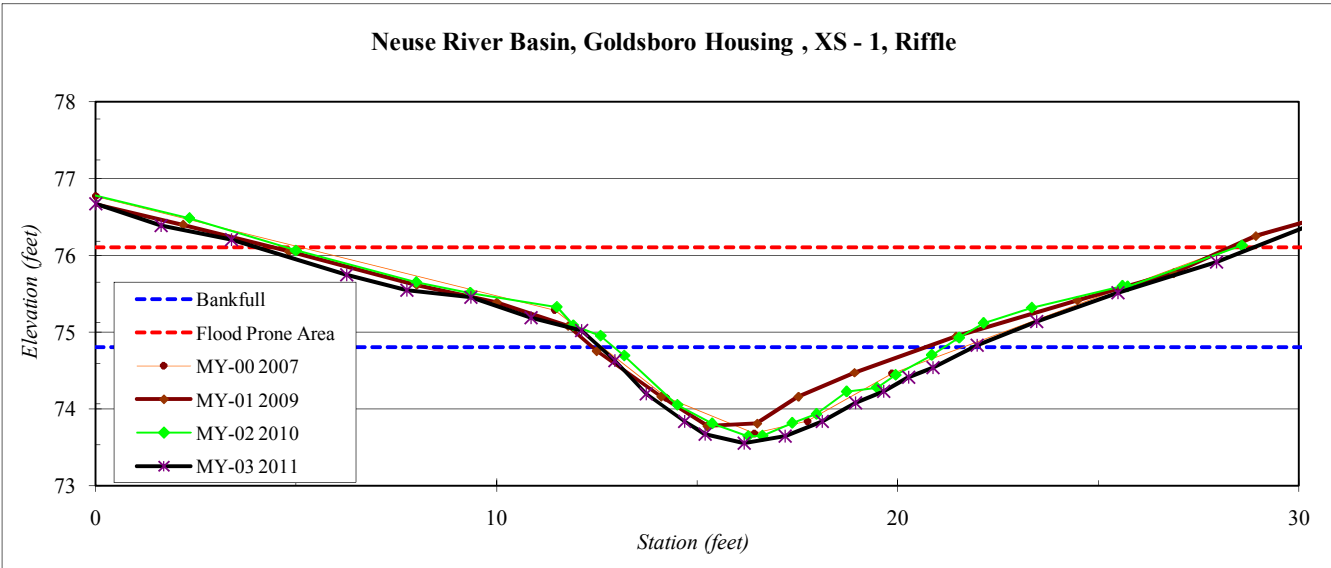
River Basin:	Neuse
Watershed:	Goldsboro Housing
XS ID	XS - 1, Riffle
Drainage Area (sq mi):	0.2
Date:	2/10/2011
Field Crew:	Dean, Perkinson

SUMMARY DATA	
Bankfull Elevation:	74.8
Bankfull Cross-Sectional Area:	6.8
Bankfull Width:	9.3
Flood Prone Area Elevation:	76.1
Flood Prone Width:	25.0
Max Depth at Bankfull:	1.3
Mean Depth at Bankfull:	0.7
W / D Ratio:	12.7
Entrenchment Ratio:	2.7
Bank Height Ratio:	1.0

Stream Type	E/C
--------------------	-----

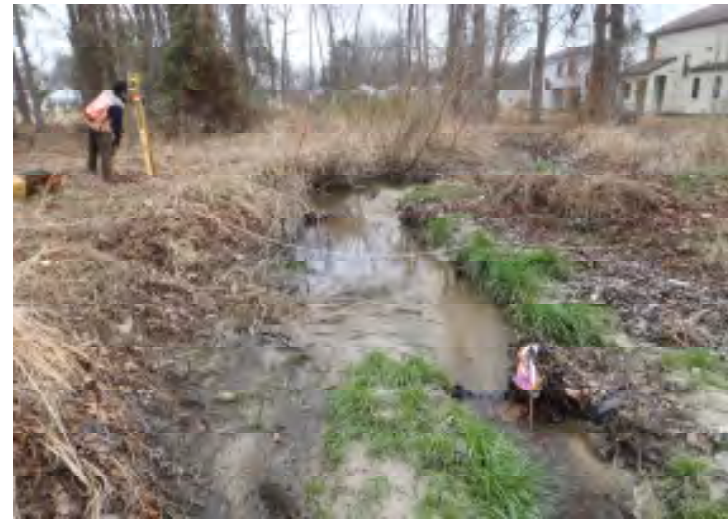
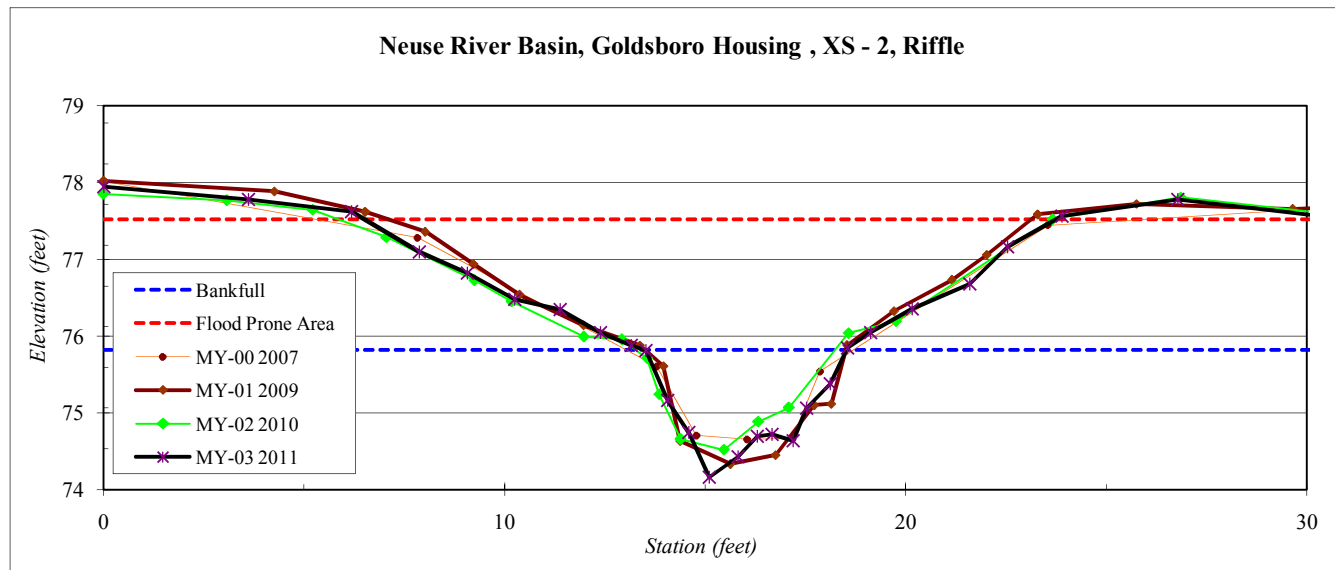
River Basin:	Neuse
Watershed:	Goldsboro Housing
XS ID	XS - 2, Riffle
Drainage Area (sq mi):	0.2
Date:	2/10/2011
Field Crew:	Dean, Perkinson

Stream Type	E
--------------------	---

SUMMARY DATA	
Bankfull Elevation:	75.8
Bankfull Cross-Sectional Area:	4.8
Bankfull Width:	5.1
Flood Prone Area Elevation:	77.5
Flood Prone Width:	18.0
Max Depth at Bankfull:	1.7
Mean Depth at Bankfull:	0.9
W / D Ratio:	5.4
Entrenchment Ratio:	3.5
Bank Height Ratio:	1.0

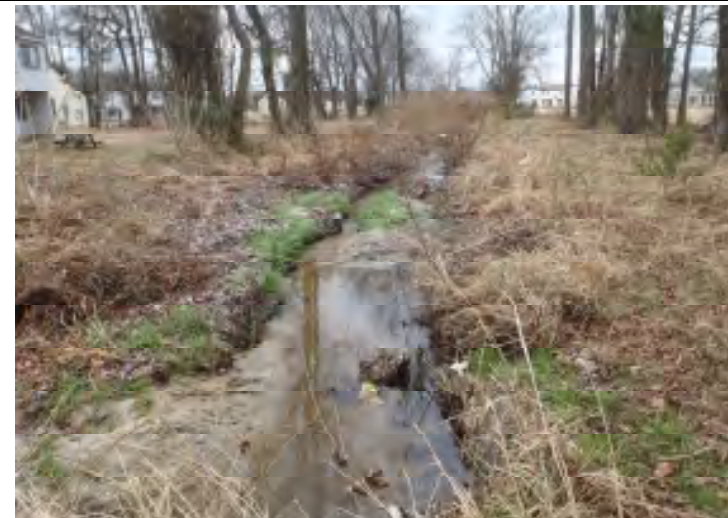
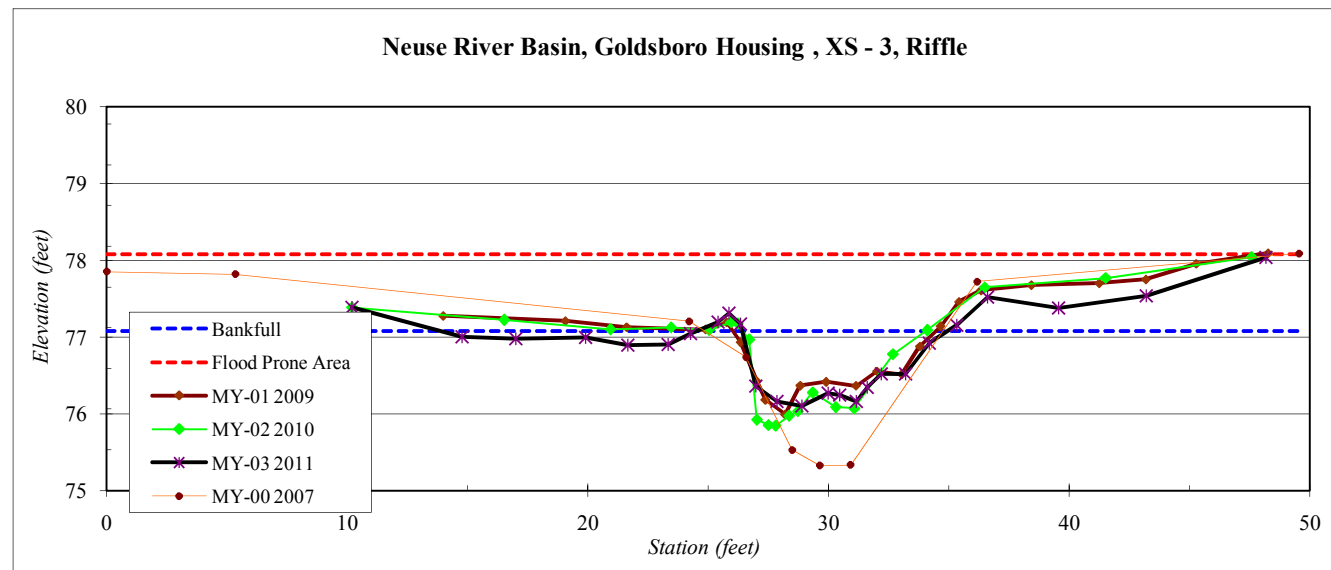
River Basin:	Neuse
Watershed:	Goldsboro Housing
XS ID	XS - 3, Riffle
Drainage Area (sq mi):	0.2
Date:	2/10/2011
Field Crew:	Dean, Perkinson

SUMMARY DATA	
Bankfull Elevation:	77.1
Bankfull Cross-Sectional Area:	5.6
Bankfull Width:	8.6
Flood Prone Area Elevation:	78.1
Flood Prone Width:	50.0
Max Depth at Bankfull:	1.0
Mean Depth at Bankfull:	0.7
W / D Ratio:	13.2
Entrenchment Ratio:	5.8
Bank Height Ratio:	1.0

Stream Type C/E

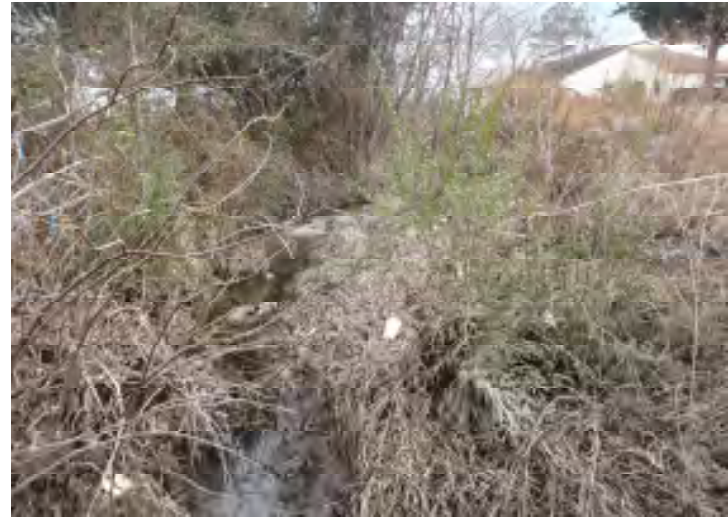
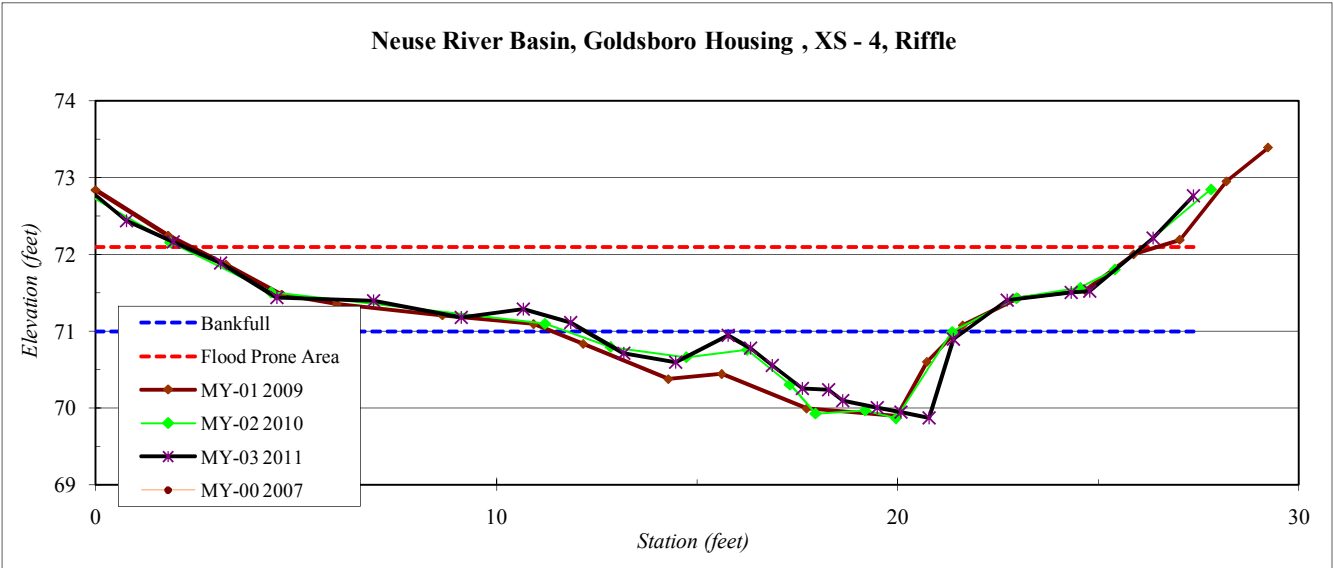
River Basin:	Neuse
Watershed:	Goldsboro Housing
XS ID	XS - 4, Riffle
Drainage Area (sq mi):	0.2
Date:	2/10/2011
Field Crew:	Dean, Perkinson

SUMMARY DATA	
Bankfull Elevation:	71.0
Bankfull Cross-Sectional Area:	4.9
Bankfull Width:	9.4
Flood Prone Area Elevation:	72.1
Flood Prone Width:	23.0
Max Depth at Bankfull:	1.1
Mean Depth at Bankfull:	0.5
W / D Ratio:	18.0
Entrenchment Ratio:	2.4
Bank Height Ratio:	1.0

Stream Type	C/E
--------------------	-----
