**FINAL
ANNUAL MONITORING REPORT
GOLDSBORO HOUSING AUTHORITY**

**STREAM RESTORATION
WAYNE COUNTY, NORTH CAROLINA
(EEP Project Number 145, Contract No. 09070009)
Construction Completed October 2008**

Monitoring Year 4 of 5 (2012)

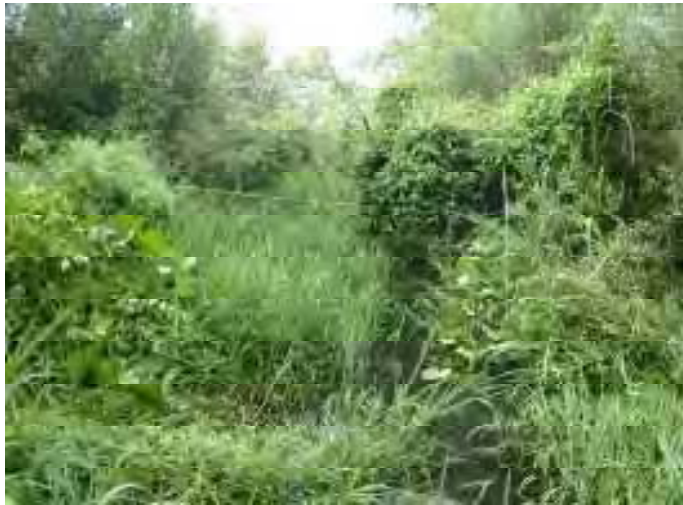
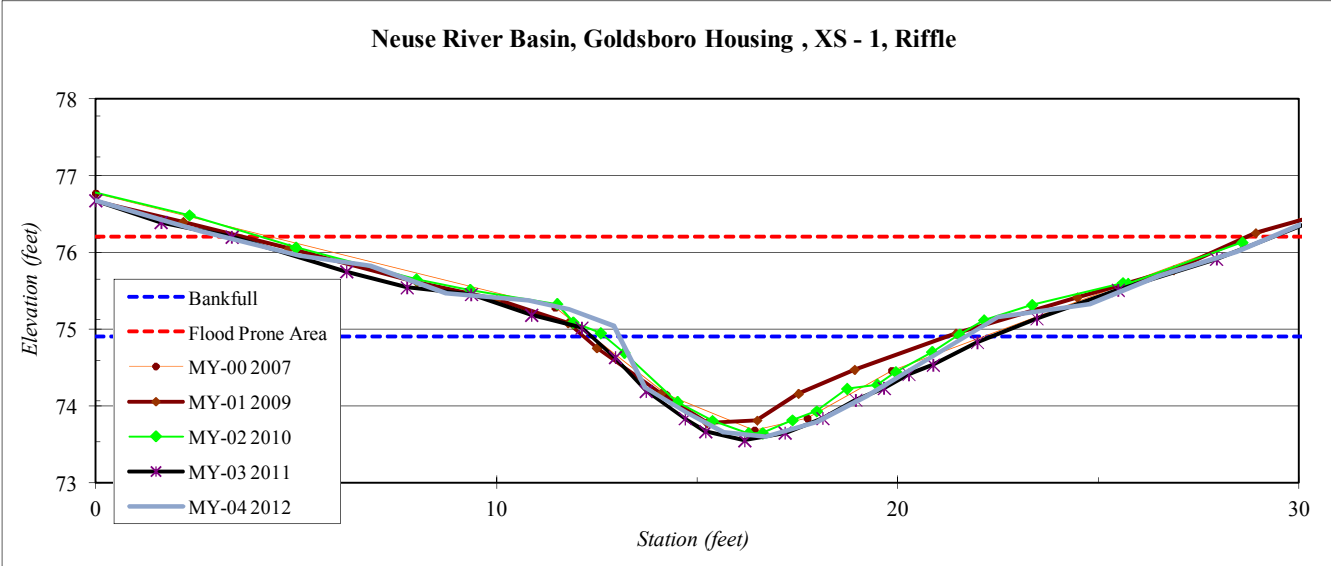
River Basin:	Neuse
Watershed:	Goldsboro Housing
XS ID	XS - 1, Riffle
Drainage Area (sq mi):	0.2
Date:	8/22/2012
Field Crew:	Perkinson, Jernigan

SUMMARY DATA	
Bankfull Elevation:	74.9
Bankfull Cross-Sectional Area:	7.1
Bankfull Width:	8.6
Flood Prone Area Elevation:	76.2
Flood Prone Width:	25.0
Max Depth at Bankfull:	1.3
Mean Depth at Bankfull:	0.8
W / D Ratio:	10.4
Entrenchment Ratio:	2.9
Bank Height Ratio:	1.0

Stream Type: E/C

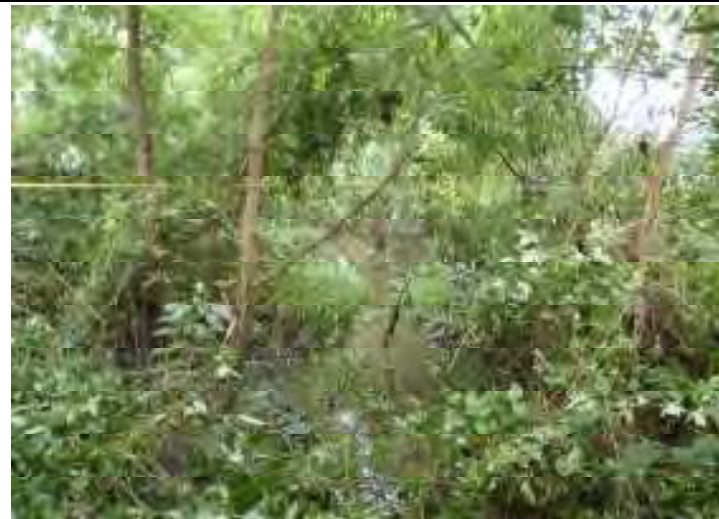
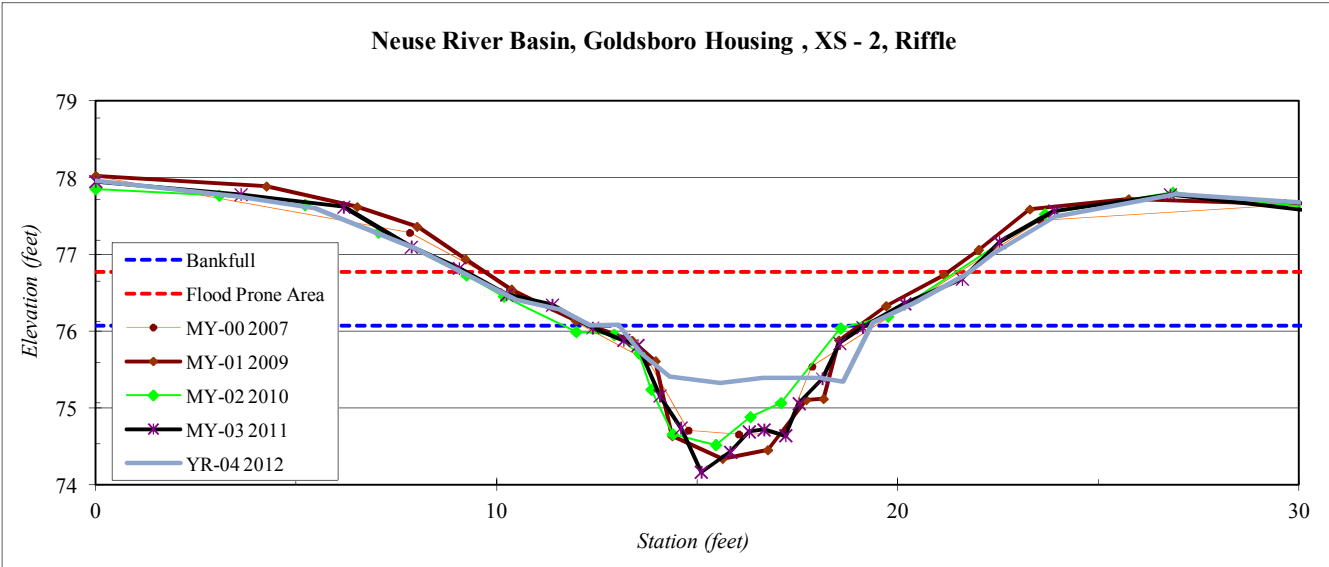
River Basin:	Neuse
Watershed:	Goldsboro Housing
XS ID	XS - 2, Riffle
Drainage Area (sq mi):	0.2
Date:	8/22/2012
Field Crew:	Perkinson, Jernigan

SUMMARY DATA	
Bankfull Elevation:	76.1
Bankfull Cross-Sectional Area:	3.7
Bankfull Width:	6.4
Flood Prone Area Elevation:	76.8
Flood Prone Width:	13.0
Max Depth at Bankfull:	0.7
Mean Depth at Bankfull:	0.6
W / D Ratio:	11.1
Entrenchment Ratio:	2.0
Bank Height Ratio:	1.0

Stream Type	E
--------------------	---

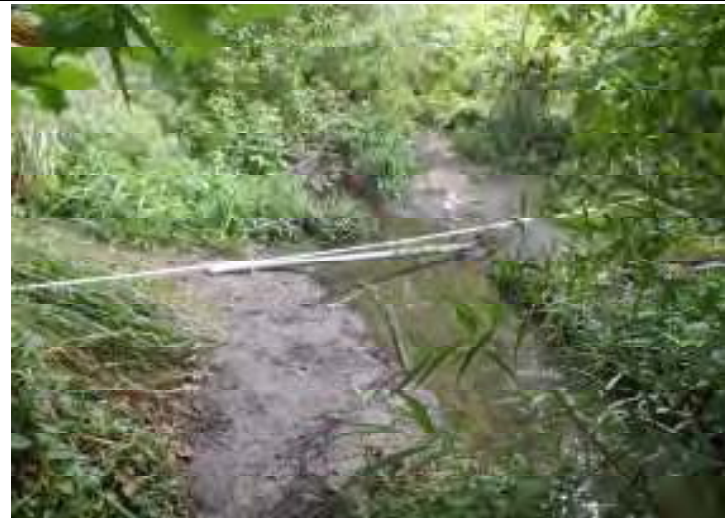
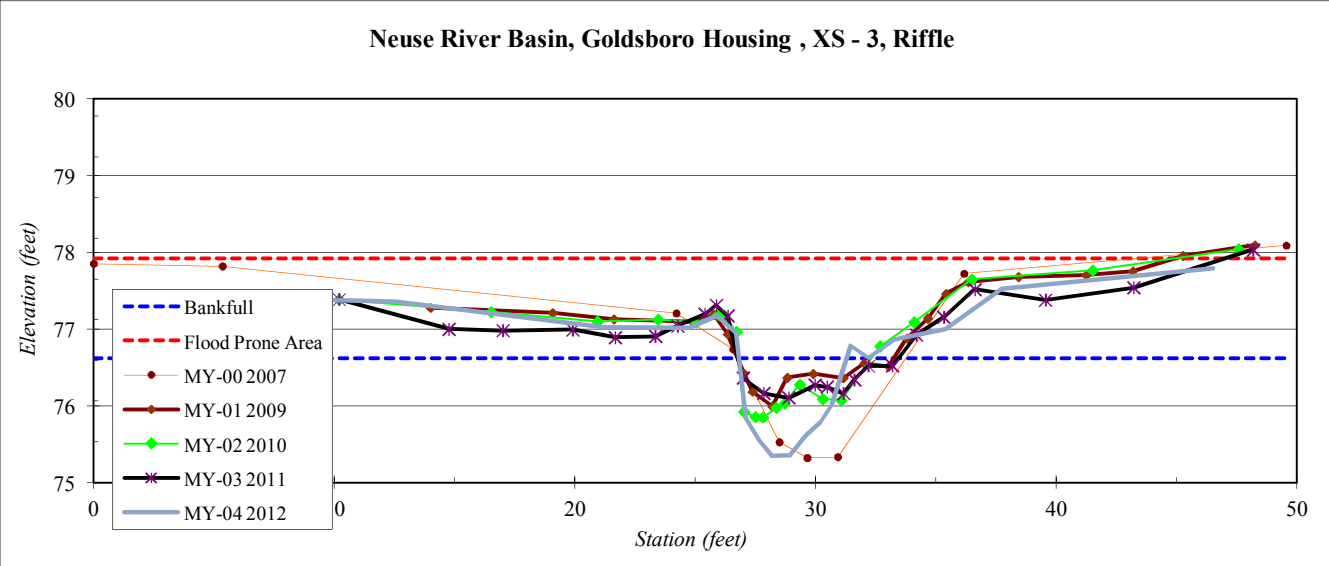
River Basin:	Neuse
Watershed:	Goldsboro Housing
XS ID	XS - 3, Riffle
Drainage Area (sq mi):	0.2
Date:	8/22/2012
Field Crew:	Perkinson, Jernigan

SUMMARY DATA	
Bankfull Elevation:	76.6
Bankfull Cross-Sectional Area:	4.0
Bankfull Width:	4.5
Flood Prone Area Elevation:	77.9
Flood Prone Width:	50.0
Max Depth at Bankfull:	1.3
Mean Depth at Bankfull:	0.9
W / D Ratio:	5.1
Entrenchment Ratio:	11.1
Bank Height Ratio:	1.0

Stream Type: C/E

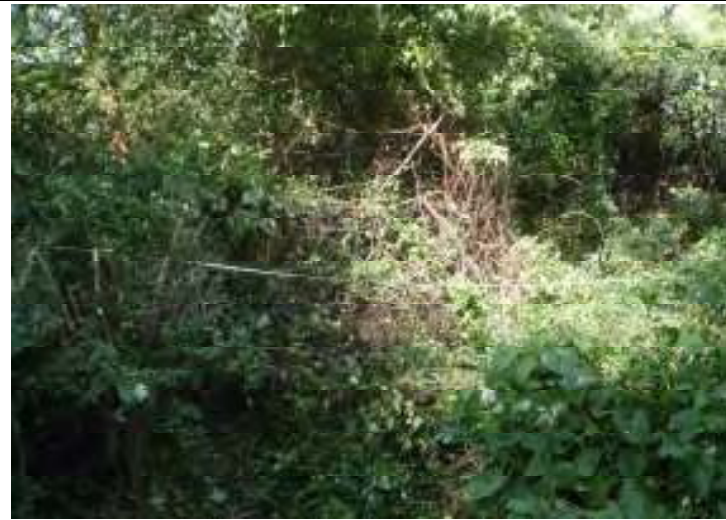
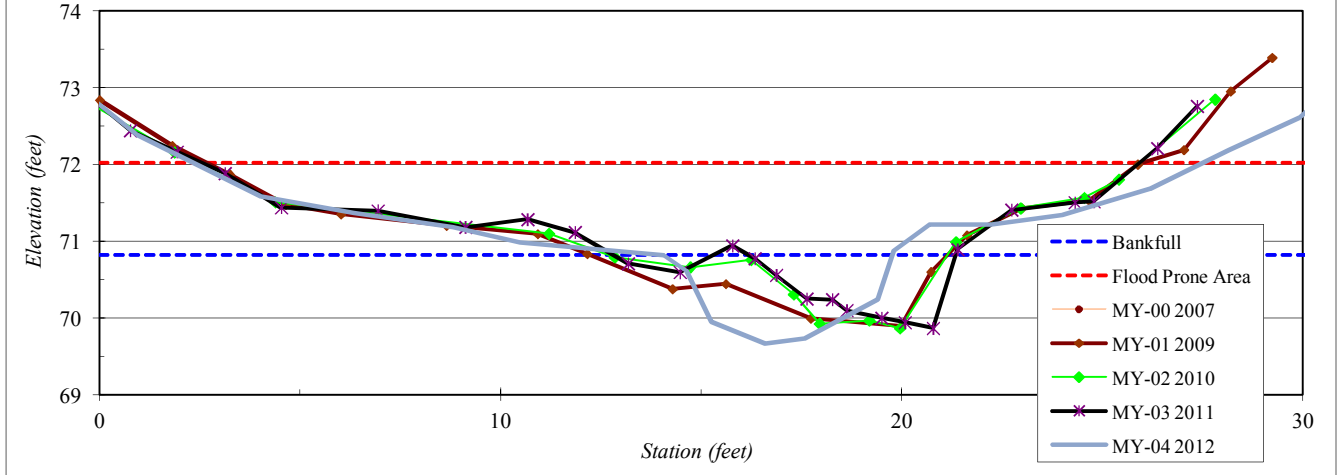
River Basin:	Neuse
Watershed:	Goldsboro Housing
XS ID	XS - 4, Riffle
Drainage Area (sq mi):	0.2
Date:	8/22/2012
Field Crew:	Perkinson, Jernigan

Stream Type	C/E
-------------	-----

SUMMARY DATA	
Bankfull Elevation:	70.8
Bankfull Cross-Sectional Area:	4.5
Bankfull Width:	5.7
Flood Prone Area Elevation:	72.0
Flood Prone Width:	23.0
Max Depth at Bankfull:	1.2
Mean Depth at Bankfull:	0.8
W / D Ratio:	7.2
Entrenchment Ratio:	4.0
Bank Height Ratio:	1.0

Note: Cross Section Right Bank End Point Was Not Found.

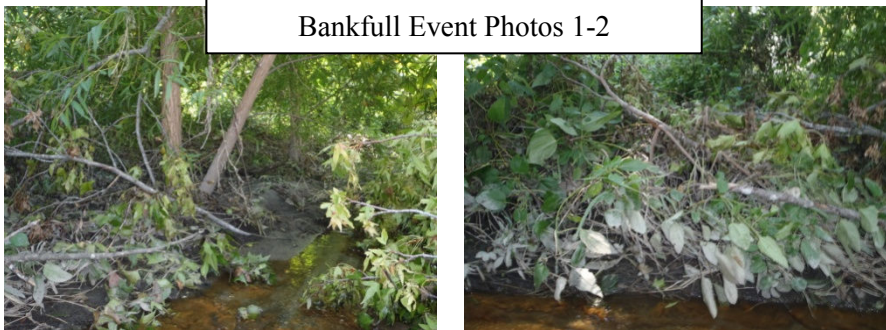
Bankfull Event Photos 1-2

Date of Data Collection	Date of Occurrence	Method	Photo (if available)
July 11, 2009	Between May 5-11, 2009	Total of 4.74 inches* of rain reported to fall over 7 days	--
November 12, 2009	November 12, 2009	Overbank resulting from a total of 4.47 inches* of rain reported to fall over 3 days as the result of Tropical Storm Ida	--
February 9, 2010	February 5, 2010	Visual observations of overbank event including crest gauge, wrack lines, and wrack in saplings from a 1.95-inch* rainfall event on February 5, 2009 that occurred after numerous rainfall events within the 3 weeks prior to that date that totaled 4.43 inches.	1-2
September 28, 2010	September 26-27, 2010	Rainfall data totaling 3.99 inches* over a period of two days.	--
February 2, 2011	February 2, 2011	Visual observations of overbank event including crest gauge, wrack lines, and wrack in saplings from a 2.58-inch* rainfall event on February 2, 2011 that occurred after a 1.89-inch rainfall event the week before.	3

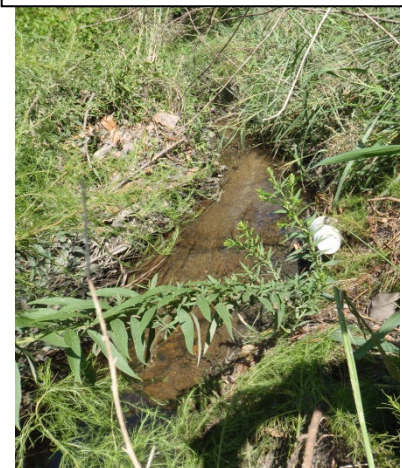
Bankfull Event Photo 4

July 21, 2011	April 16, 2011	Visual observations of overbank event including crest gauge, wrack lines, and wrack in saplings from a 2.25-inch* rainfall event on April 16, 2011 that occurred after a total of 2.25 inches of rain that fell the ten days before.	--
August 31, 2011	August 25, 2011	Visual observations of stream overbanking as a result from 6.12-inch* rainfall from Hurricane Irene	4
August 23, 2012	July 24, 2012	Total of 4.52 inches* of rain reported to fall over 5 days	--
