**FINAL  
ANNUAL MONITORING REPORT  
GOLDSBORO HOUSING AUTHORITY**

**STREAM RESTORATION  
WAYNE COUNTY, NORTH CAROLINA  
(EEP Project Number 145, Contract No. 09070009)  
Construction Completed October 2008**

Monitoring Year 5 of 5 (2013)

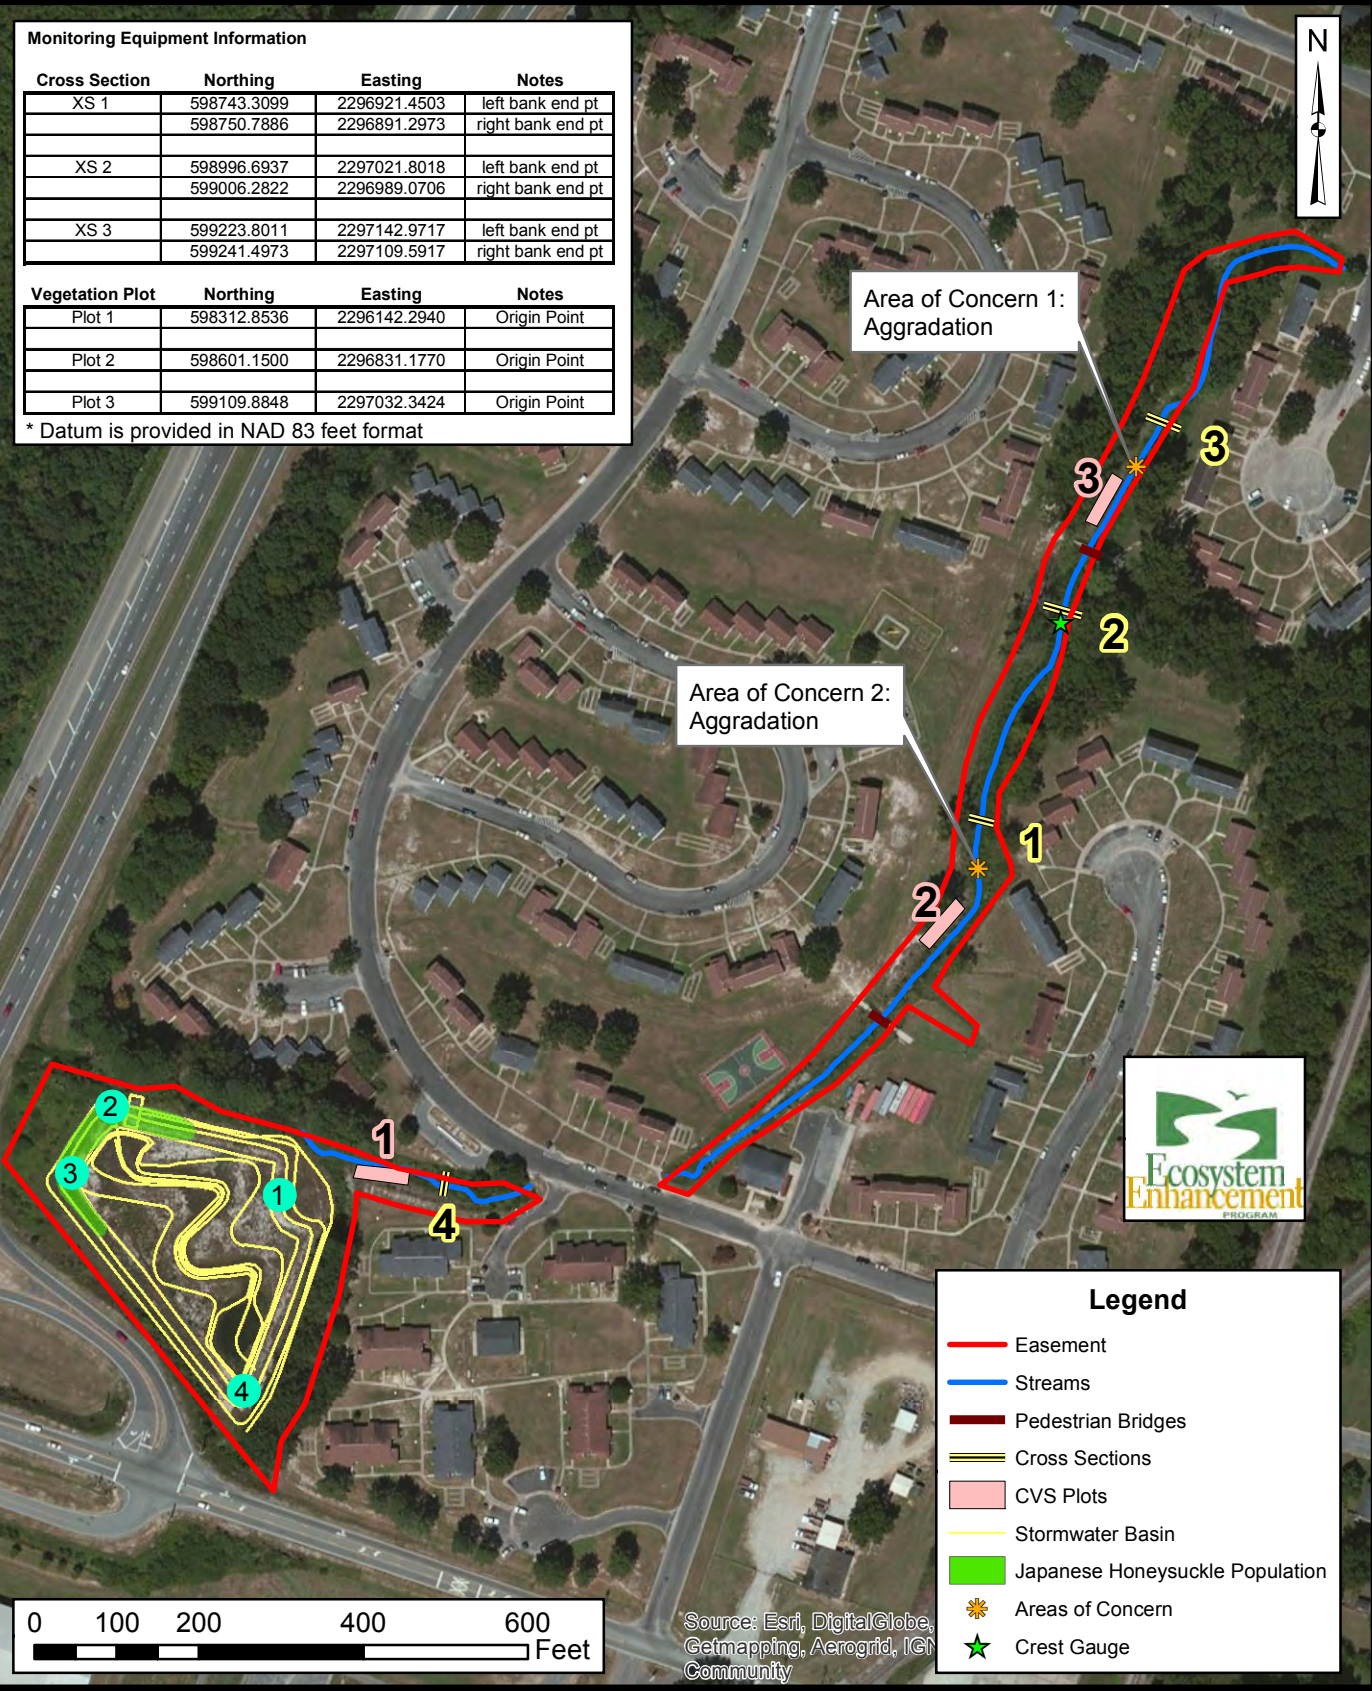
**FIGURE  
2**

One dense Japanese honeysuckle (*Lonicera japonica*) population was identified on the outer rim of the stormwater BMP. This area is identified on Figure 2 (Appendix B). Invasive species controls, consisting of two herbicide treatments, occurred during the summer of 2013. Treatments targeted Chinese privet (*Ligustrum sinense*), callery pear (*Pyrus calleryana*), and tree of heaven (*Ailanthus altissima*) throughout the area between Oak Street and Aster Court (see photo to right). Treatments included cutting and applying herbicide to stumps of larger woody stems, and foliar application of herbicide to smaller material.

Two stream areas of concern were noted within the Site as outlined in the following table (Figure 2, Appendix B).

<b>Map Identifier</b>	<b>Feature/Issue</b>	<b>Probable Cause</b>
Area of Concern 1	Aggradation at an upstream bend	Sediment deposition from culvert outlet
Area of Concern 2	Aggradation at a pool near veg plot 2	Sediment and trash deposition from the surrounding community

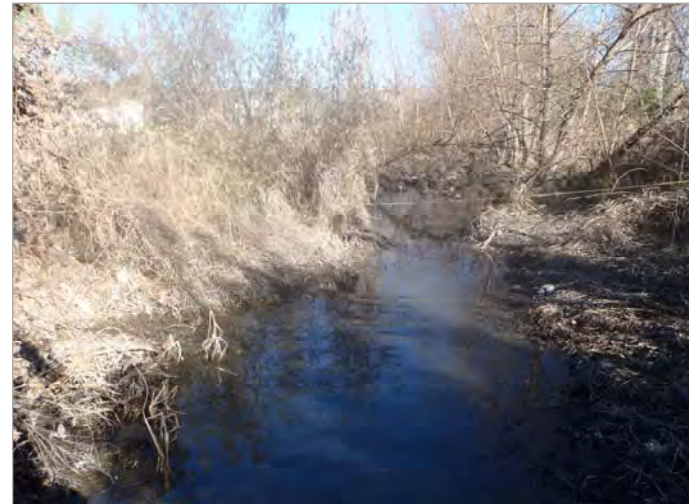
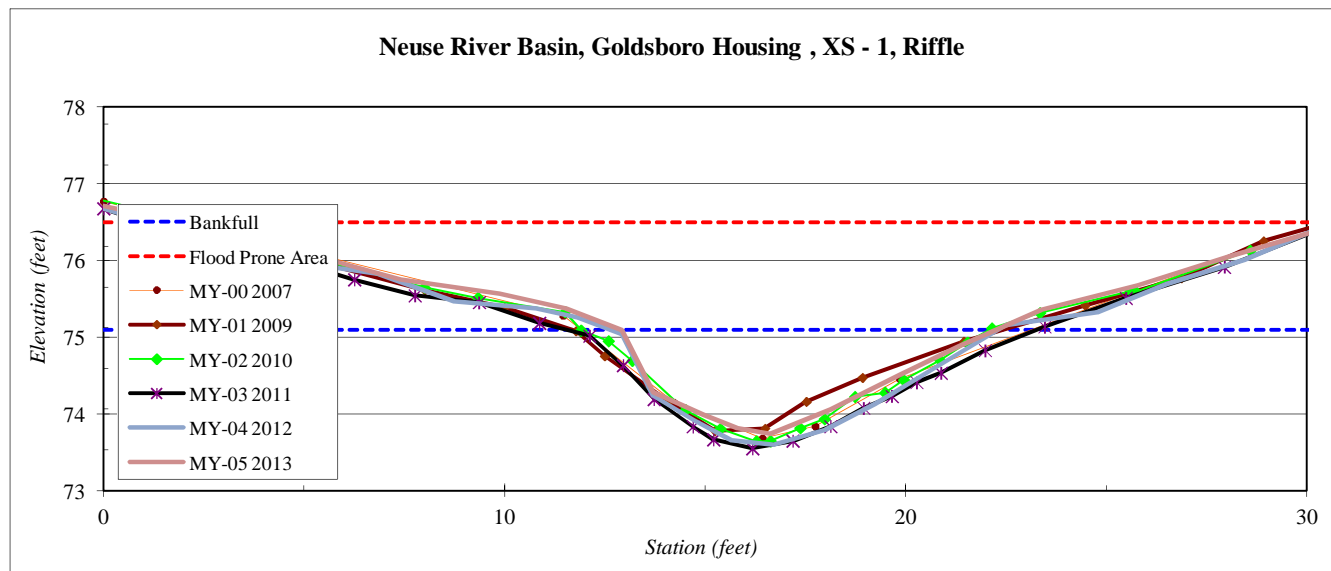
<b>River Basin:</b>	Neuse
<b>Watershed:</b>	Goldsboro Housing
<b>XS ID</b>	XS - 1, Riffle
<b>Drainage Area (sq mi):</b>	0.2
<b>Date:</b>	2/22/2013
<b>Field Crew:</b>	Perkinson, Jernigan

SUMMARY DATA	
<b>Bankfull Elevation:</b>	75.1
<b>Bankfull Cross-Sectional Area:</b>	7.5
<b>Bankfull Width:</b>	9.3
<b>Flood Prone Area Elevation:</b>	76.5
<b>Flood Prone Width:</b>	25.0
<b>Max Depth at Bankfull:</b>	1.4
<b>Mean Depth at Bankfull:</b>	0.8
<b>W / D Ratio:</b>	11.5
<b>Entrenchment Ratio:</b>	2.7
<b>Bank Height Ratio:</b>	1.0

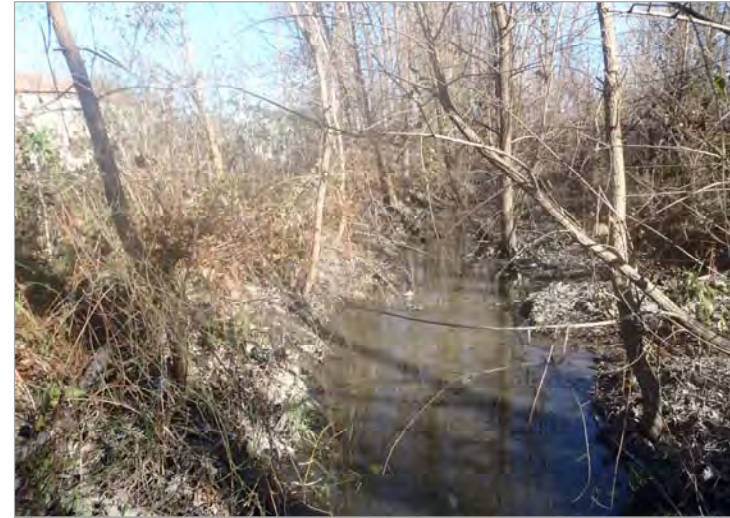
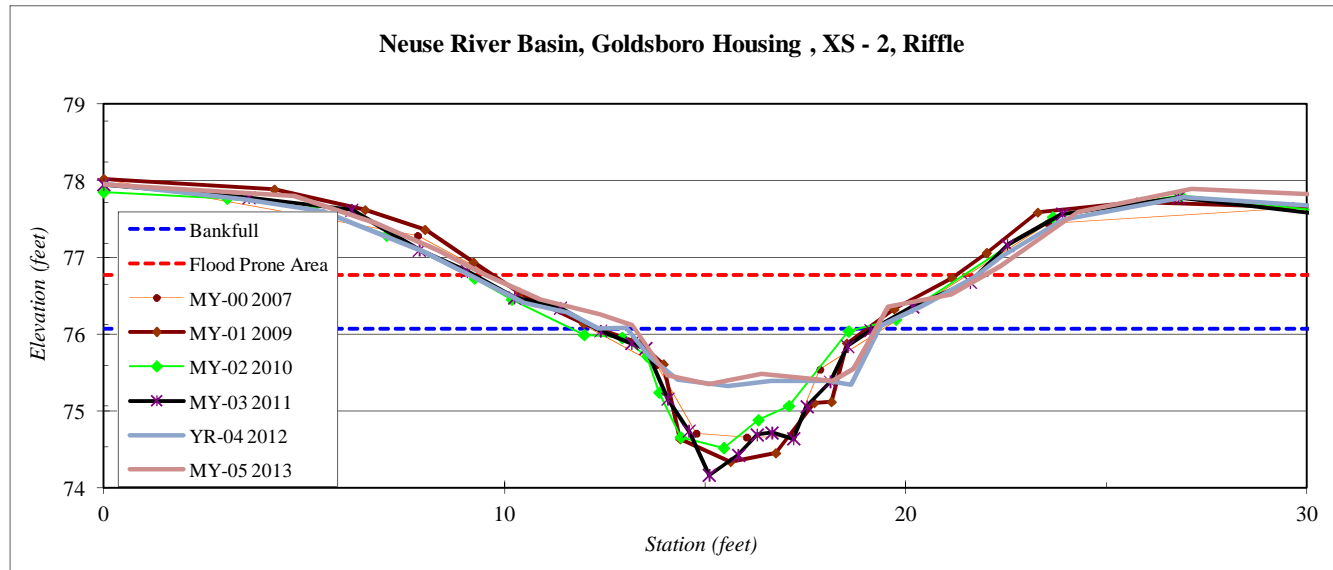
<b>River Basin:</b>	Neuse
<b>Watershed:</b>	Goldsboro Housing
<b>XS ID</b>	XS - 2, Riffle
<b>Drainage Area (sq mi):</b>	0.2
<b>Date:</b>	2/22/2013
<b>Field Crew:</b>	Perkinson, Jernigan

SUMMARY DATA	
<b>Bankfull Elevation:</b>	76.1
<b>Bankfull Cross-Sectional Area:</b>	3.4
<b>Bankfull Width:</b>	6.0
<b>Flood Prone Area Elevation:</b>	76.8
<b>Flood Prone Width:</b>	13.0
<b>Max Depth at Bankfull:</b>	0.7
<b>Mean Depth at Bankfull:</b>	0.6
<b>W / D Ratio:</b>	10.6
<b>Entrenchment Ratio:</b>	2.2
<b>Bank Height Ratio:</b>	1.0

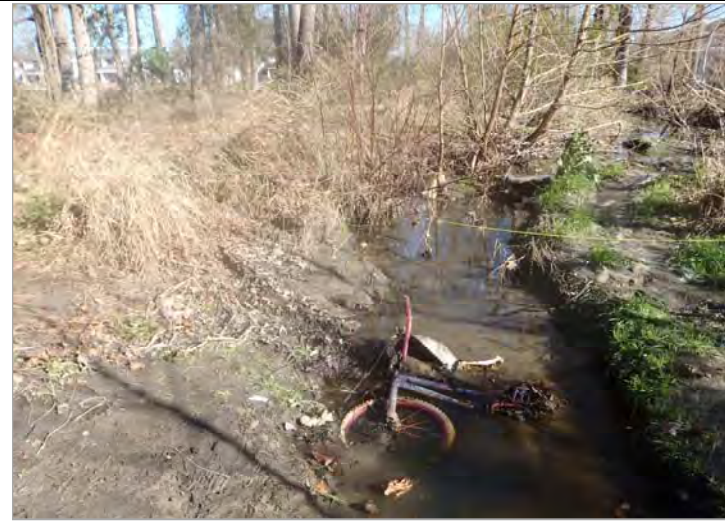
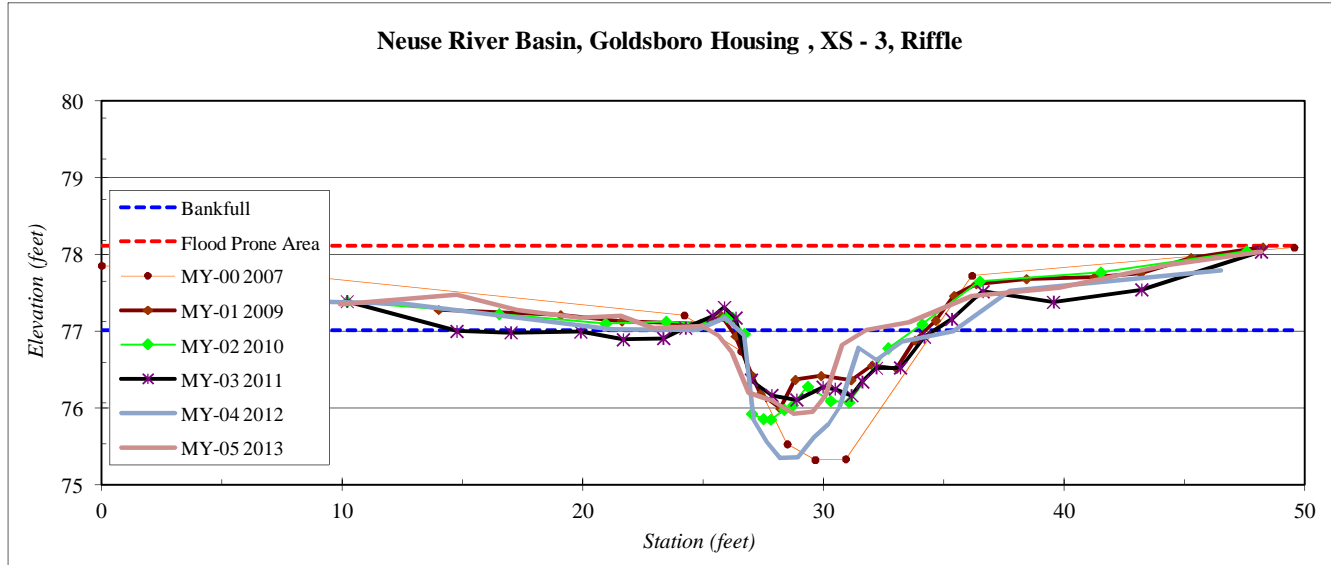
<b>River Basin:</b>	Neuse
<b>Watershed:</b>	Goldsboro Housing
<b>XS ID</b>	XS - 3, Riffle
<b>Drainage Area (sq mi):</b>	0.2
<b>Date:</b>	2/22/2013
<b>Field Crew:</b>	Perkinson, Jernigan

SUMMARY DATA	
<b>Bankfull Elevation:</b>	77.0
<b>Bankfull Cross-Sectional Area:</b>	4.1
<b>Bankfull Width:</b>	6.6
<b>Flood Prone Area Elevation:</b>	78.1
<b>Flood Prone Width:</b>	50.0
<b>Max Depth at Bankfull:</b>	1.1
<b>Mean Depth at Bankfull:</b>	0.6
<b>W / D Ratio:</b>	10.6
<b>Entrenchment Ratio:</b>	7.6
<b>Bank Height Ratio:</b>	1.0

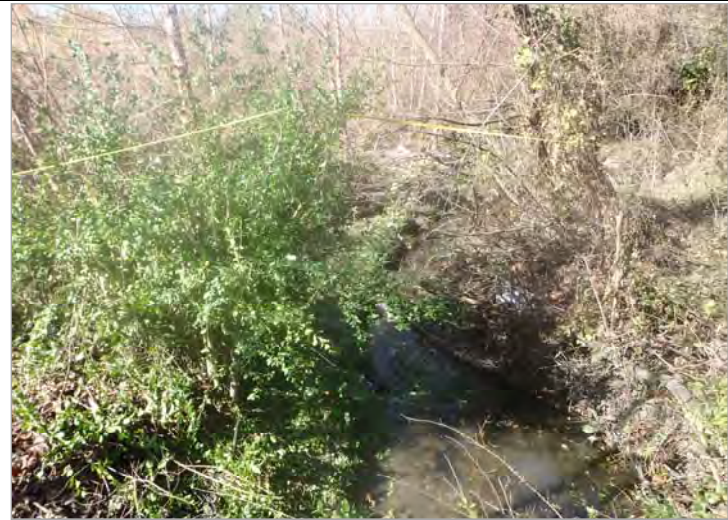
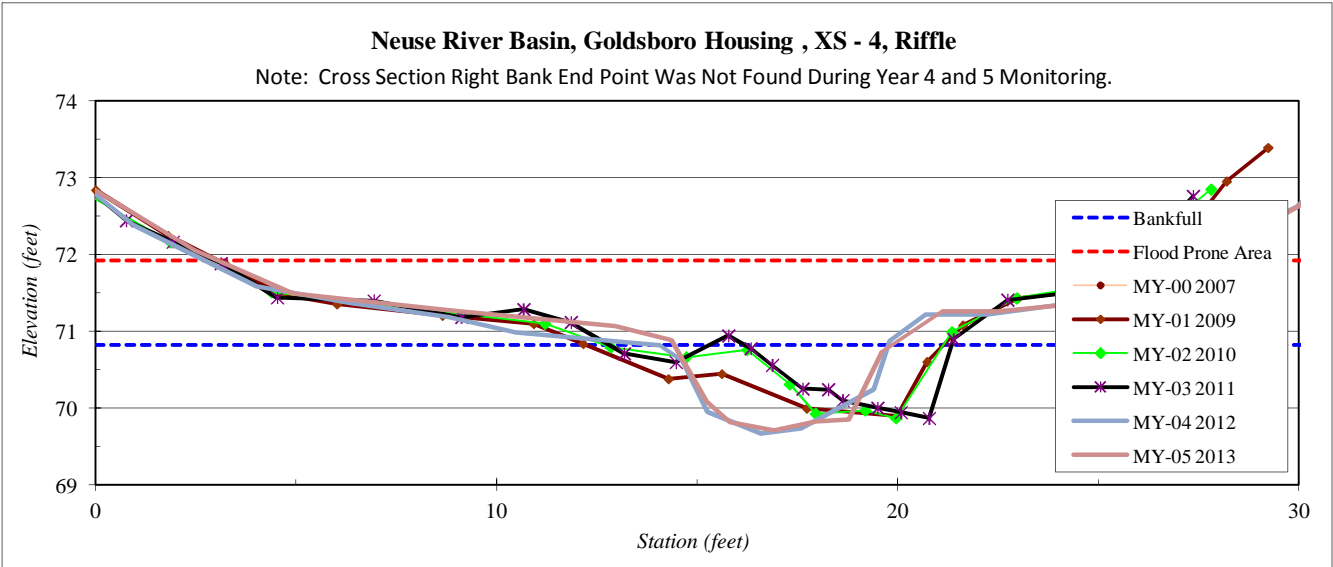
<b>River Basin:</b>	Neuse
<b>Watershed:</b>	Goldsboro Housing
<b>XS ID</b>	XS - 4, Riffle
<b>Drainage Area (sq mi):</b>	0.2
<b>Date:</b>	2/22/2013
<b>Field Crew:</b>	Perkinson, Jernigan

SUMMARY DATA	
<b>Bankfull Elevation:</b>	70.8
<b>Bankfull Cross-Sectional Area:</b>	4.3
<b>Bankfull Width:</b>	5.5
<b>Flood Prone Area Elevation:</b>	71.9
<b>Flood Prone Width:</b>	23.0
<b>Max Depth at Bankfull:</b>	1.1
<b>Mean Depth at Bankfull:</b>	0.8
<b>W / D Ratio:</b>	7.0
<b>Entrenchment Ratio:</b>	4.2
<b>Bank Height Ratio:</b>	1.0

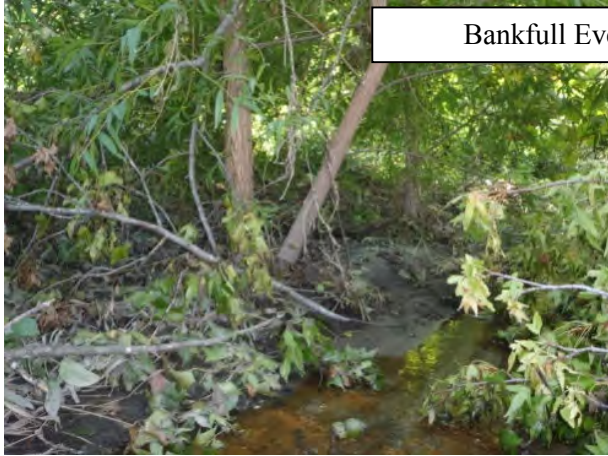
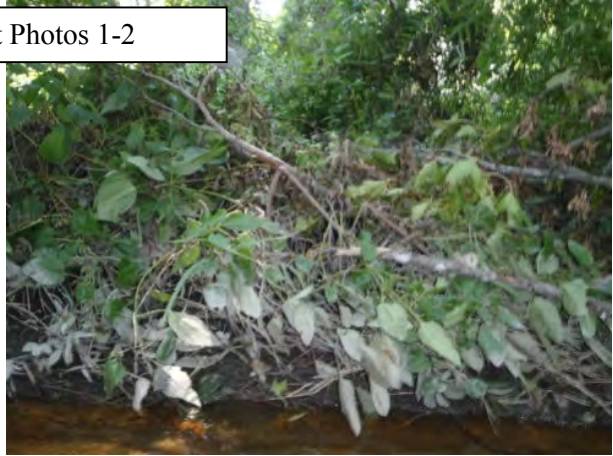
Bankfull Event Photos 1-2

<b>Date of Data Collection</b>	<b>Date of Occurrence</b>	<b>Method</b>	<b>Photo (if available)</b>
July 11, 2009	Between May 5-11, 2009	Total of 4.74 inches* of rain reported to fall over 7 days	--
November 12, 2009	November 12, 2009	Overbank resulting from a total of 4.47 inches* of rain reported to fall over 3 days as the result of Tropical Storm Ida	--
February 9, 2010	February 5, 2010	Visual observations of overbank event including crest gauge, wrack lines, and wrack in saplings from a 1.95-inch* rainfall event on February 5, 2009 that occurred after numerous rainfall events within the 3 weeks prior to that date that totaled 4.43 inches.	1-2
September 28, 2010	September 26-27, 2010	Rainfall data totaling 3.99 inches* over a period of two days.	--
February 2, 2011	February 2, 2011	Visual observations of overbank event including crest gauge, wrack lines, and wrack in saplings from a 2.58-inch* rainfall event on February 2, 2011 that occurred after a 1.89-inch rainfall event the week before.	3

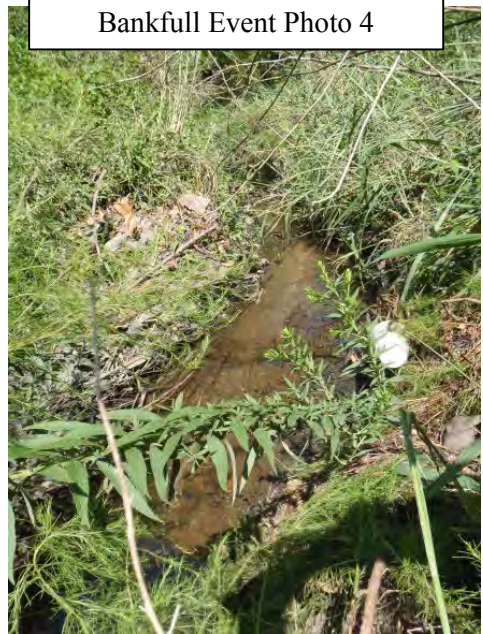
Bankfull Event Photo 4

July 21, 2011	April 16, 2011	Visual observations of overbank event including crest gauge, wrack lines, and wrack in saplings from a 2.25-inch* rainfall event on April 16, 2011 that occurred after a total of 2.25 inches of rain that fell the ten days before.	--
August 31, 2011	August 25, 2011	Visual observations of stream overbanking as a result from 6.12-inch* rainfall from Hurricane Irene	4
August 23, 2012	July 24, 2012	Total of 4.52 inches* of rain reported to fall over 5 days	--
October 2, 2013	June 26, 2013	Total of 8 inches** of rain reported to fall between June 22-July 2, 2013	--
October 2, 2013	September 22, 2013	Total of 2.5 inches** of rain reported to fall over 2 days	--
