**Goodman Property Stream Restoration Project  
Lenoir County, NC**

**2009 Annual Monitoring Report  
Year 1**

**NCEEP Project Number D000616  
Neuse River Basin**

Date: February, 2010

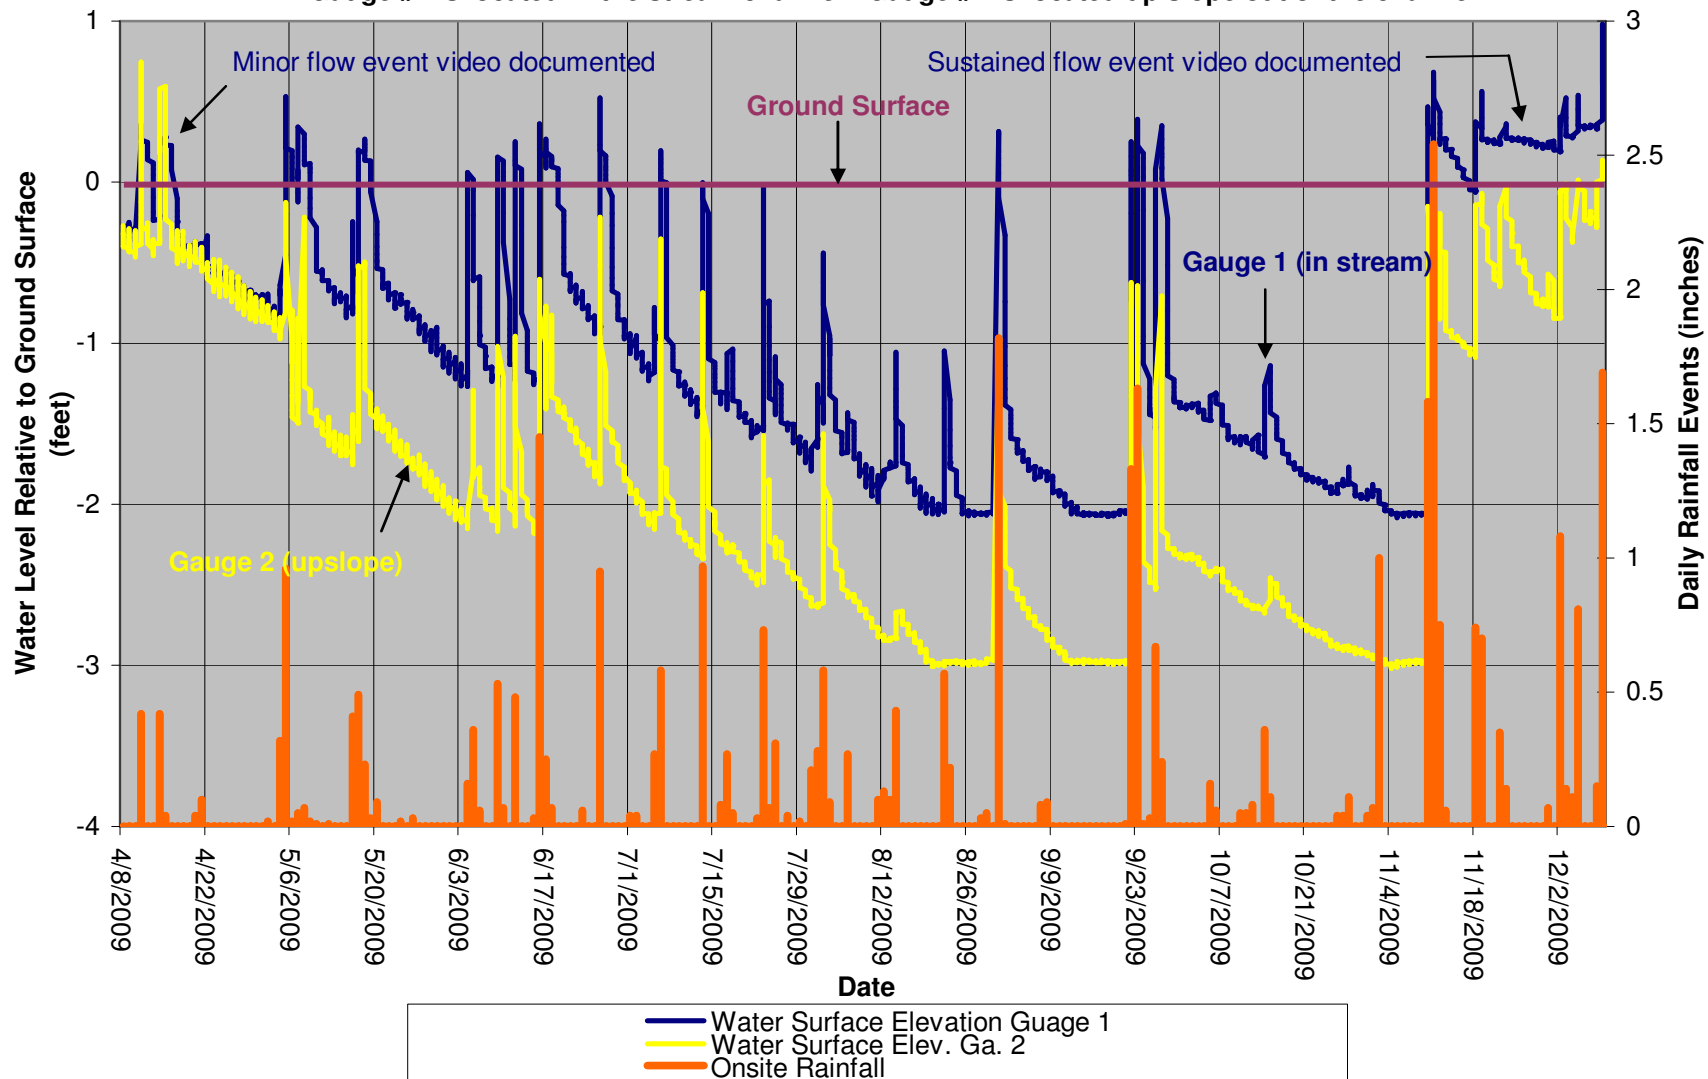
**Figure F1.  
Goodman Monitoring Gauges #1 and #2**

Figure F1 shows gauges 1 and 2 which are in the northern branch near the inlet pipe from the swamp run above the project. Due to its location, gauge 1 shows prolonged water flow in December which is corroborated by video evidence. Figure F2 illustrates the water flow at gauges 3 and 4 which is less robust, but present nevertheless. Gauges 3 and 4 are located near the head of the southern branch where the stream channel is shallow and the true watershed is the surrounding agricultural field. When rainfall is heavy enough, water does indeed drain from the surrounding field into the project area near these two gauges as well as at the head of this branch. Figure 4 in Appendix D shows how water from the surrounding agricultural field drains into this branch.

Gauge #1 is located in the stream channel. Gauge #2 is located up slope out of the channel.

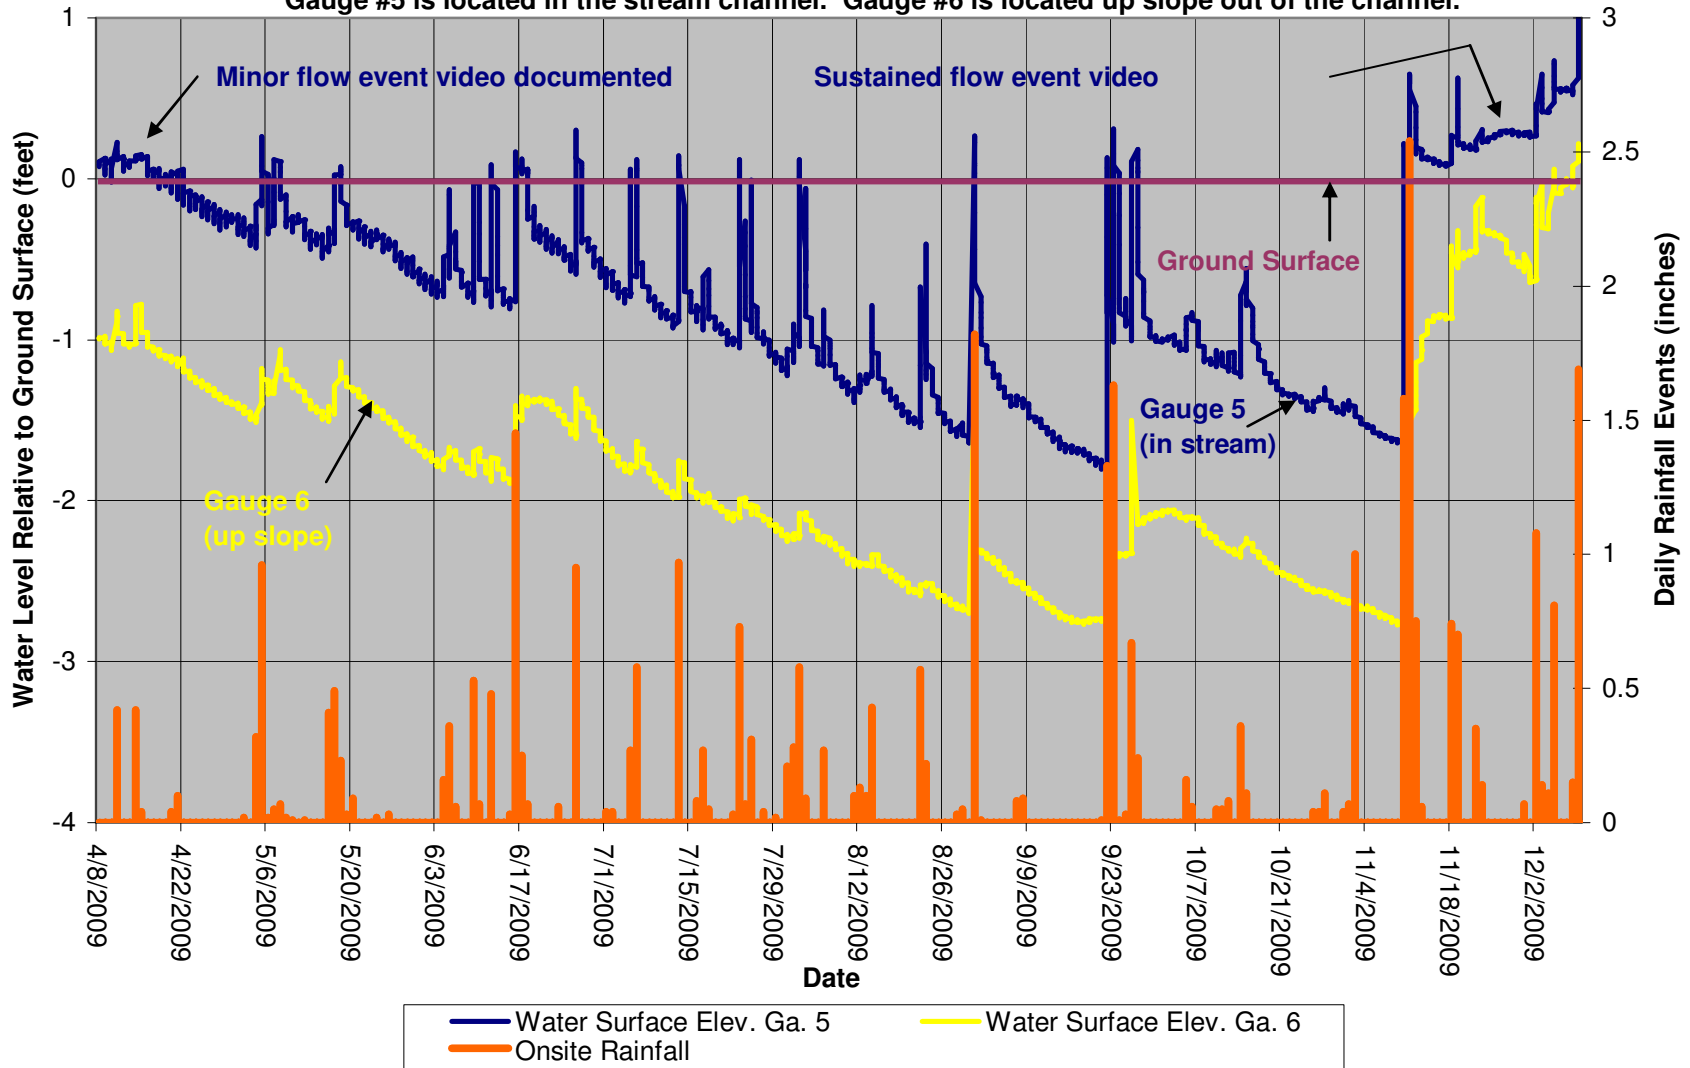
**Figure F3.**  
**Goodman Monitoring Gauges #5 and #6**

Figure F3 illustrates what is probably the most substantial flow data and captured during 2009. It is also perhaps the strongest indication of the project's success. Gauges 5 and 6 are located in the southern branch – which is fed by the same watershed as gauges 3 and 4 (the surrounding field - not the inlet pipe from the upstream swamp run). The data are mirror images and gauge 5 shows water flowing in the channel at a depth of six inches or more during November and December. Gauge 6, located upslope from the channel approximately 50 feet, shows overbank flooding at least to that point in December.

Gauge #5 is located in the stream channel. Gauge #6 is located up slope out of the channel.

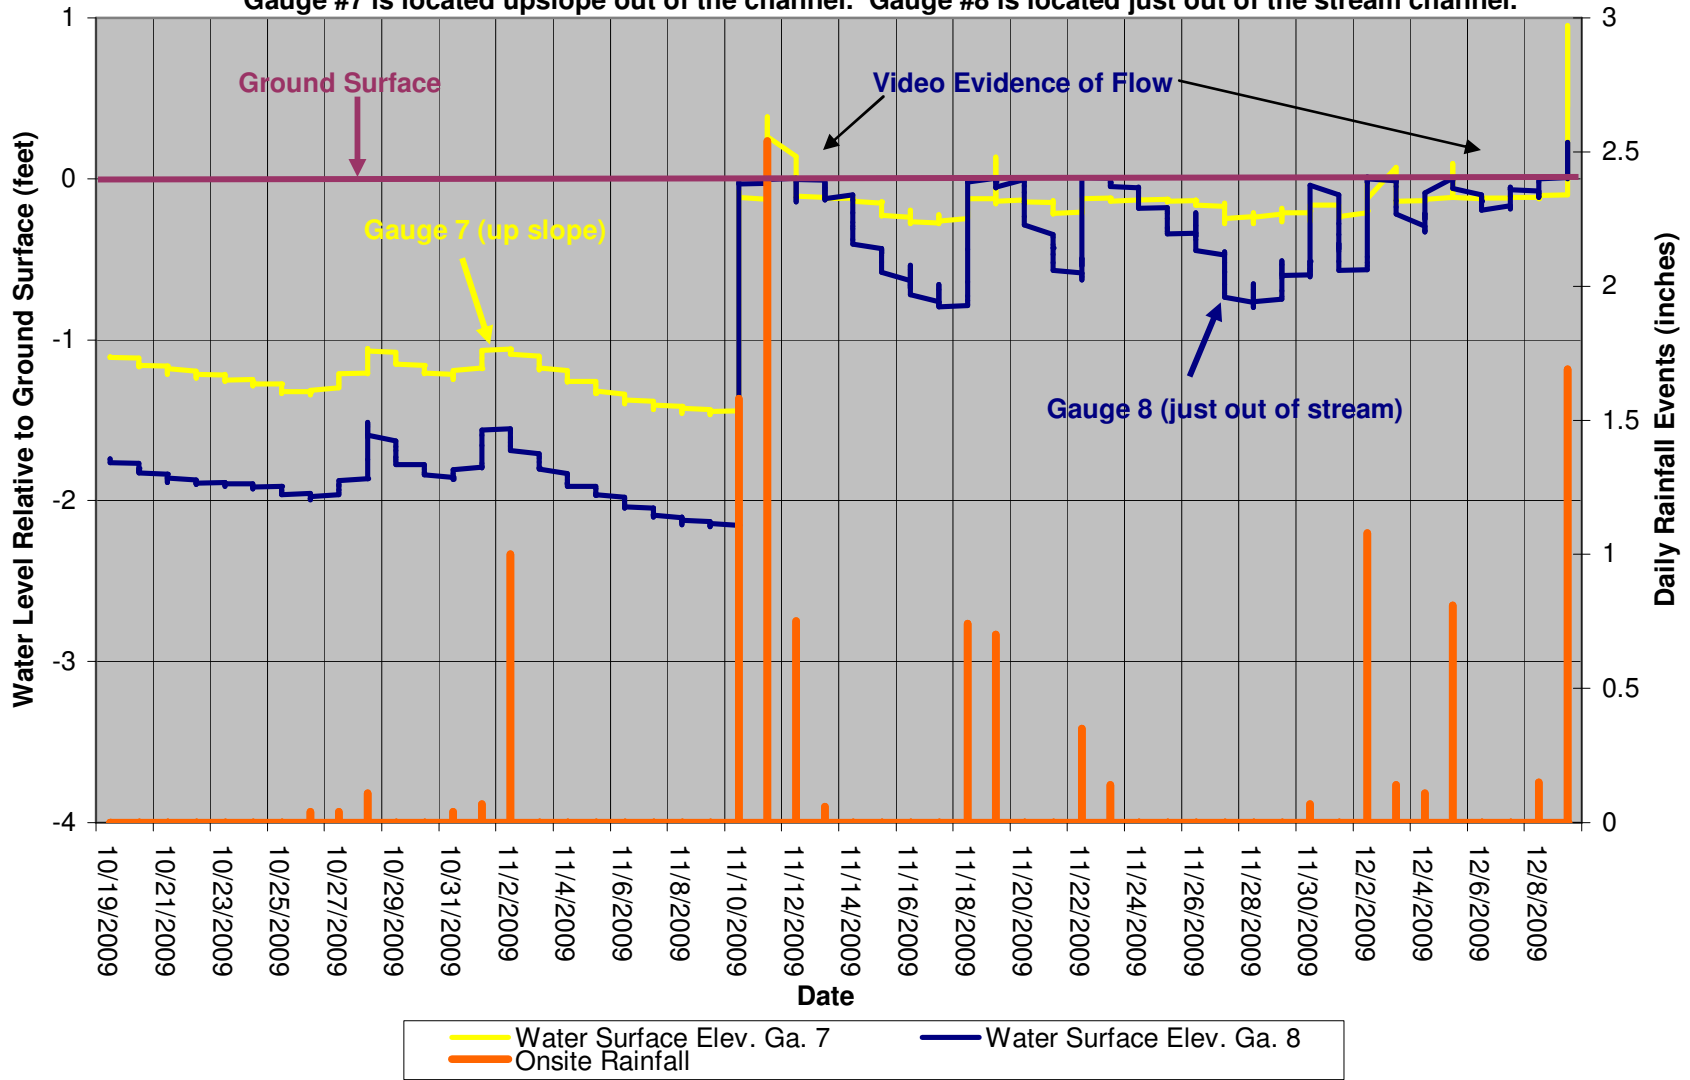
**Figure F4.**  
**Goodman Monitoring Gauges #7 and #8**

Figure F4 contains the data from gauges 7 and 8 but due the malfunction of the data logger at gauge 8, the data for the first part of the year was not usable. The logger was replaced and the data from November and December show good flow at the outfall end of the project. Since gauge 8 is outside and slightly above the stream channel, each time the water level reaches the zero line (ground surface) it is an indication of overbank flooding. With each rainfall event, the water level at this end of the project rises out of the channel and slowly recedes back as indicated and corroborated with video evidence.

Gauge #7 is located upslope out of the channel. Gauge #8 is located just out of the stream channel.

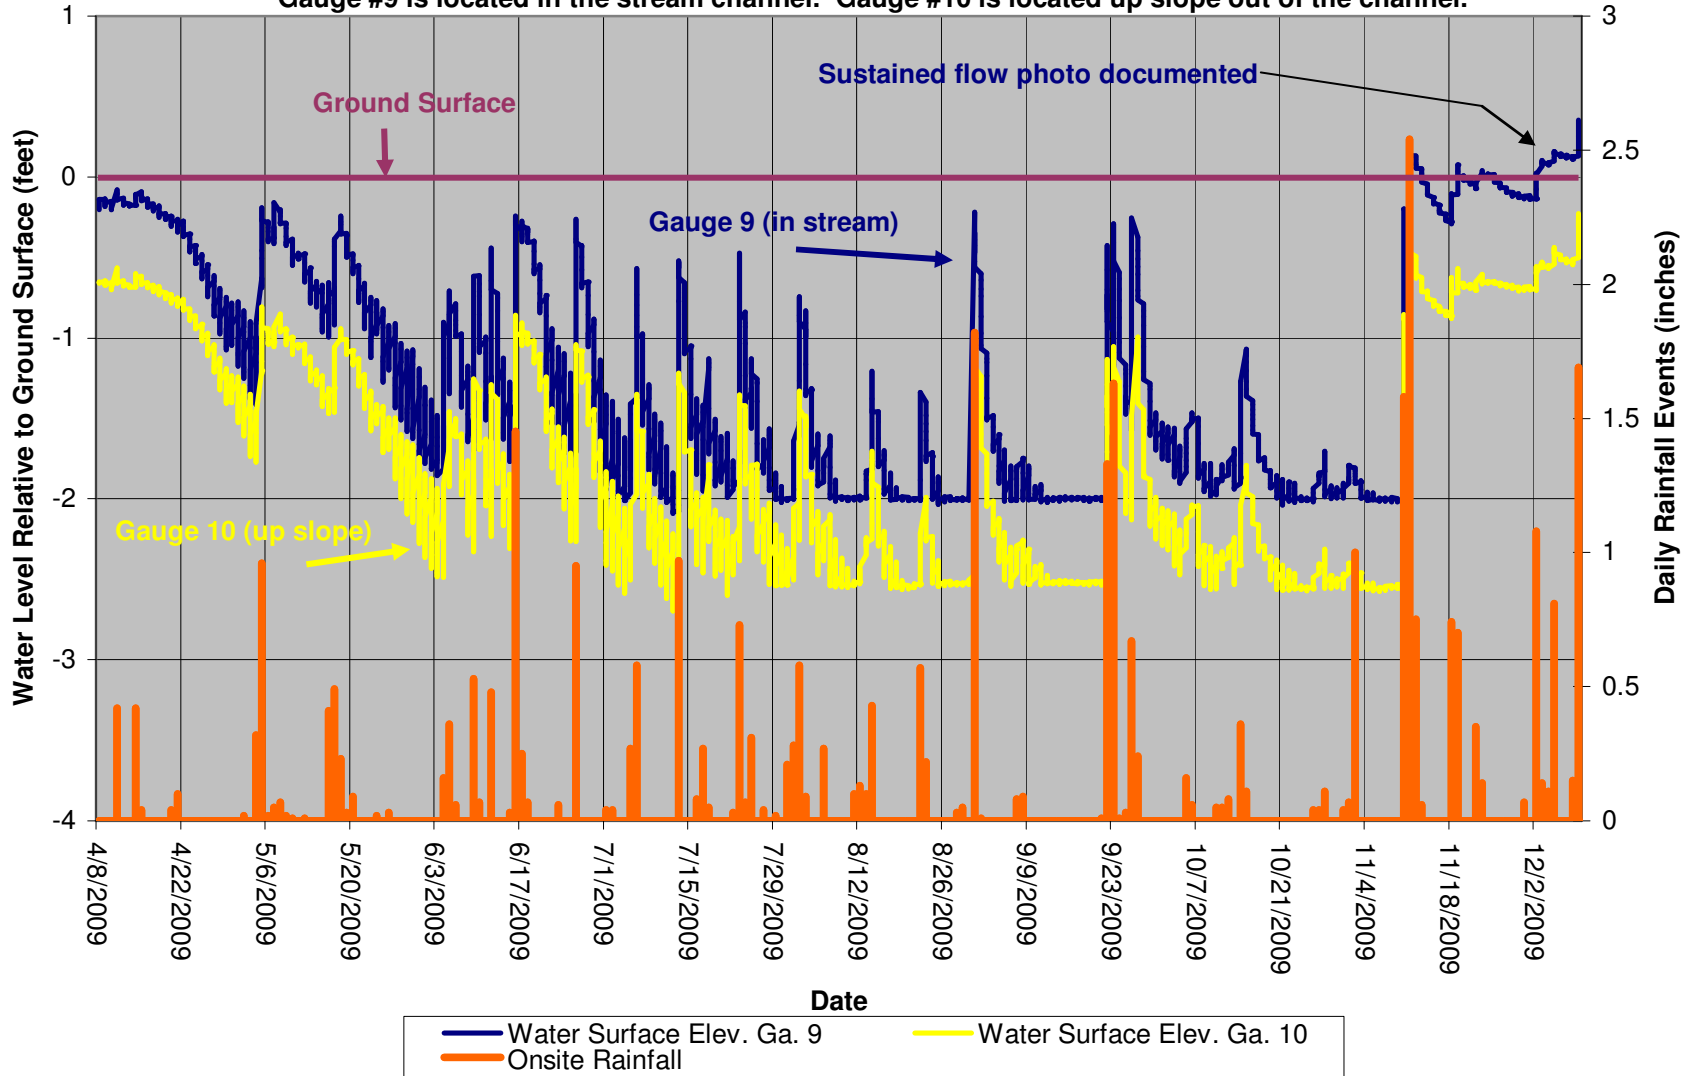
**Figure F5.**  
**Goodman Monitoring Gauges #9 and #10**

Figure F5 represents the data from the reference area which actually shows less flow due to the dry conditions in 2009. The minor flow event documented on the project in March did not occur in the reference site since the swamp in the reference area was still too dry from the droughty

conditions in 2008. But in November and December, the reference swamp was fully charged and flowing again.

Gauge #9 is located in the stream channel. Gauge #10 is located up slope out of the channel.

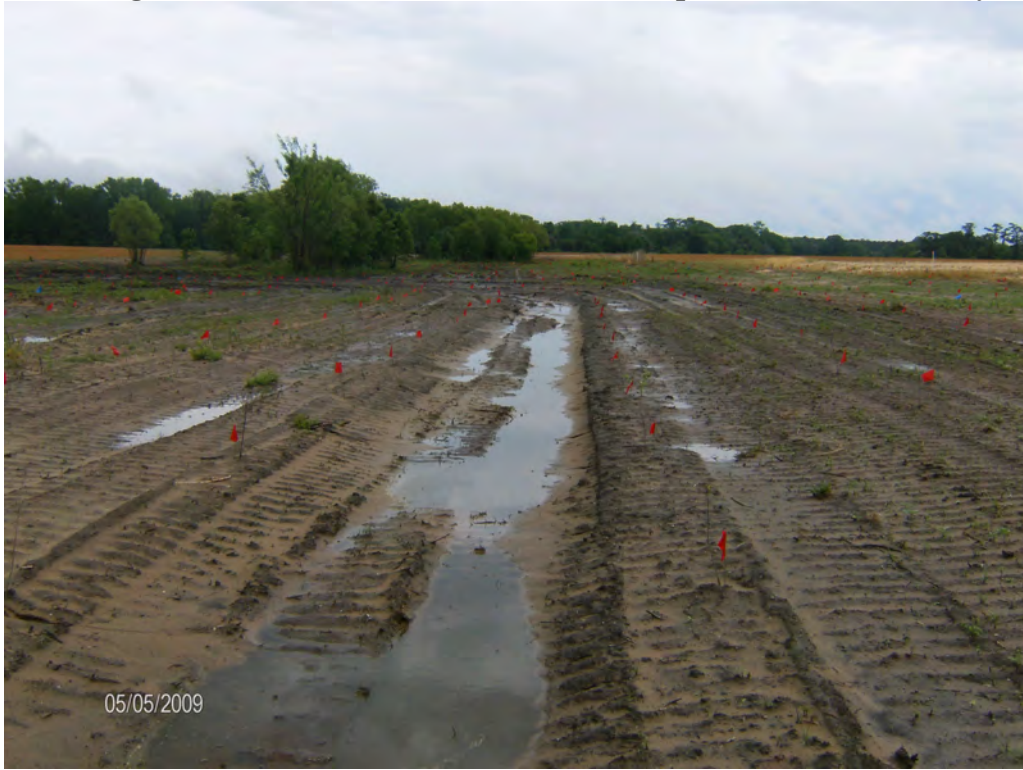
**Looking downstream on the southern branch - post construction (May)**

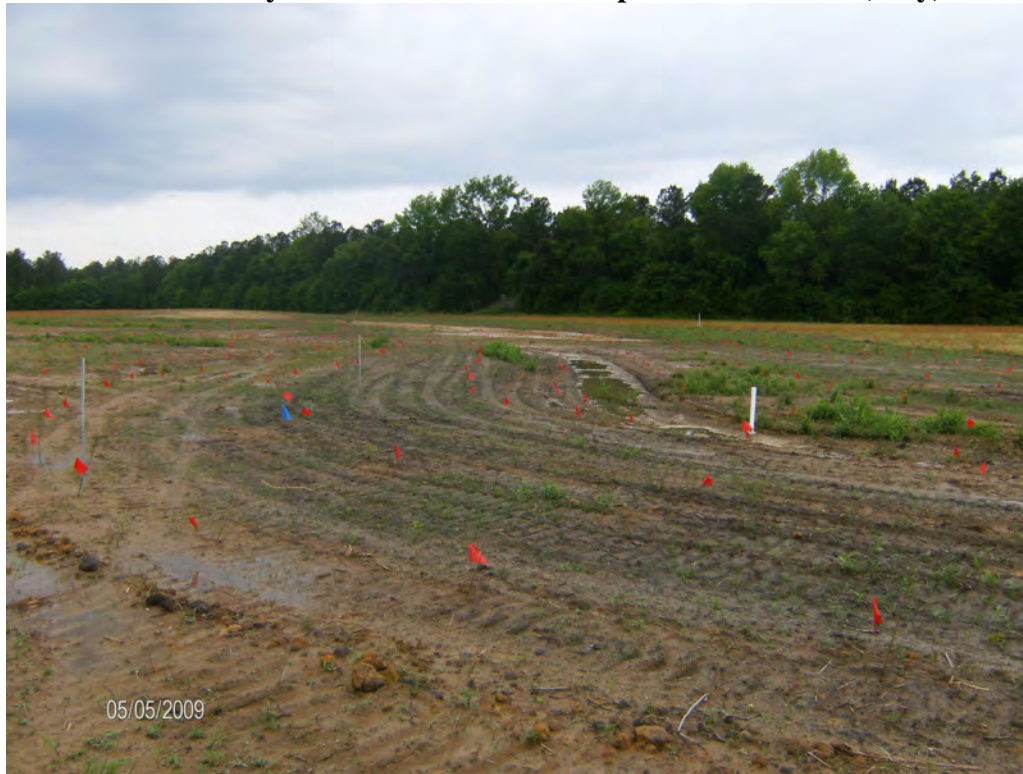
**View of newly created north channel - post construction (May)**

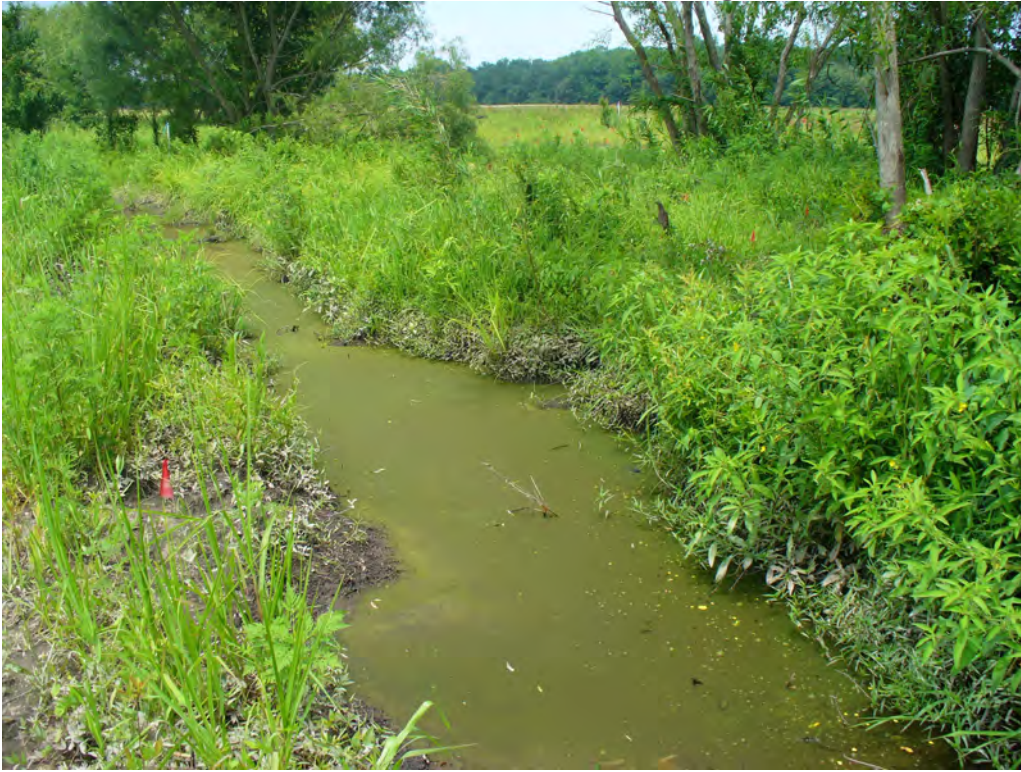
**Channel below confluence of two branches shows high water mark (June)**

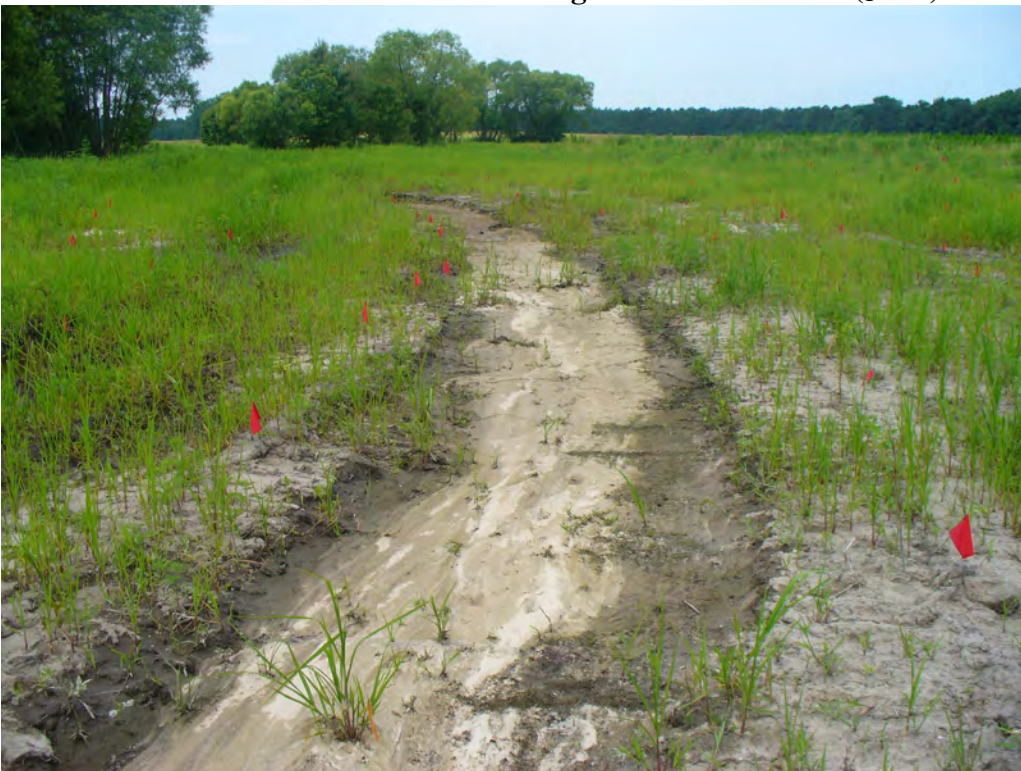
**Channel establishment and scouring – southern branch (June)**

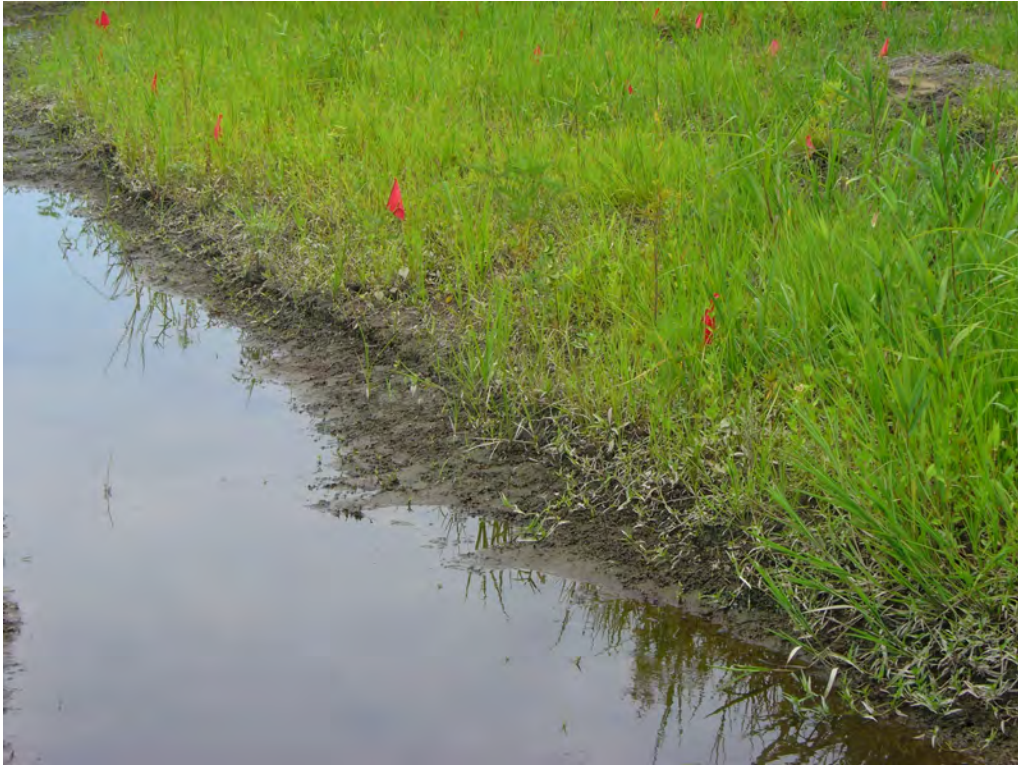
**Evidence of bank establishment (June)**

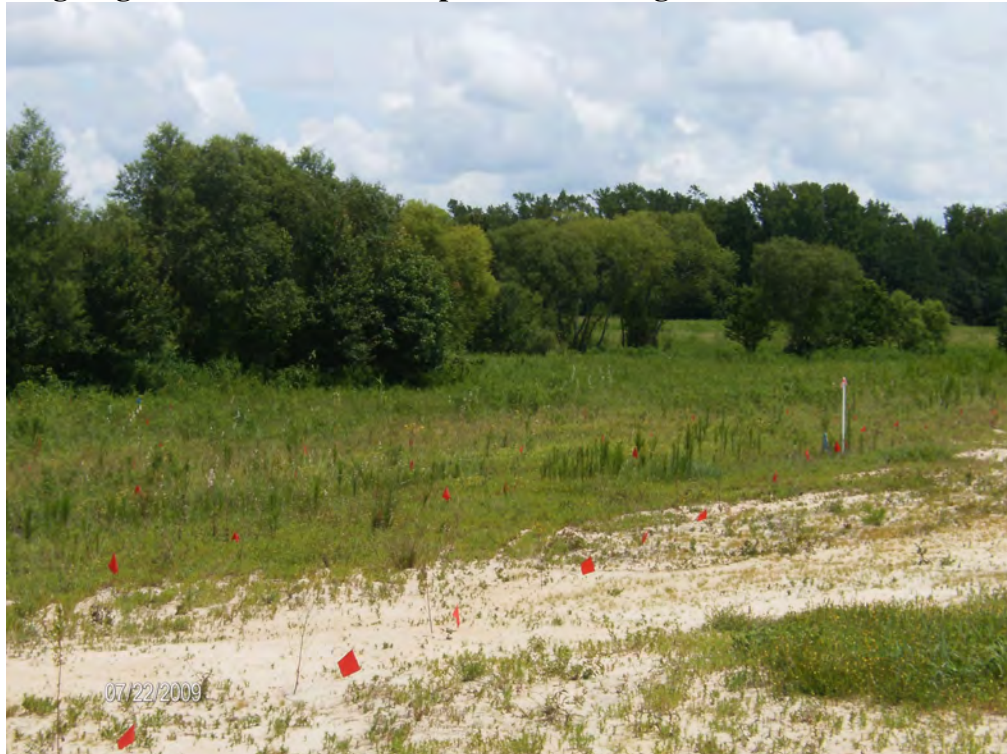
**Trees along original ditch course were protected during construction and are doing well**

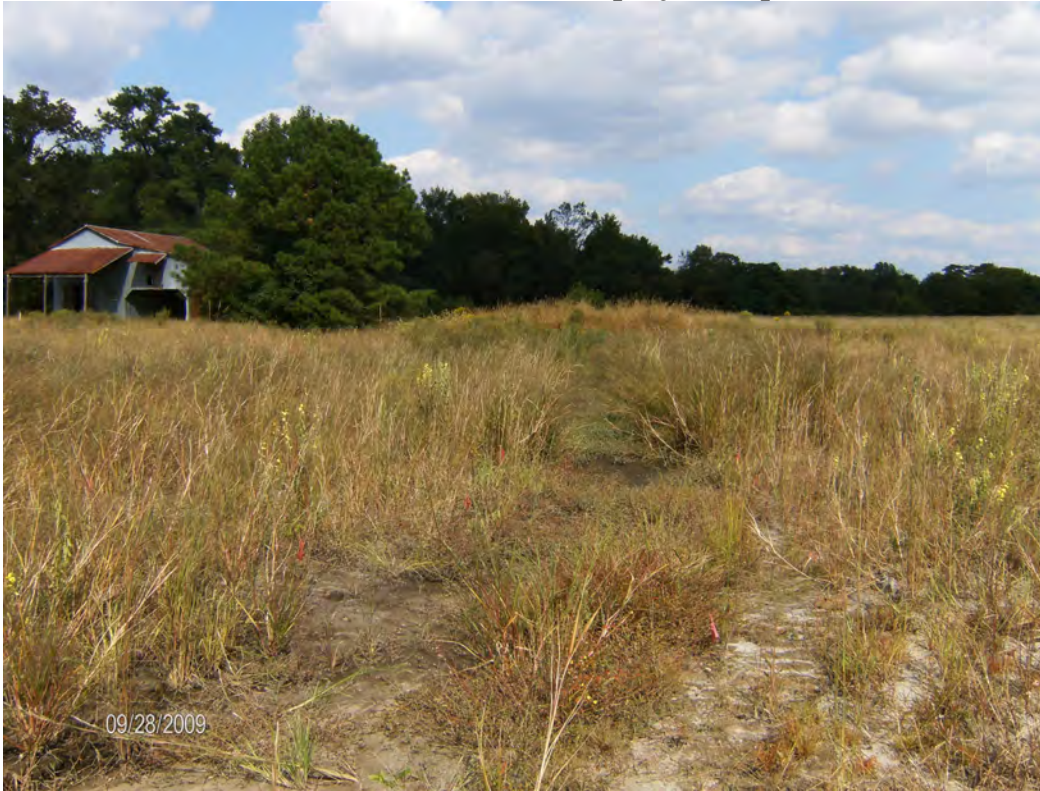
**Scoured channel at outlet end of project (September)**

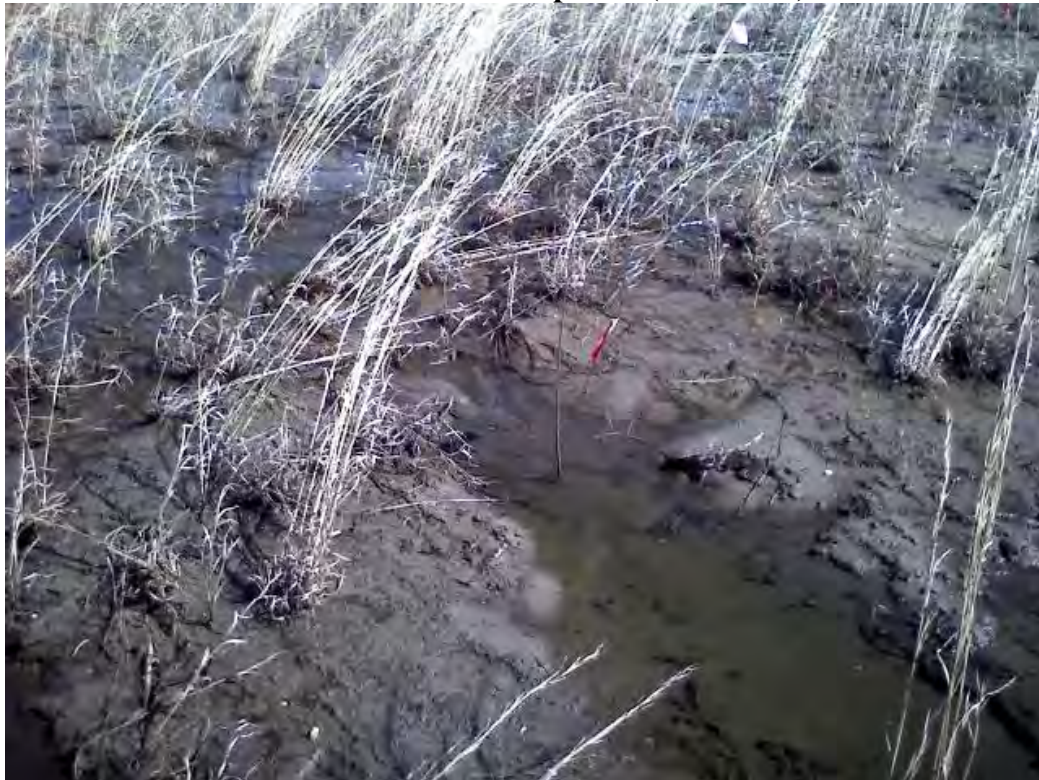
**Lateral channel development (December)**

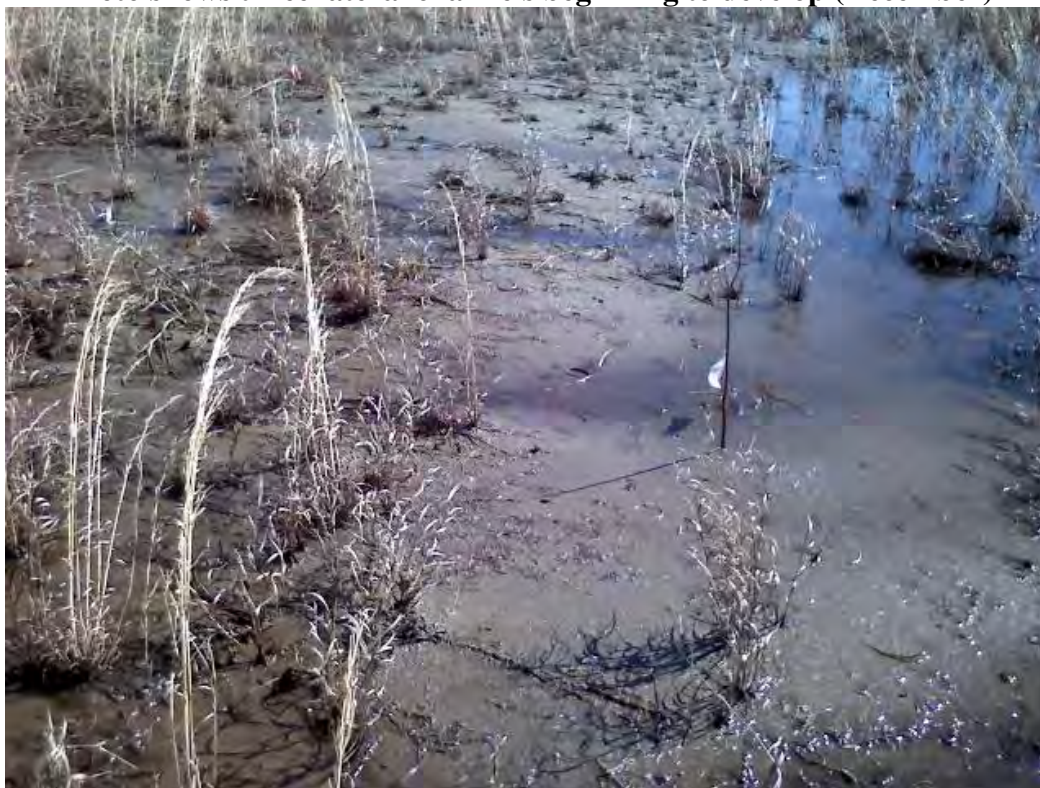
**Photo shows three lateral channels beginning to develop (December)**

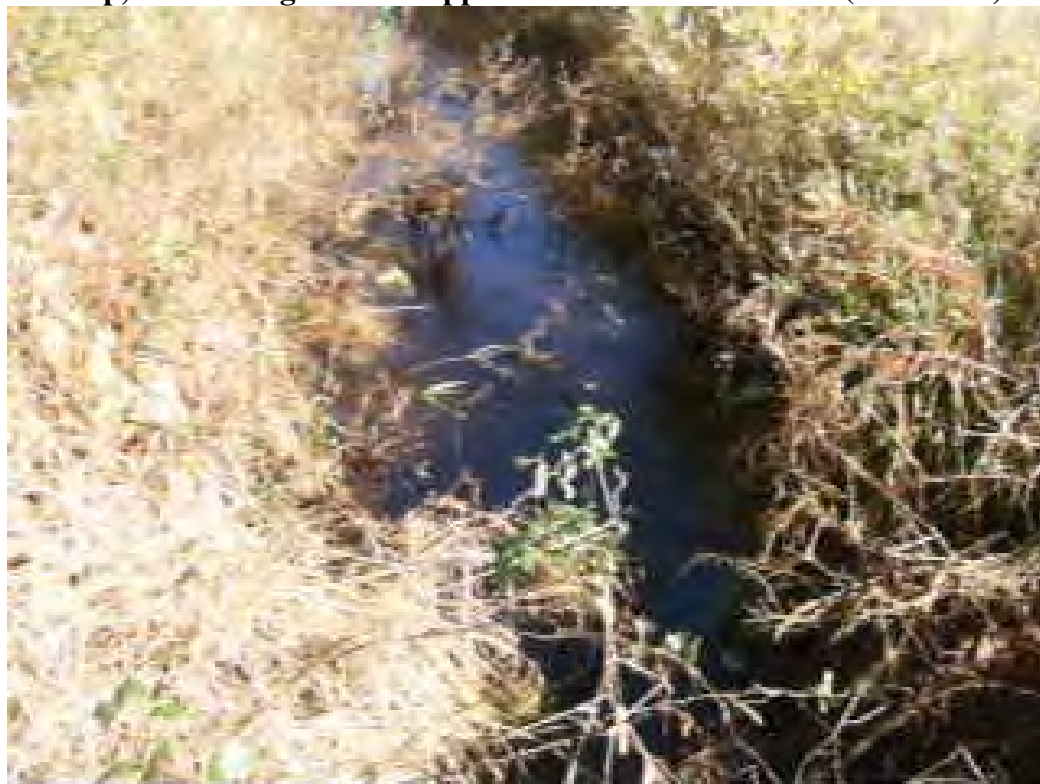
**Deep, fast moving water at upper end of northern branch (December)**

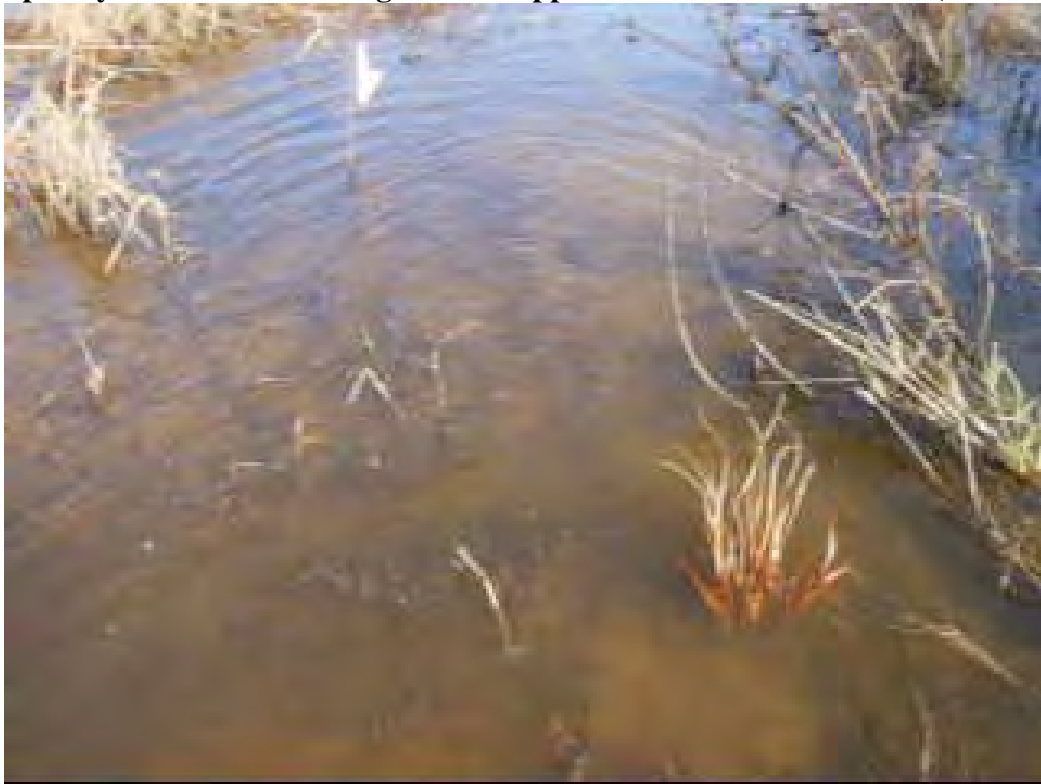
**Completely flooded and flowing channel upper end of northern branch (December)**

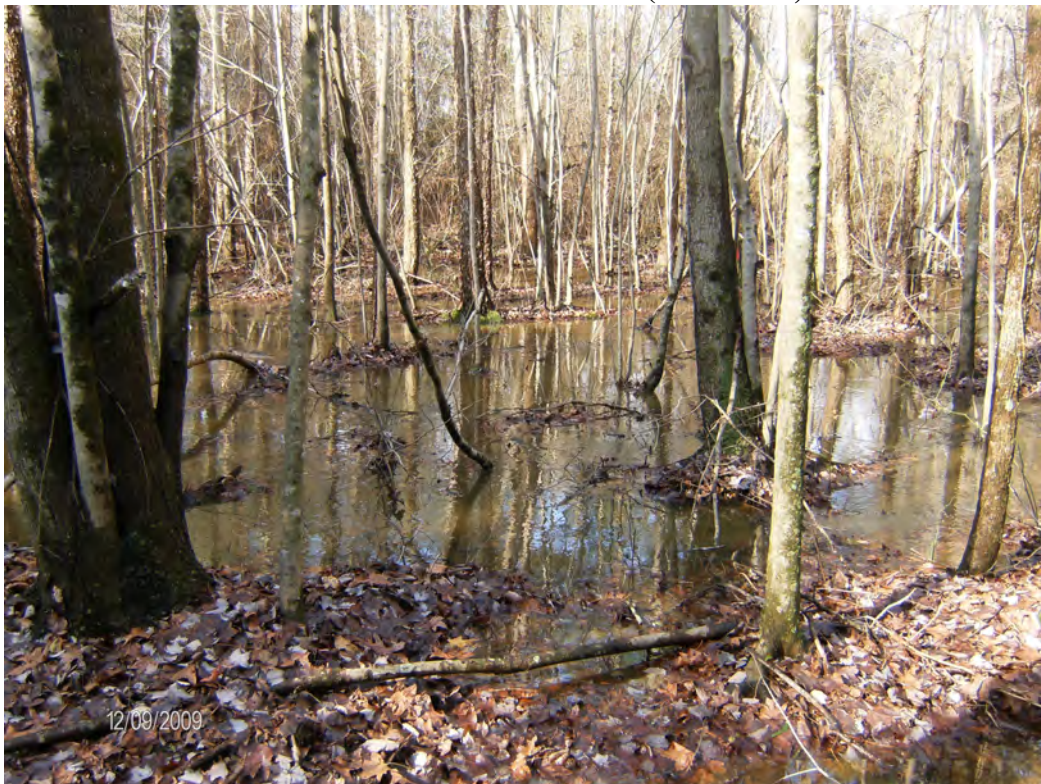
**Water flow in reference area (December)**

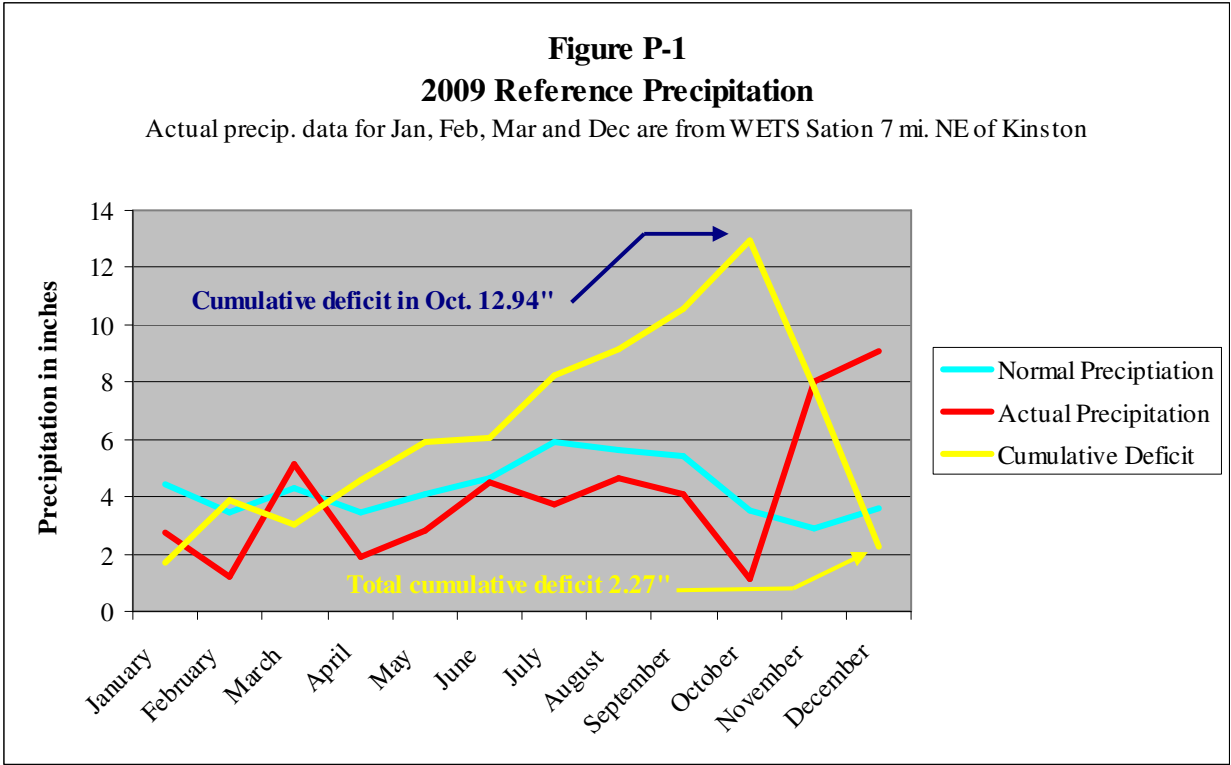
Accumulated rainfall deficit through October 2009 was 12.94 inches. Total for the year was reduced to 2.27 inches due to heavy rainfall in November and December.

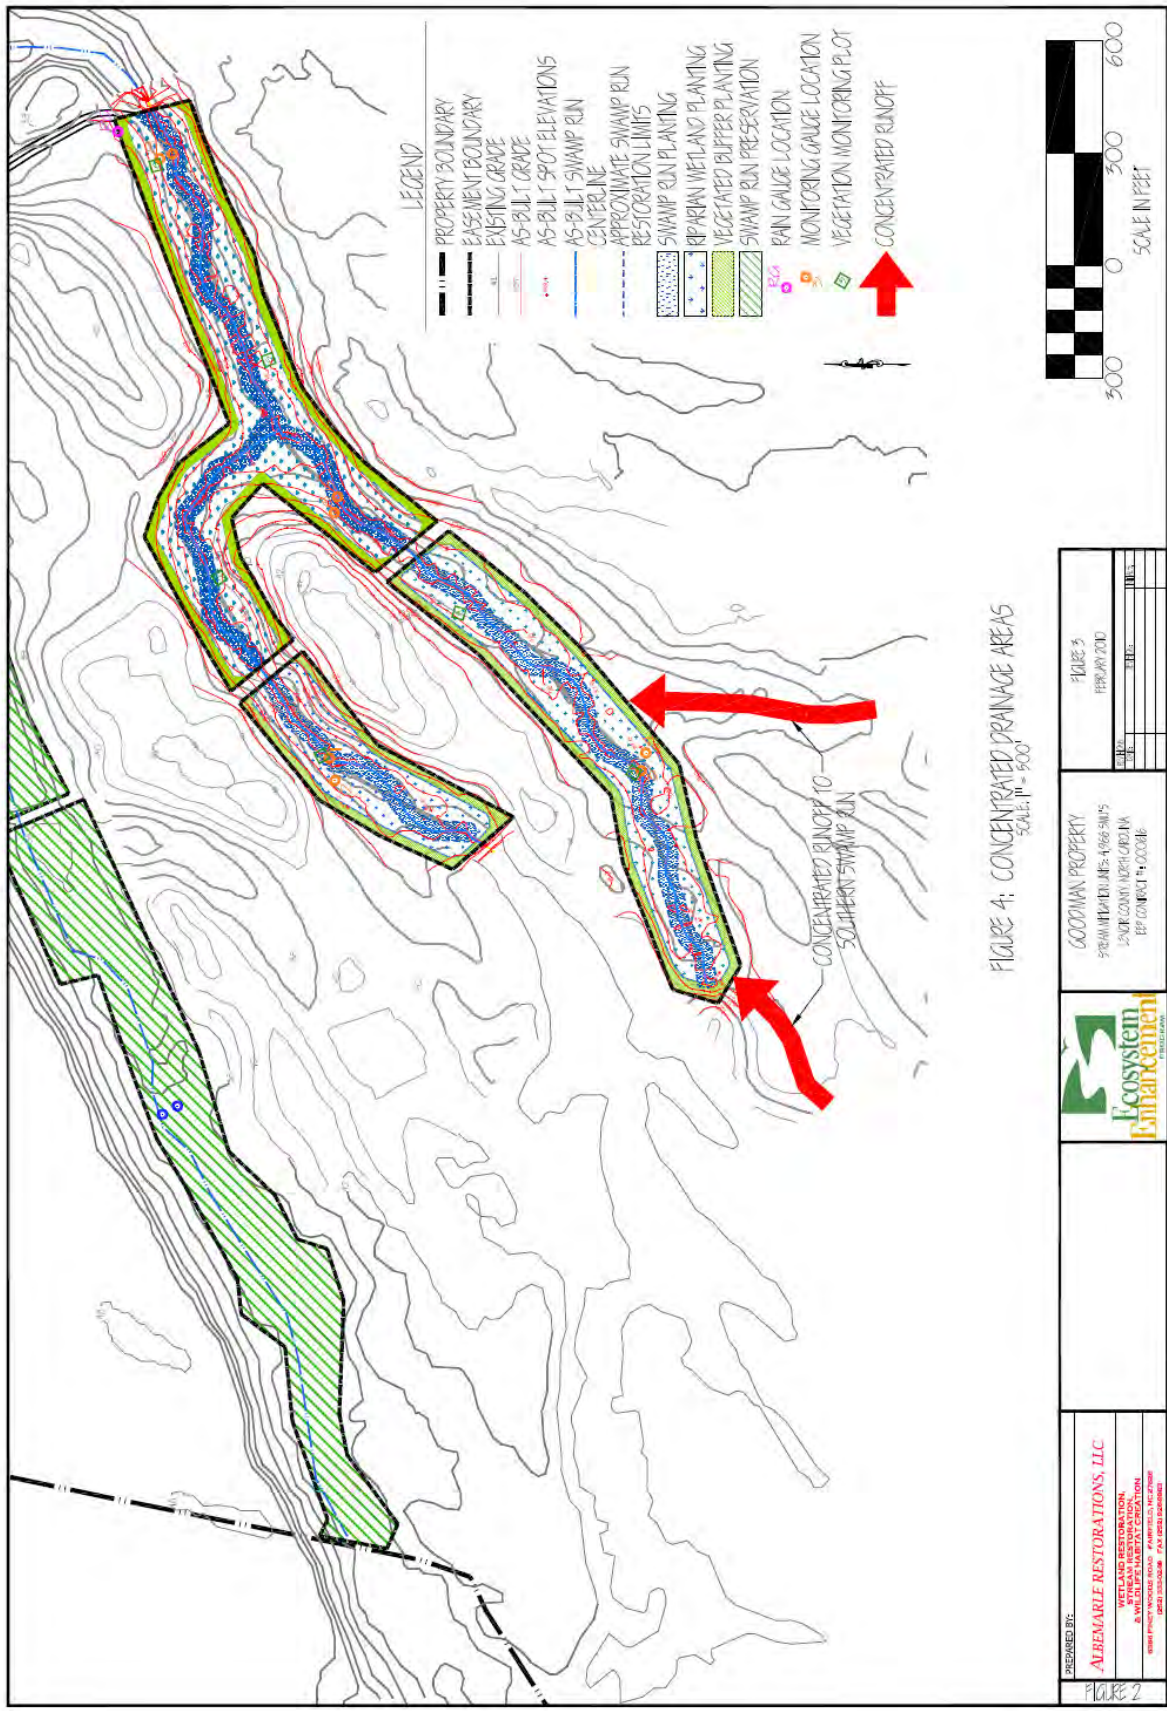
FIGURE 4: CONCENTRATED DRAINAGE AREAS  
SCALE: 1" = 500'

Figure 4 in Appendix D provides an overview of the watershed success of the southern branch of the project. The northern branch is directly connected to an existing, functioning swamp run upstream, but the southern branch relies solely on rainfall and field drainage. Given the data and video evidence captured in 2009, this potentially weaker part of the project was entirely successful.
