**Goodman Property Stream Restoration Project
Lenoir County, NC**

**2010 Annual Monitoring Report
Year 2**

**NCEEP Project Number D000616
Neuse River Basin**

Date: November, 2010

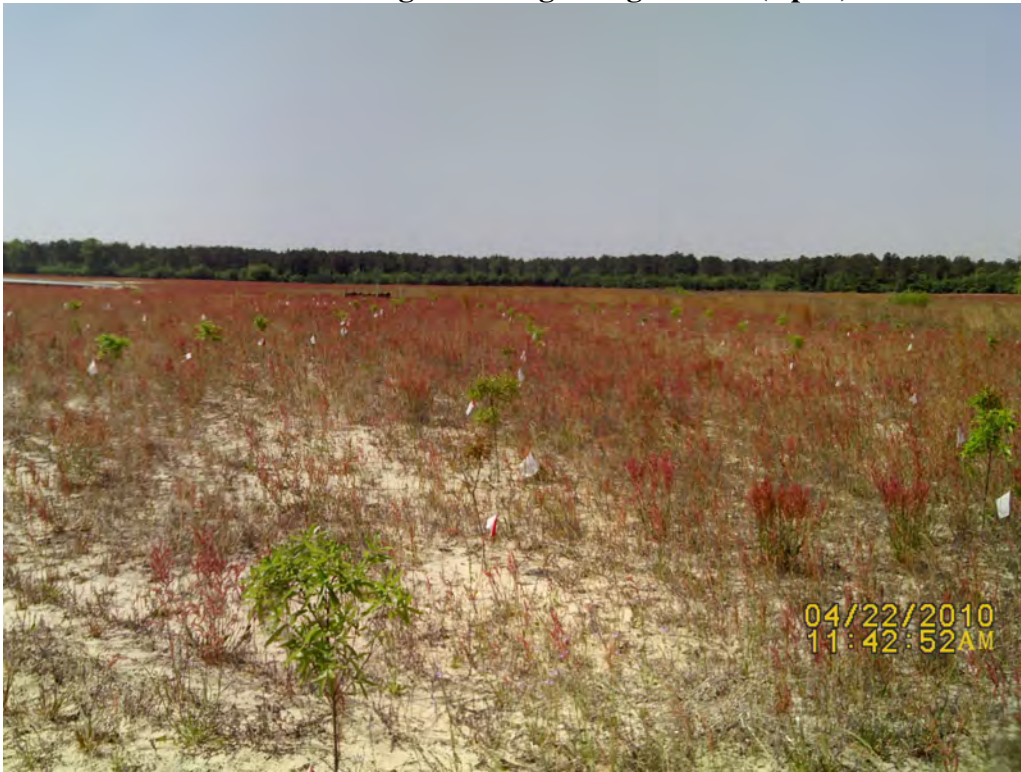
Tree survival is good in beginning of 2010 (April)

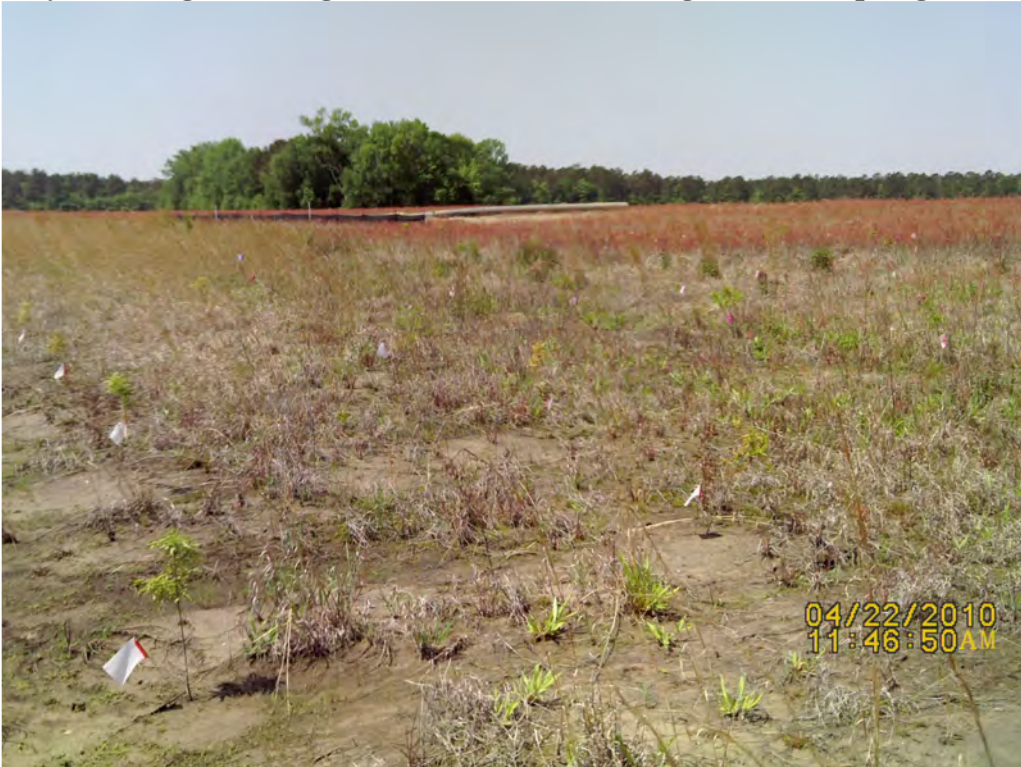
Grey colored ground/vegetation shows extent of high water in spring of 2010

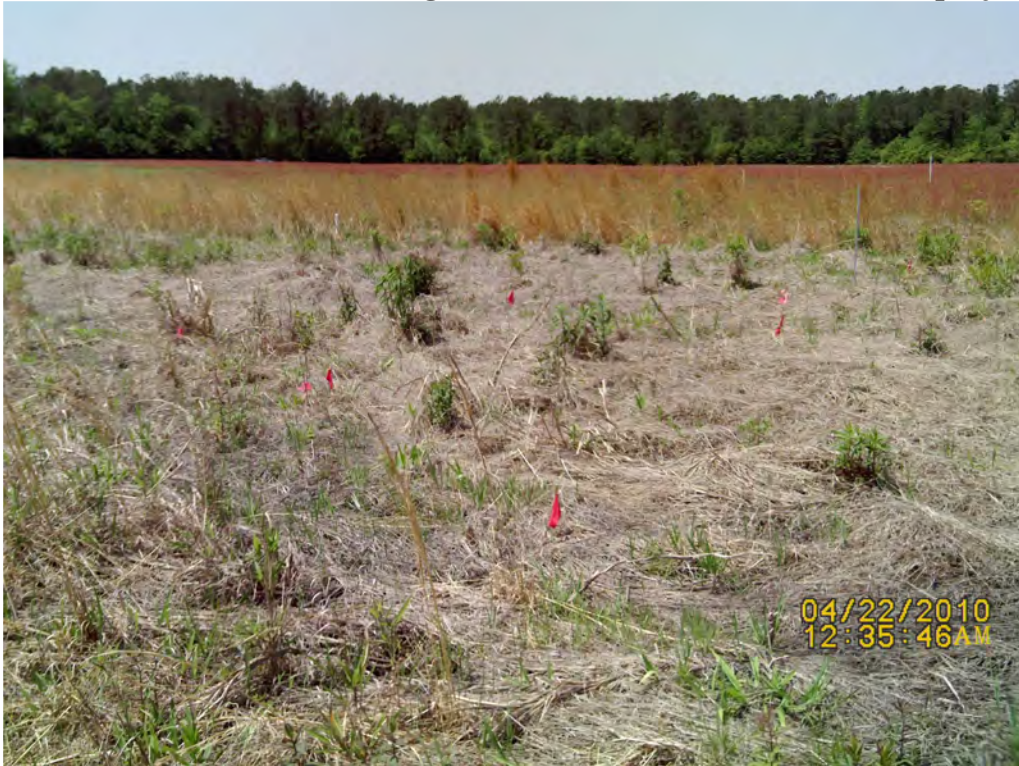
Another view of the extent of high water in the middle reaches of the project

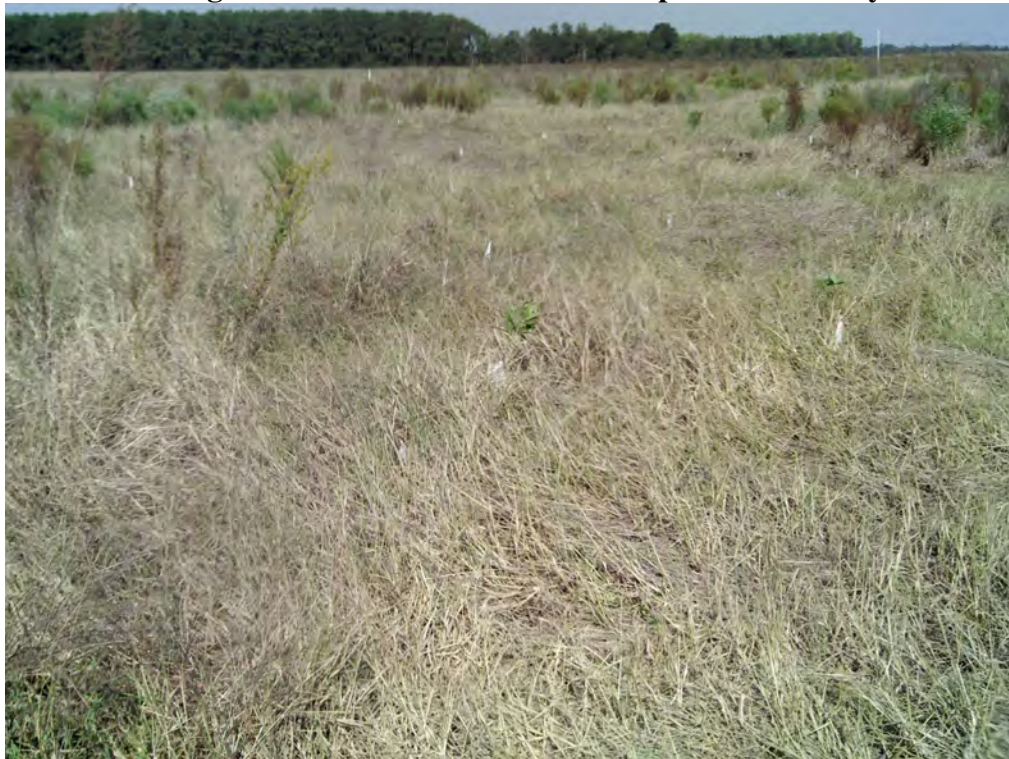
Matted vegetation in October 2010 after September's heavy rain

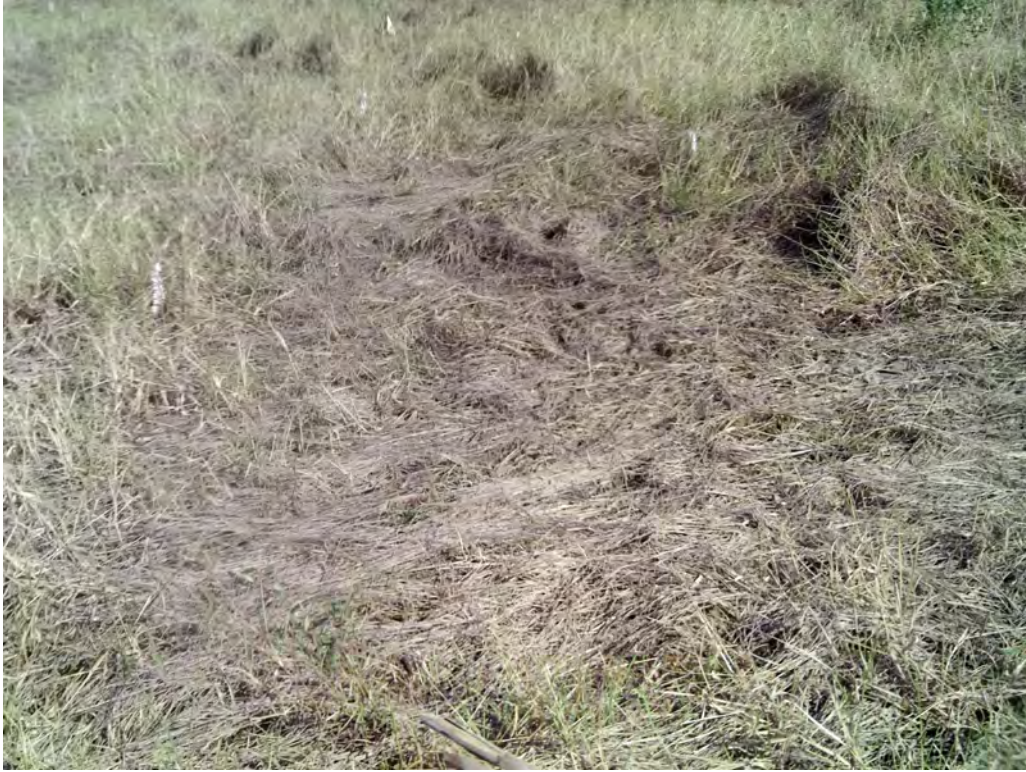
Another view of matted vegetation in October after heavy rain in September

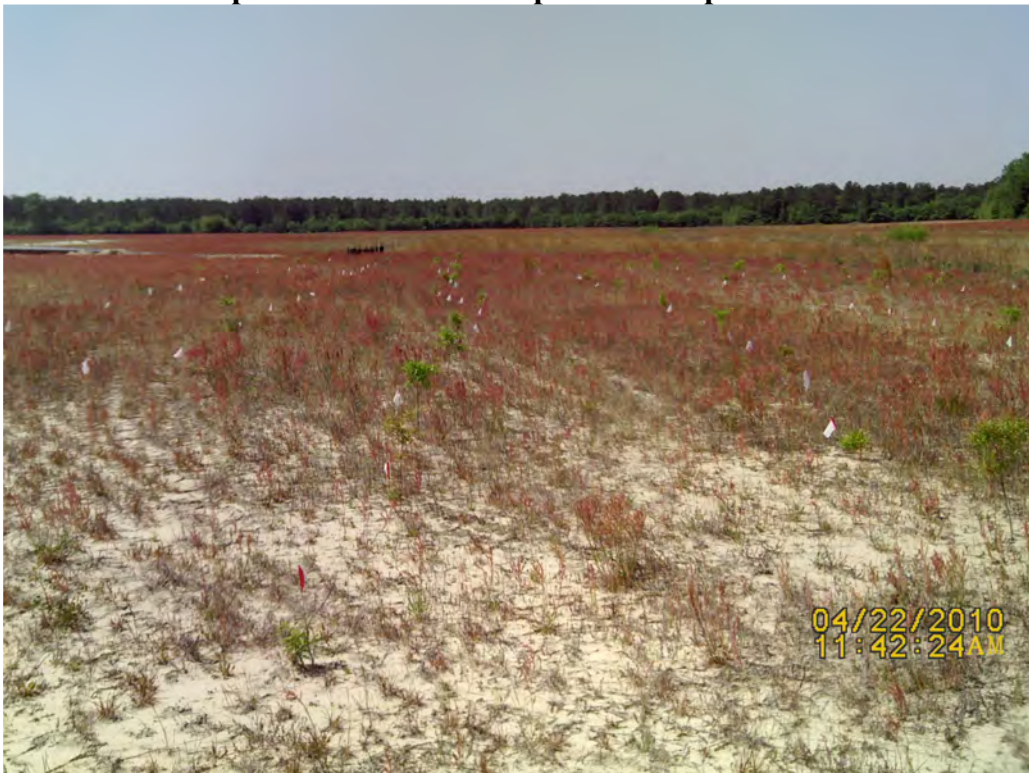
Sparse herbaceous competition in April 2010

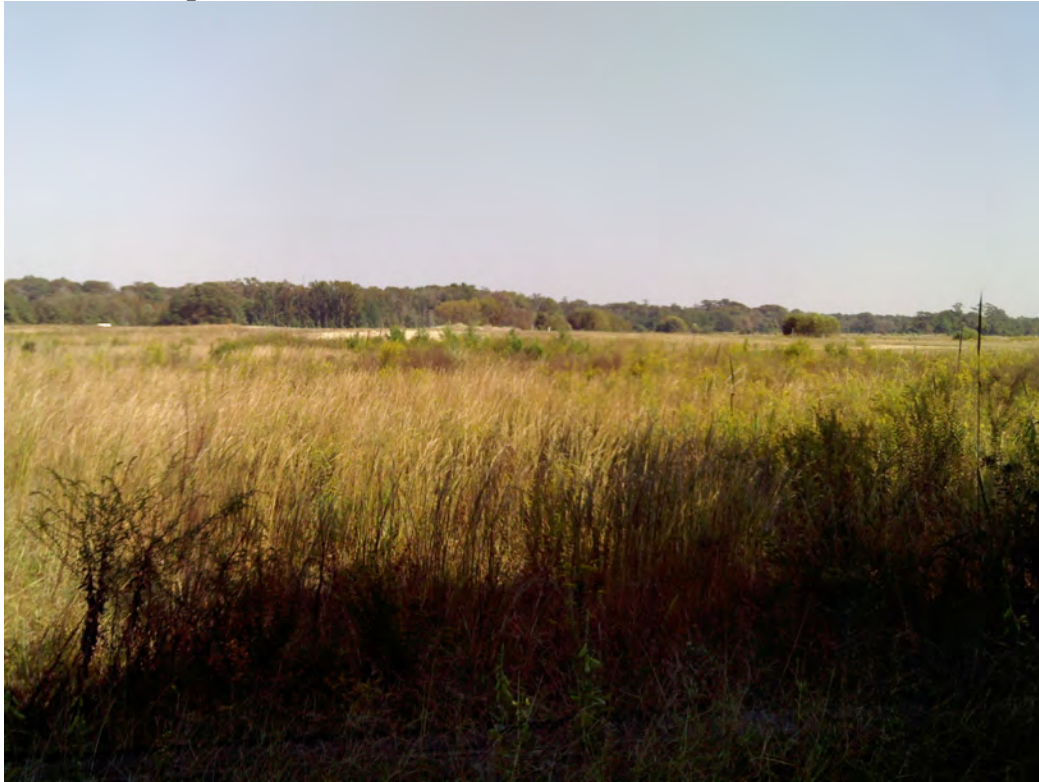
The survival rates on Plots 3 and 4 were slightly less than the year-three criterion of a minimum of 320 stems per acre. Stocking levels on the other four plots well exceeded 320 stems per acre. Both plots 3 and 4 suffer from extremely dense, very tall herbaceous competition, primarily dog fennel (*Eupatorium capillifolium*) which created a tall dense, pernicious canopy over the young trees. Trees on these plots were very difficult to locate while completing survival checks in 2010. Light supplemental planting will be done during the fall/winter of 2010-2011 on the portion of the project around Plots 3 and 4 to bring the stocking up to adequate levels (greater than 320 stems per acre). Future survival will be closely monitored on these two plots and their surrounding area to be sure stocking is adequate to reach the long-term success criteria.

Herbaceous competition has become much more intense at end of season (October)

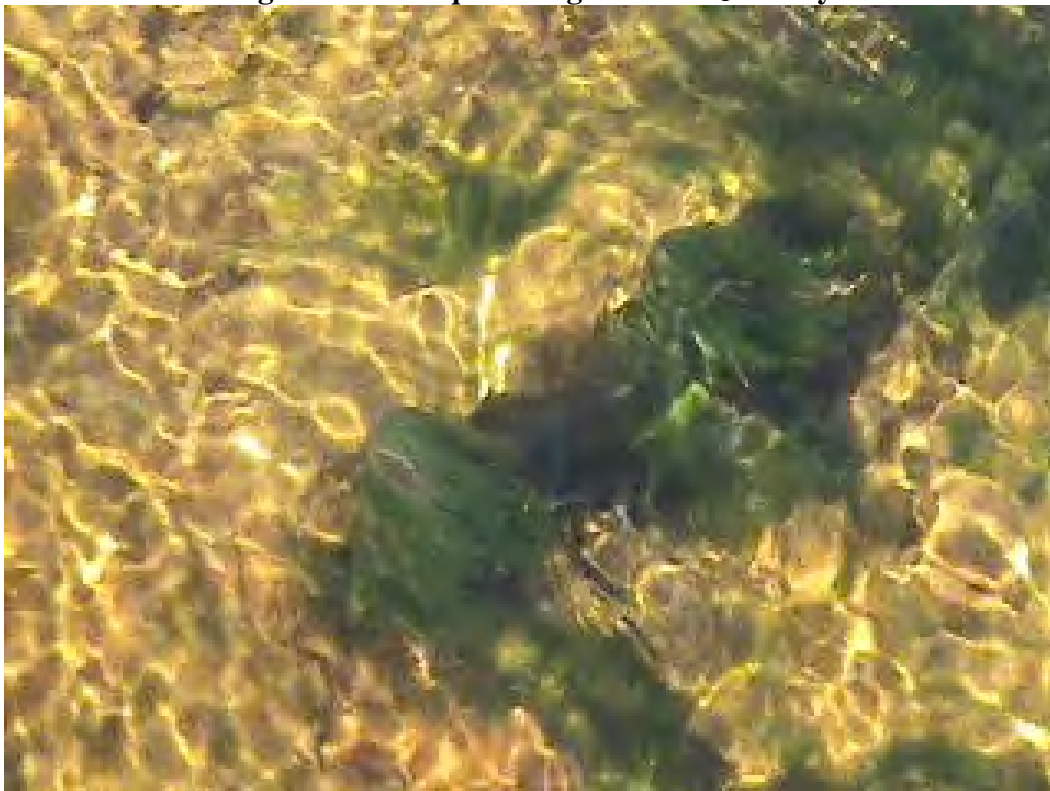
Photo of flowing water and aquatic vegetation in January at outlet end

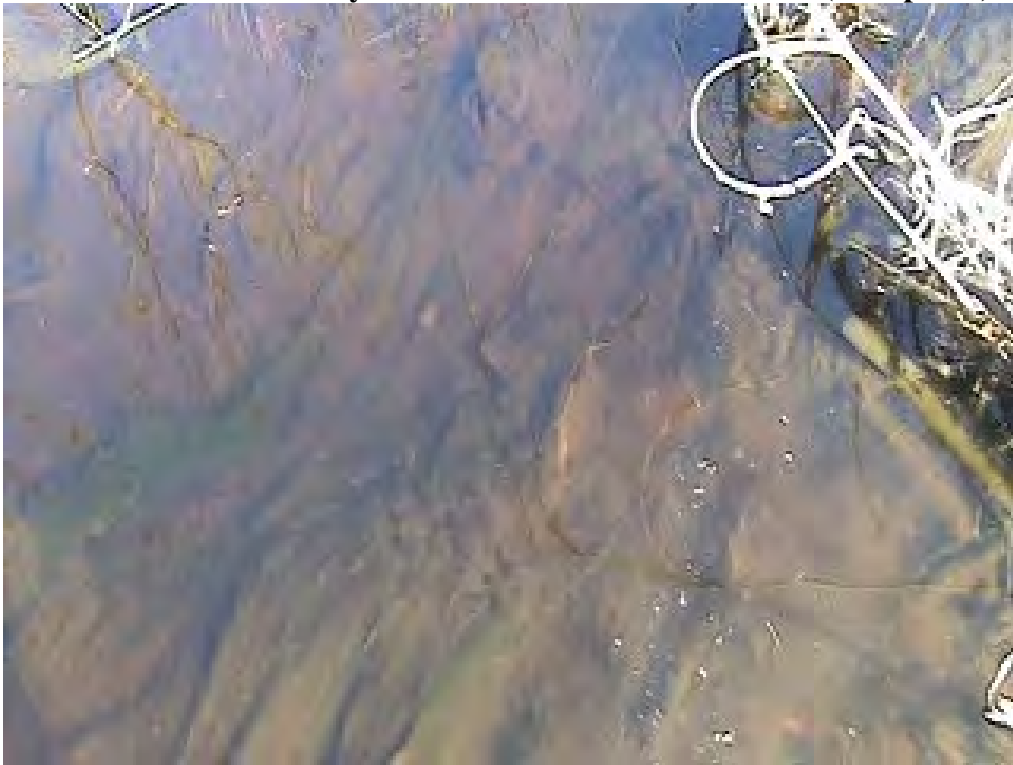
Other photos in Appendix A illustrate high water marks and vegetation matting during the winter and spring of 2010. Site flooding near the confluence of the two branches (near Plot 5) extended from the center of the run outward approximately 20 feet on both sides during the site inspection in January, 2010.

Photo of flow in January near confluence of two branches (near plot 5)

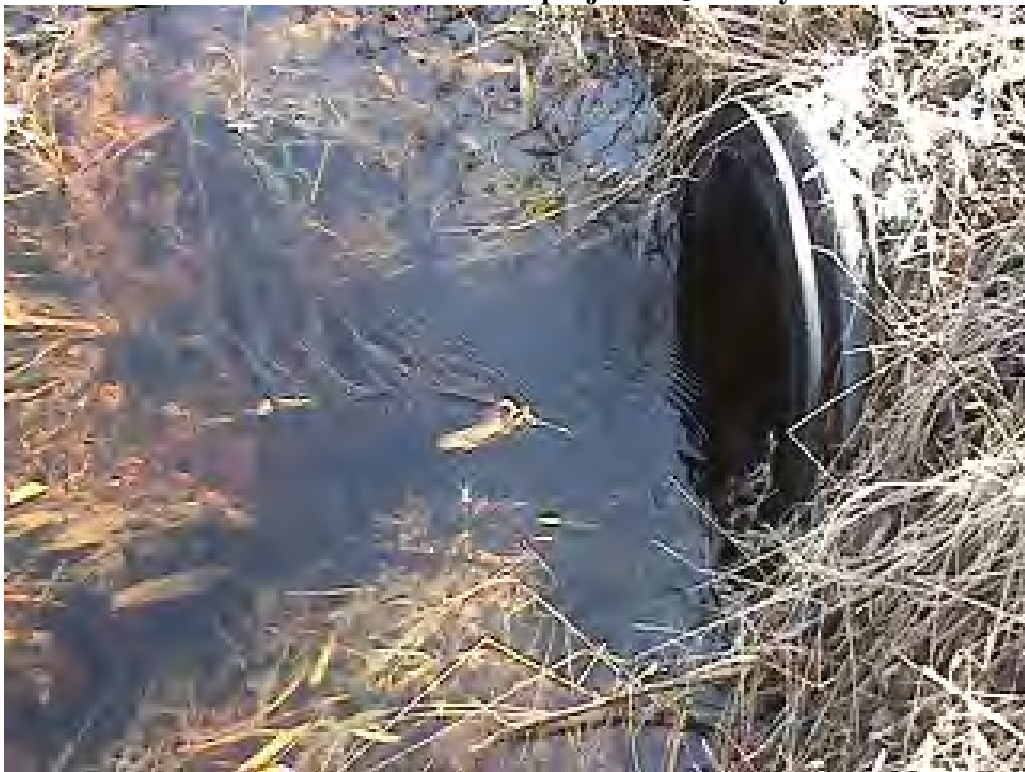
Photo of inflow to the project in January

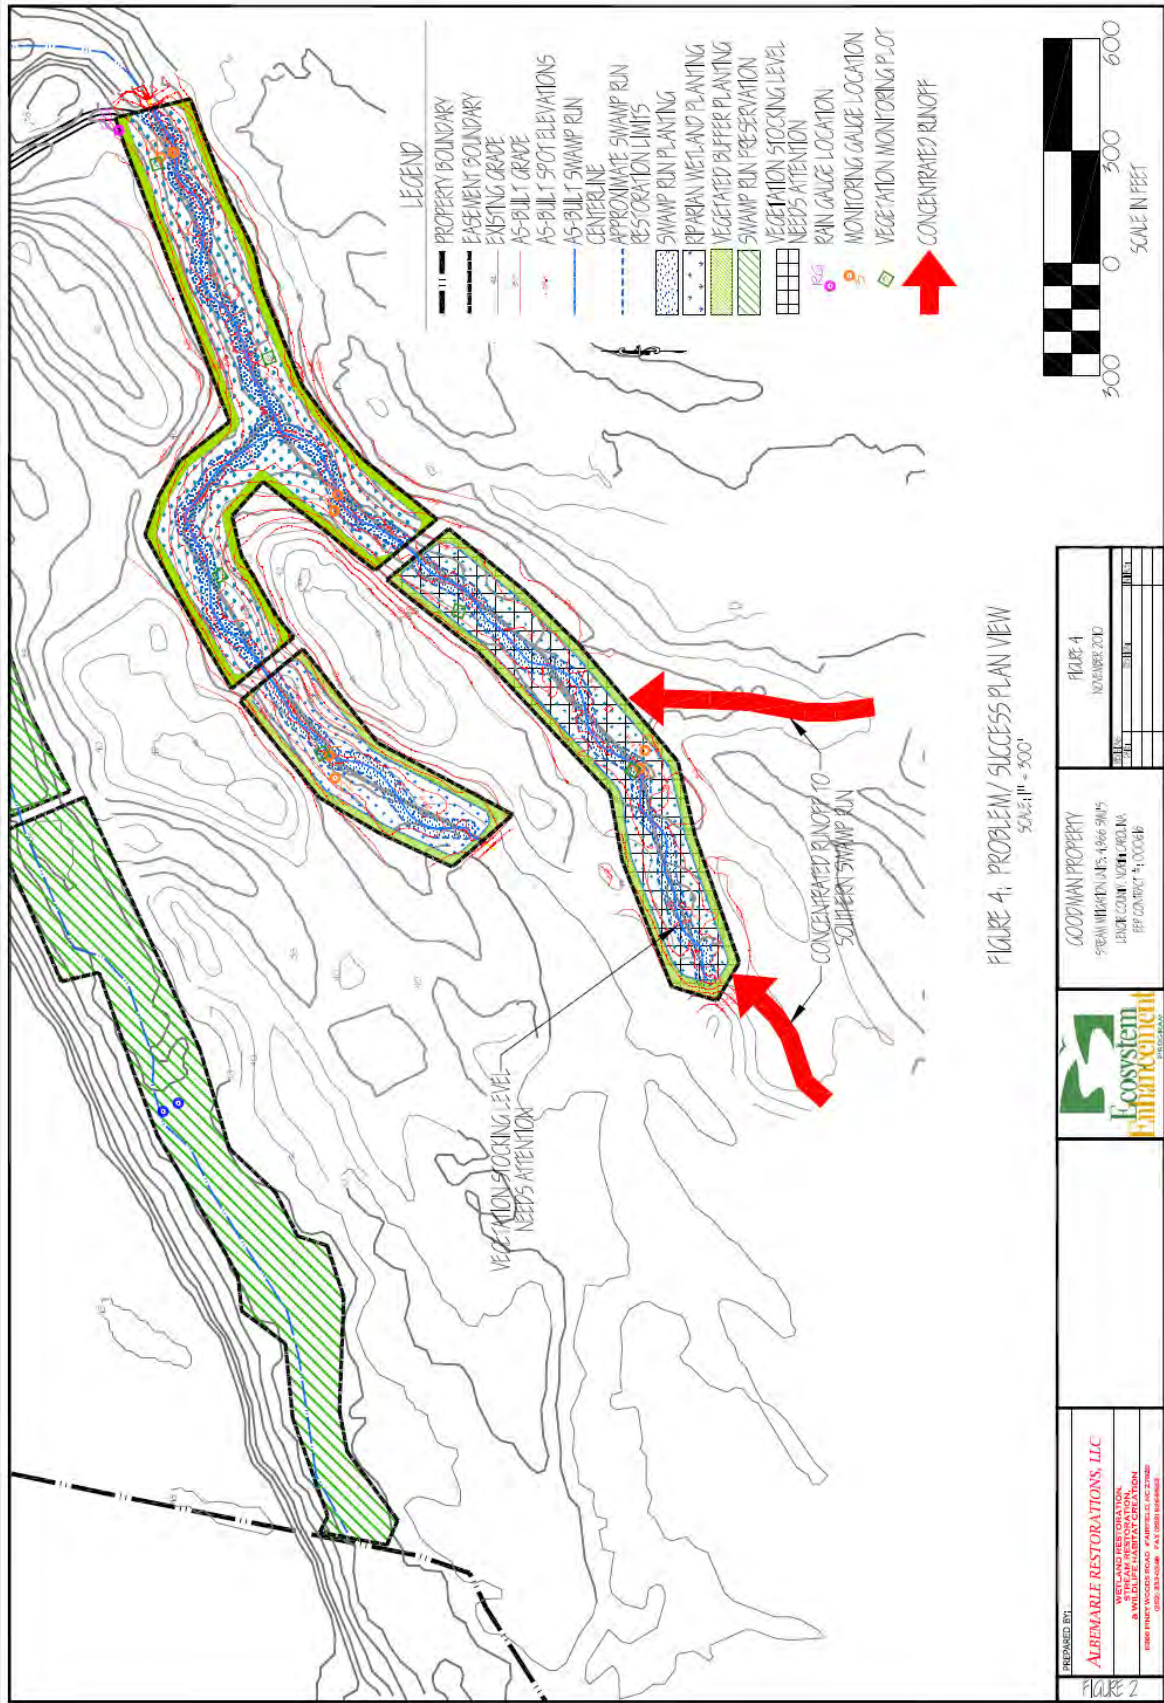
Problems/Success Plan View

The area of the project around Plot 3 continues to be fed by runoff from the adjoining agricultural field in at least two locations. Given the heavy herbaceous cover along the southern branch, this portion of the project is providing a necessary buffer to any runoff from the field. The Plan View in Appendix D gives some indication as to the areas where runoff from the field enters the project.

Figure 4 in Appendix D provides an overview of the watershed success of the project. The northern branch is directly connected to an existing, functioning swamp run upstream, but the southern branch relies solely on rainfall and field drainage. Drainage from the field into the southern branch has been noted in at least two different locations as shown on the Plan View. The portion of the project around Plots 3 and 4 will receive supplemental planting to bring stocking levels up to a minimum of 320 stems per acre.
