**Goodman Property Stream Restoration Project
Lenoir County, NC**

**2011 Annual Monitoring Report
Year 3**

**NCEEP Project Number D000616
Neuse River Basin**

Date: November, 2011

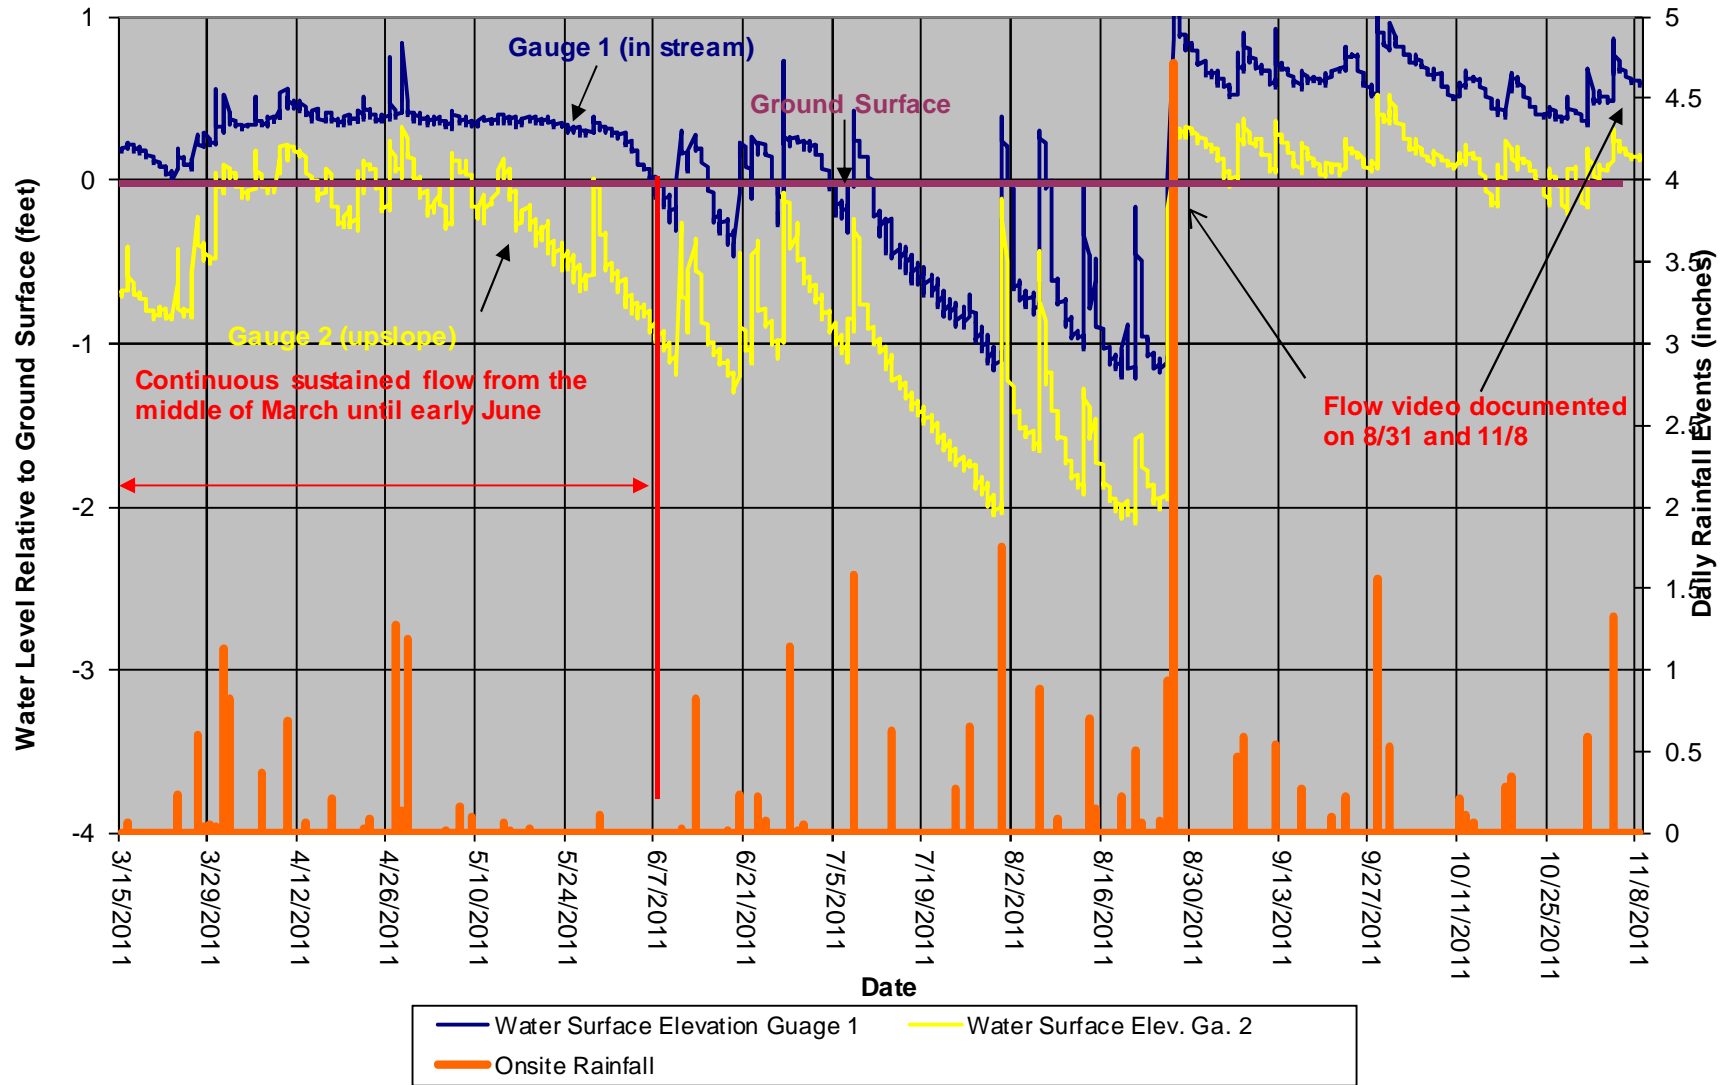
Figure F1.
Goodman Monitoring Gauges #1 and #2
 Gauge #1 is located in the stream channel. Gauge #2 is located up slope out of the channel.

Each of the four pairs of gauges in the project area indicates prolonged, continuous flow from sometime in March of 2011 until either late May or early June, 2011. On two separate occasions, August 31, 2011 and November 8, 2011, flow was video documented on site. The videos are included on the CD included with this report and show good flow throughout the entire project.

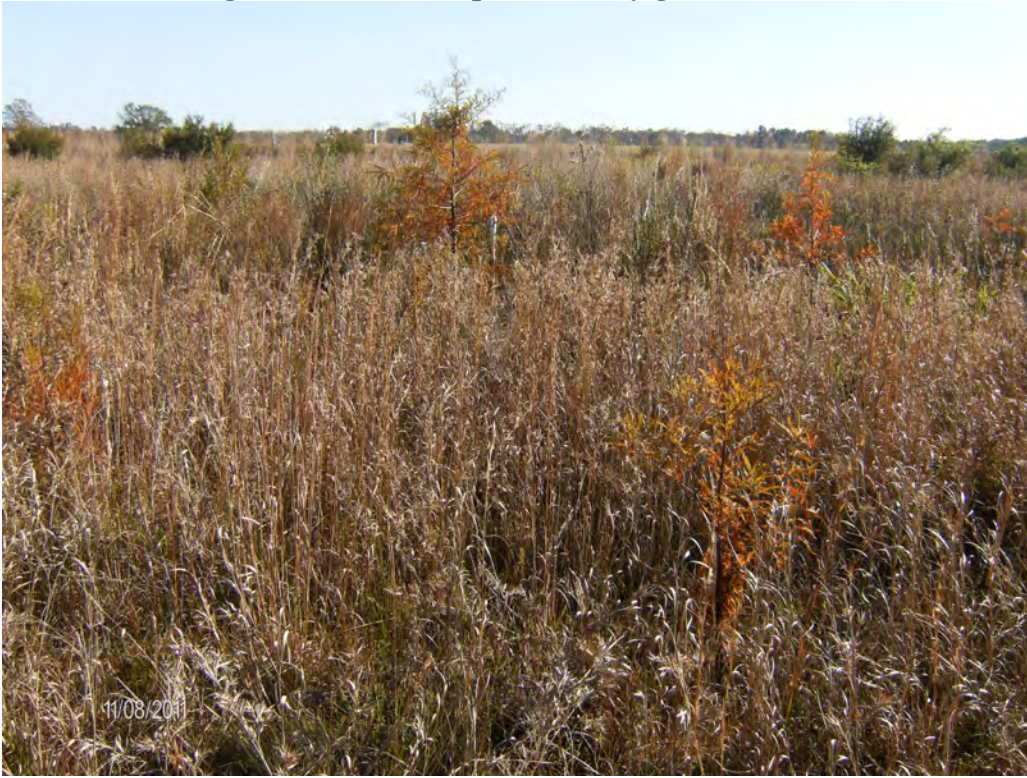
Tree growth at around plot 4 is very good (Nov. 2011)

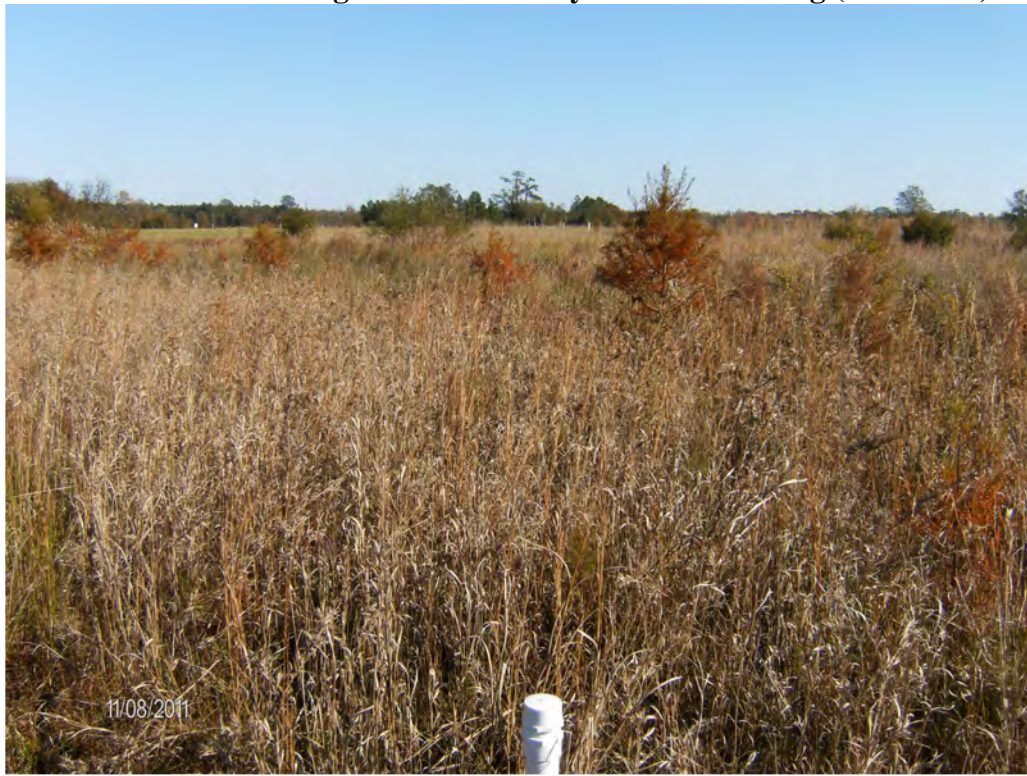
Another view of tree growth in the 3rd year of monitoring (Nov. 2011)

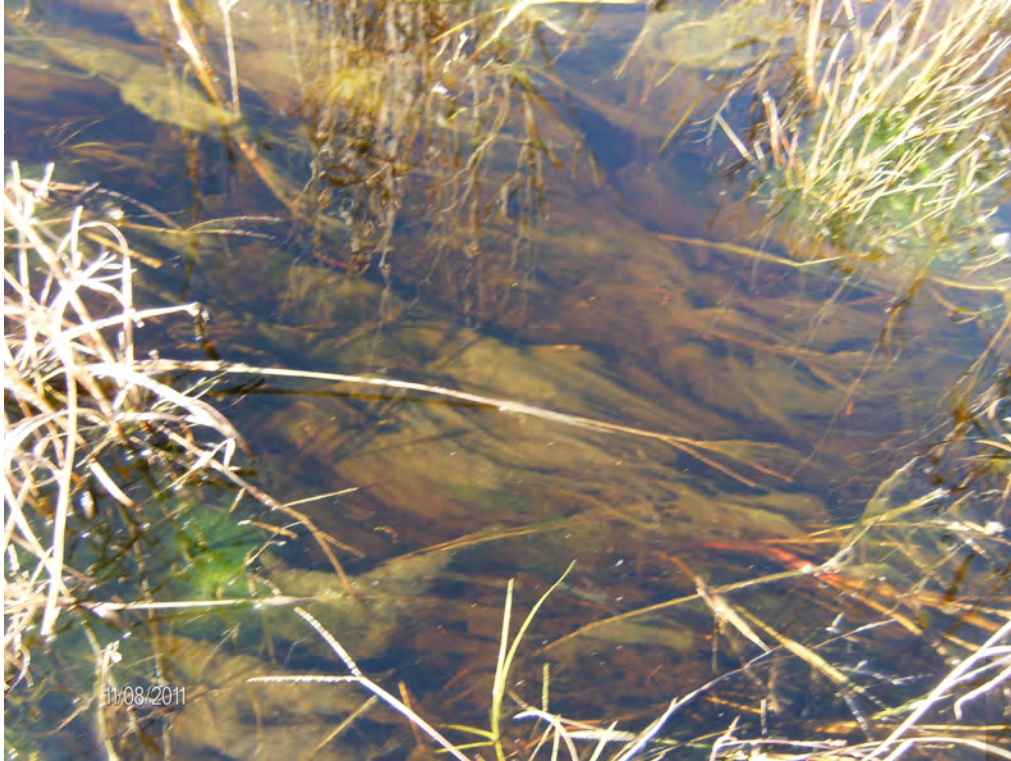
Still shot of flow in November 2011

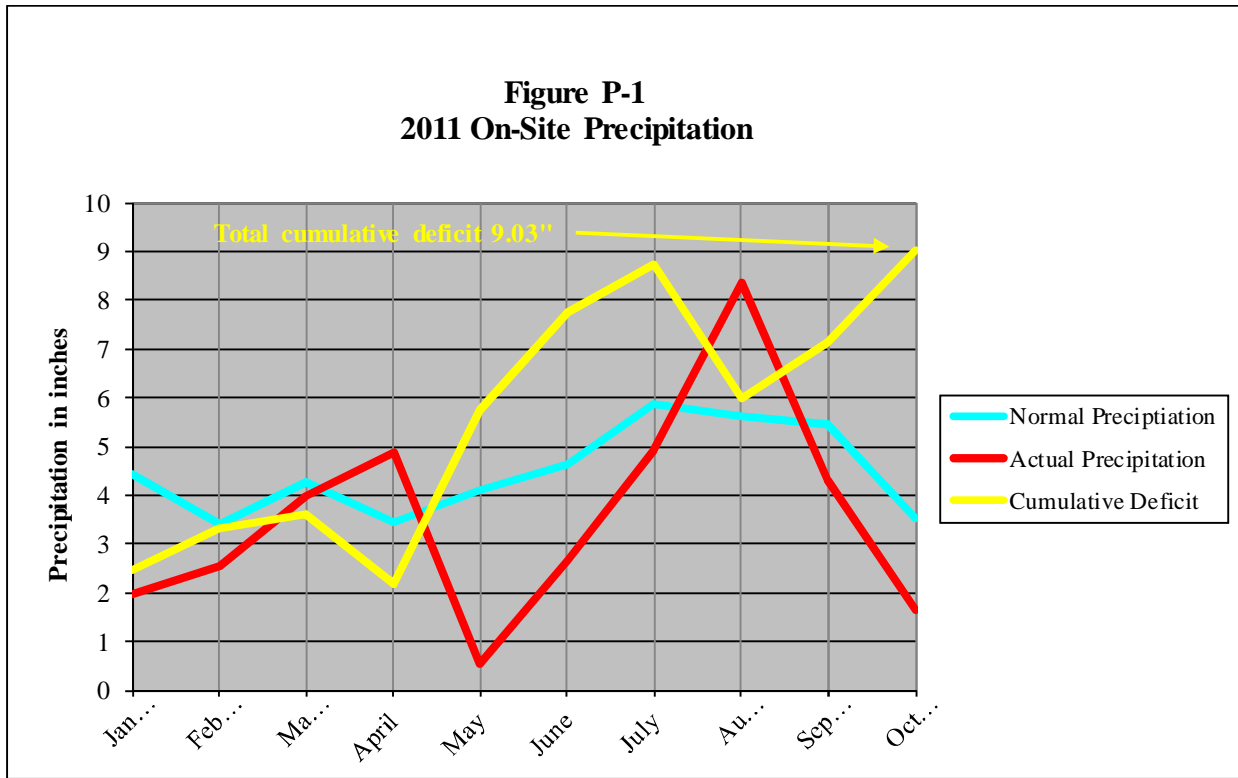
**Figure P-1
2011 On-Site Precipitation**

Accumulated rainfall deficit through October 2011 was 9.03 inches. Total rainfall during the month of May was .52 inches. A total of 8.35 inches fell in August due to Hurricane Irene but that was not enough to correct the total deficit.

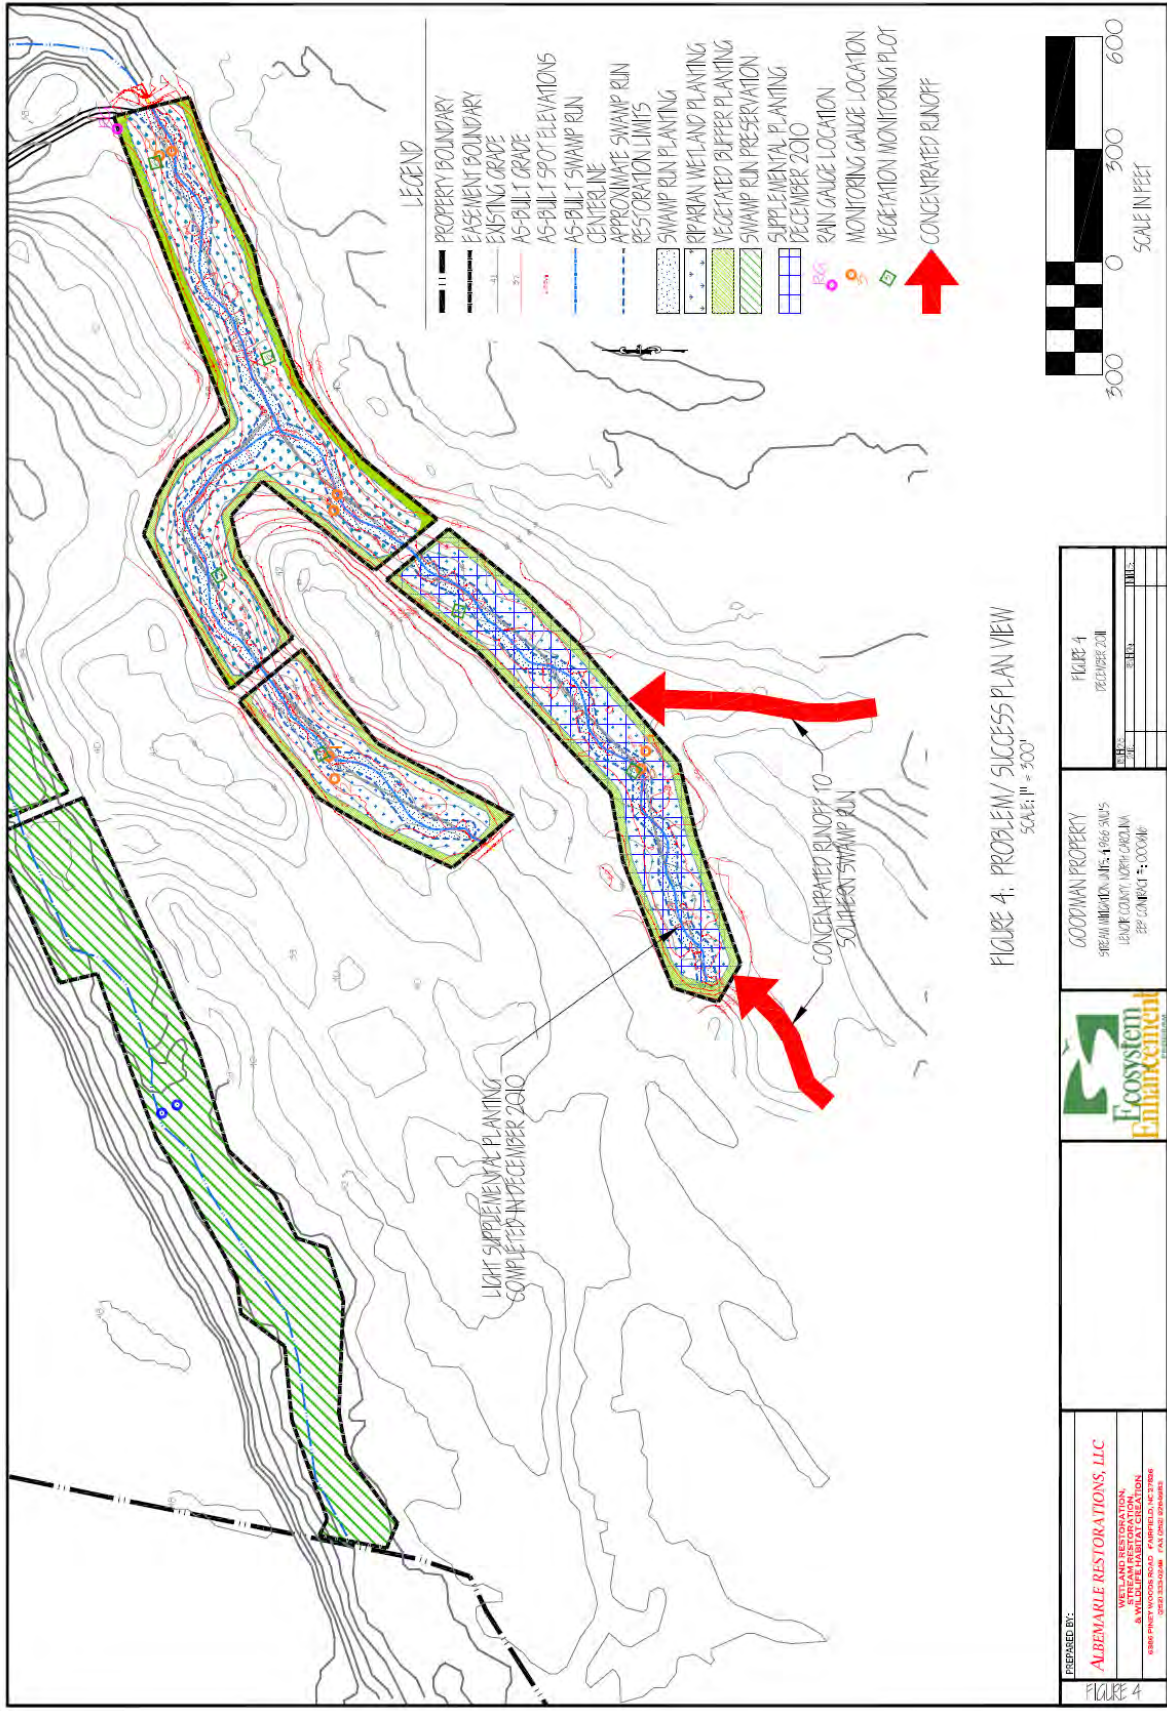
FIGURE 4
DECEMBER 2011
DATE:
BY:
REV:

The area of the project around plot 3 continues to be fed by runoff from the adjoining agricultural field in at least two locations. In fact, water flowing into the project from the southern field has actually carved a small lateral channel through the project. Given the heavy herbaceous cover along the southern branch, this portion of the project is providing a necessary buffer to any runoff from the field. The Plan View in Appendix D gives some indication as to the areas where runoff from the field enters the project.

Figure 4 in Appendix D provides an overview of the watershed success of the project. The northern branch is directly connected to an existing, functioning swamp run upstream, but the southern branch relies solely on rainfall and field drainage. Drainage from the field into the southern branch has been noted in at least two different locations in monitoring years 2 and 3 as shown on the Plan View.
