**Goodman Property Stream Restoration Project  
Lenoir County, NC**

**2012 Annual Monitoring Report  
Year 4**

**NCEEP Project Number D000616  
Neuse River Basin**

Date: December, 2012

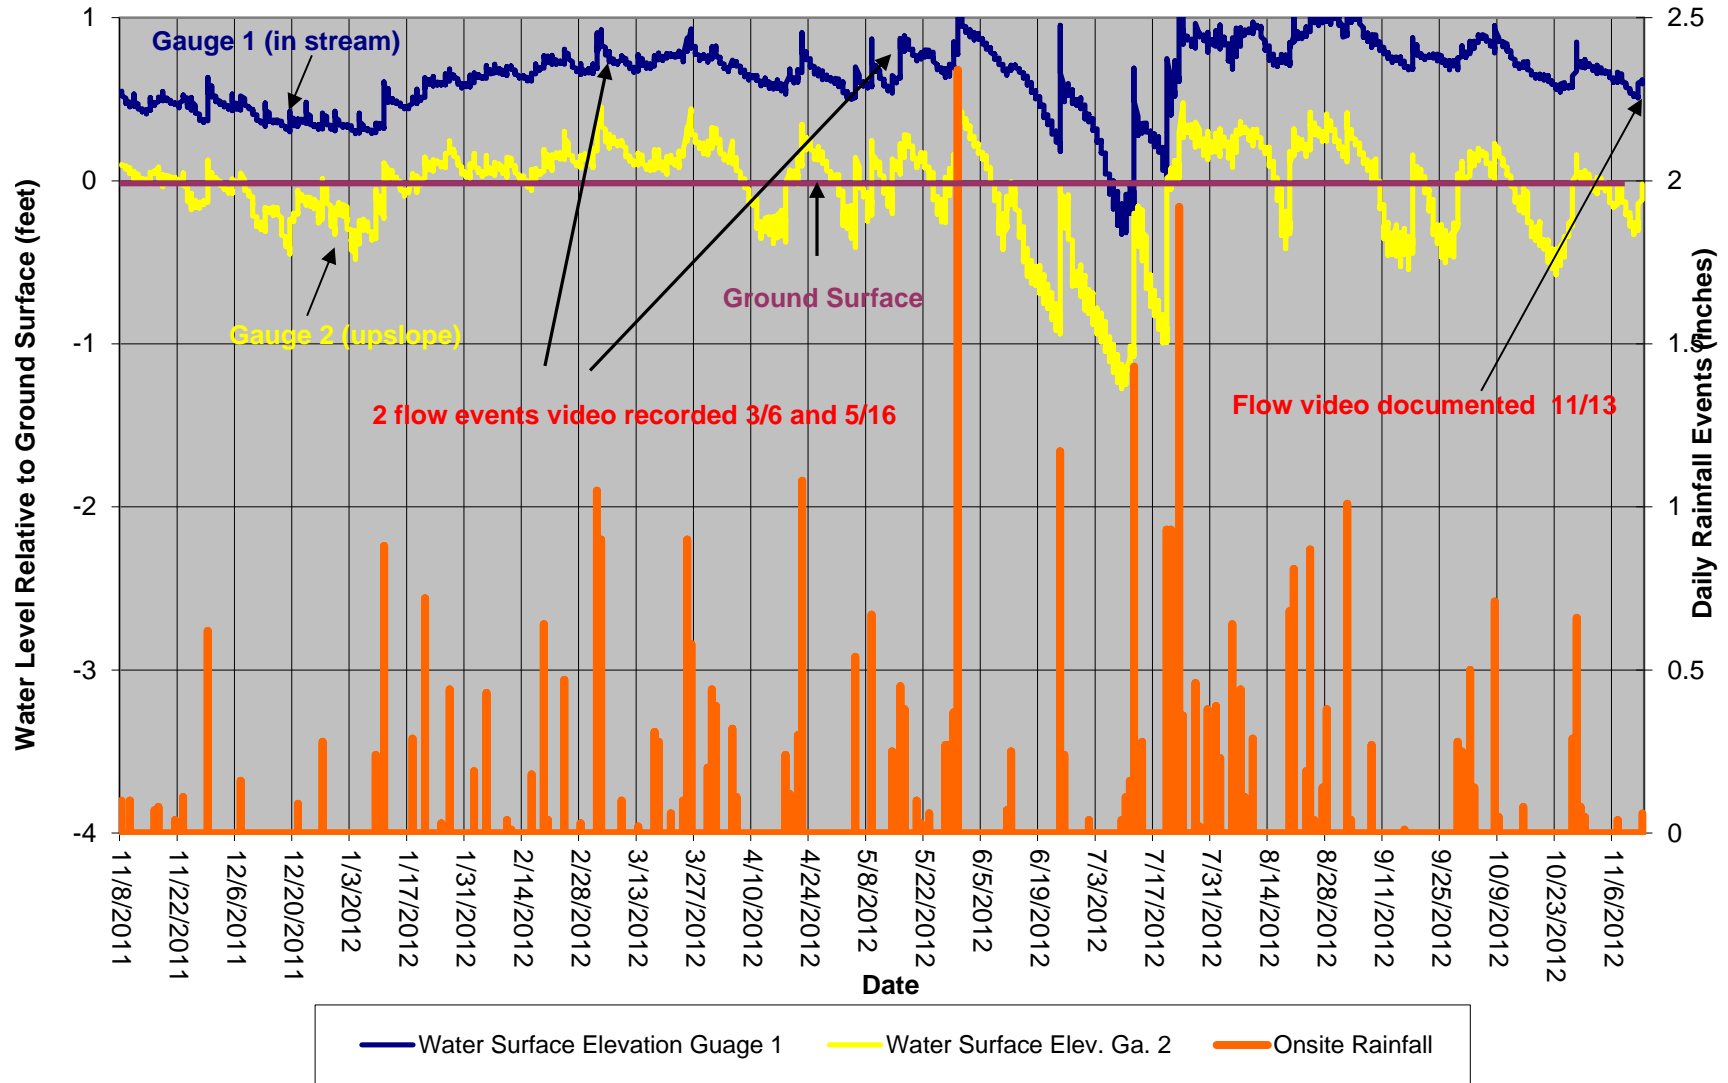
Each of the four pairs of gauges in the project area indicates prolonged, continuous flow during nearly the entire data collection period from Nov. 8, 2011 through November 13, 2012. On three separate occasions, March 6, May 16 and November 13, 2012, flow was video documented on site. The videos are included on the CD accompanying this report and show good flow throughout the entire project.

**Figure F1.**  
**Goodman Monitoring Gauges #1 and #2**  
 Gauge #1 is located in the stream channel. Gauge #2 is located up slope out of the channel.

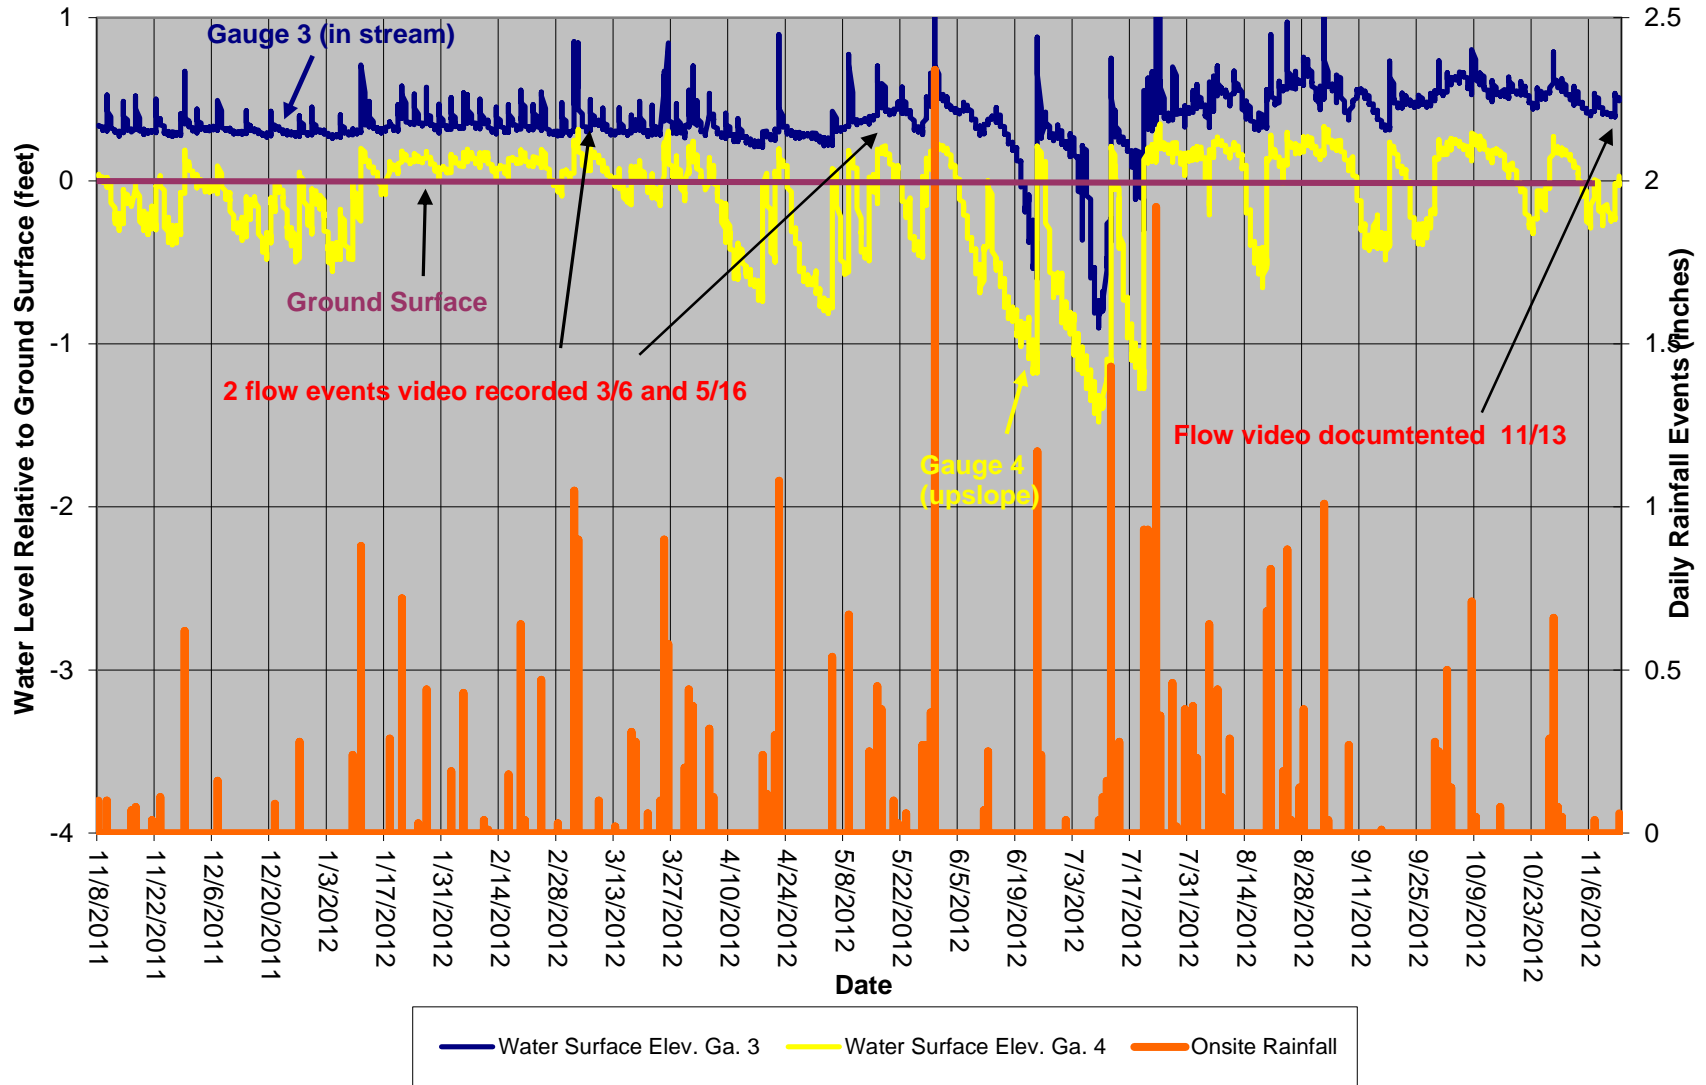
**Figure F2.**  
**Goodman Monitoring Gauges #3 and #4**  
 Gauge #3 is located in the stream channel. Gauge #4 is located up slope out of the channel.

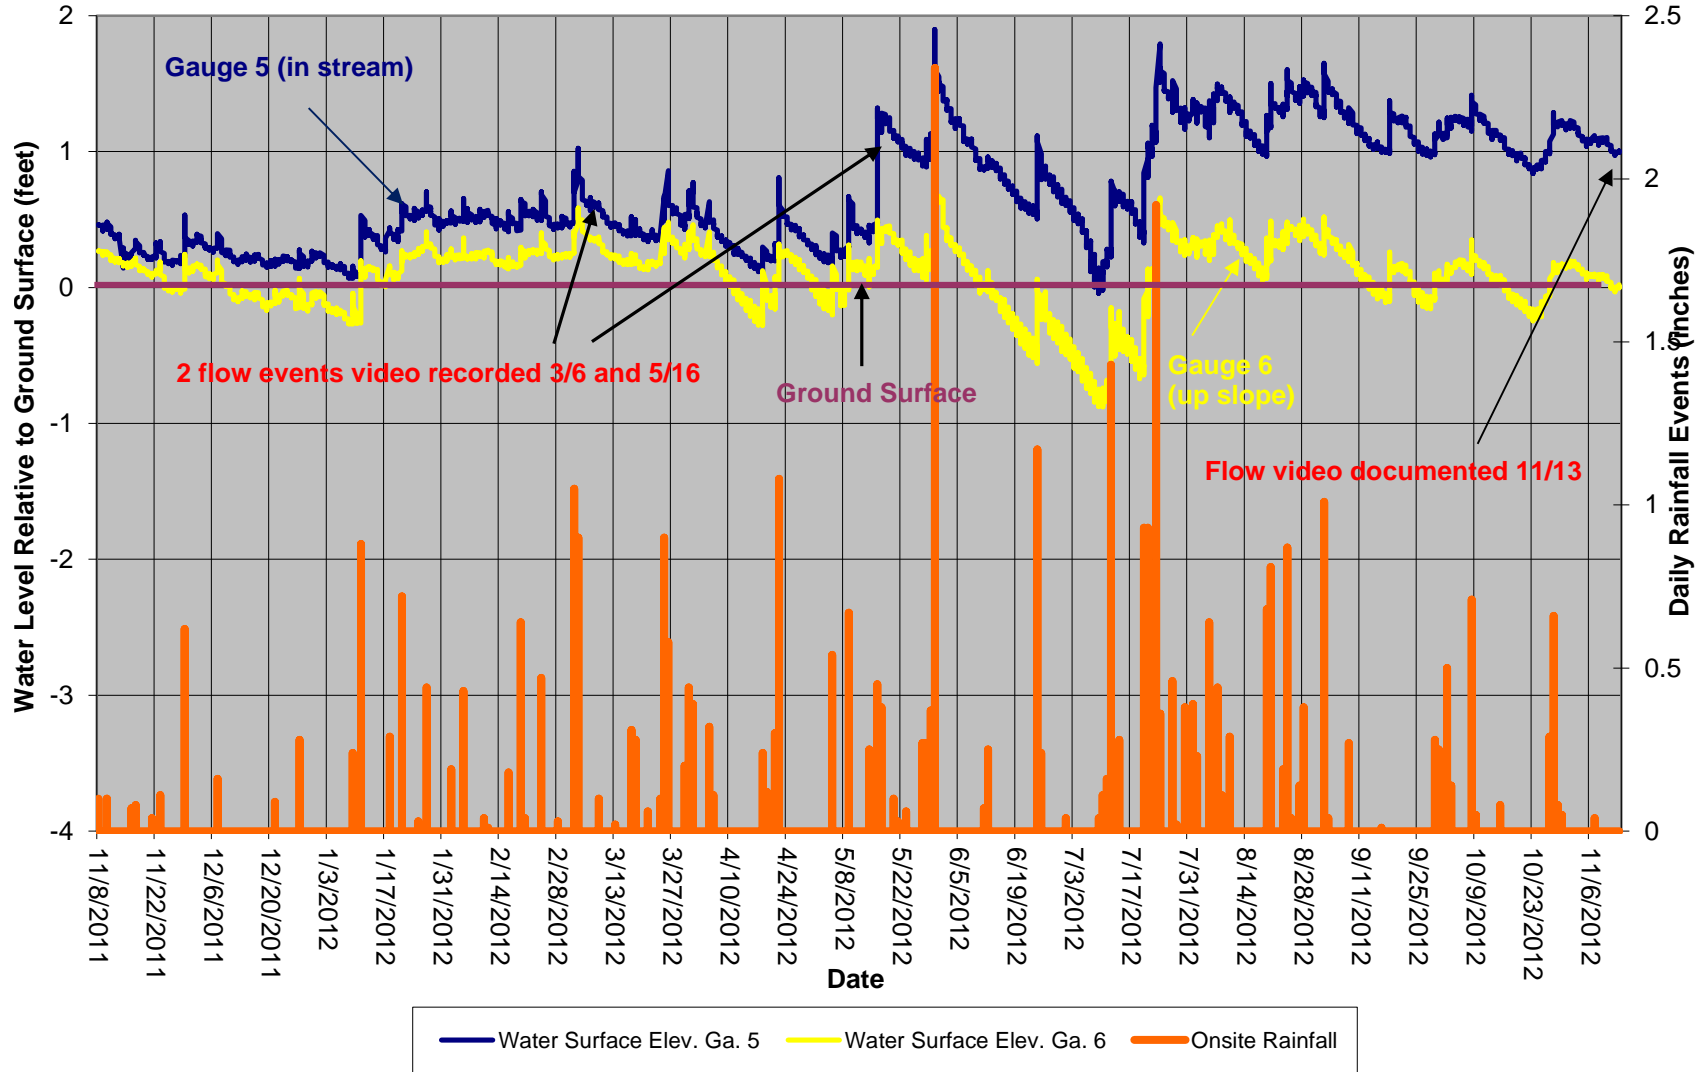
**Figure F3.**  
**Goodman Monitoring Gauges #5 and #6**  
 Gauge #5 is located in the stream channel. Gauge #6 is located up slope out of the channel.

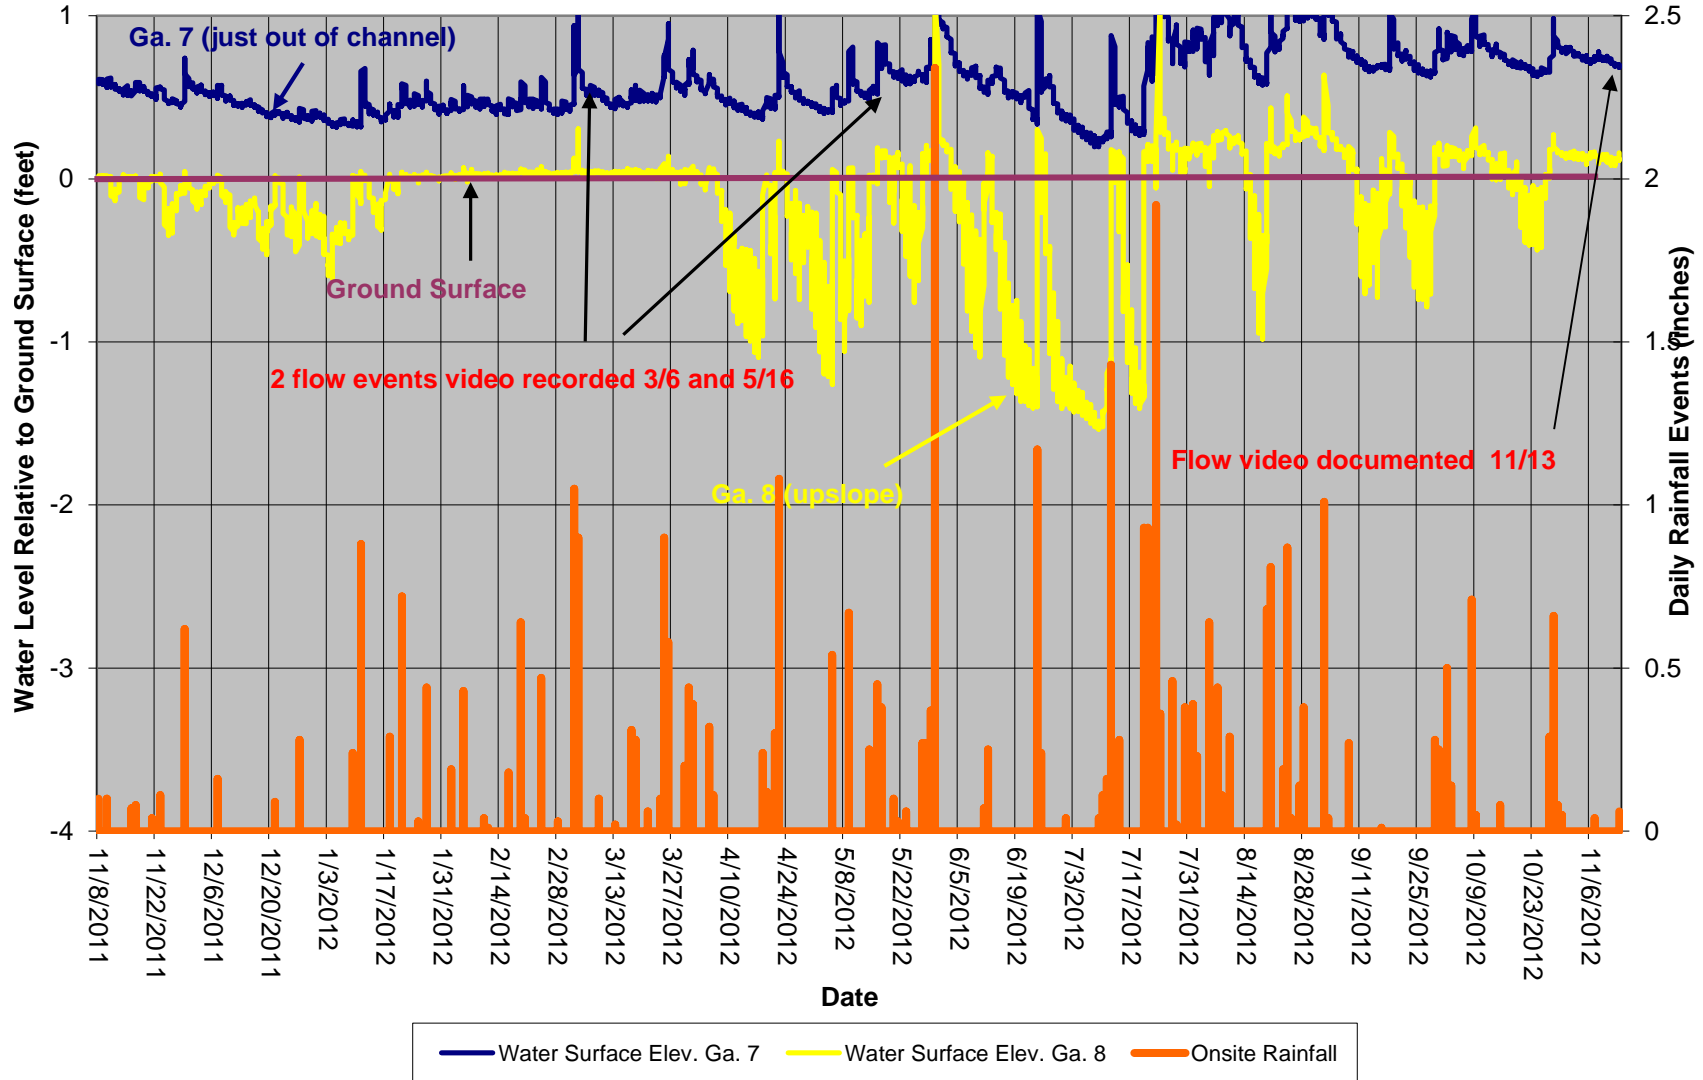
**Figure F4.**  
**Goodman Monitoring Gauges #7 and #8**  
 Gauge #7 is located just out of the channel. Gauge #8 is located upslope from the stream channel.

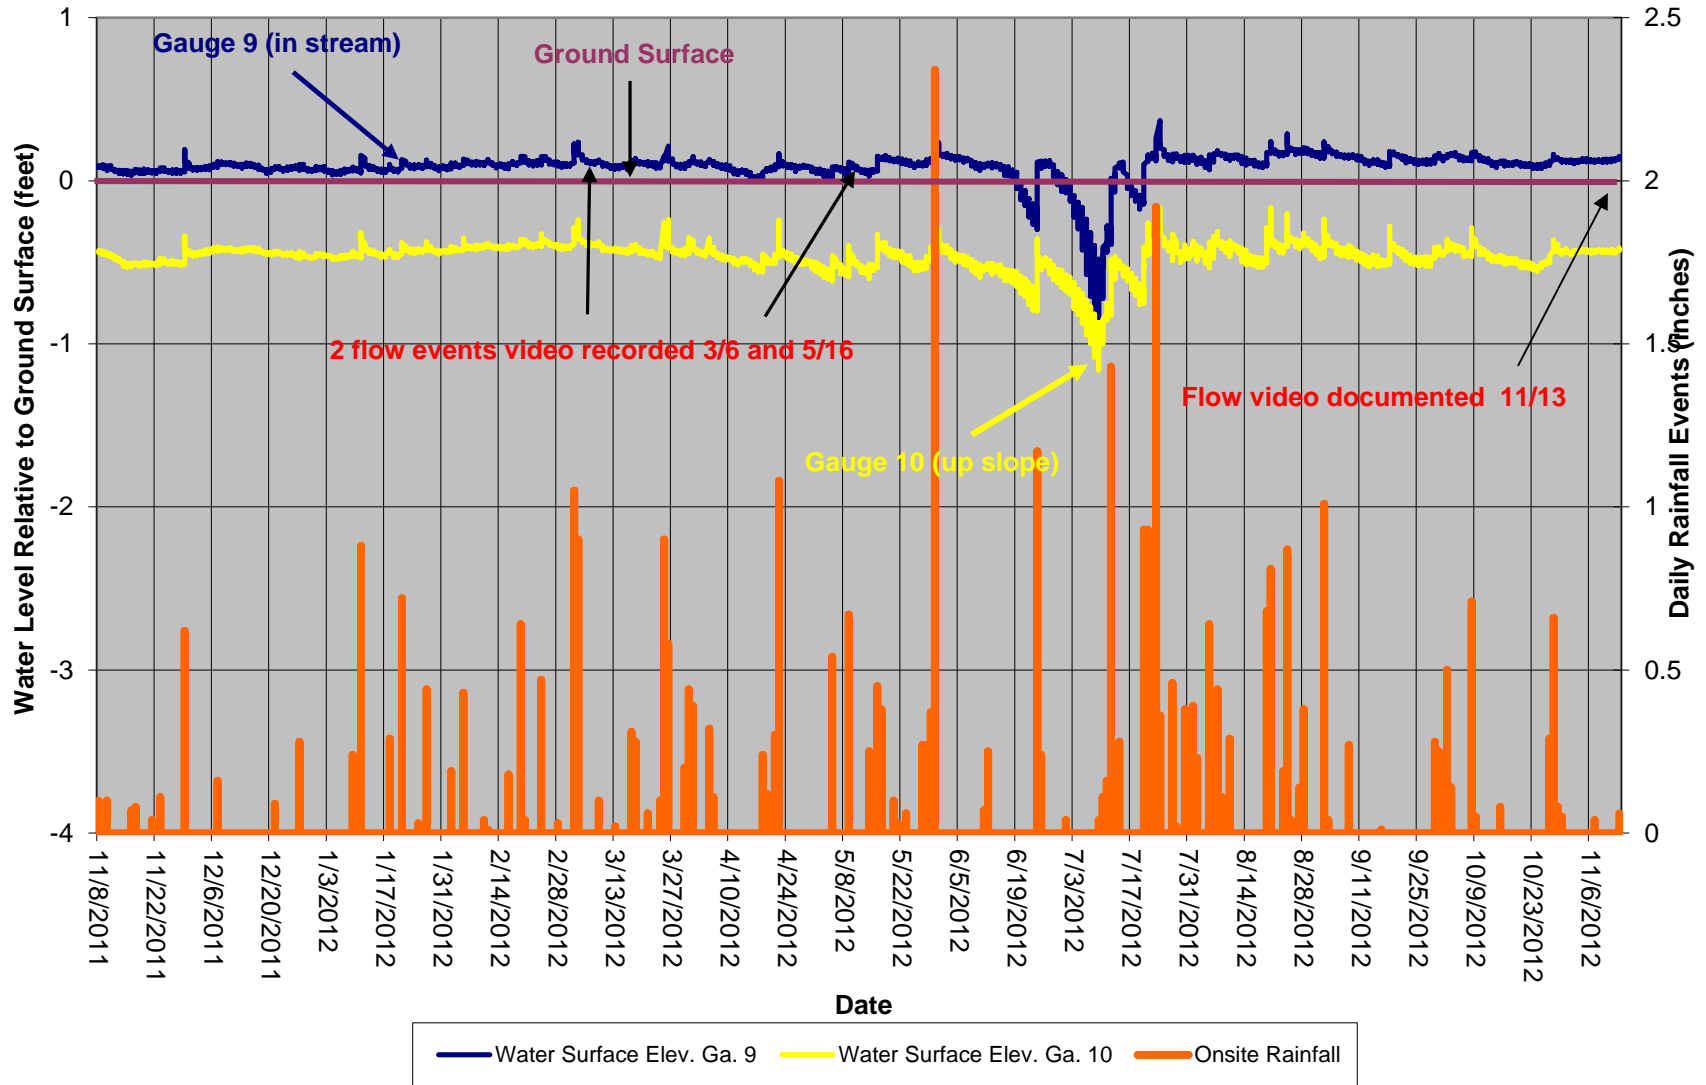
After four years of monitoring, it has become readily apparent that the southern branch of the project mirrors the reference site in duration of flow, showing sometimes shorter periods of flow or water depths that more closely approximate those in the reference area. The southern branch is fed strictly by rainfall and runoff from the adjacent field, while the northern branch is stream fed. A comparison of the flow patterns found in Figures F2 and F5 will illustrate this point. Since the northern branch of the project is stream fed, it should be expected to mirror the reference area, but in fact it shows better flow patterns than the reference area.

**Figure F5.**  
**Goodman Monitoring Reference Gauges #9 and #10**  
 Gauge #9 is located in the stream channel. Gauge #10 is located up slope out of the channel.

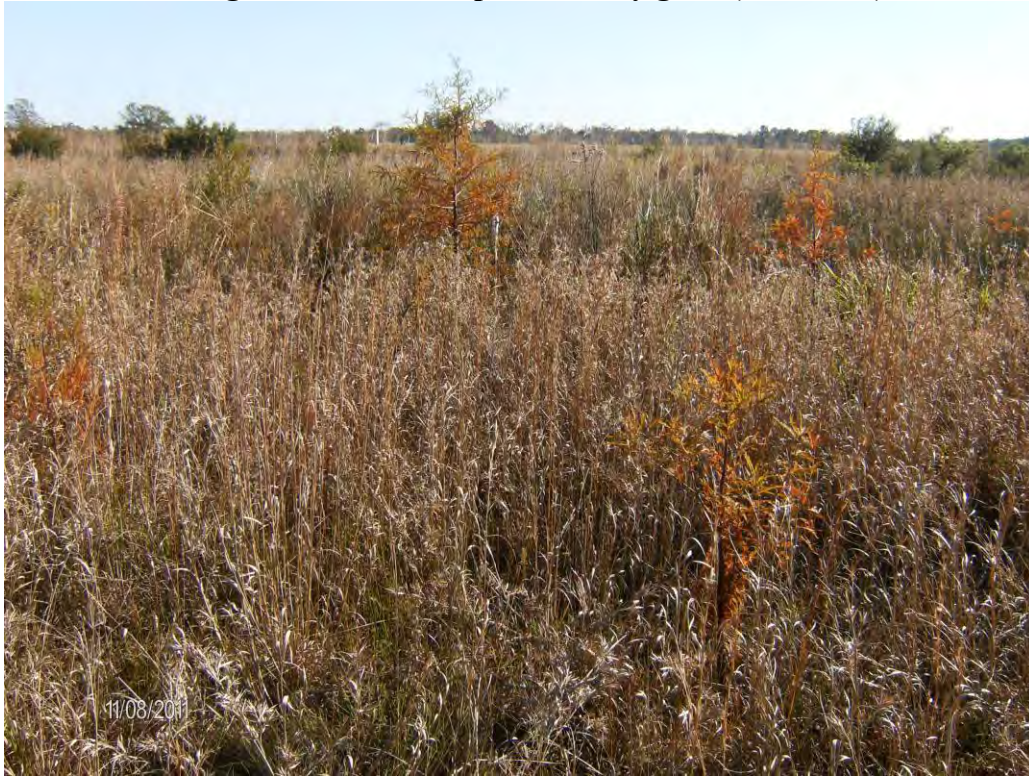
**Tree growth at around plot 4 is very good (Nov. 2011)**

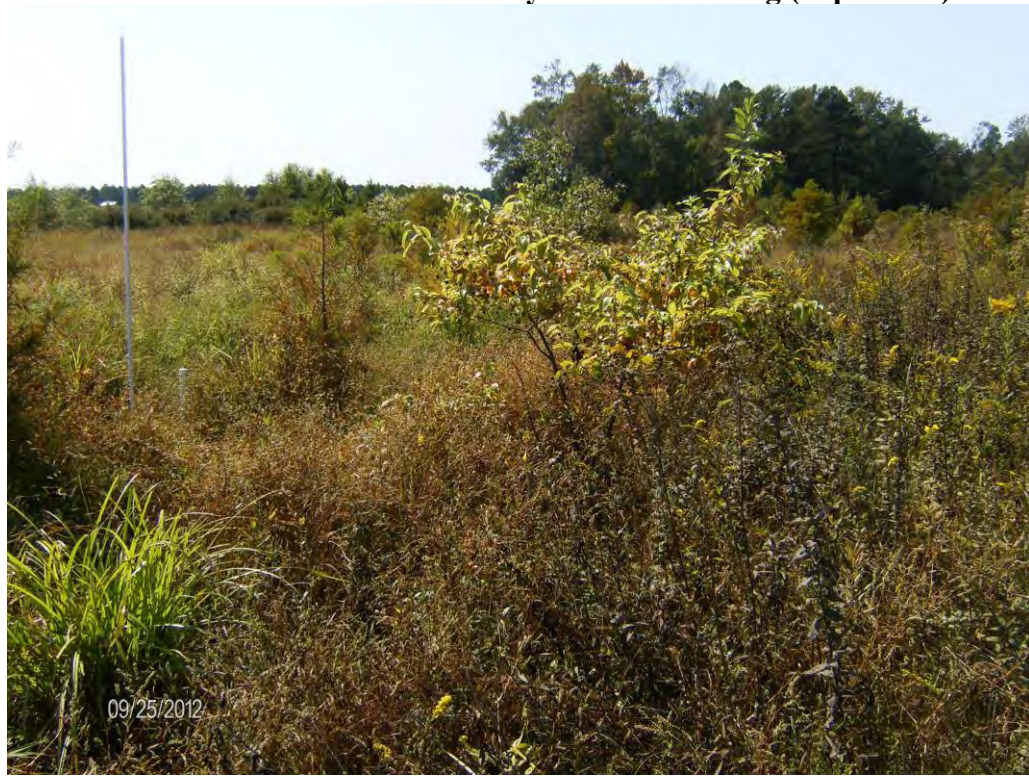
**View of the same area in the 4<sup>th</sup> year of monitoring (Sept. 2012)**

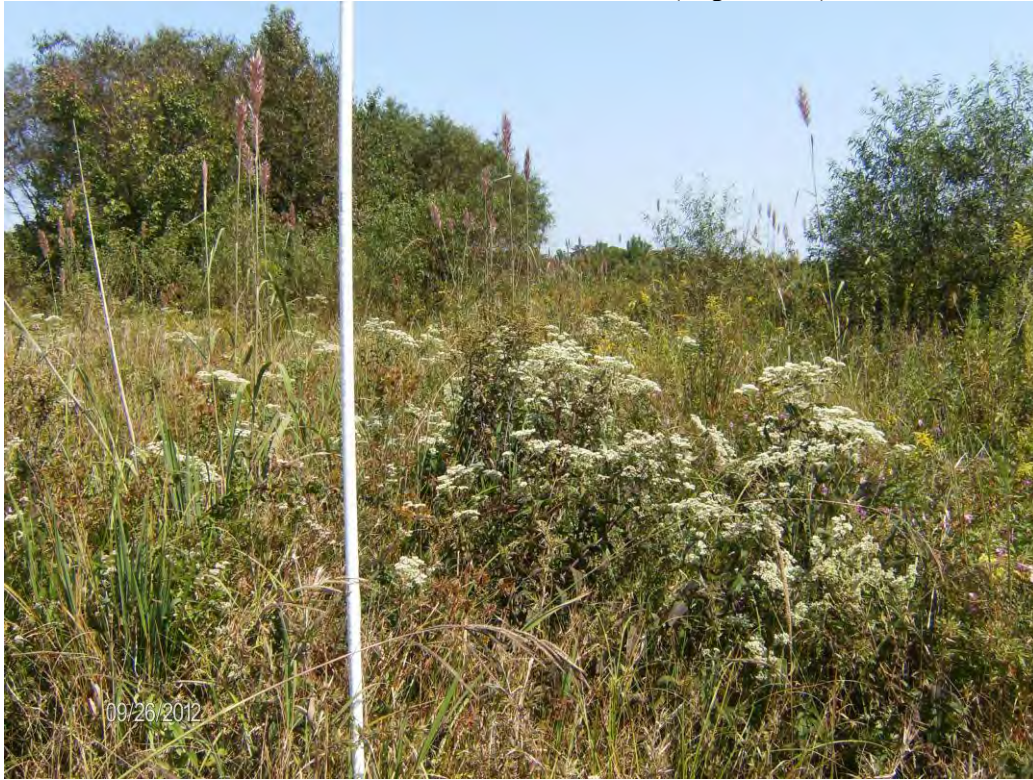
The survival rate on plot 5 continues to be slightly less than that on the remaining plots but it remains above the minimum number of stems allowed at year 5 (289 actual vs. 260 required). Due to the proximity of plot 5 to the stream channel, this plot rarely suffers from a lack of moisture. As a result, the herbaceous vegetation here is extremely dense. Trees on this plot were very difficult to locate during the survival checks in 2011 and again in 2012 and it is entirely possible that some stems were missed. Light supplemental planting was done early in 2011 on the portion of the project around plots 3 and 4 to bring the stocking up to adequate levels (greater than 320 stems per acre). The planting consisted of 200 stems each of: *F. pennsylvanica*, *M. cerifera*, *Q. michauxii* and *T. distichum*. As can be seen by the survival rates in 2012, the supplemental planting did adequately correct the problem.

**Dense herbaceous cover at Plot 5 (Sept. 2012)**

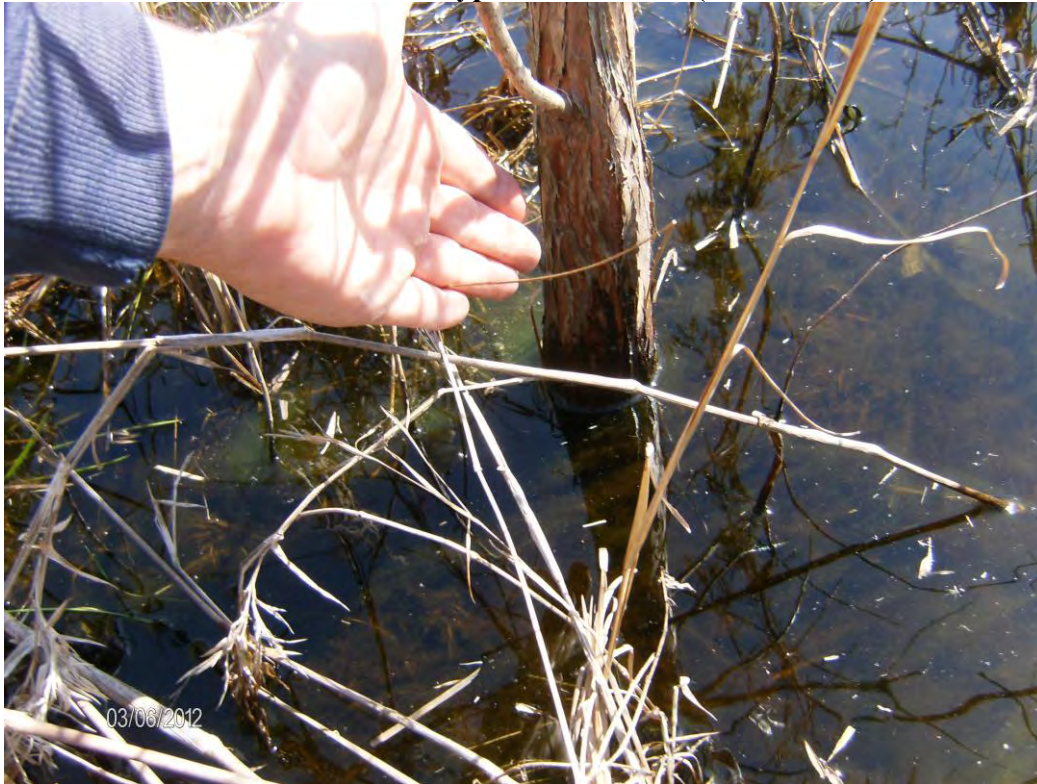
**Stem diameter on a cypress in the run (March 2012)**

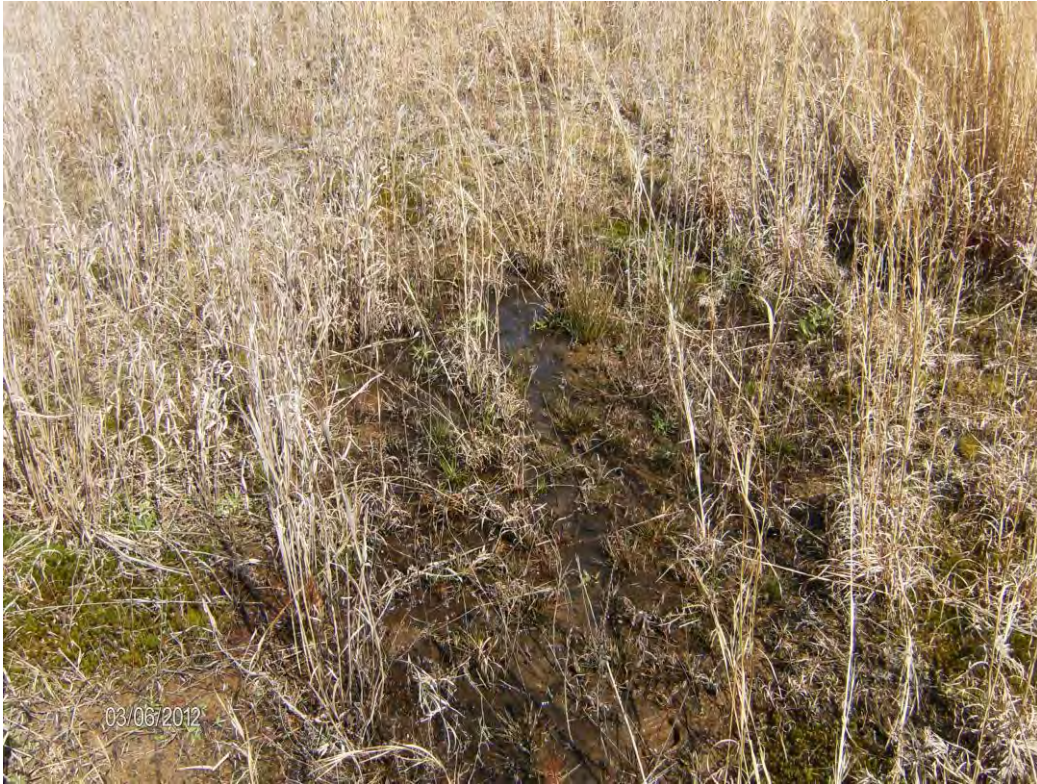
**Headwater terminus of the southern run (March 2012)**

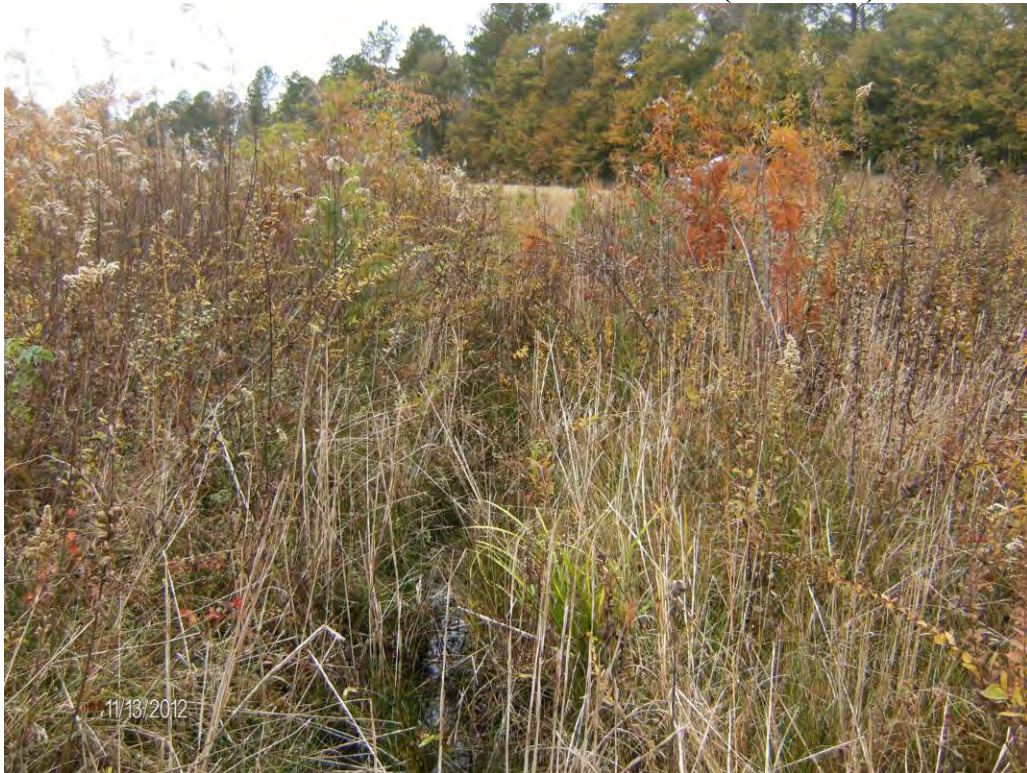
Channel and bank development continue to in 2012 and have become even more pronounced at the end of the fourth year of monitoring especially at the headwater end of the southern run. Additionally, lateral channels are developing where there is enough runoff from the adjacent field to promote it. There are small areas of shelf formation, scouring, minor sediment deposits and lateral channel formation that are all indicators of successful stream development. Nearly the entire lower half of the project supports submerged aquatic vegetation for the majority of the year. The upper half of the project will support it during the wetter months of winter and spring.

**Headwater terminus of the southern run (Nov. 2012)**

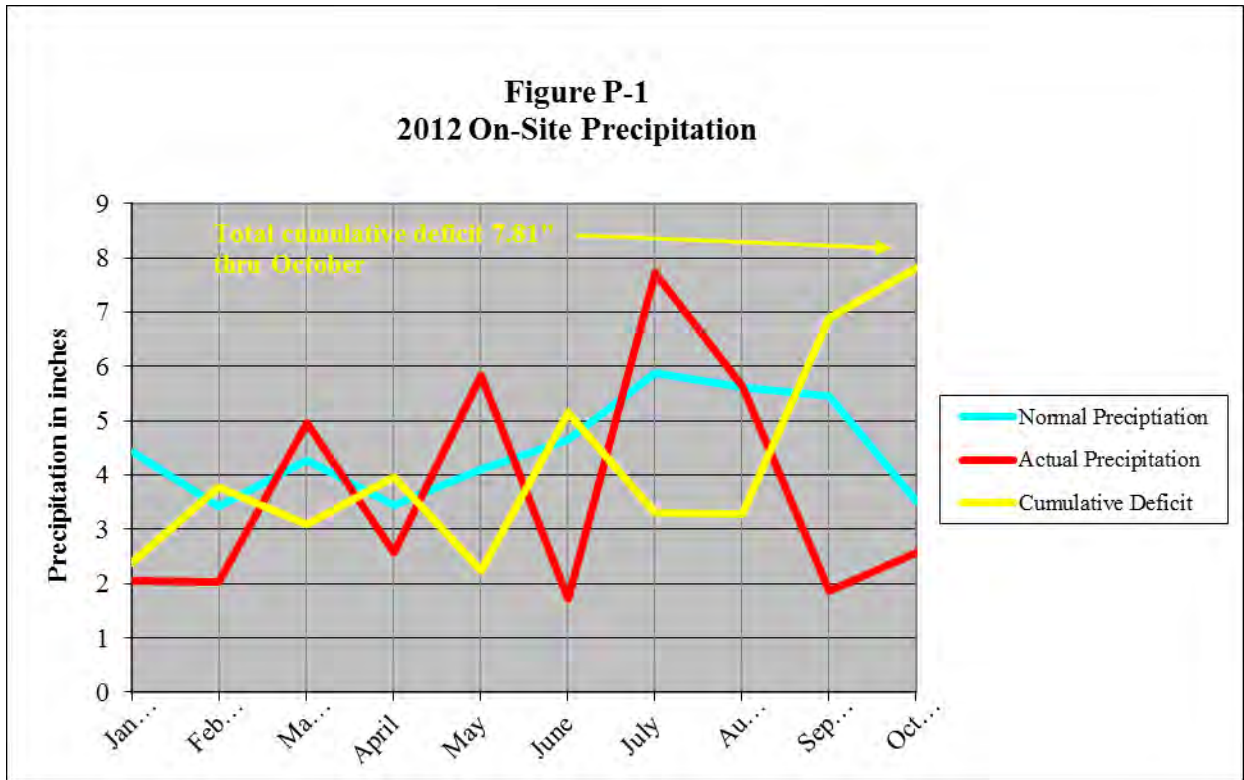
**Figure P-1**  
**2012 On-Site Precipitation**

Accumulated rainfall deficit through October 2012 was 7.81 inches. Due to enough prolonged periods of heavier precipitation, several flow events were observed and recorded during 2012.

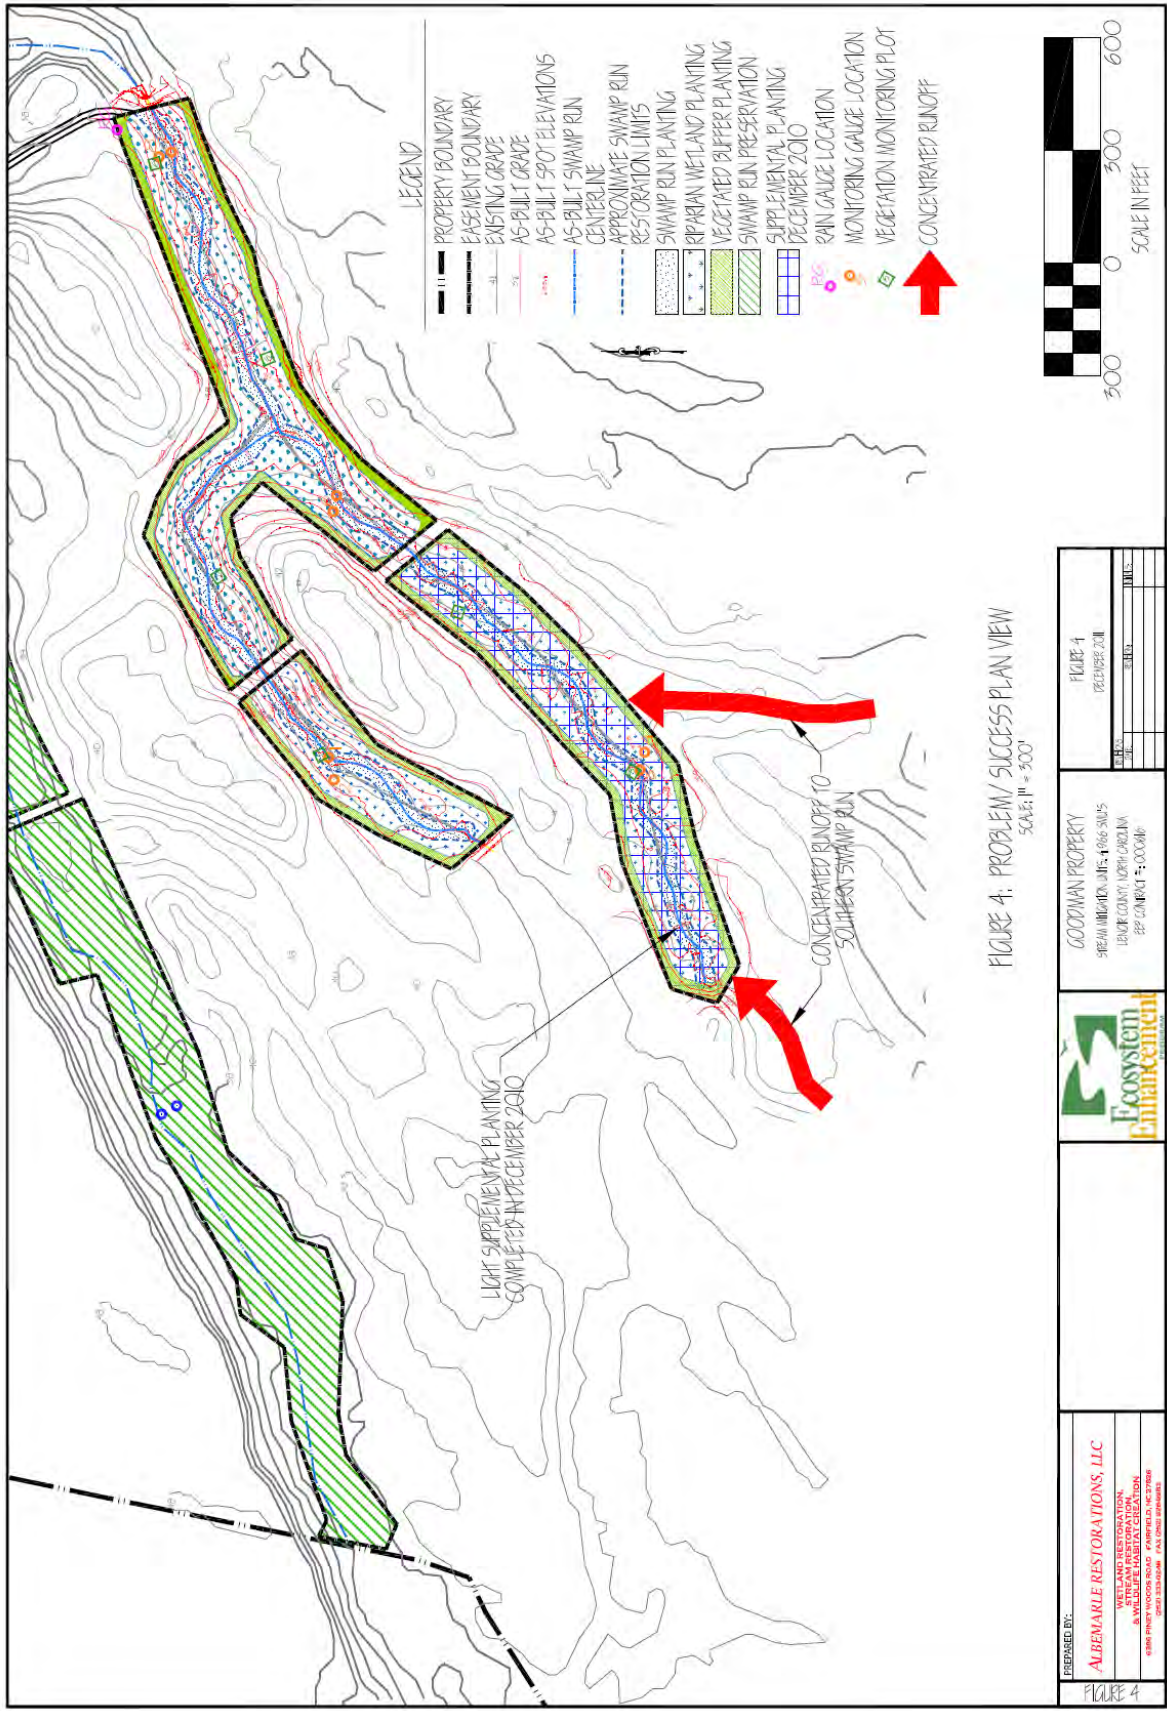
Problems/Success Plan View

The area of the project around plot 3 continues to be fed by runoff from the adjoining agricultural field in at least two locations. In fact, water flowing into the project from the southern field has actually carved a small lateral channel through the project that connects to the main run. Given the heavy herbaceous cover along the southern branch, this portion of the project is providing a necessary buffer to any runoff from the field. The Plan View in Appendix D gives some indication as to the areas where runoff from the field enters the project.

Figure 4 in Appendix D provides an overview of the watershed success of the project. The northern branch is directly connected to an existing, functioning swamp run upstream, but the southern branch relies solely on rainfall and field drainage. Drainage from the field into the southern branch has been noted in at least two different locations as shown on the Plan View.
