Goodman Property Stream Mitigation Project
EEP ID (IMS#) 92761
FDP Contract Number D000616
USACE Action ID # SAW-2008-03188
DWQ Project# 08-1647

CLOSEOUT REPORT

STREAM

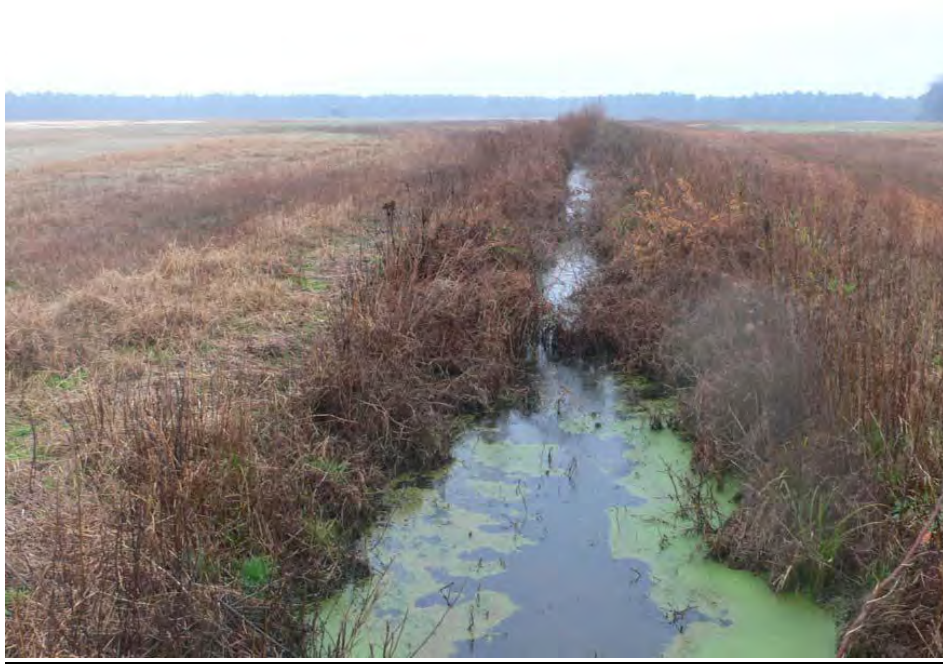
Ditched stream draining the cropland prior to swamp run restoration.

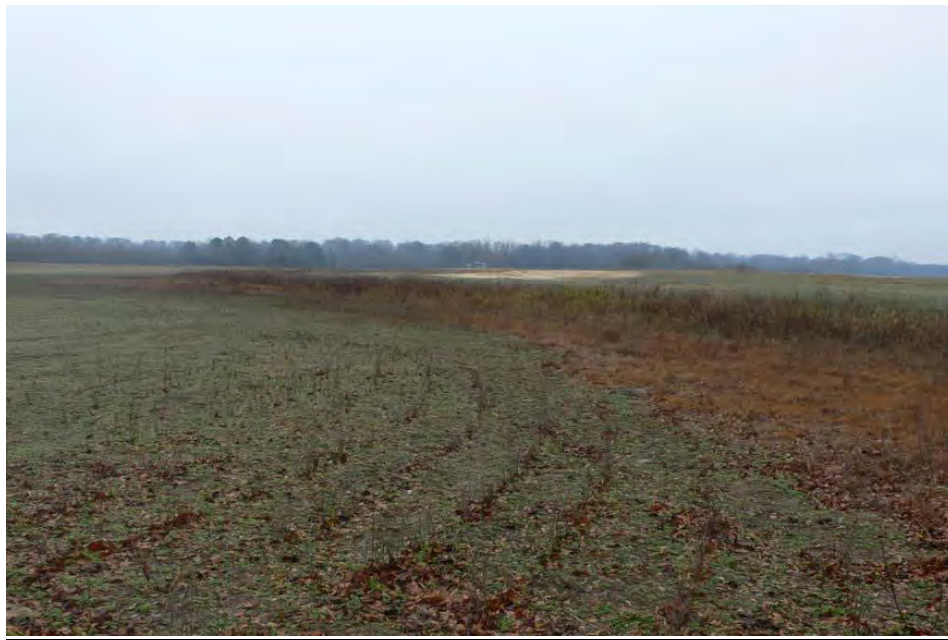
View of the valley showing “hook” tributary or the center tributary prior to swamp run restoration.

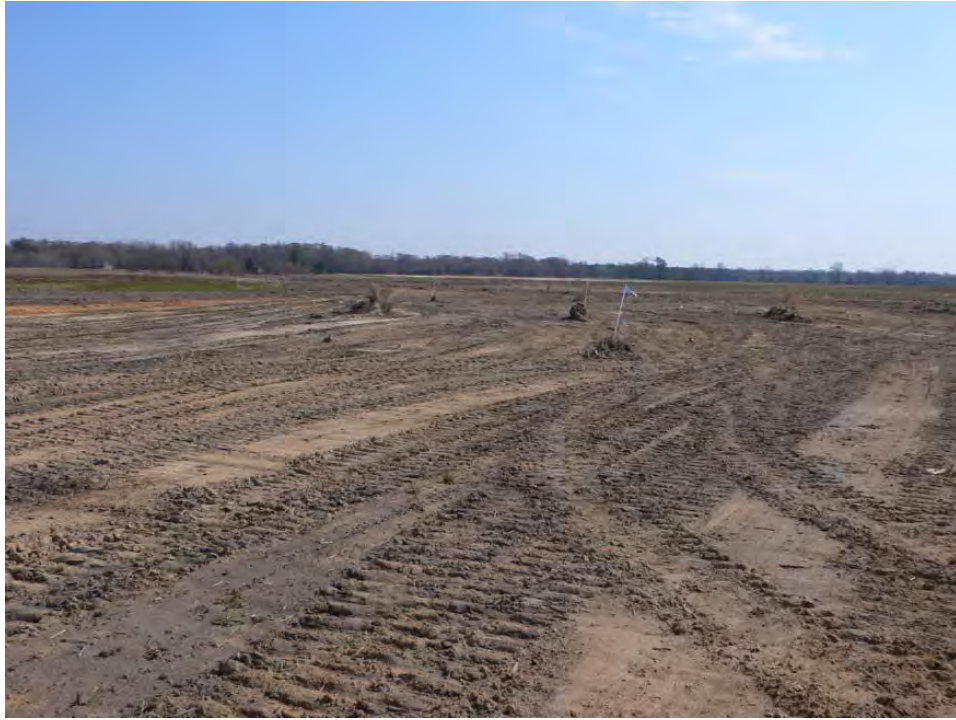
Graded Swamp Run

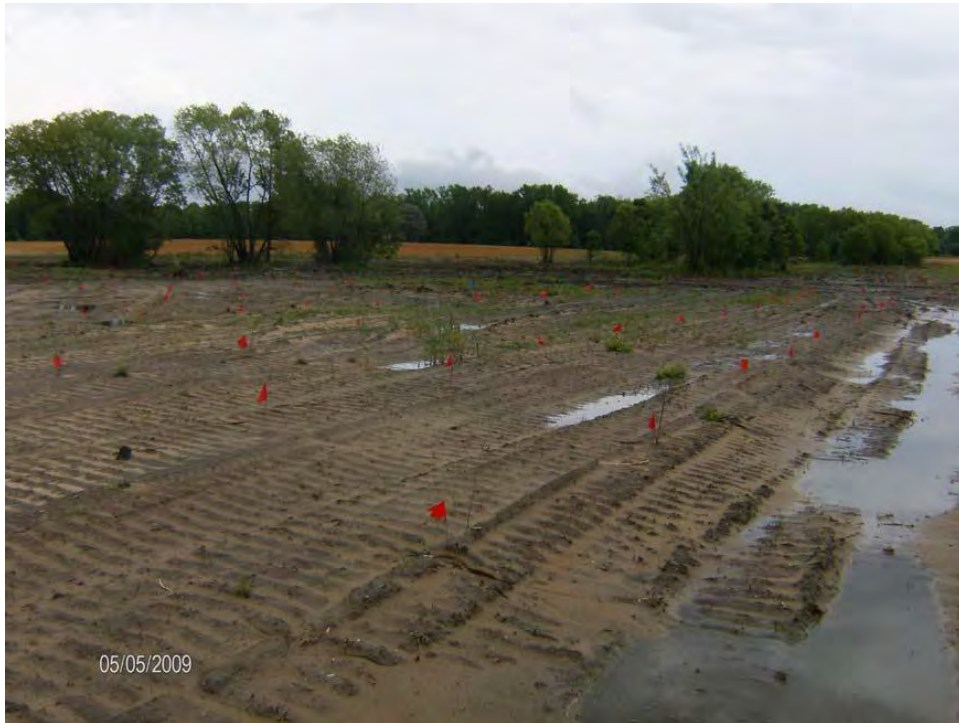
Confluence of swamp runs. Natural stand of willows left intact.

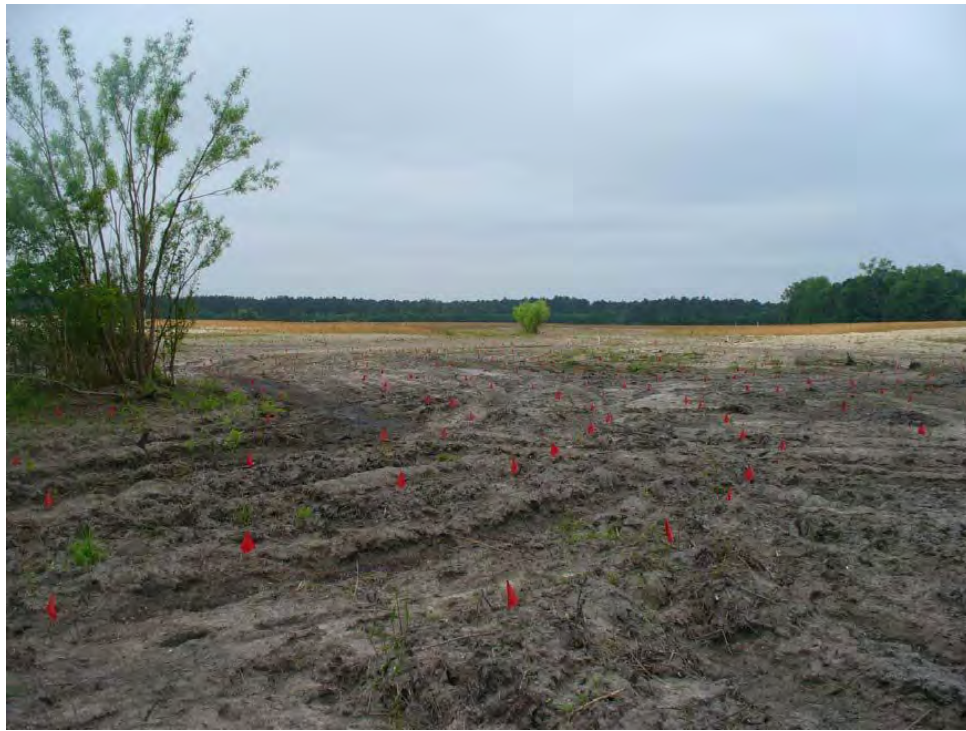
Facing upstream in the restored northern swamp run.

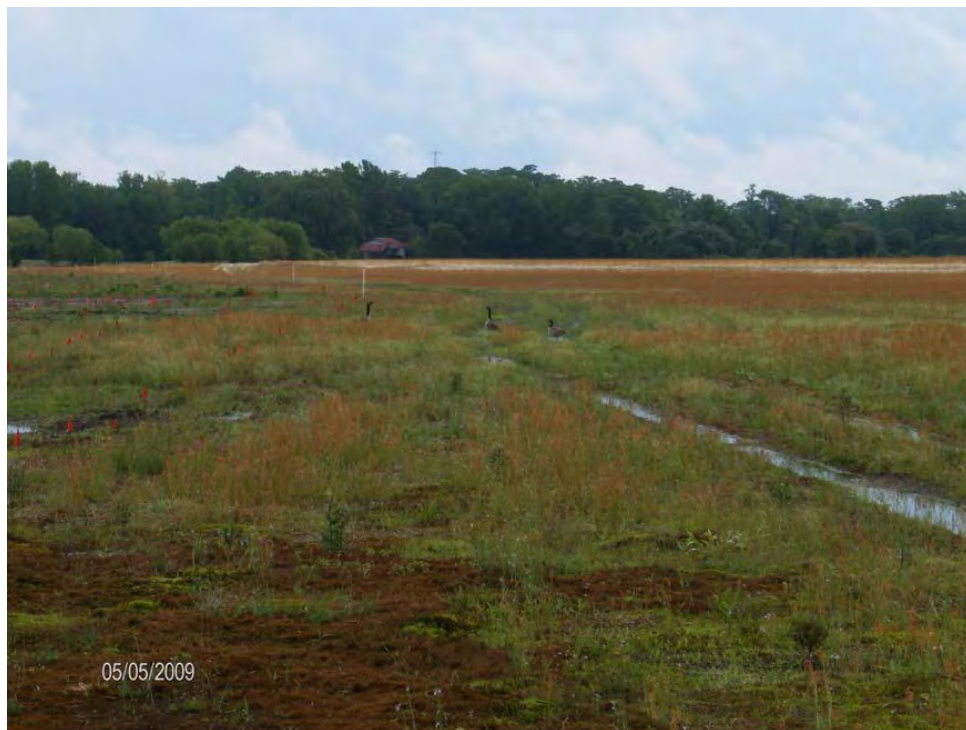
Looking downstream in the northern restored swamp run one month post-construction.

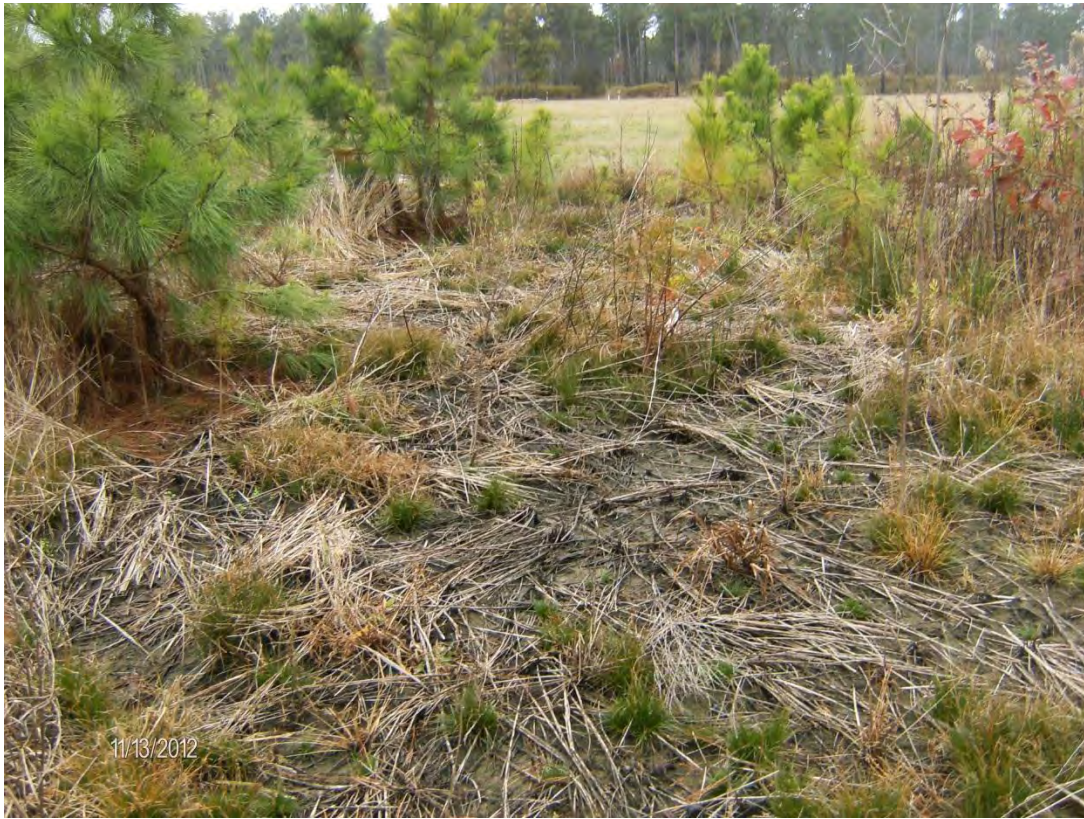
Debris deposition cause by rainfall flood event in November 2013 at headwater end of South Swamp Run.

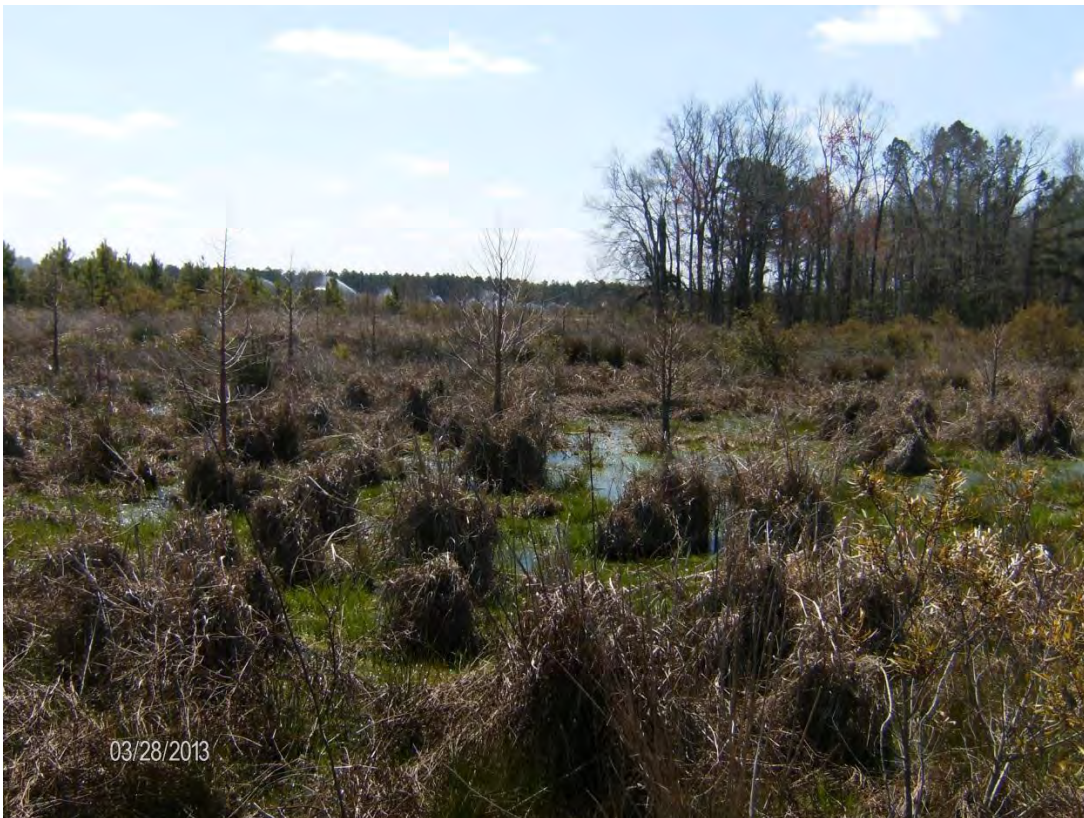
Photo from March 2013 showing extend of flooding during a flow event in the North Swamp Run.
