Mitigation Plan and As-built Baseline Report
9/25/09

Goose Creek Stream Restoration Project

EEP Project #147
SCO No. 04-06298-01
DENR No. D05035S
Durham County
Data Collection: September 15, 2008-May 27, 2009

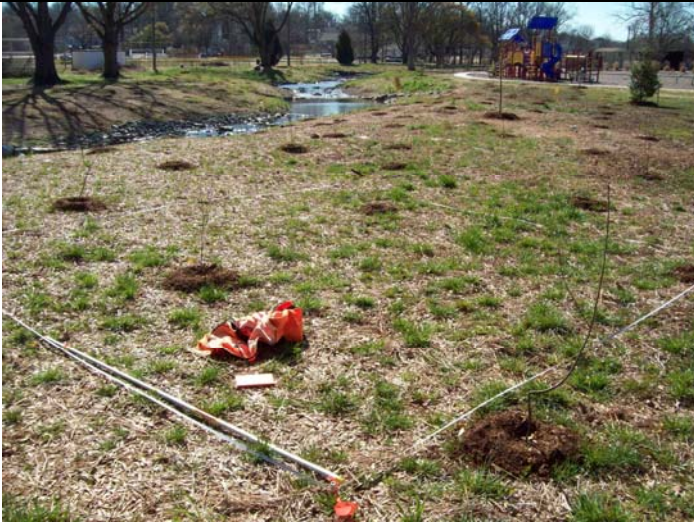
Plot 1, Longmeadow reach, downstream, left bank.

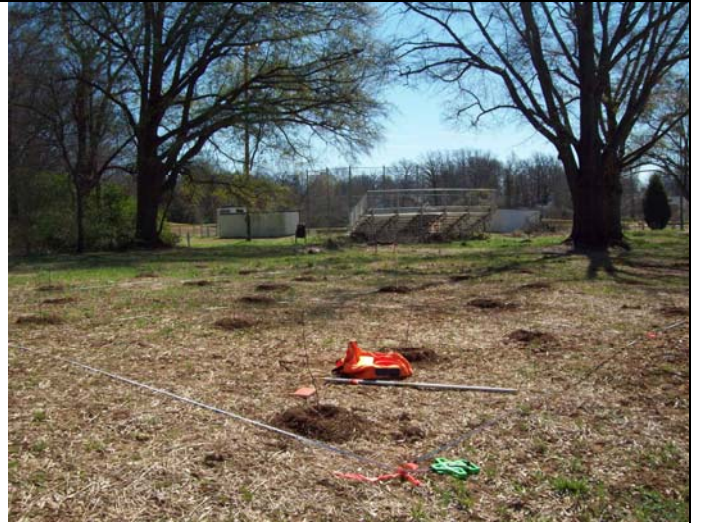
Plot 2, Longmeadow reach, downstream, right bank.

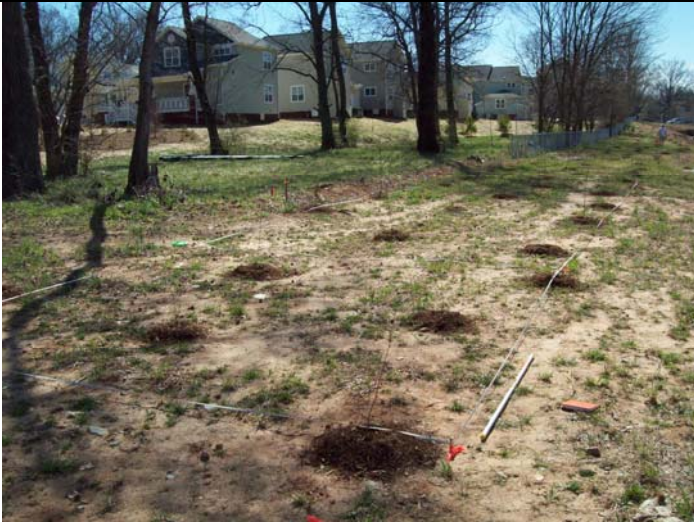
Plot 3, Eastway reach, downstream, right bank.

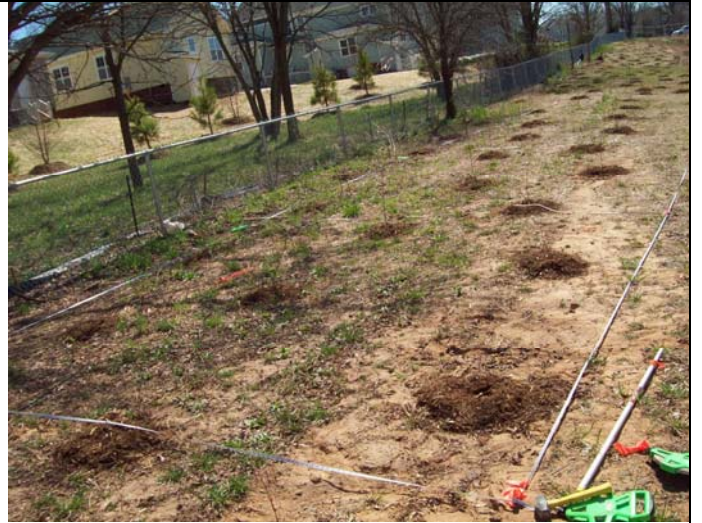
Plot 4, Eastway reach, upstream, right bank.
