ANNUAL MONITORING REPORT GOOSE CREEK

STREAM RESTORATION
DURHAM COUNTY, NORTH CAROLINA
(EEP Project Number 147)

Monitoring Year 1 of 5 (2009)

Axiom Environmental, Inc.
20 Enterprise Street, Suite 7
Raleigh, North Carolina 27607

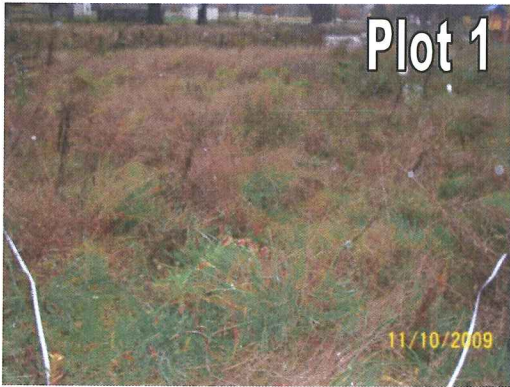
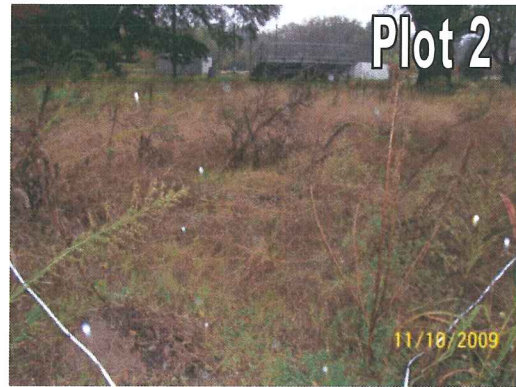
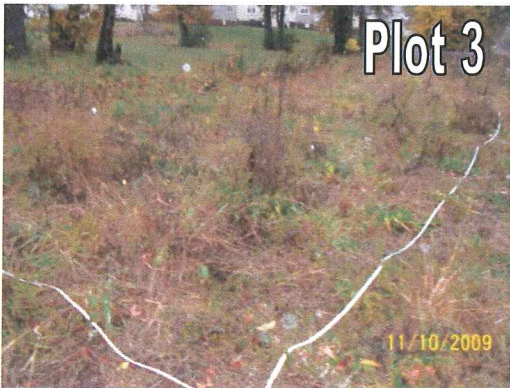
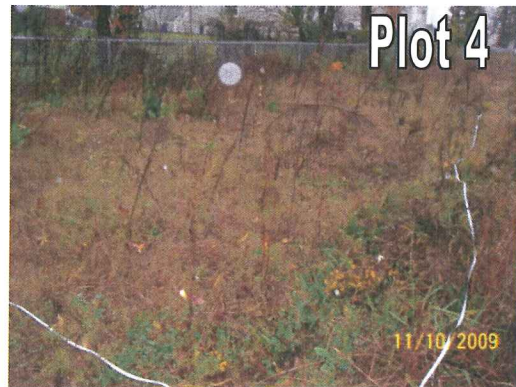
**Goose Creek Restoration Site
Year 1 (2009) Annual Monitoring
Vegetation Plot Photos (taken November 2009)**

Vegetation Plot ID	Vegetation Survival Threshold Met?	Tract Mean
1	Yes	100%
2	No	
3	Yes	
4	Yes

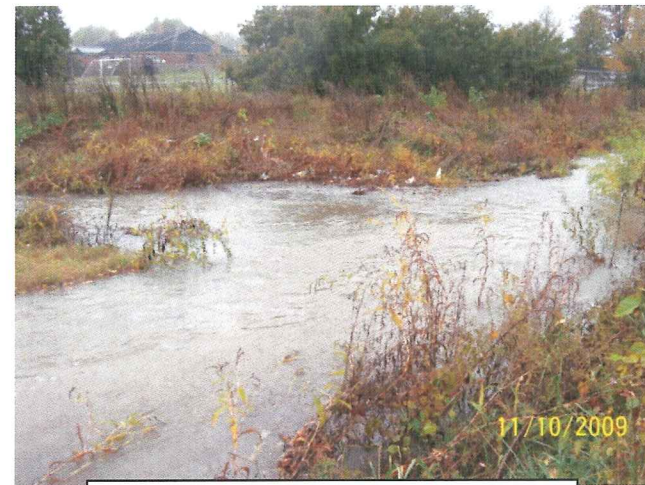
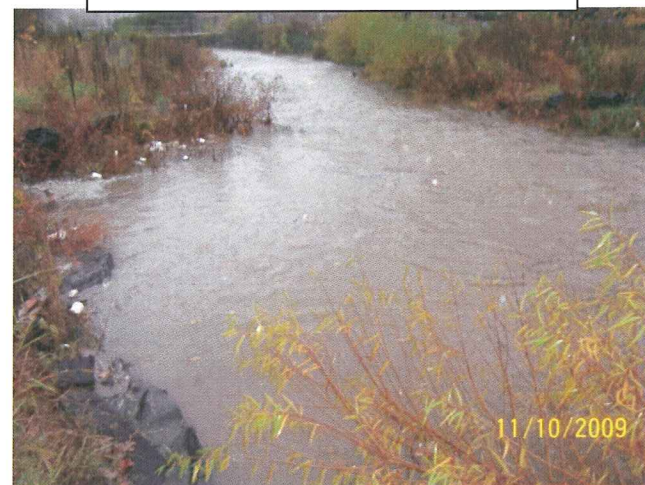
Date of Data Collection	Date of Occurrence	Method	Photo (if available)
November 11, 2009	November 11, 2009	Visual observation of overbank as the result of Tropical Storm Ida	1-2

Bankfull Event Photos 1-2 showing an overbank event.

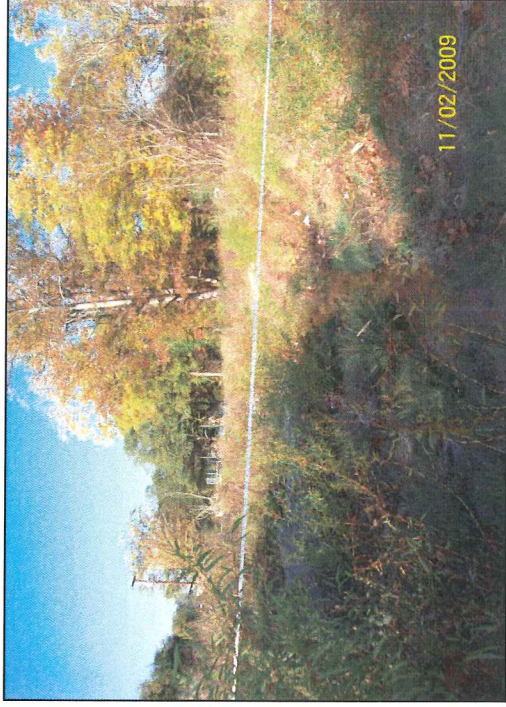
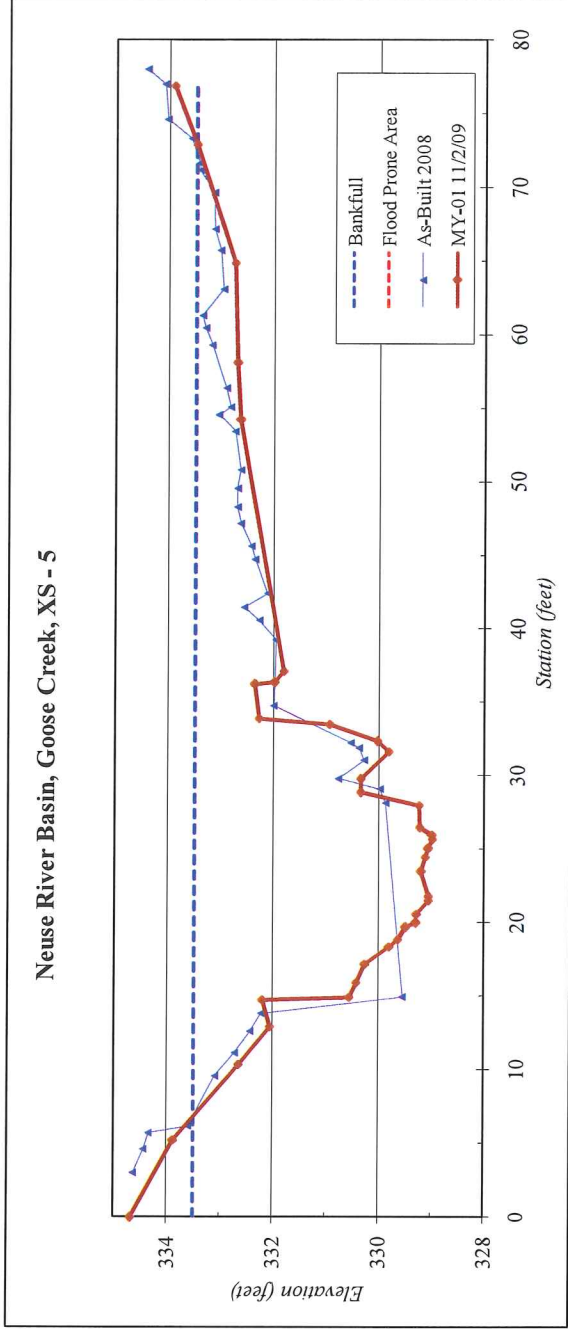
River Basin:	Neuse
Watershed:	Goose Creek
XS ID	XS - 5
Feature	Pool
Date:	11/2/2009
Field Crew:	Dean, Perkinson

Success criteria for stream restoration reaches dictate that little to no change from the as-built channel over the five-year monitoring period. Year 1 (2009) monitoring measurements indicate that there have been minimal changes in cross-sections and profile downstream of Liberty Street as compared to as-built data. Profile upstream of Liberty Street was designed to adjust itself to changes in watershed flows. One bankfull event was documented to occur on November 11, 2009 during the year 1 (2009) monitoring period as the result of Tropical Storm Ida. Noted problem areas within the Site include an area of bank erosion on the right bank just downstream of Cross-section 7 and Cross-section 5, which was originally intended to be a pool, was functioning like a riffle (Figure 2, Appendix A).

SUMMARY DATA	
Bankfull Elevation:	333.5
Bankfull Cross-Sectional Area:	115.7
Bankfull Width:	66.1
Flood Prone Area Elevation:	-
Flood Prone Width:	-
Max Depth at Bankfull:	4.5
Mean Depth at Bankfull:	1.8
W/D Ratio:	-
Entrenchment Ratio:	-
Bank Height Ratio:	-
