**FINAL
ANNUAL MONITORING REPORT
GOOSE CREEK**

**STREAM RESTORATION
DURHAM COUNTY, NORTH CAROLINA
(EEP Project Number 147)**

Monitoring Year 2 of 5 (2010)

Prepared by:
Axiom Environmental, Inc.
20 Enterprise Street, Suite 7
Raleigh, North Carolina 27607

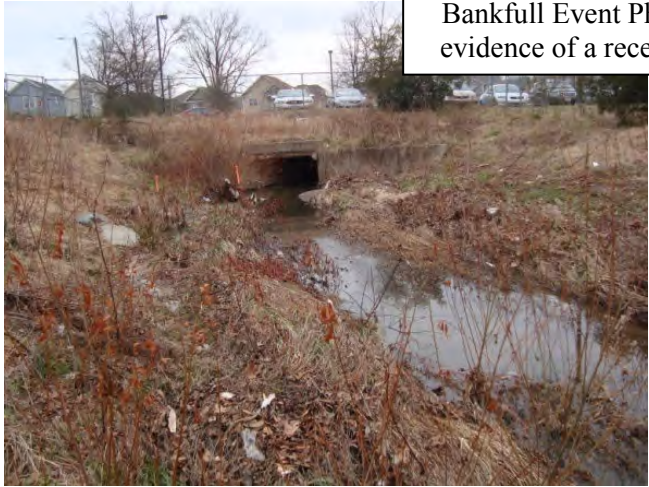
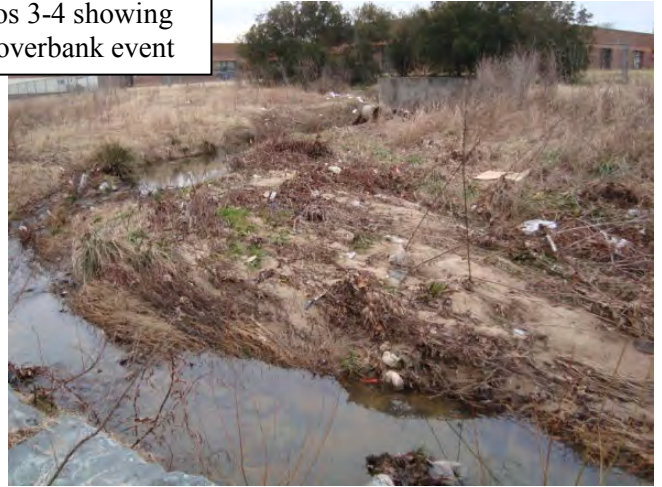
Bankfull Event Photos 3-4 showing evidence of a recent overbank event
