**FINAL
ANNUAL MONITORING REPORT
GOOSE CREEK**

**STREAM RESTORATION
DURHAM COUNTY, NORTH CAROLINA
(EEP Project Number 147)**

Monitoring Year 3 of 5 (2011)

Prepared by:
Axiom Environmental, Inc.
218 Snow Avenue
Raleigh, North Carolina 27603

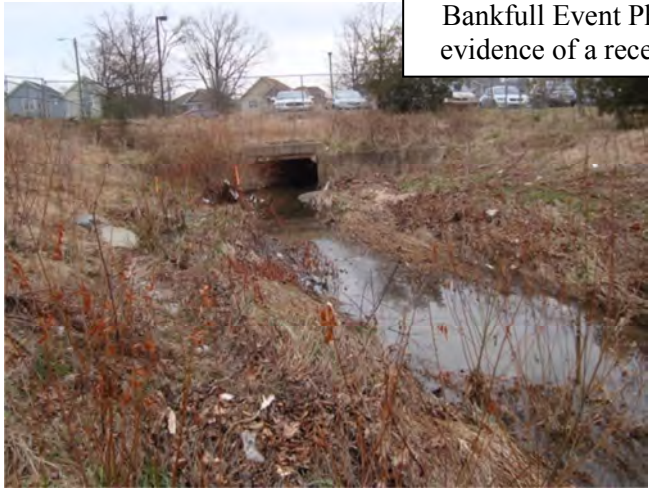
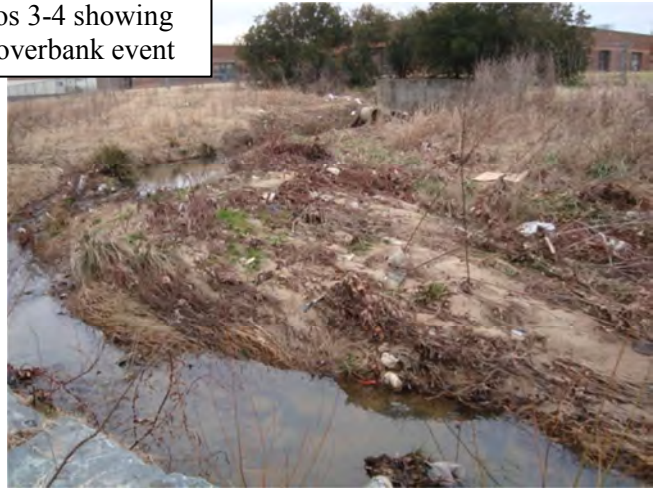
September 29, 2010	September 27, 2010	A total of 2.9 inches* of rain fall between September 26-27, 2010 with more rain expected to follow.	--
June 23, 2011	May 27, 2011	Visual observations of overbank event including wrack lines resulting from a 1.64 inch* rainfall event on May 27, 2011.	5

Bankfull Event Photos 3-4 showing evidence of a recent overbank event

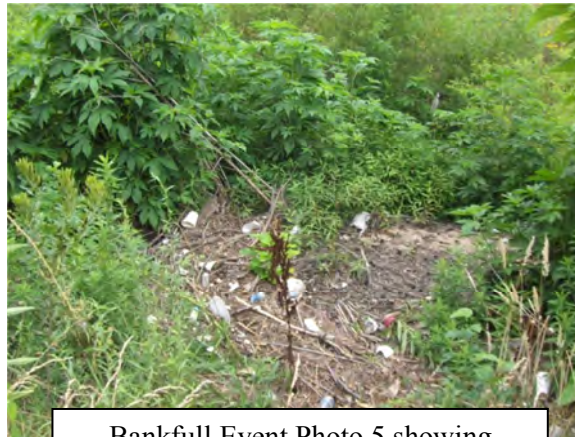
Bankfull Event Photo 5 showing wrack due to a recent overbank event
