**FINAL
ANNUAL MONITORING REPORT
GOOSE CREEK**

**STREAM RESTORATION
DURHAM COUNTY, NORTH CAROLINA
(EEP Project Number 147, Contract Number 004681)**

Monitoring Year 4 of 5 (2012)

Prepared by:
Axiom Environmental, Inc.
218 Snow Avenue
Raleigh, North Carolina 27603

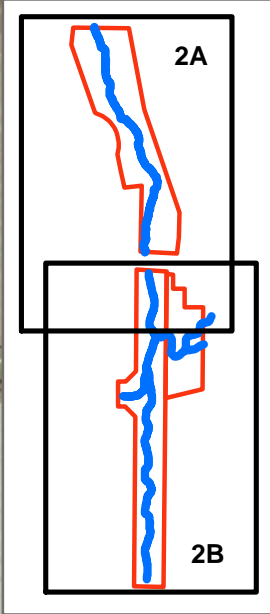
FIGURE
2A

Noted vegetation problem areas within the Site, depicted on the attached Figures 2A-2B (Appendix B), include the development of invasive species such as Johnson grass (*Sorghum halepense*) scattered along the northern/downstream reach between Liberty Street and Holloway Street. Other invasive species include small patches of Japanese hops (*Humulus japonicas*) just north of the Liberty Street bridge on the right bank and adjacent to the left bank of the western tributary to the southern/upstream reach. Mimosa (*Albizia julibrissin*), chinaberry (*Melia azedarach*), and white mulberry (*Morus alba*), are located in several locations along the northern (downstream reach). Chinese privet (*Ligustrum sinense*) and Japanese privet (*Ligustrum japonicum*) are located just north of the stormwater wetland and adjacent to the fence just south of the tributary to the southern/upstream reach coming from the west. Scotch broom (*Cytisus scoparius*) is located at the very southeastern corner of the Site and has spread rapidly over the past year; some treatment/control of this species occurred in the 2011 monitoring year by cutting plants to remove the seed source. In addition, scattered stems of Bradford pear (*Pyrus calleryana*), white mulberry, wintercreeper (*Euonymus fortunei*), air yam (*Discorea bulbifera*), and multiflora rose (*Rosa multiflora*) are located adjacent to the southern/upstream reach. Herbaceous species including Nepalese browntop (*Microstegium vimineum*) and Asiatic dayflower (*Commelina communis*) are also located in several areas along the southern/upstream reach near the stream channel. Currently, invasive species within the Site are not affecting planted tree stem survival or growth, and are therefore expected to be shaded out as planted trees mature; however, they will continue to be watched throughout the monitoring period.

Wisteria (*Wisteria frutescens*) is located just north of Liberty Street on the right bank adjacent to the bridge and giant ragweed (*Ambrosia trifida*) is scattered throughout the Site and occasionally forms thick stands. Wisteria and giant ragweed are not invasive species but can be problematic due to their growth habits and potential to shade or, in the case of wisteria, girdle planted trees.

Three large willow oaks removed by City of Durham; area was planted with 165 containerized trees.

Japanese hops are located on the right bank and wisteria on the left bank adjacent to the bridge.

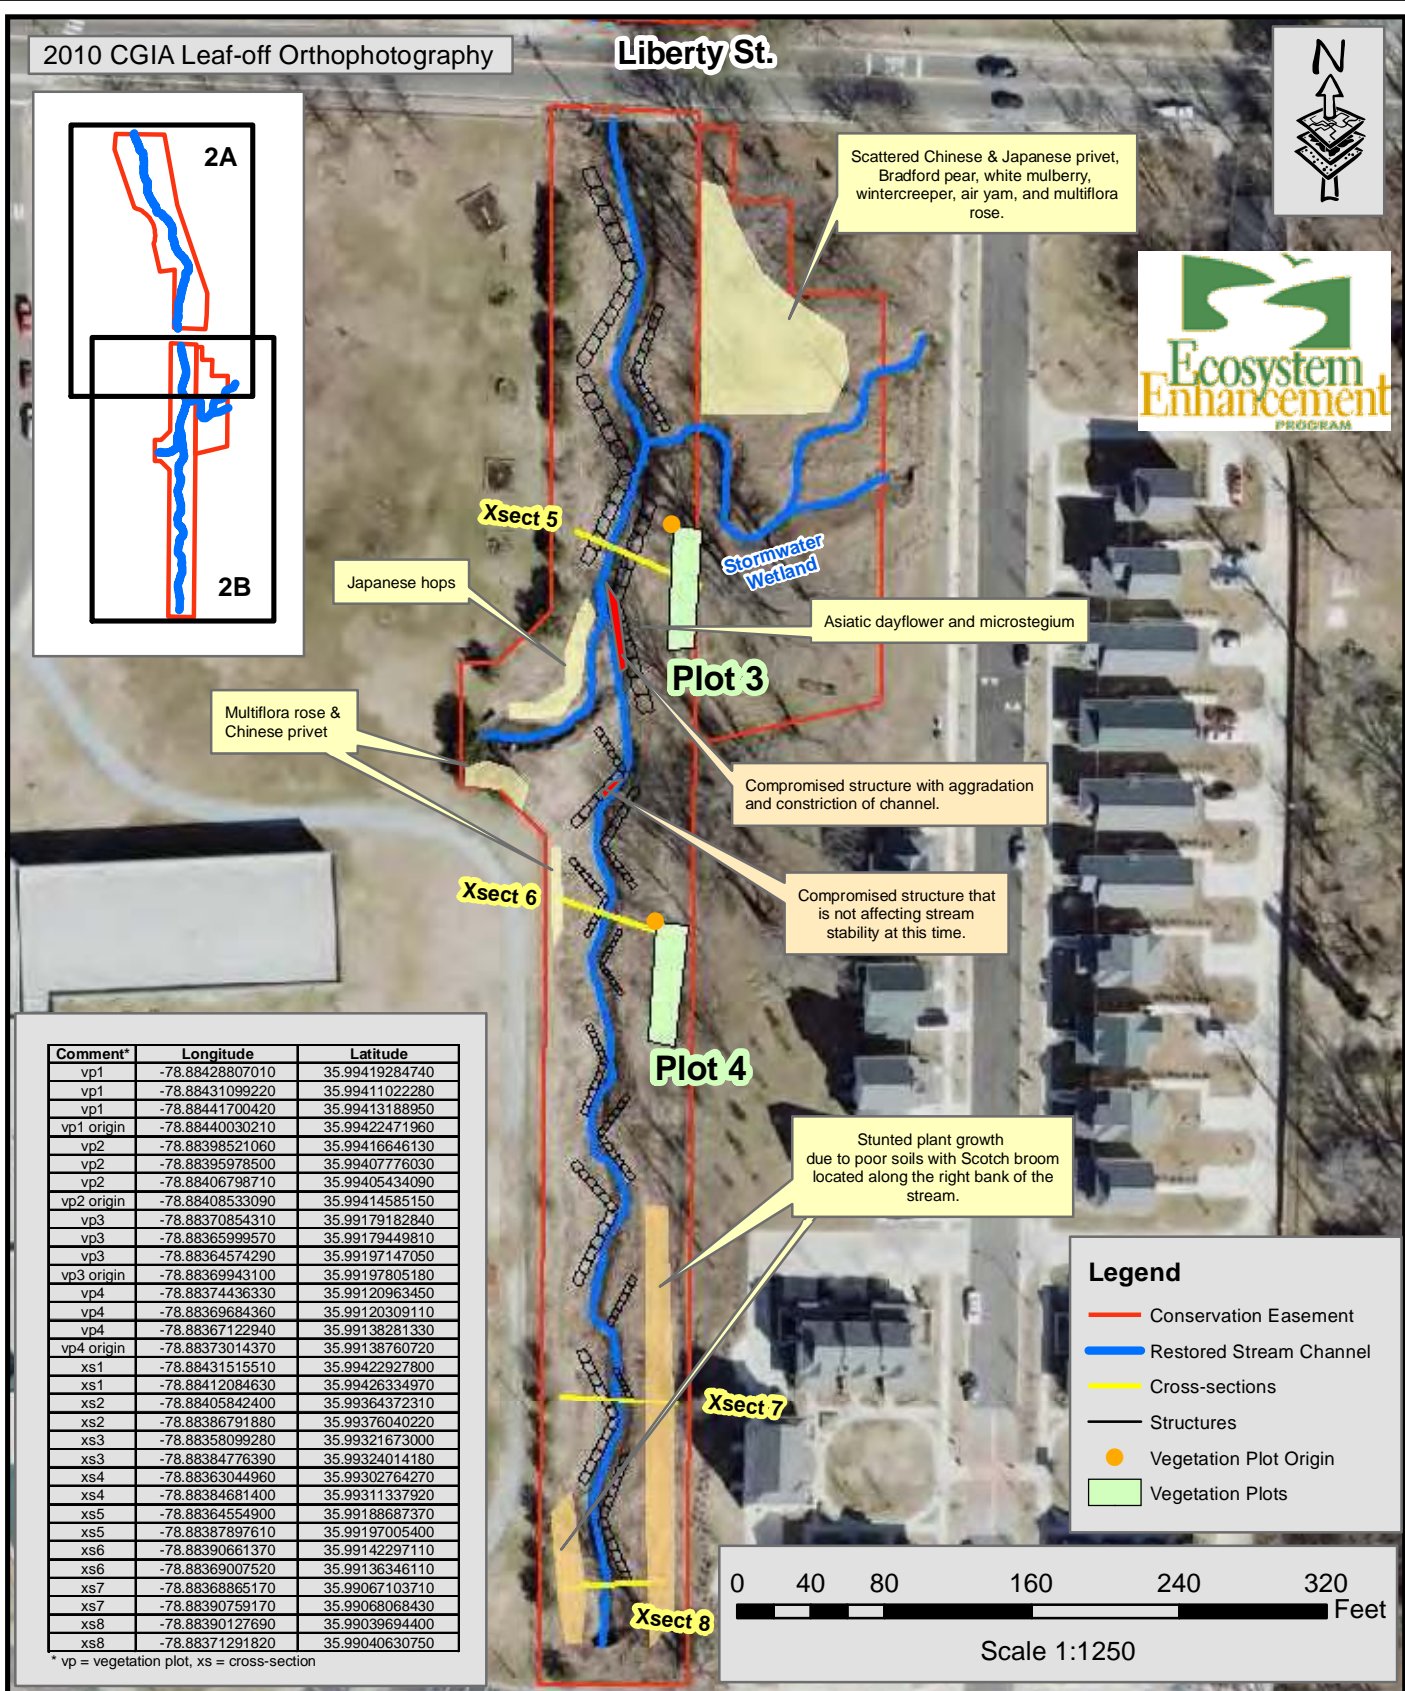
FIGURE
2B

Noted stream problem areas within the Site include two compromised structures (Figure 2B, Appendix B). The structure upstream of Cross-section 5 is compromised due to undercutting of the structure on the right bank. Subsequently structure rocks have fallen into the stream causing aggradation of sediment. This has created a bench that supports limited herbaceous growth and has caused the channel to constrict. Reduced channel width appears to have caused additional erosion to the left bank just downstream at the confluence of the adjacent tributary. An additional structure downstream of Cross-section 6 is compromised due to undercutting of the structure on the left bank. Subsequently structure rocks appear to have fallen into the stream; however, this does not appear to be affecting stream stability. Stream instability appears localized to the immediate vicinity of both failing structures. Dense, rooted vegetation adjacent to the structures is reducing lateral erosion and bed scour appears contained to the footprint of

the structure. No further maintenance is recommended at this time; however, these structures should be watched throughout the remainder of the annual monitoring timeframe.

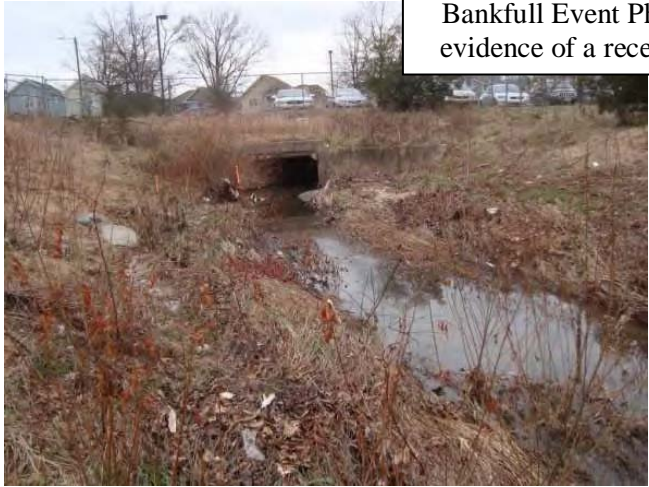
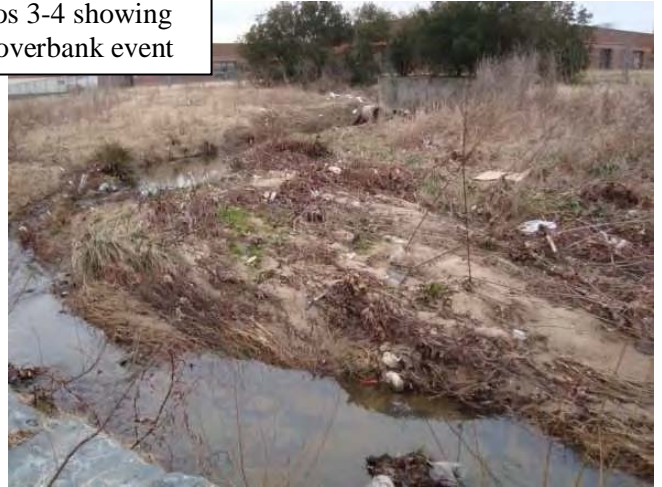
Bankfull Event Photos 3-4 showing evidence of a recent overbank event

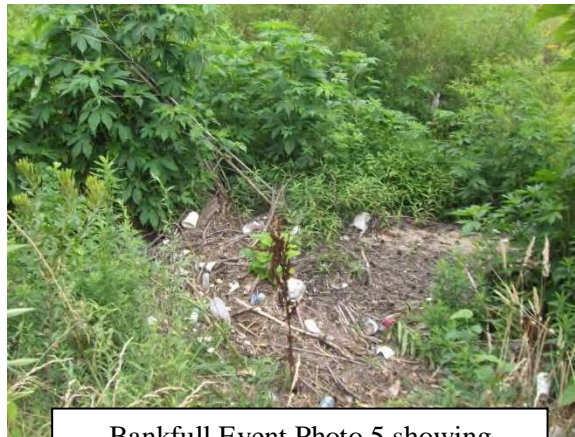
Bankfull Event Photo 5 showing wrack due to a recent overbank event
