FINAL
ANNUAL MONITORING REPORT
GOOSE CREEK

STREAM RESTORATION
DURHAM COUNTY, NORTH CAROLINA
(EEP Project Number 147, Contract Number 004681)
Construction Completed September 2008

Monitoring Year 5 of 5 (2013)

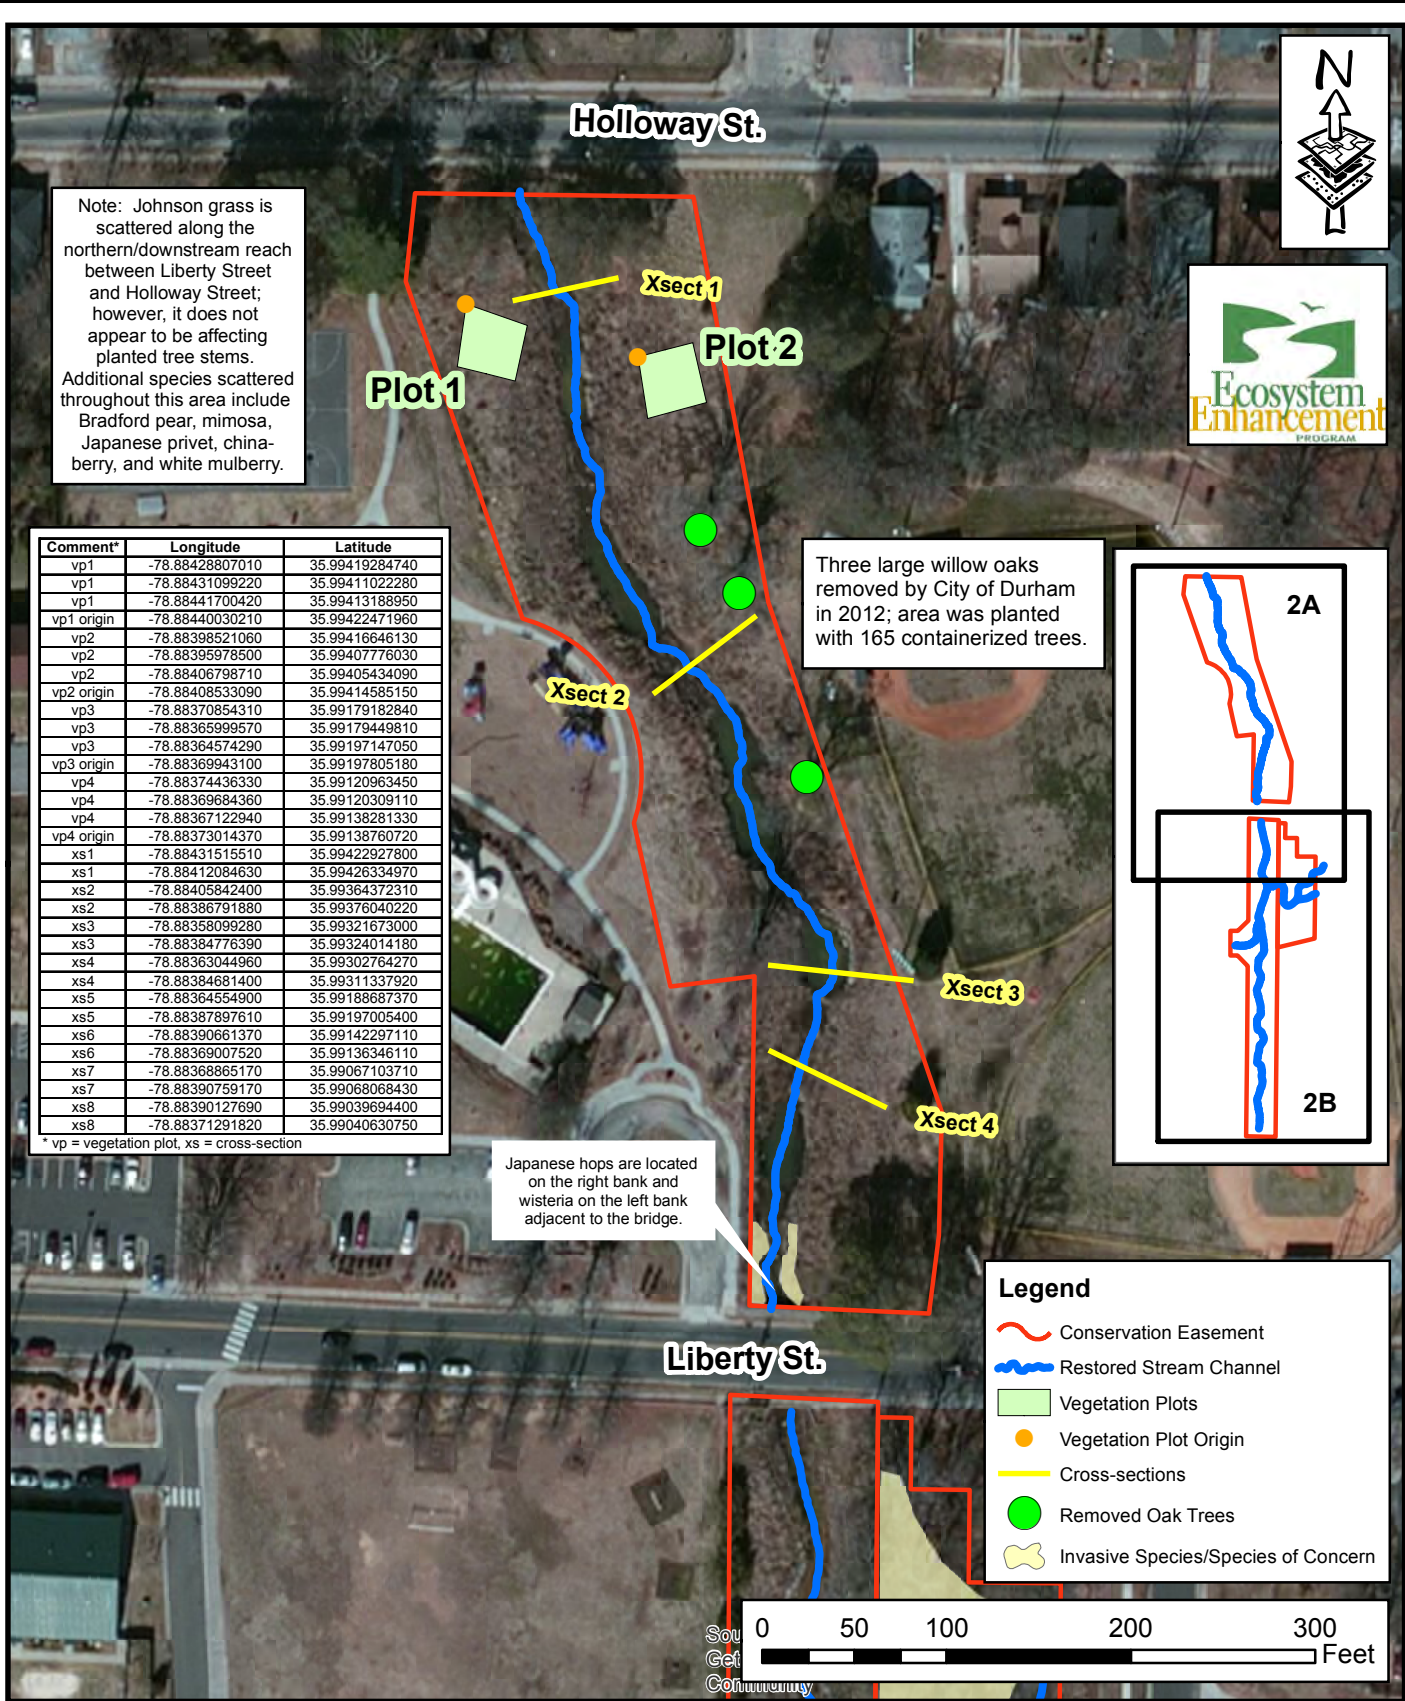
Dwn. by:	CLF/KRJ	FIGURE 2A
Date:	Oct. 2013	
Project:	12-004.06

Note: Johnson grass is scattered along the northern/downstream reach between Liberty Street and Holloway Street; however, it does not appear to be affecting planted tree stems. Additional species scattered throughout this area include Bradford pear, mimosa, Japanese privet, china-berry, and white mulberry.

Three large willow oaks removed by City of Durham in 2012; area was planted with 165 containerized trees.

Japanese hops are located on the right bank and wisteria on the left bank adjacent to the bridge.

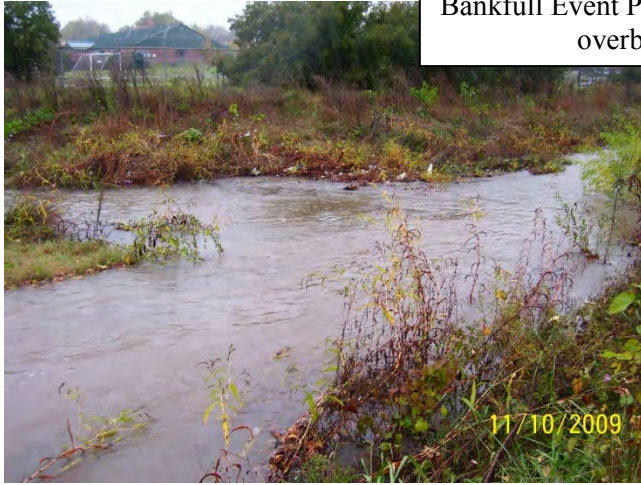
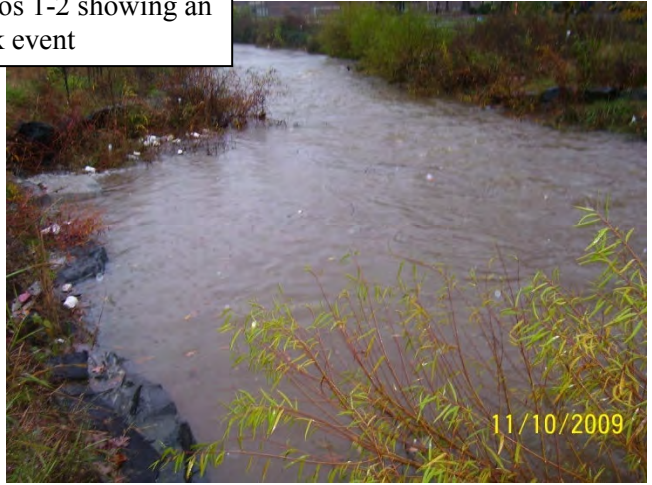
Bankfull Event Photos 1-2 showing an overbank event

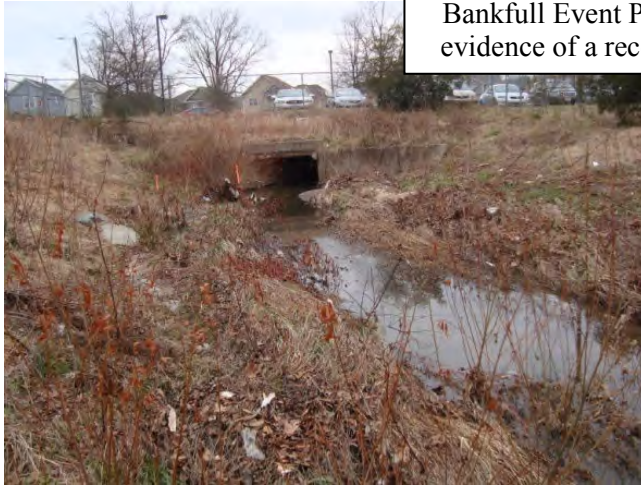
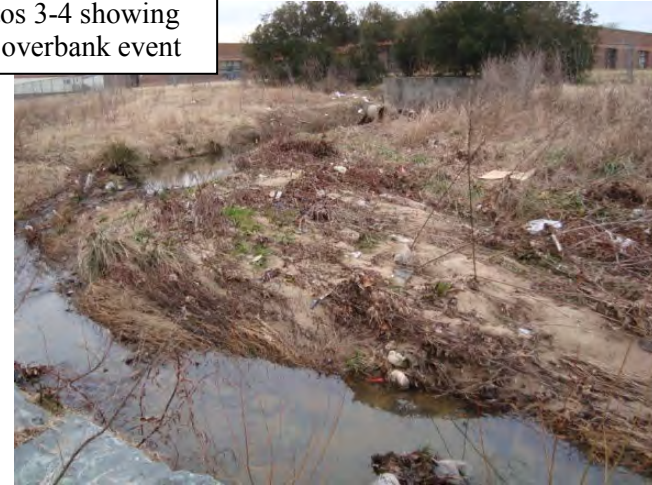
Bankfull Event Photos 3-4 showing evidence of a recent overbank event

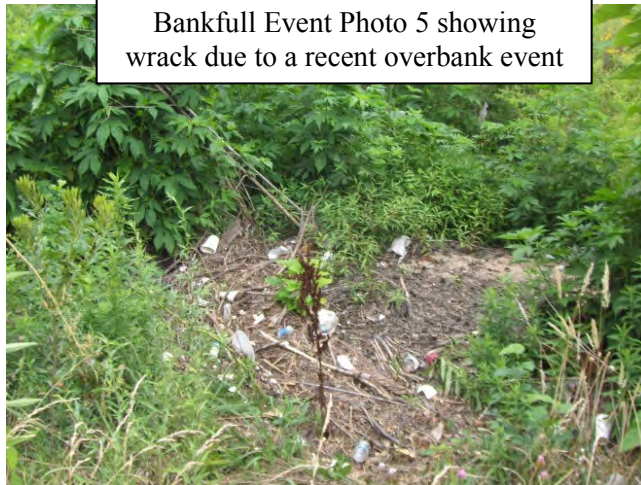
Bankfull Event Photo 5 showing wrack due to a recent overbank event

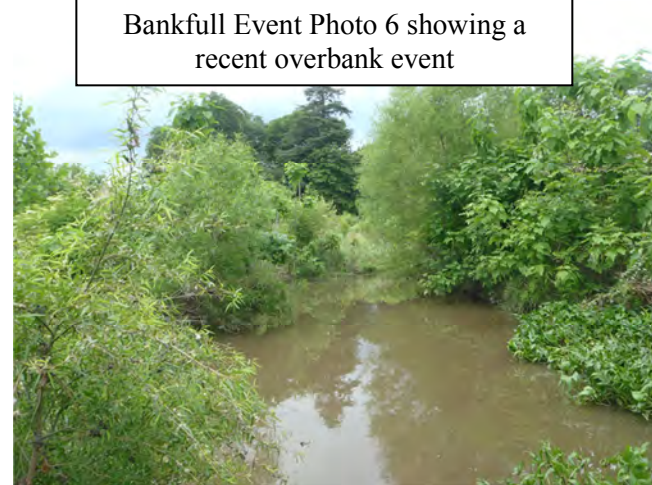
Bankfull Event Photo 6 showing a recent overbank event
