**Goose Creek (Greene Mitigation)
Stream Enhancement Project
Project No. 92709
2009 Monitoring Report: Year 1 of 5**

November 2009

Prepared for: NCDENR-EEP
1652 Mail Service Center
Raleigh, NC 27699-1652

Prepared by: Jordan, Jones & Goulding
9101 Southern Pine Blvd., Suite 160
Charlotte, NC 28273

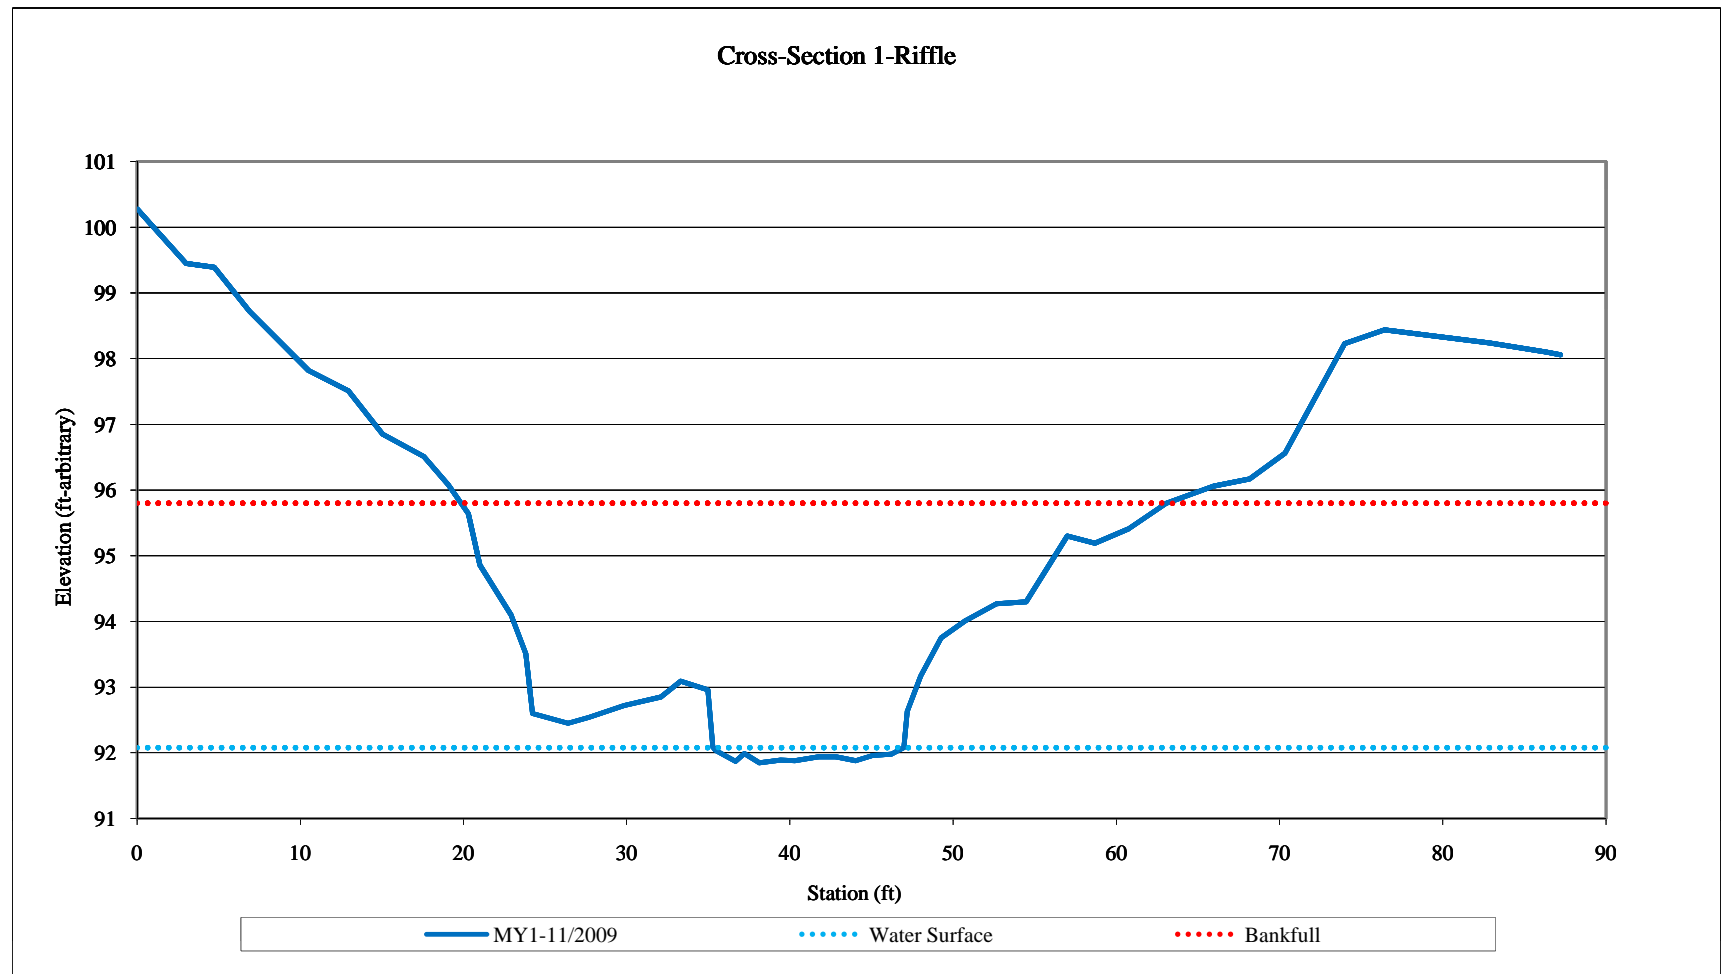
Summary Data	
Bankfull Cross-sectional Area (ft ²)	104.53
Bankfull Width (ft)	43.12
Bankfull Mean Depth (ft)	2.42
Bankfull Max Depth (ft)	3.94
Width/Depth Ratio	17.82
Entrenchment Ratio	1.98

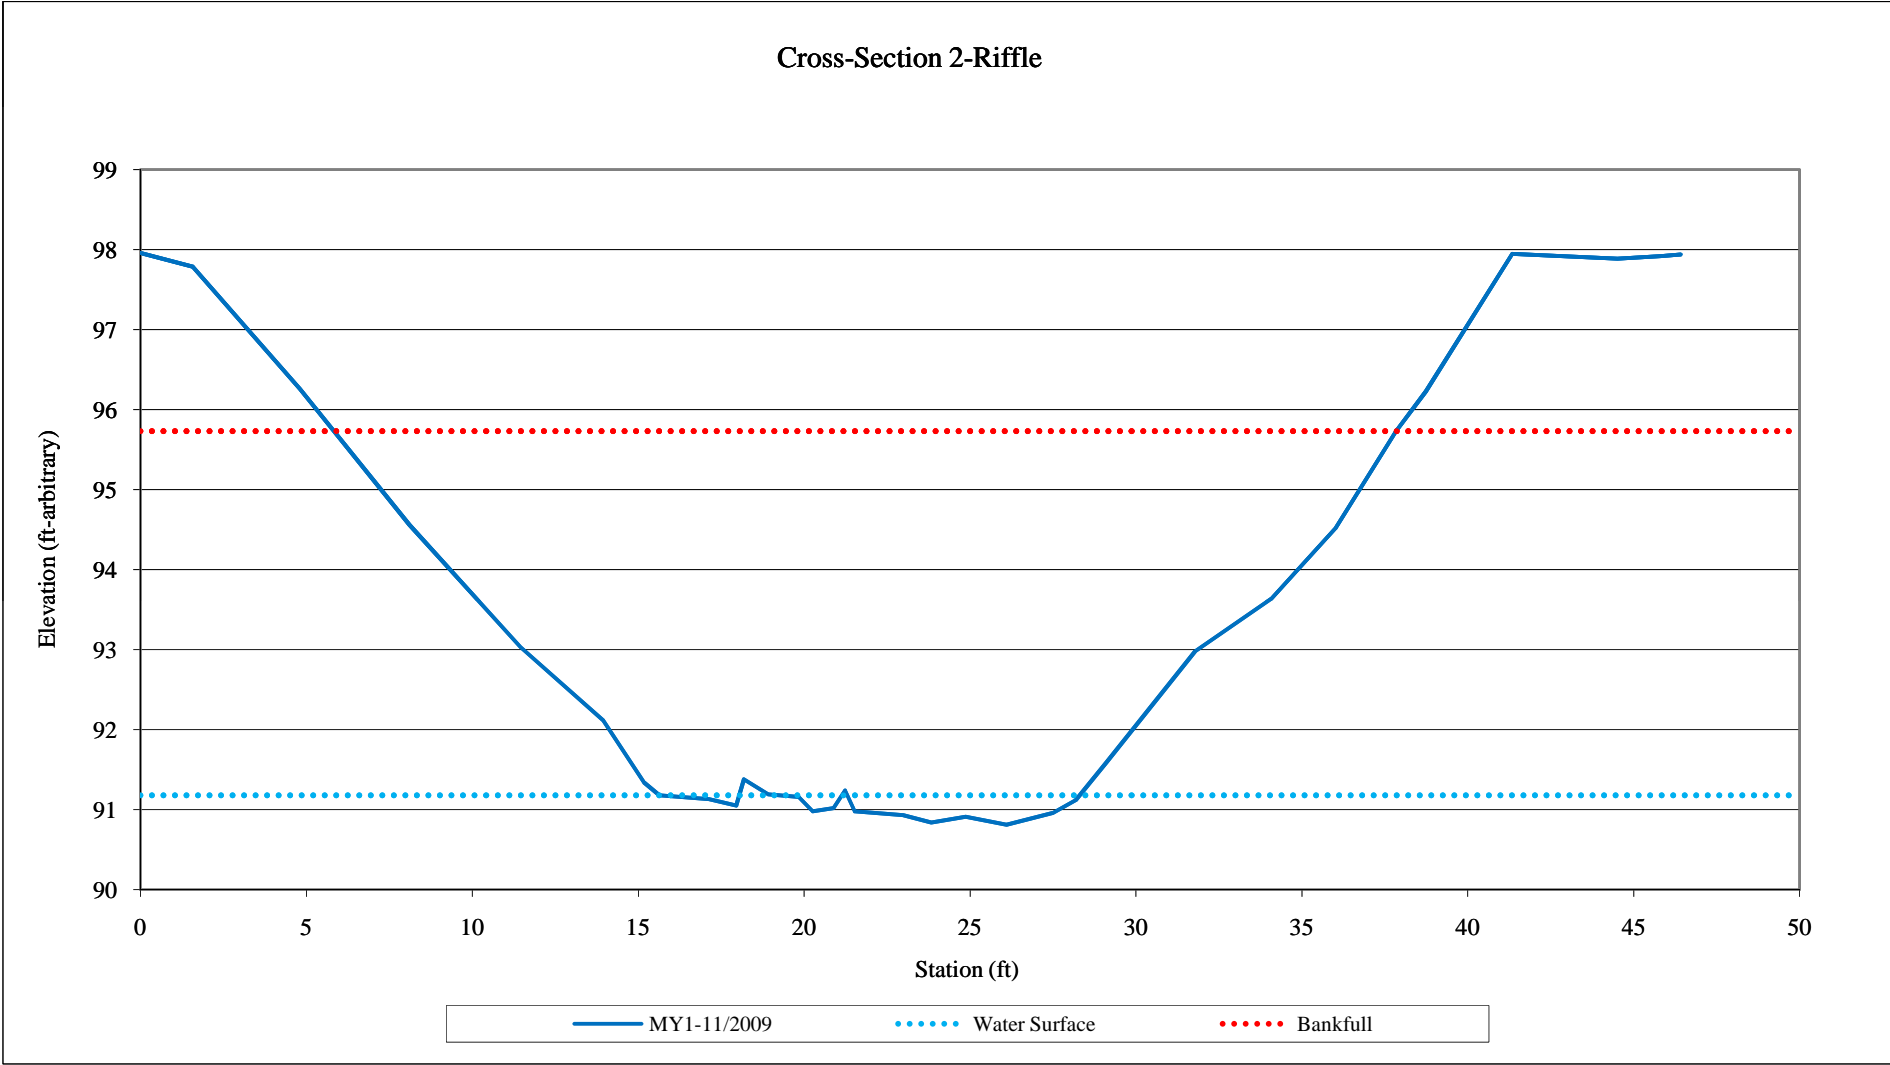
Summary Data	
Bankfull Cross-sectional Area (ft ²)	104.90
Bankfull Width (ft)	32.03
Bankfull Mean Depth (ft)	3.28
Bankfull Max Depth (ft)	4.92
Width/Depth Ratio	9.77
Entrenchment Ratio	2.2+

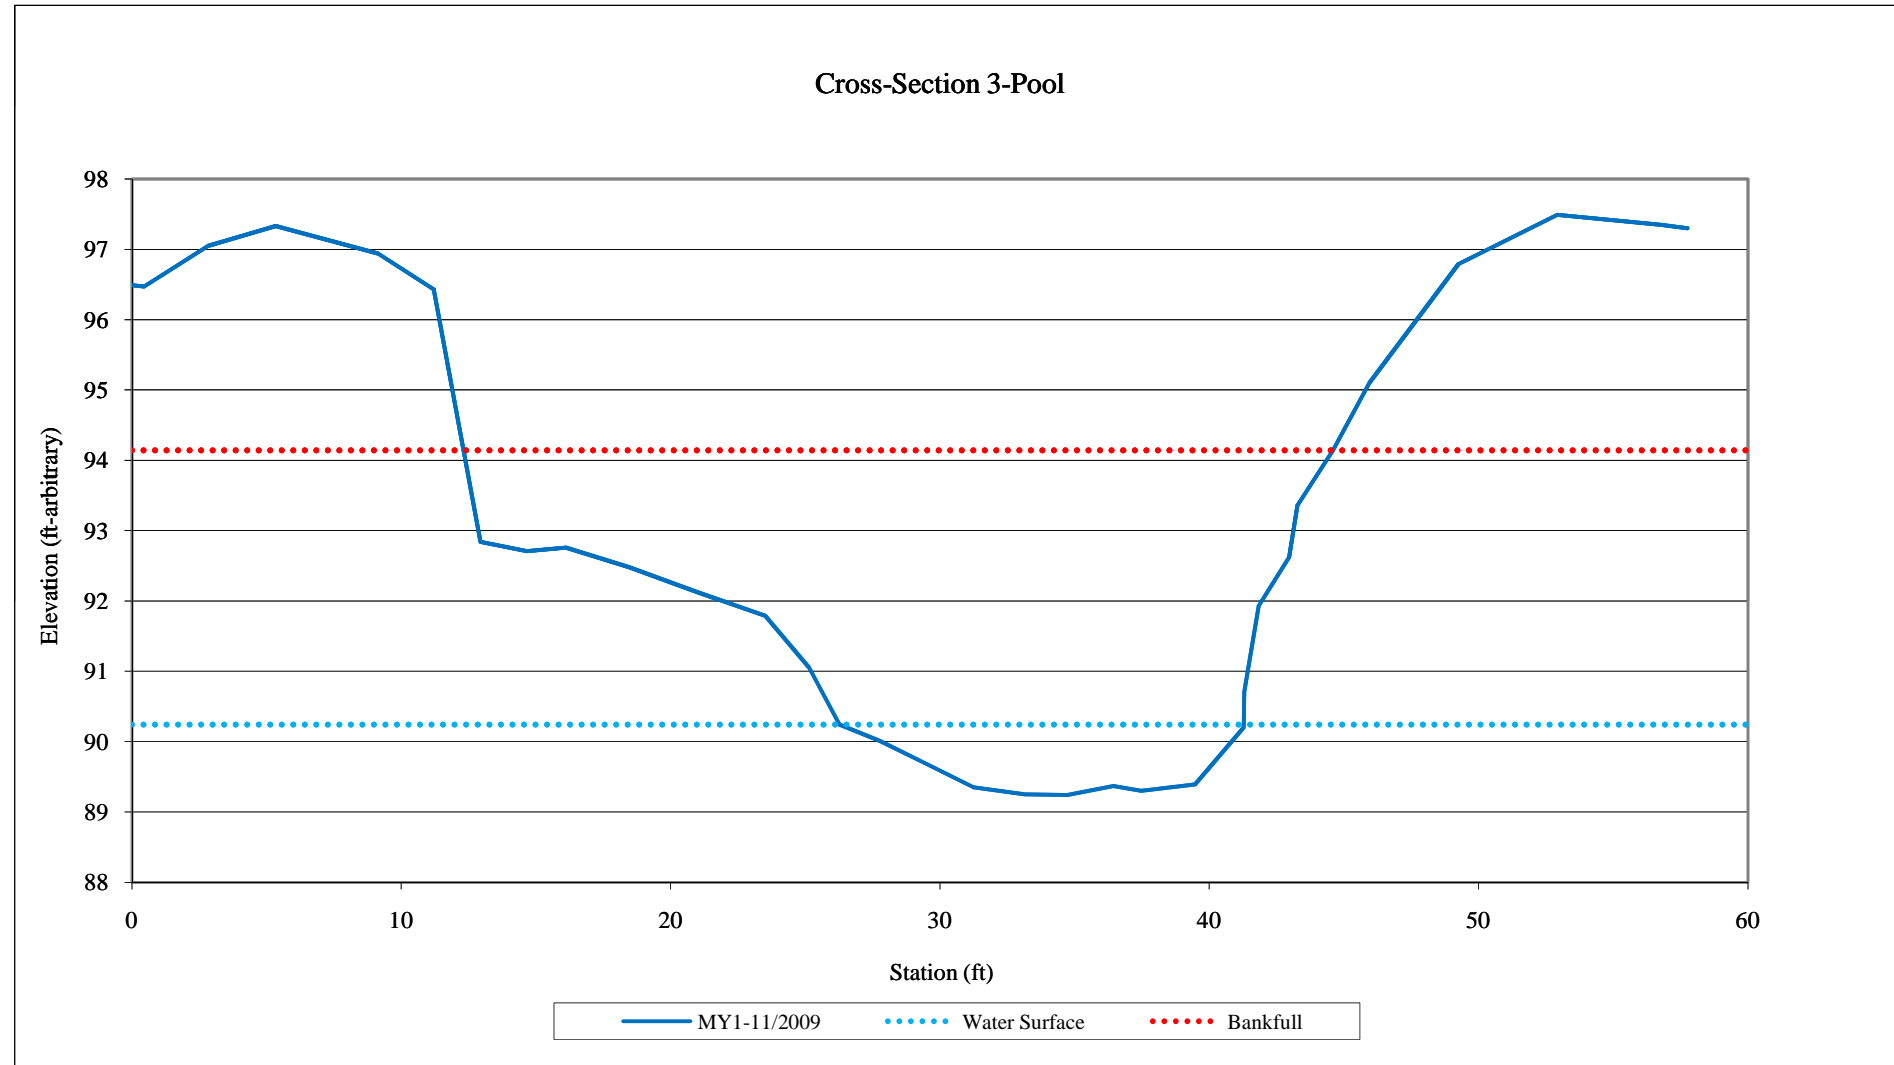
Summary Data	
Bankfull Cross-sectional Area (ft ²)	100.89
Bankfull Width (ft)	32.29
Bankfull Mean Depth (ft)	3.12
Bankfull Max Depth (ft)	4.90
Width/Depth Ratio	10.35
Entrenchment Ratio	2.2+

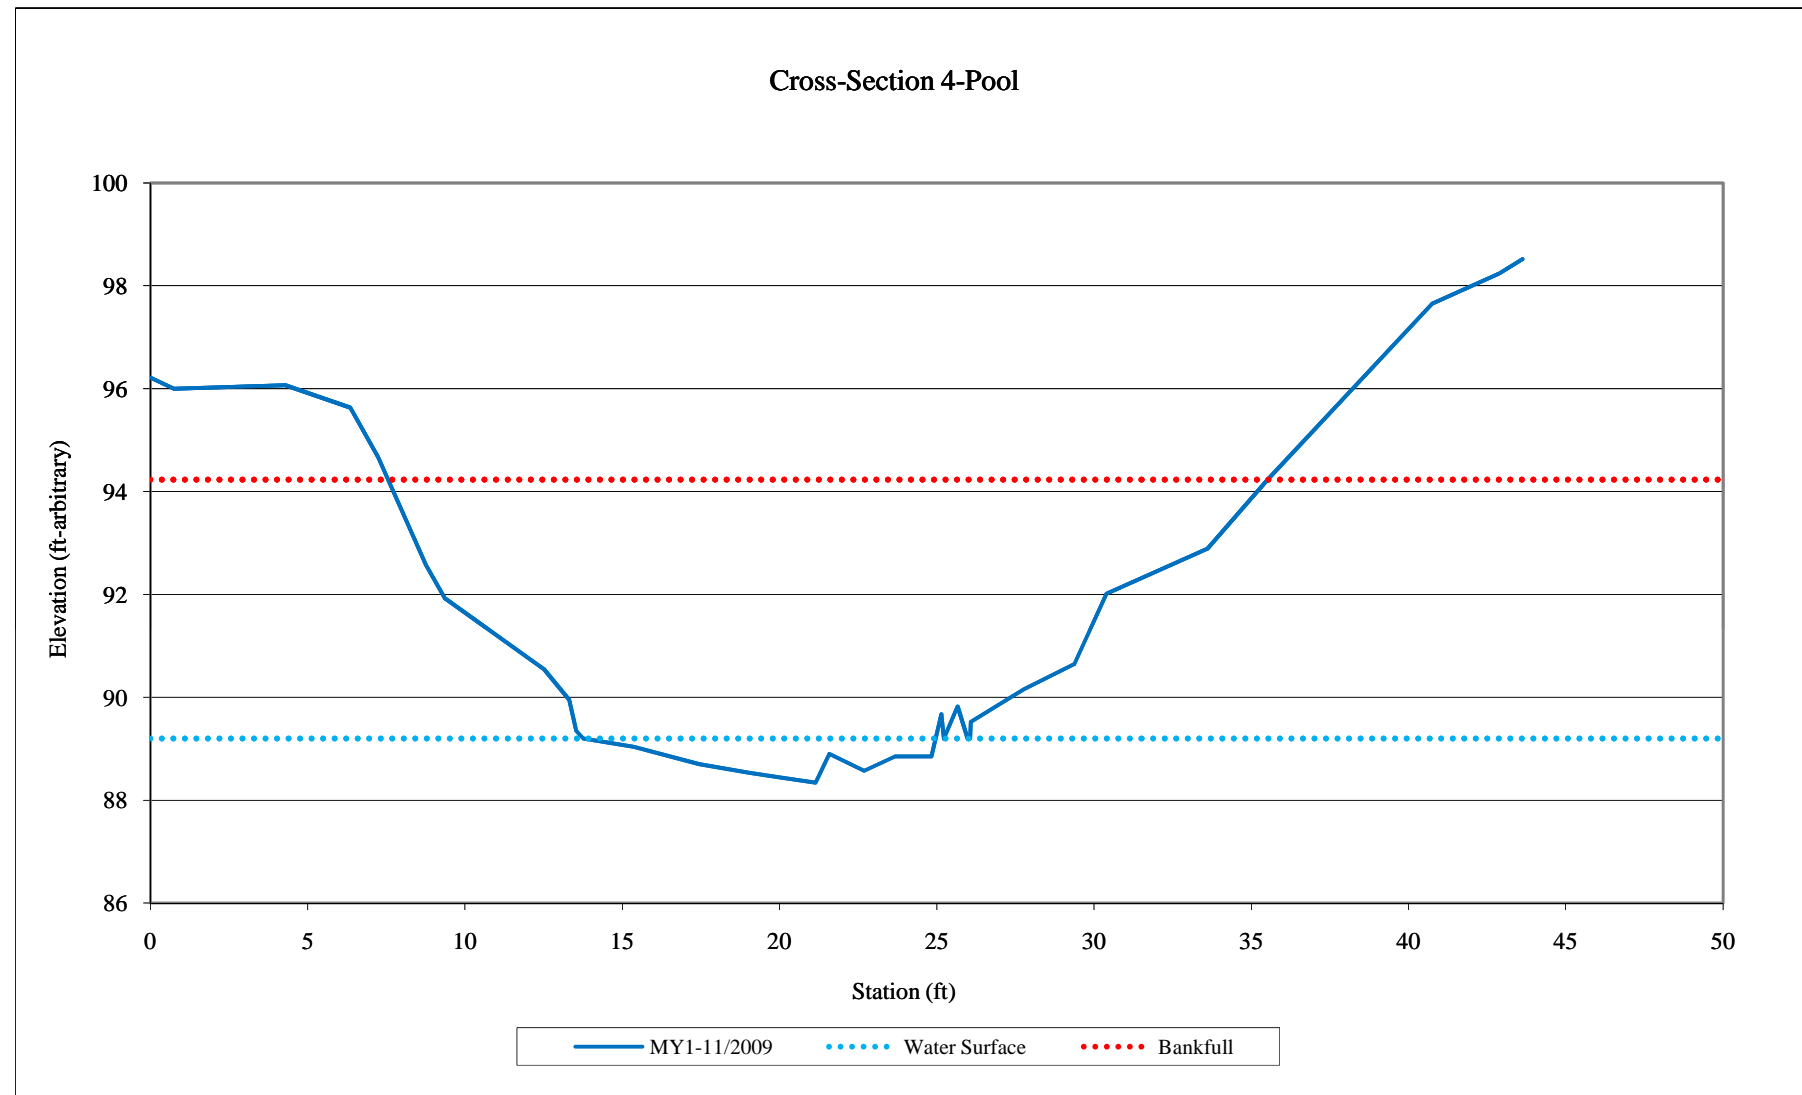
Summary Data	
Bankfull Cross-sectional Area (ft ²)	107.15
Bankfull Width (ft)	27.96
Bankfull Mean Depth (ft)	3.83
Bankfull Max Depth (ft)	5.89
Width/Depth Ratio	7.30
Entrenchment Ratio	2.2+

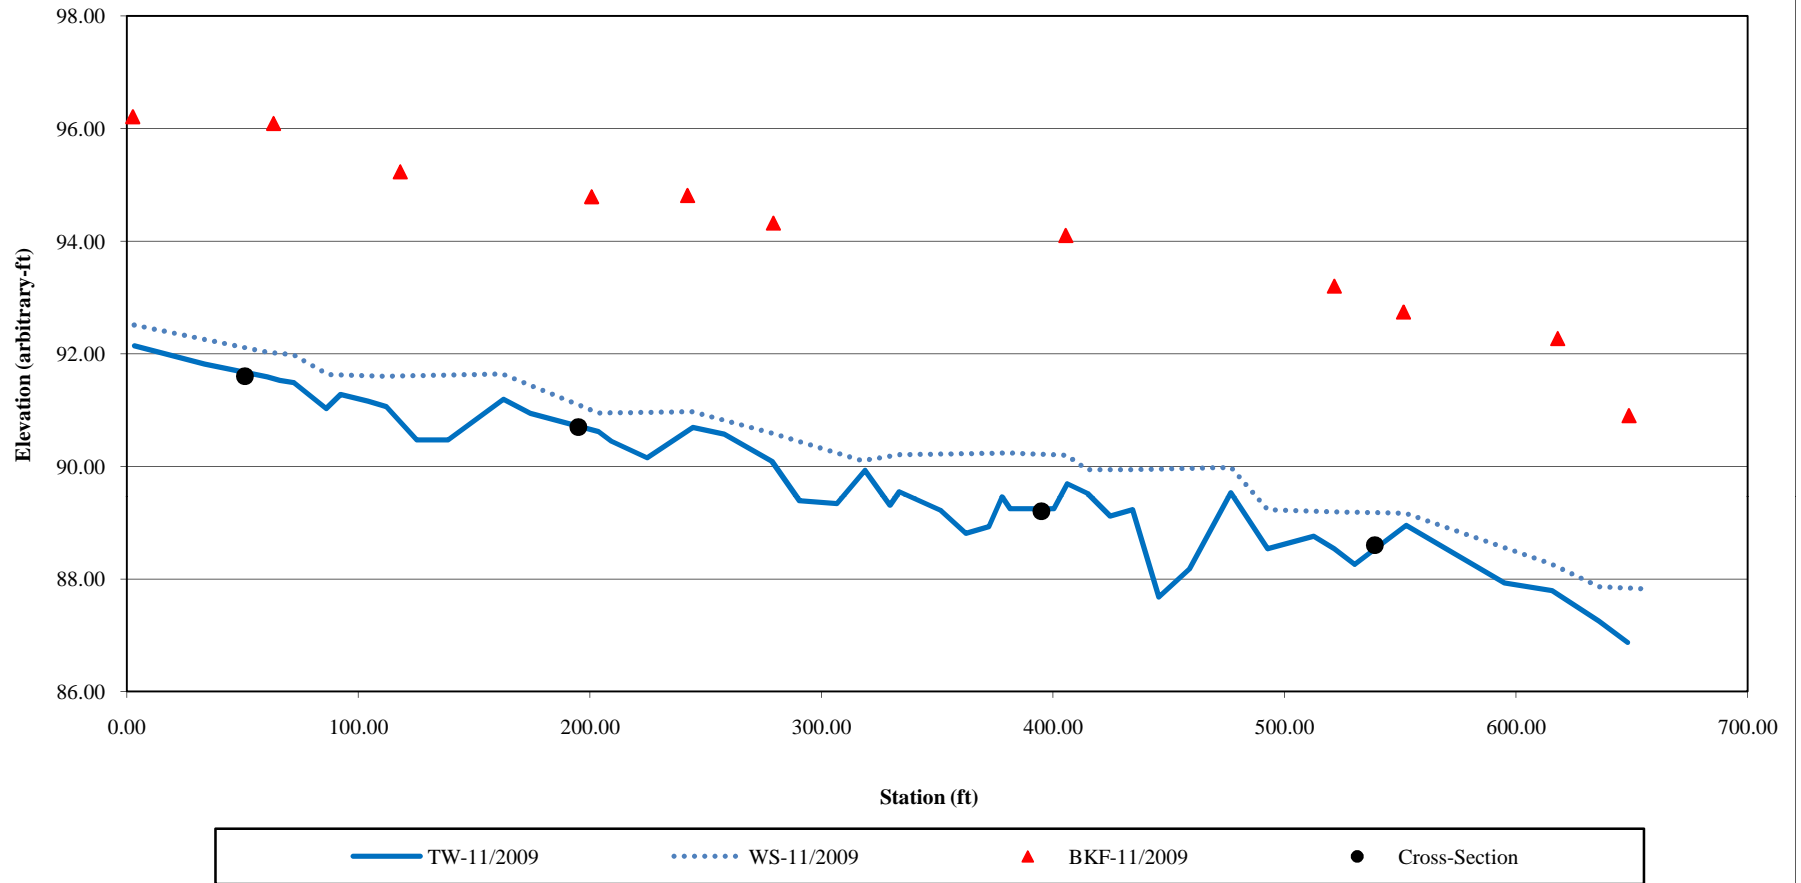
**Goose Creek
Longitudinal Profile
2009 Monitoring Year**

Bankfull/Top of Bank = $-0.0069 \cdot \text{STA} + 96.36$
 Water Surface = $-0.0065 \cdot \text{STA} + 92.477$
