**Goose Creek (Greene Mitigation)
Stream Enhancement Project
EEP Project No. 92709
2010 Monitoring Report: Year 2 of 5**

**Construction Completed: February 2005
Submission Date: March 2011**

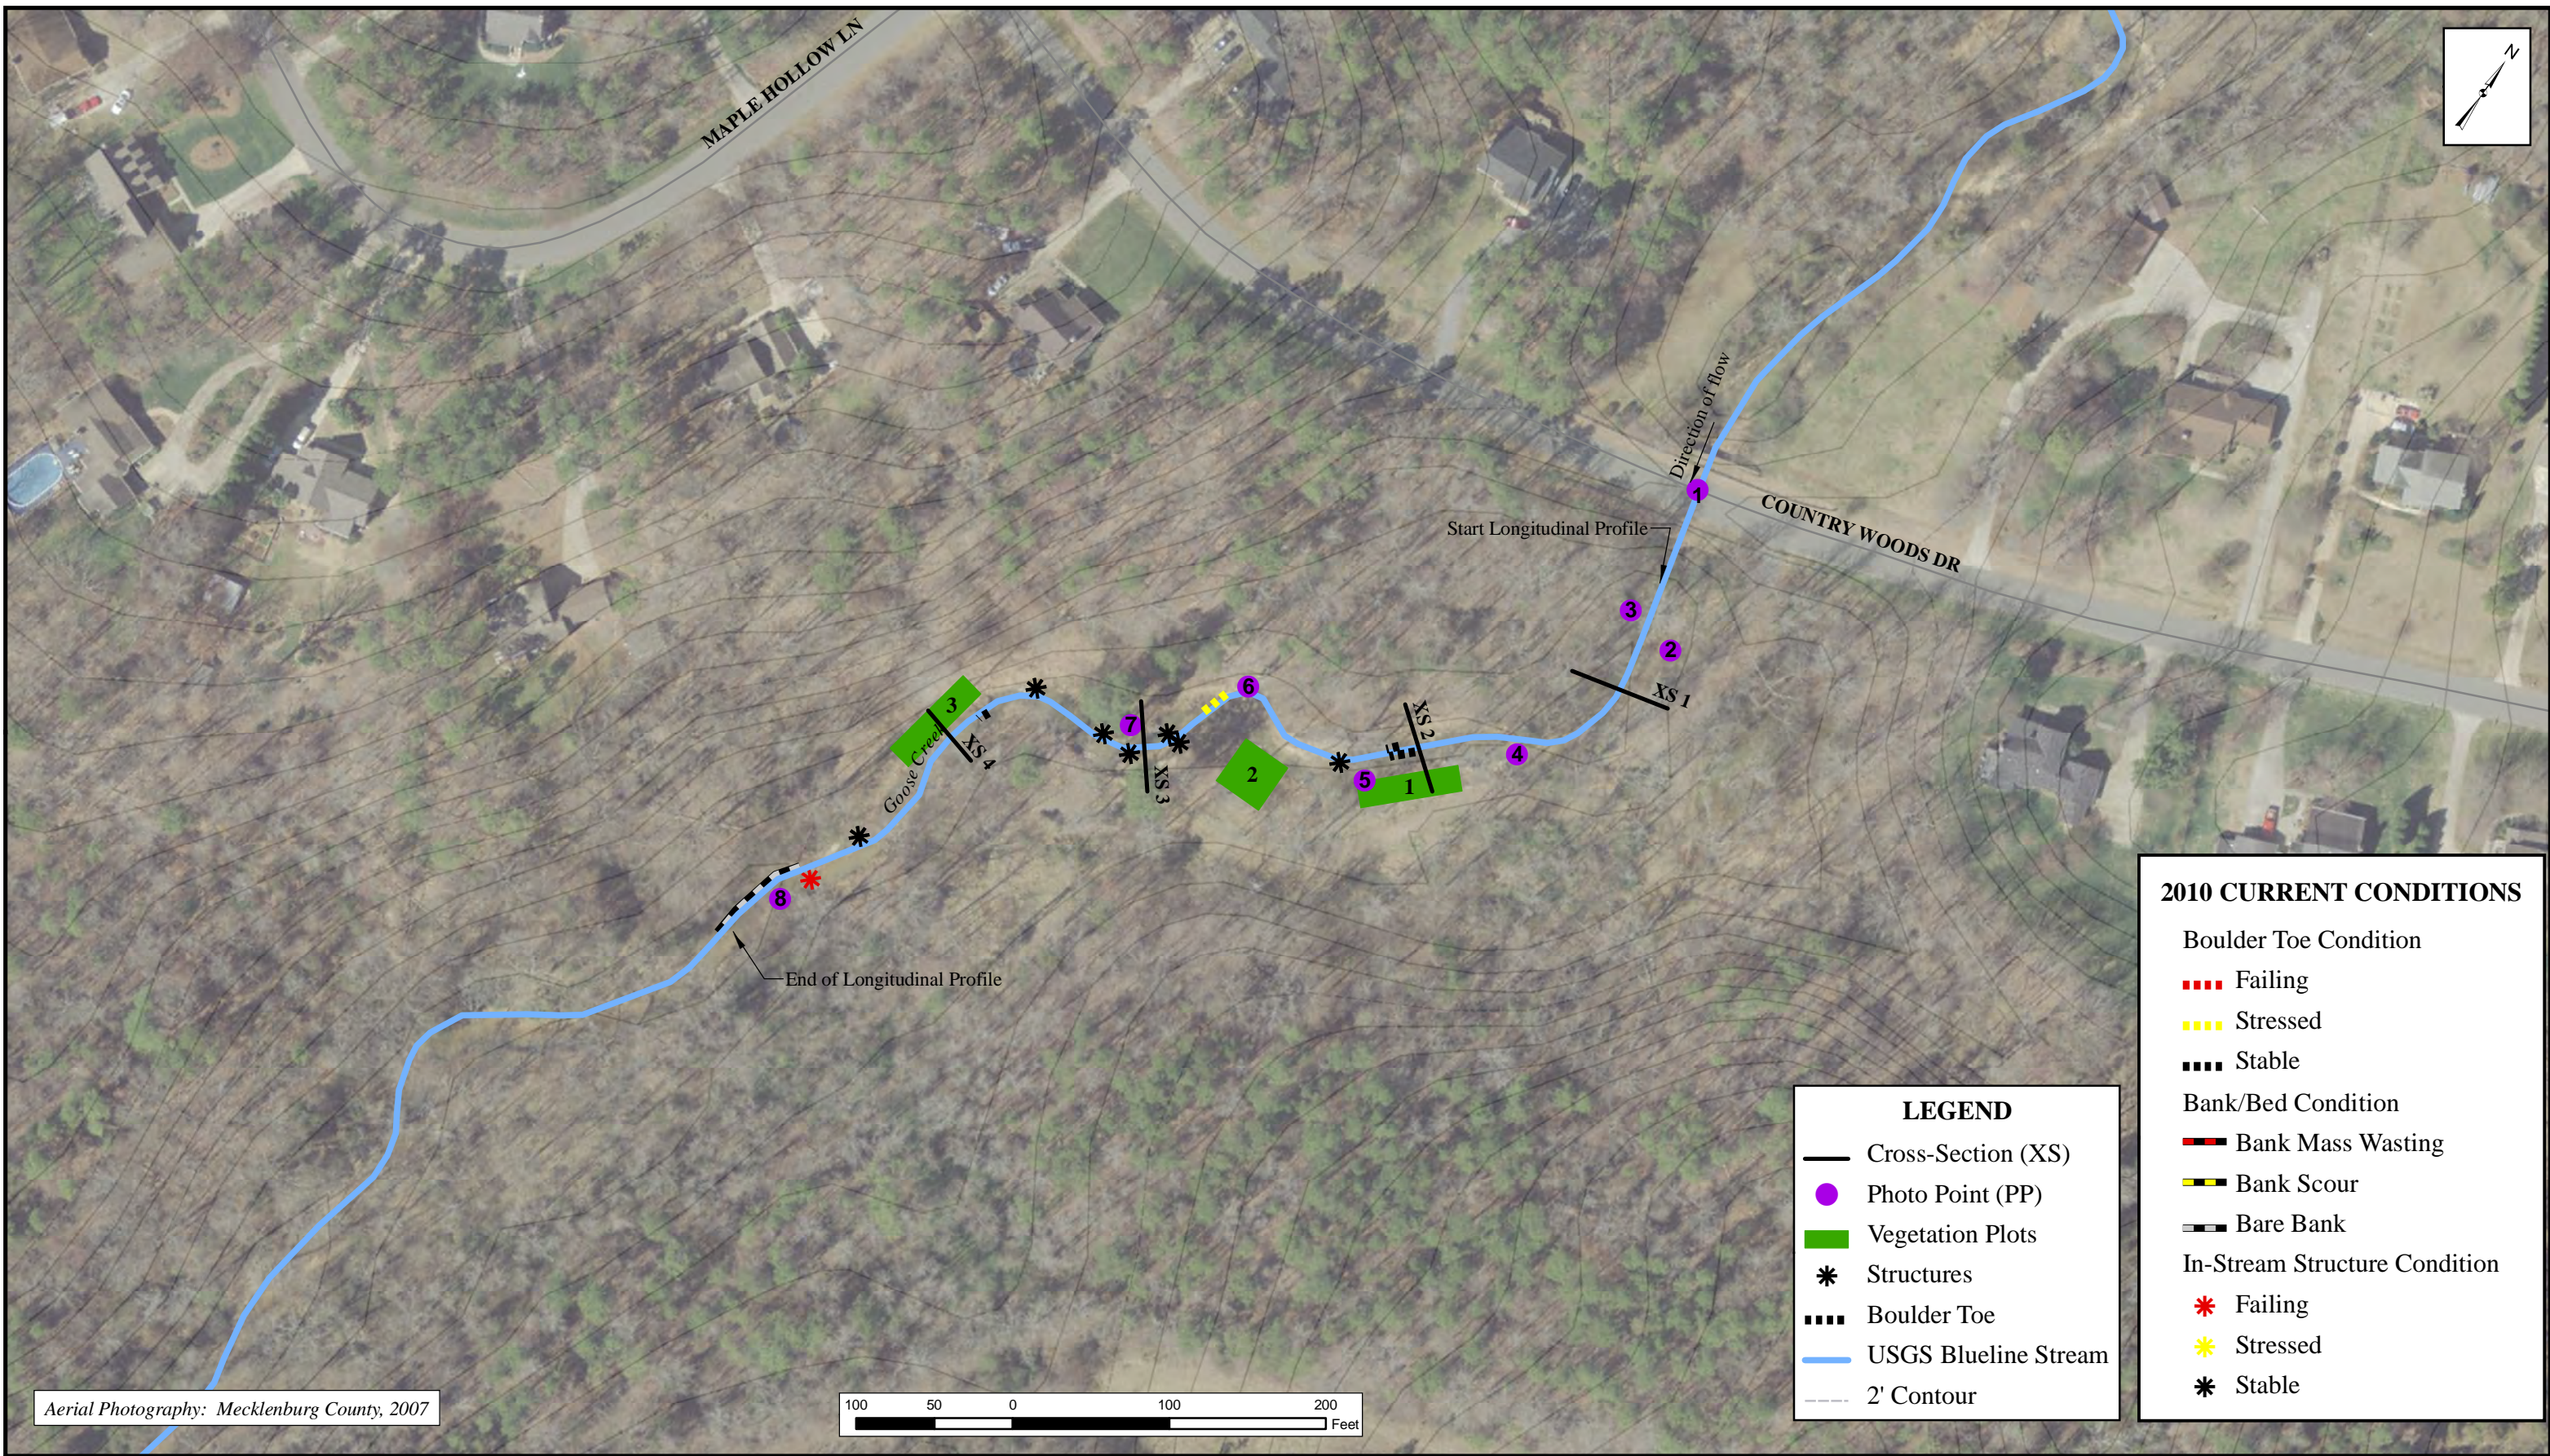
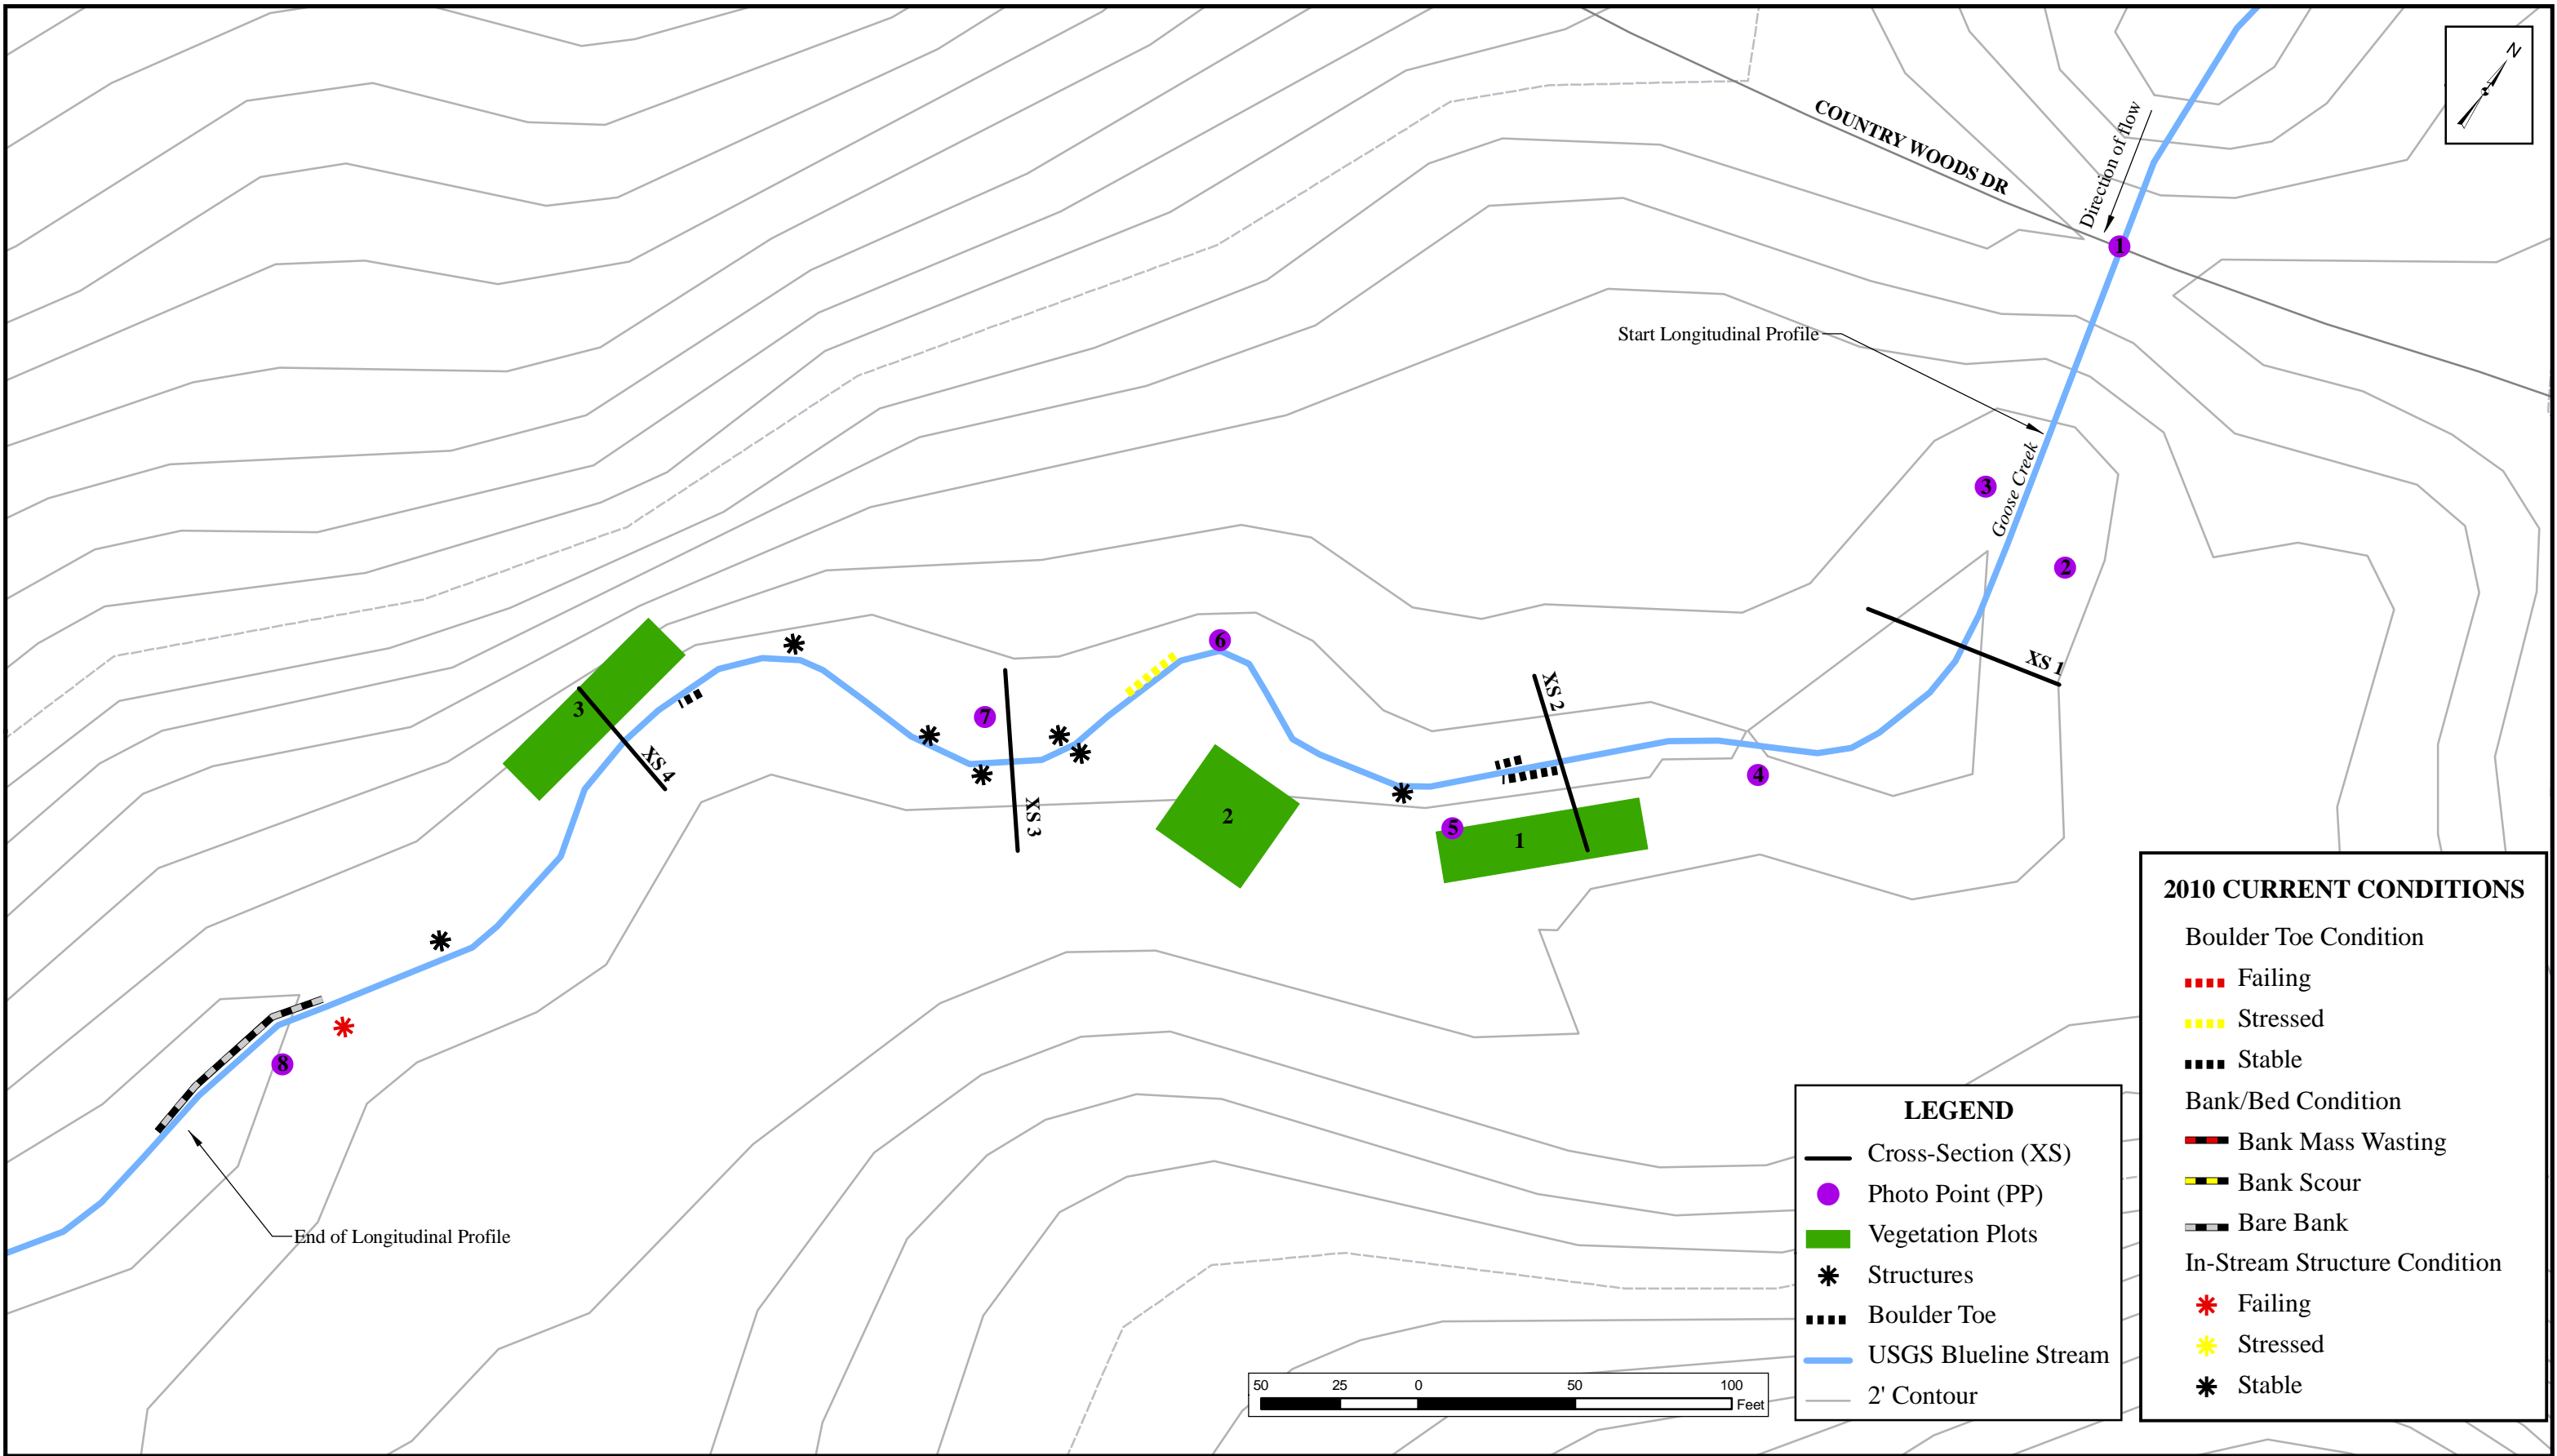
APPENDIX 1.2
 CURRENT CONDITION PLAN VIEW

Results from the 2010 stream monitoring effort indicate that stream pattern, profile, and dimension of Goose Creek is maintaining vertical and lateral stability with minimal problem areas. Areas along the stream enhancement reach noted with bare banks appear to be stabilized by the roots of larger trees established on the banks. These areas will continue to be monitored closely for significant adjustments in the bank, bed features, and channel thalweg.

Near station 4+00 feet (ft), a debris jam that has formed has temporarily affected the profile. This change in the profile is not a significant change that appears to be permanent. The debris jam and accumulated sediment will probably be flushed out of the system with future rain events. Other areas that are being watched include a stressed boulder toe with dislodged boulders and a failed structure at the end of the project that is no longer providing adequate bank protection. This structure is not providing the intended protection as it has become dislodged, and the neighboring bank has exhibited bank erosion. The structure may need to be removed.

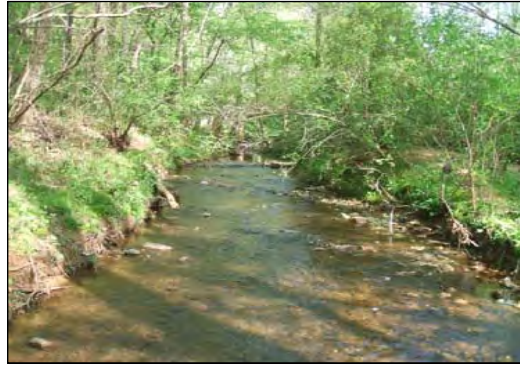
XS-1: View Upstream

SUMMARY DATA	
Bankfull Elevation (ft)	95.80
Bankfull Cross-Sectional Area (ft²)	107.95
Bankfull Width (ft)	43.82
Flood Prone Area Elevation (ft)	99.91
Flood Prone Width (ft)	>100
Bankfull Mean Depth (ft)	2.46
Bankfull Max Depth (ft)	4.11
W/D Ratio	17.81
Entrenchment Ratio	>2.2
Bank Height Ratio	2.00

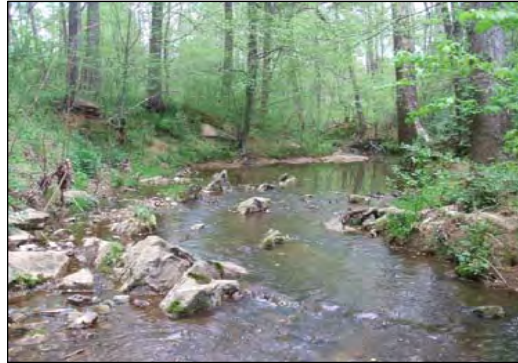
XS-2: View Upstream

SUMMARY DATA	
Bankfull Elevation (ft)	95.73
Bankfull Cross-Sectional Area (ft²)	105.22
Bankfull Width (ft)	31.89
Flood Prone Area Elevation (ft)	100.68
Flood Prone Width (ft)	>100
Bankfull Mean Depth (ft)	3.30
Bankfull Max Depth (ft)	4.95
W/D Ratio	9.66
Entrenchment Ratio	~3.14
Bank Height Ratio	2.00

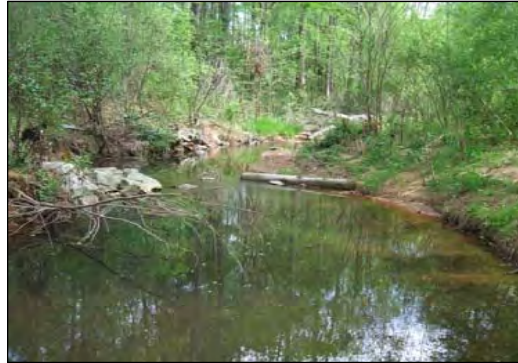
XS-3: View Upstream

SUMMARY DATA	
Bankfull Elevation (ft)	94.14
Bankfull Cross-Sectional Area (ft²)	106.68
Bankfull Width (ft)	33.33
Flood Prone Area Elevation (ft)	99.25
Flood Prone Width (ft)	N/A
Bankfull Mean Depth (ft)	3.20
Bankfull Max Depth (ft)	5.11
W/D Ratio	10.42
Entrenchment Ratio	N/A
Bank Height Ratio	2.00

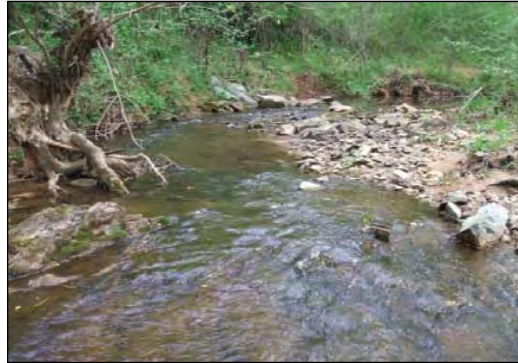
XS-4: View Upstream

SUMMARY DATA	
Bankfull Elevation (ft)	94.23
Bankfull Cross-Sectional Area (ft²)	104.53
Bankfull Width (ft)	27.27
Flood Prone Area Elevation (ft)	100.11
Flood Prone Width (ft)	N/A
Bankfull Mean Depth (ft)	3.83
Bankfull Max Depth (ft)	5.88
W/D Ratio	7.12
Entrenchment Ratio	N/A
Bank Height Ratio	2.00
