**UT Goose Creek (Greene Mitigation)
Stream Enhancement Project
EEP Project No. 92709
2011 Monitoring Report: Year 3**

**Construction Completed: February 2005
Submission Date: April 2012**

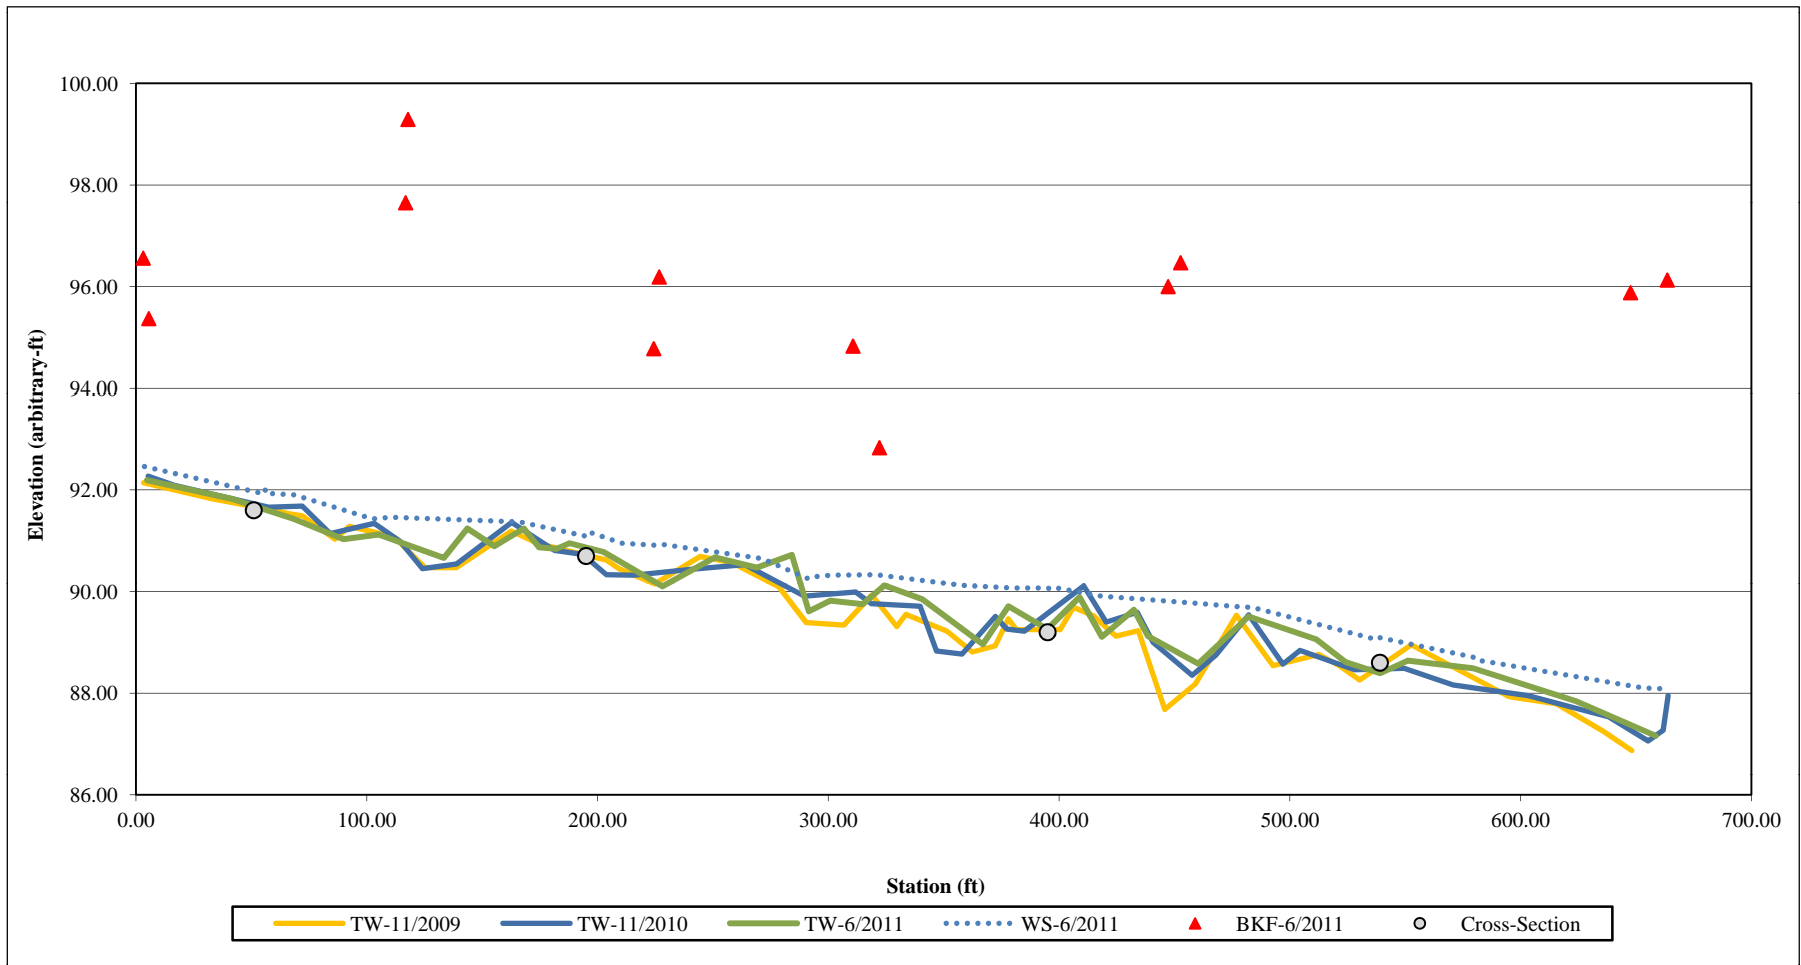
Near station 4+00 feet (ft), a debris jam has formed and has temporarily affected the profile. This profile adjustment is most likely temporary. It is anticipated that the debris jam and accumulated sediment will be flushed from the system during future rain events. Other areas that are of some concern include a stressed boulder toe with dislodged boulders and a failing vane structure at the end of the project that is no longer providing adequate bank protection. This structure has become dislodged and is redirecting flow from the thalweg to the outside meander bend. The change in flow vector is resulting in bank erosion, which is compromising bank stability. The structure may need to be adjusted to regain proper functionality or be removed.
