Gray Farm Stream Restoration Monitoring Report – Year One

Contract # D05016-2

Iredell County, North Carolina

March 2007

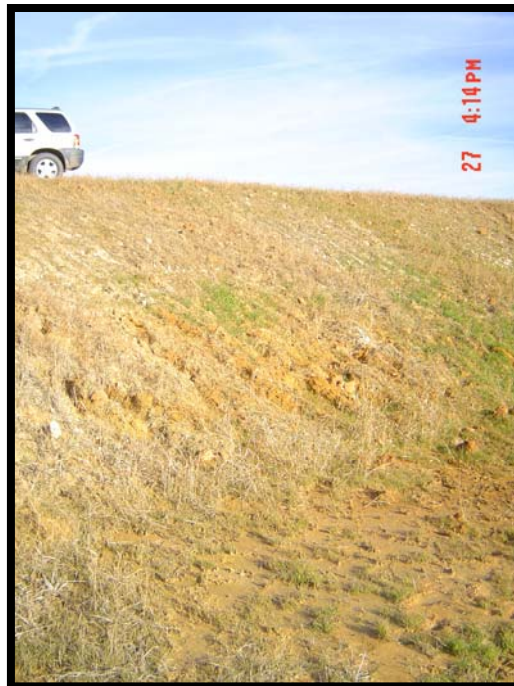
During a field inspection on November 27, 2006, a total of five localized areas of bare floodplain were observed. On Reach 1, three insignificant areas were observed, which appear to be due to surface flows creating small rills in the ground surface. These areas are shown on sheets 6 through 9.

Reach 1			
Feature/Issue	Station # / Range	Probable Cause	Photo #
Bare Flood Plain	5+10 - 5+50	Surface flow	1
	6+60 - 7+00	Surface flow	
	51+50 - 52+75	Surface flow	
Reach 2			
Feature/Issue	Station # / Range	Probable Cause	Photo #
Bare Flood Plain	2+40 - 2+65	Poor soil quality	2
	2+75 - 3+15	Poor soil quality

Typical Bare Bench/Floodplain—Reach 1—Year 1 (2006)

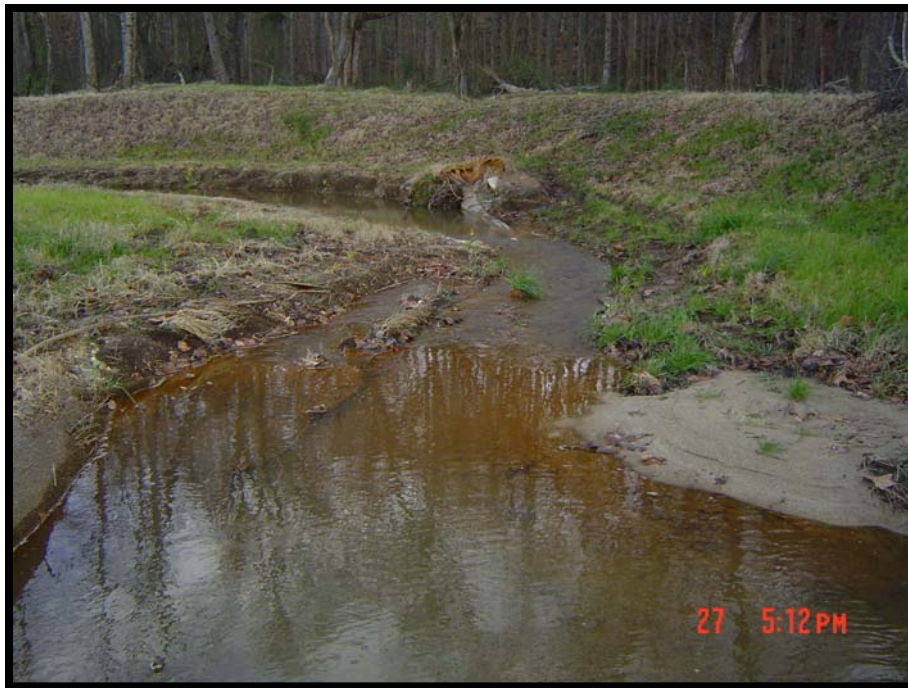
An assessment of channel stability was also performed on November 27, 2006, by S&EC. Areas of concern that were observed and documented included some minor localized bank scour and a single stressed structure. These problem areas are shown on Sheets 6 through 9 for Reach 1 and Sheets 14 through 16 for Reach 2 (Problem Area Plan View).

Exhibit Table B1a - Stream Problem Areas Gray Farm Stream and Wetland Restoration Site/EEP Project #XXXXXX Reach 1			
Feature Issue	Station numbers	Suspected Cause	Photo number
Bank Scour	5+30	Surface flow	1
	6+85	Surface flow	
	41+30	Downcutting Left Bank	
	41+30	Downcutting Right Bank	
	48+75	Structure geometry incorrect

Typical Bank Scour—Reach —Year 1 (2006)

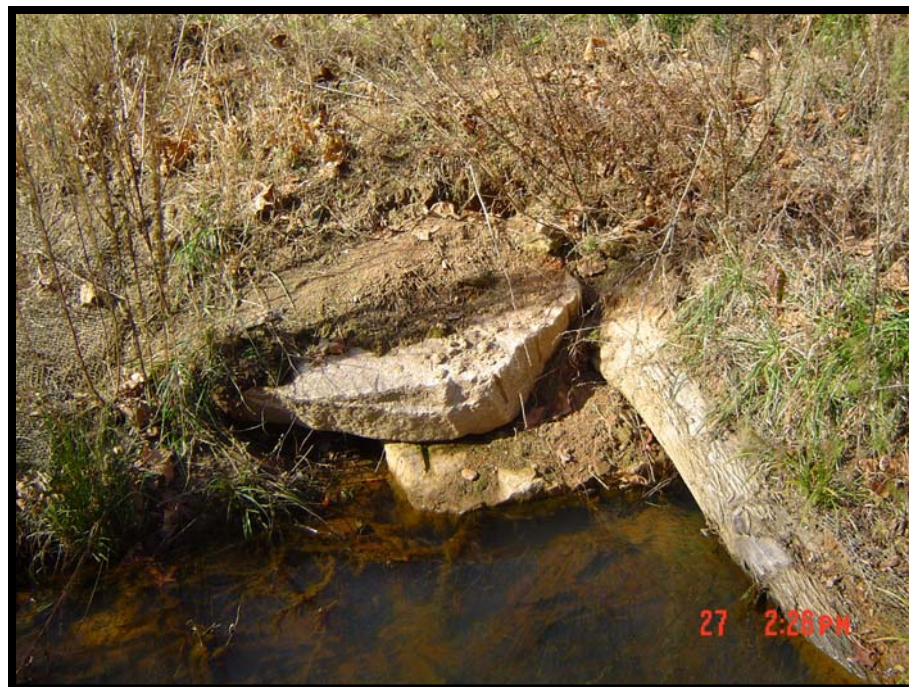
Exhibit Table B1b - Stream Problem Areas Gray Farm Stream and Wetland Restoration Site/EEP Project #XXXXXX Reach 2			
Feature Issue	Station numbers	Suspected Cause	Photo number
Bank Scour	17+60	Stressed structure – rock shift	2
Structures	17+60	Stressed structure – rock shift

Typical Stressed Structure/Bank Scour—Reach 2—Year 1 (2006)

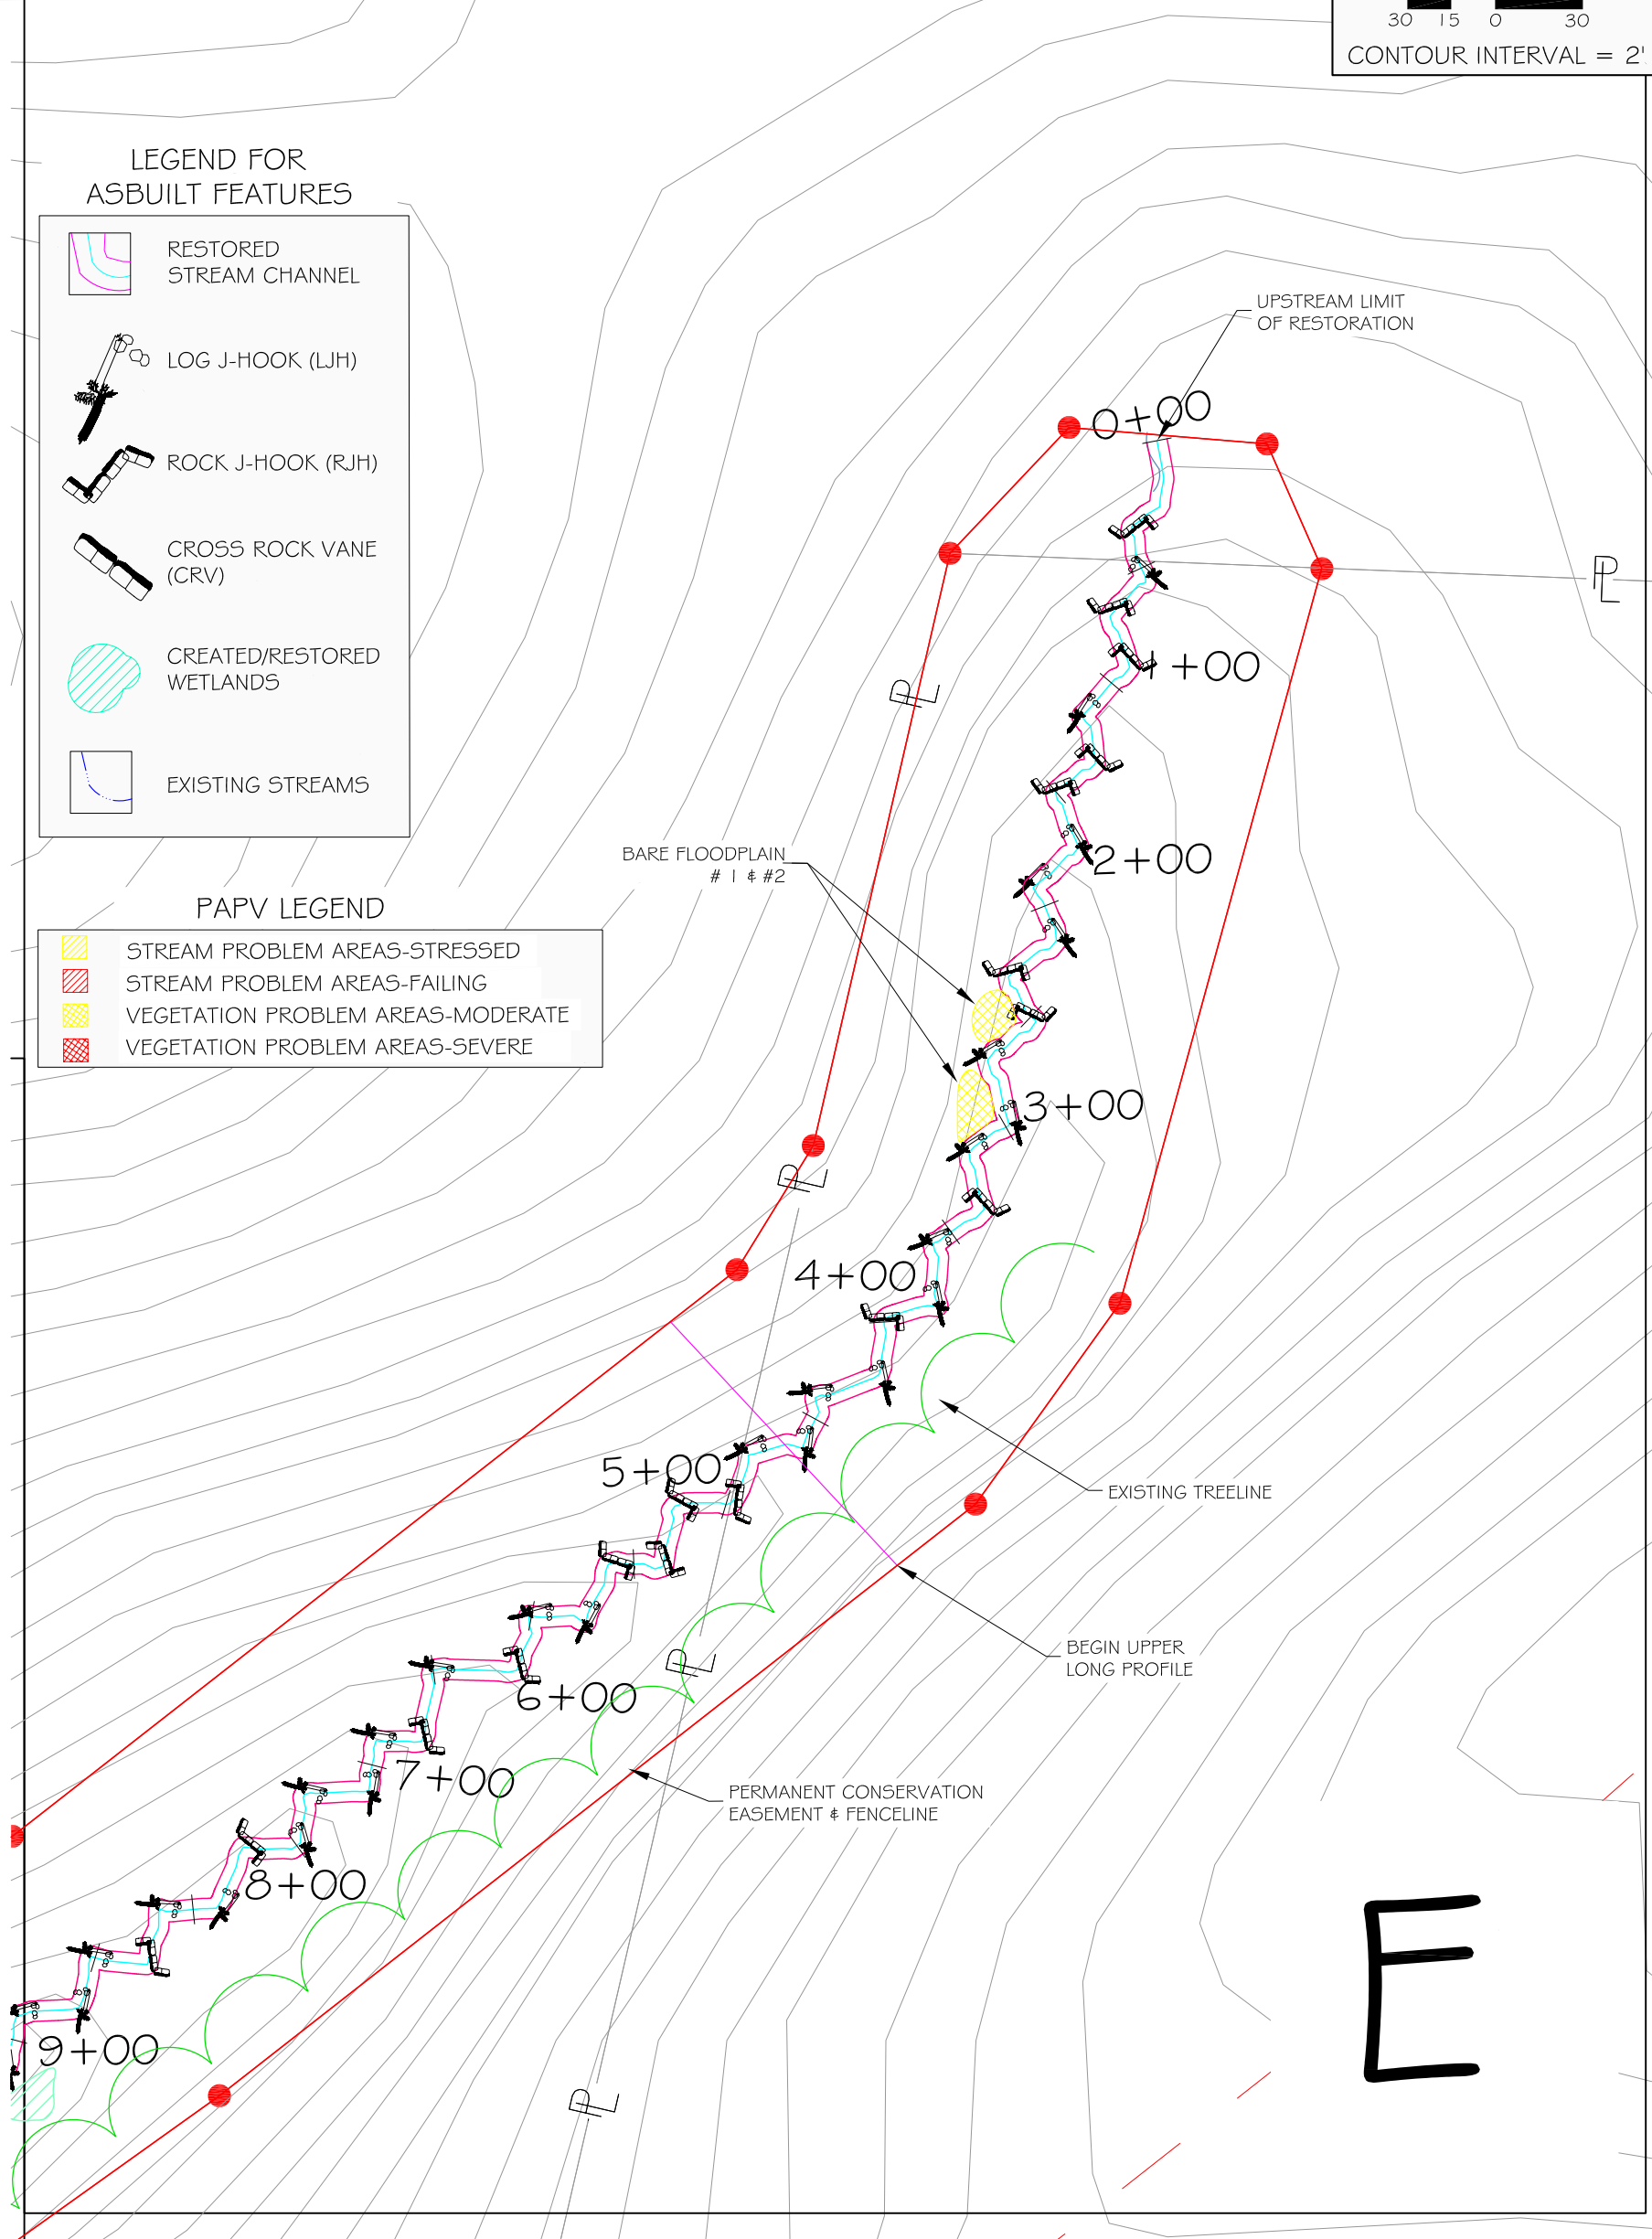
REACH 2 PROBLEM AREA PLAN VIEW - E

On Reach 2, two insignificant areas of bare floodplain were observed. These appear to be due to localized poor soils which have inhibited plant growth on the floodplain and are shown on Sheets 14 through 16. Photos are included in Appendix A.
