Gray Farm Stream Restoration Monitoring Report – Year Two

**Contract # D05016-2
EEP Project # 92219**

Iredell County, North Carolina

December 2007

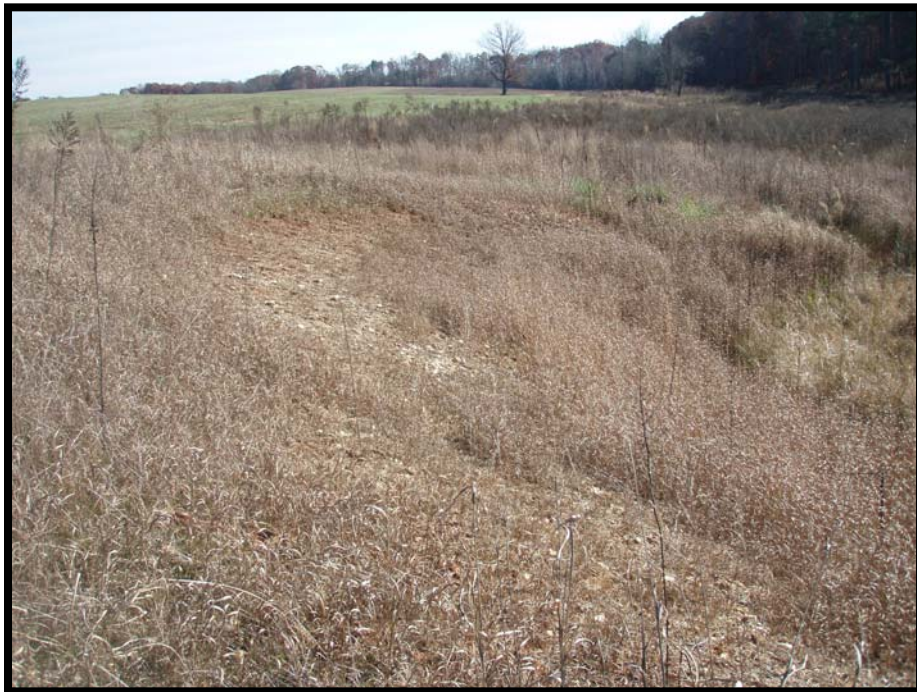
During a field inspection on November 27 & 28, 2007, a total of twelve localized areas of bare banks and floodplain were observed on Reaches 1 and 2. These areas appear to be due primarily to either surface flows or poor soil conditions. Drought conditions during the growing season have likely contributed as well. These areas are shown on Sheets 6 through 9 (Reach 1) and Sheets 14 through 16 (Reach 2). Photos are included in Appendix A.

Photo 1—Typical Bare Bench/Floodplain—Reach 1—Year 2 (2007)

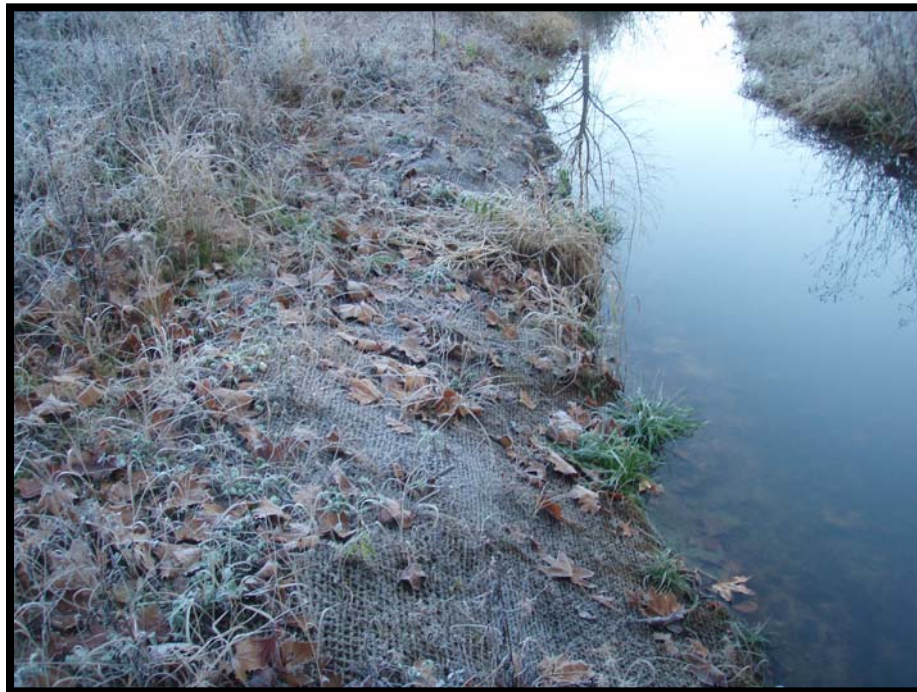
Photo 3—Typical Bare Bank—Reach 1—Year 2 (2007)

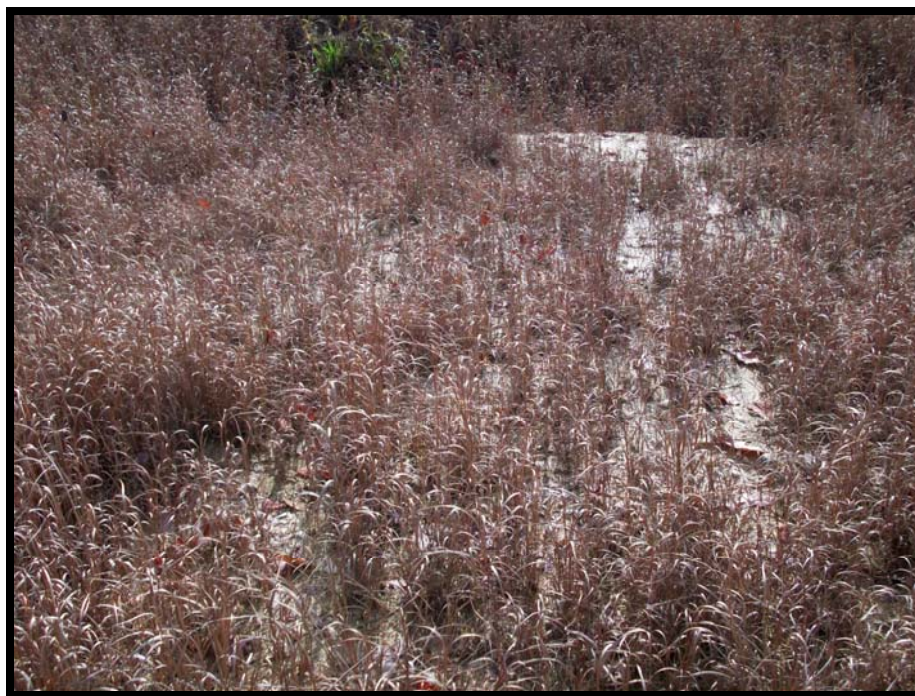
The dense herbaceous vegetation at the lower end of Reach 2 combined with the steep slope and drought conditions have severely stressed planted tree species and caused their slow establishment. This area will be monitored closely and, if necessary, recommendations will be made for management or supplemental planting.

Photo 5—Typical Bare Bench/Floodplain—Reach 2—Year 2 (2007)

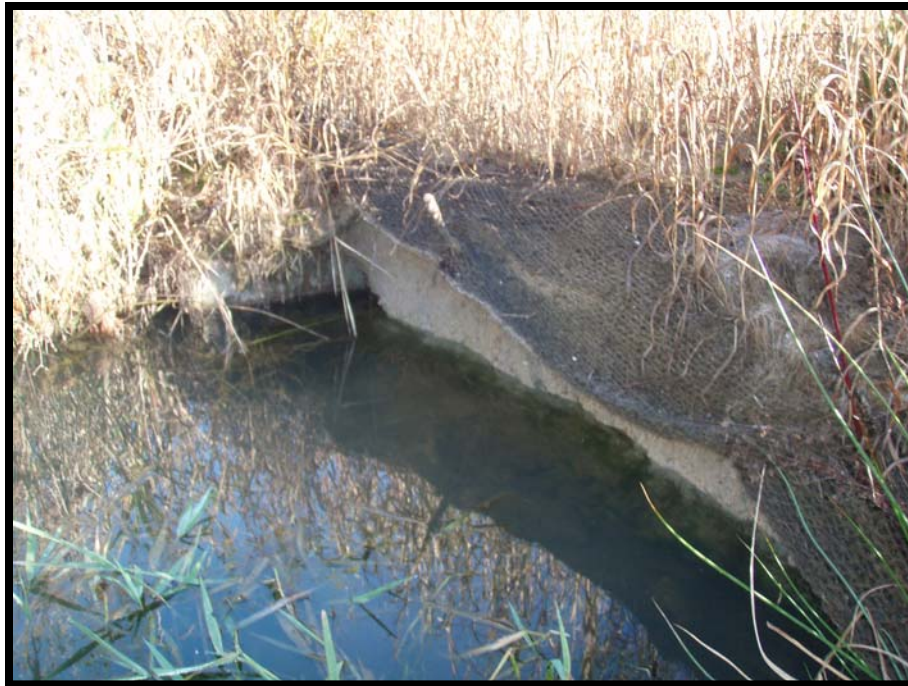
An assessment of channel stability was also performed on November 27 & 28, 2007, by S&EC. Areas of concern that were observed and documented included some minor localized bank scour and four stressed structures. Detail of such scour is evidenced in cross-section 6 (pool). These problem areas are shown on Sheets 6 through 9 for Reach 1 and Sheets 14 through 16 for Reach 2 (Problem Area Plan View).

Photo 1—Typical Bank Scour—Reach 1—Year 2 (2007)
