# **Gray Farm Stream Restoration Monitoring Report – Year Three**

**Contract # D05016-2  
EEP Project # 92219**

**Iredell County, North Carolina**

**December 2008**

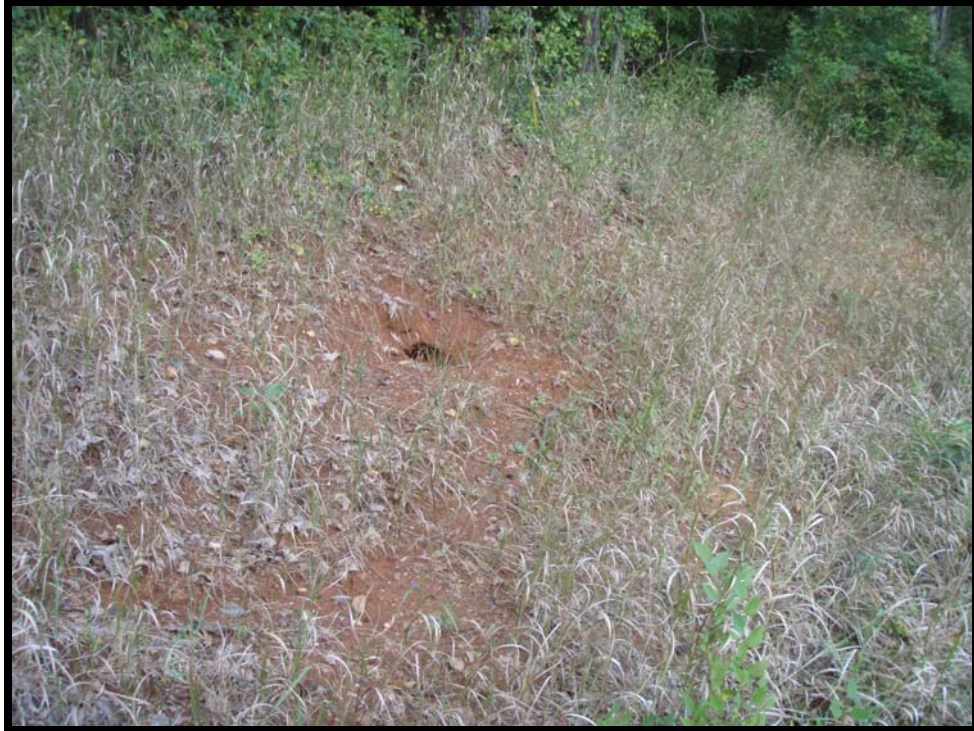
During field inspections on May 19<sup>th</sup>, September 17<sup>th</sup> and November 19<sup>th</sup> and 20<sup>th</sup>, 2008, a total of fourteen localized areas of bare bank and floodplain were observed on Reaches 1 and 2. These areas appear to be due primarily to either

**Photo 1 – Typical Bare Bench/Floodplain – Reach 1 – Year 3 (2008)**

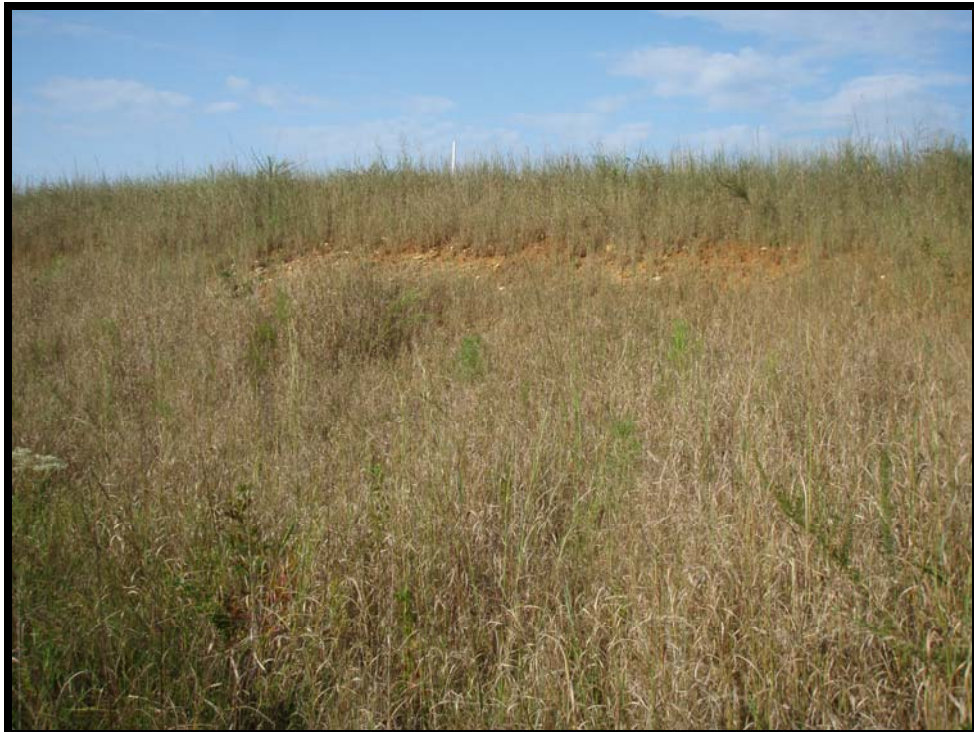
**Photo 2 – Typical Bare Bench/Floodplain – Reach 1 – Year 3 (2008)**

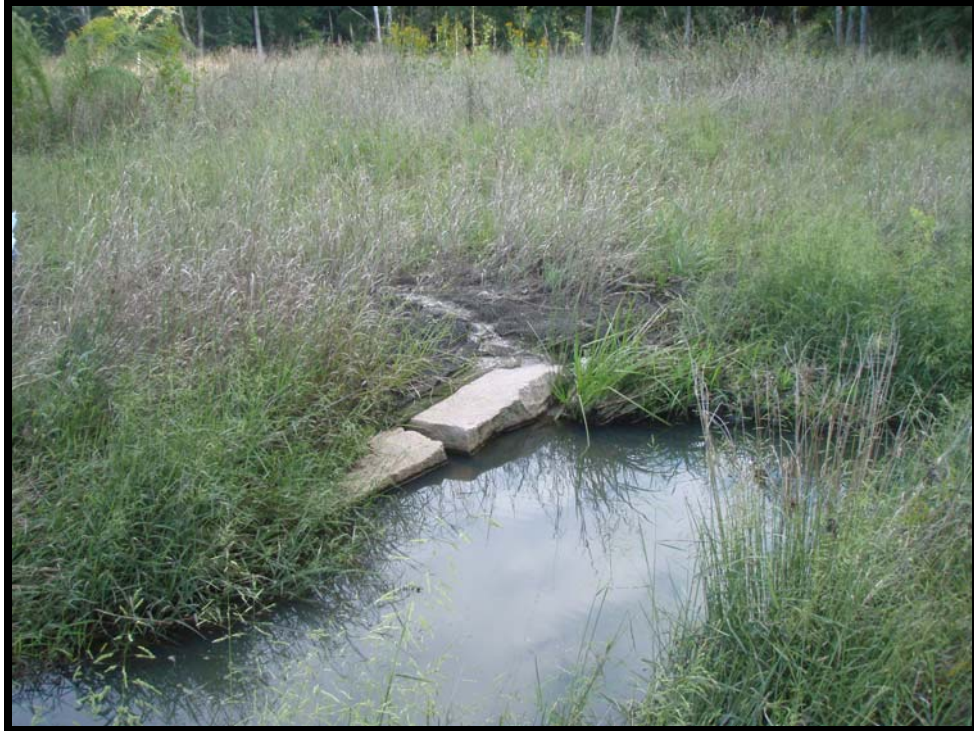
**Photo 3 – Typical Bare Bank – Reach 1 – Year 3 (2008)**

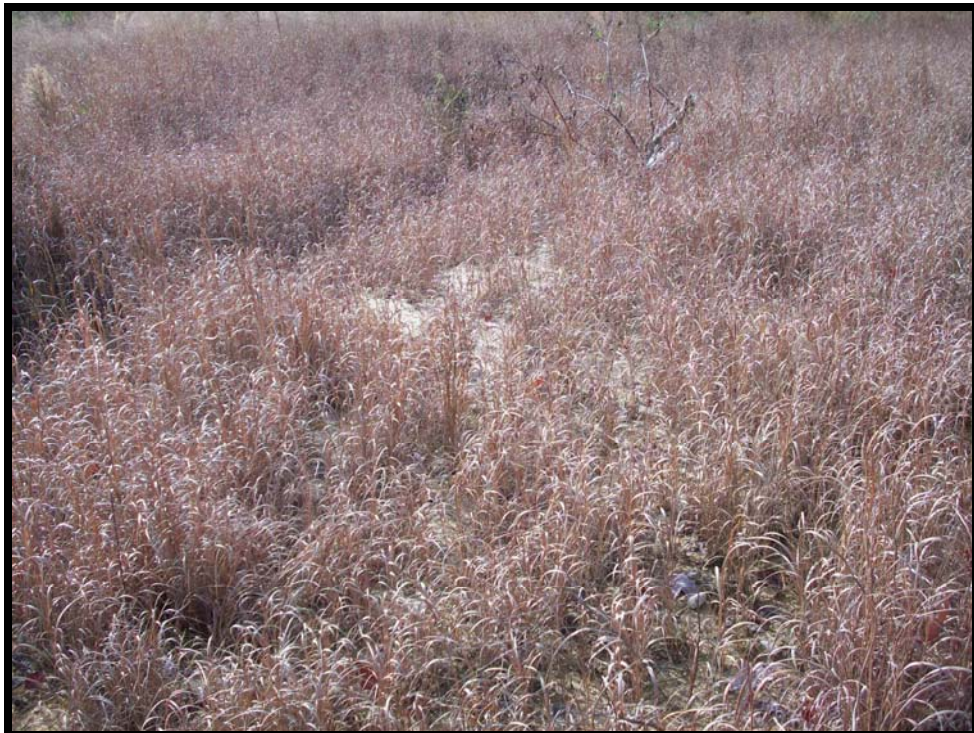
**Photo 4 – Typical Bare Bench/Floodplain – Reach 2 – Year 3 (2008)**

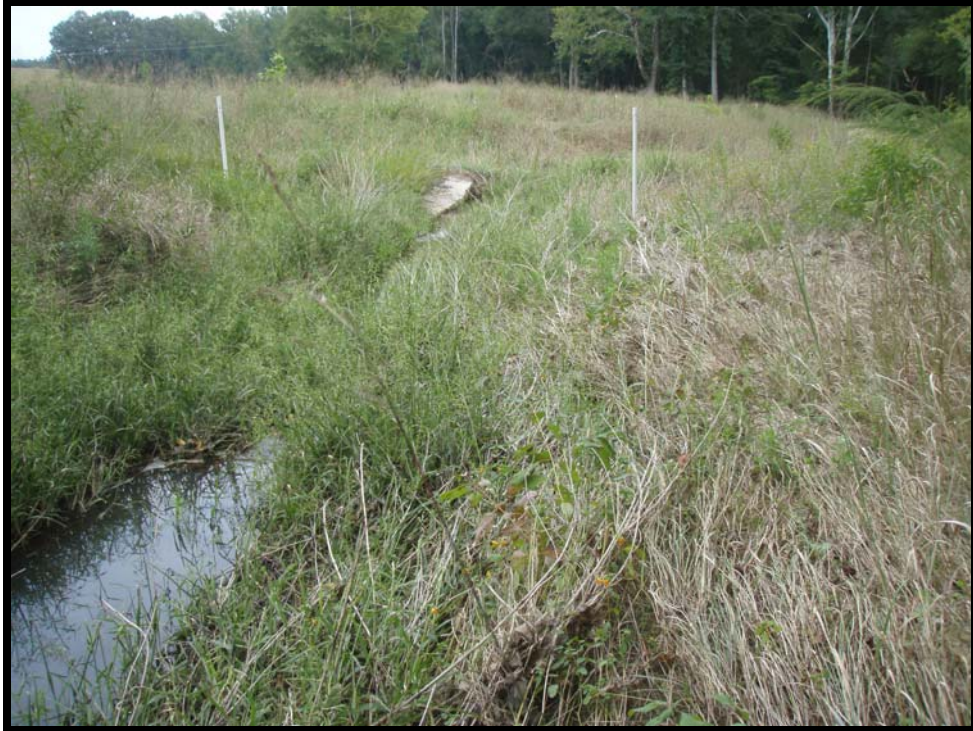
**Photo 1 – Reach 1 – Flattened Vegetation from Surface Flow**

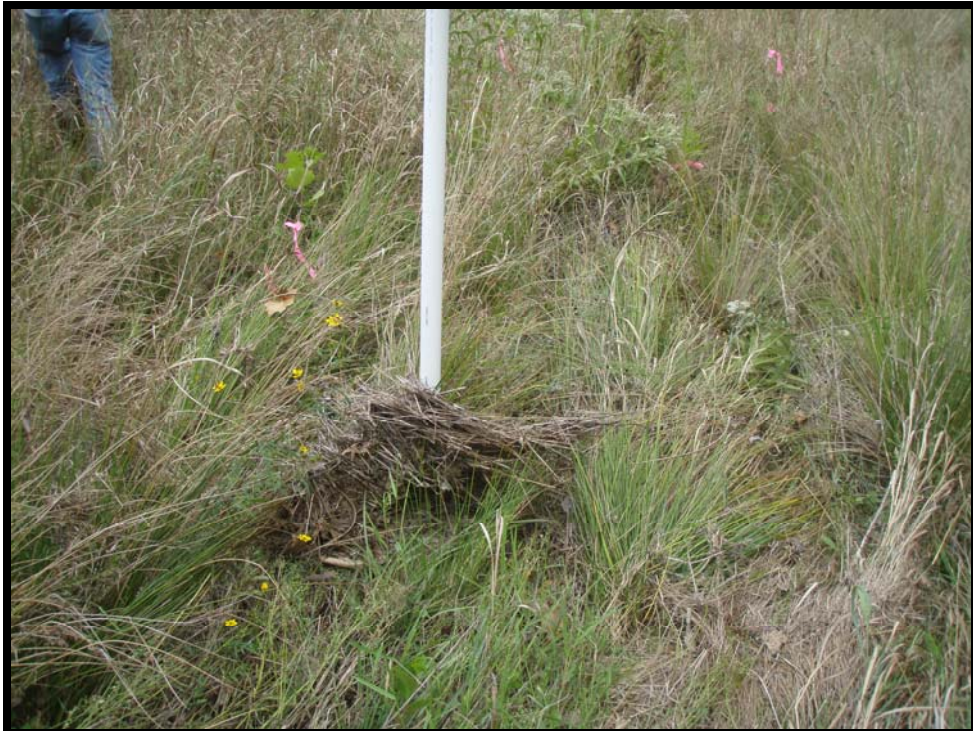
**Photo 2 – Reach 1 – Wrack Pile at Corner of Buffer Monitoring Plot 3**

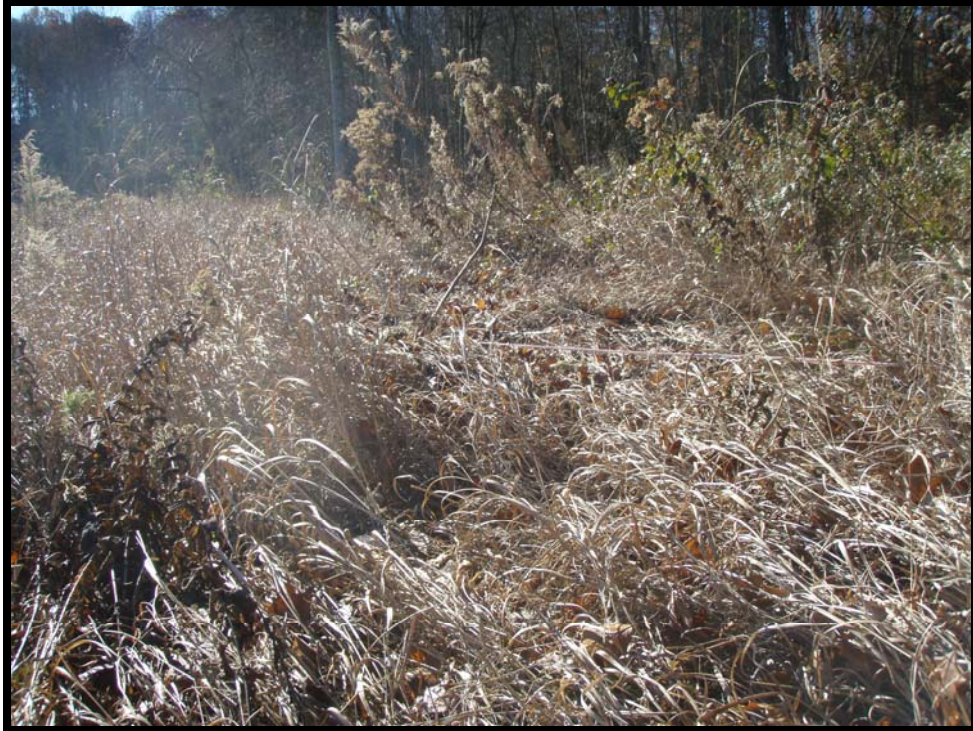
**Photo 3 – Reach 1 – Flattened Vegetation from Surface Flow**

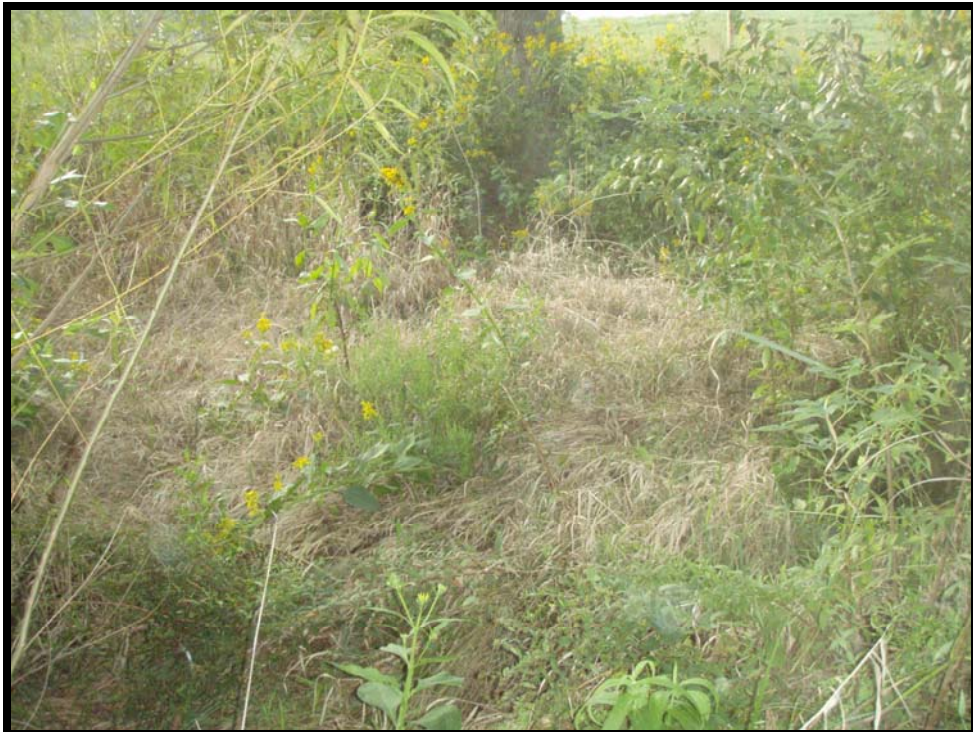
**Photo 4 – Reach 2 – Flattened Vegetation from Surface Flow**

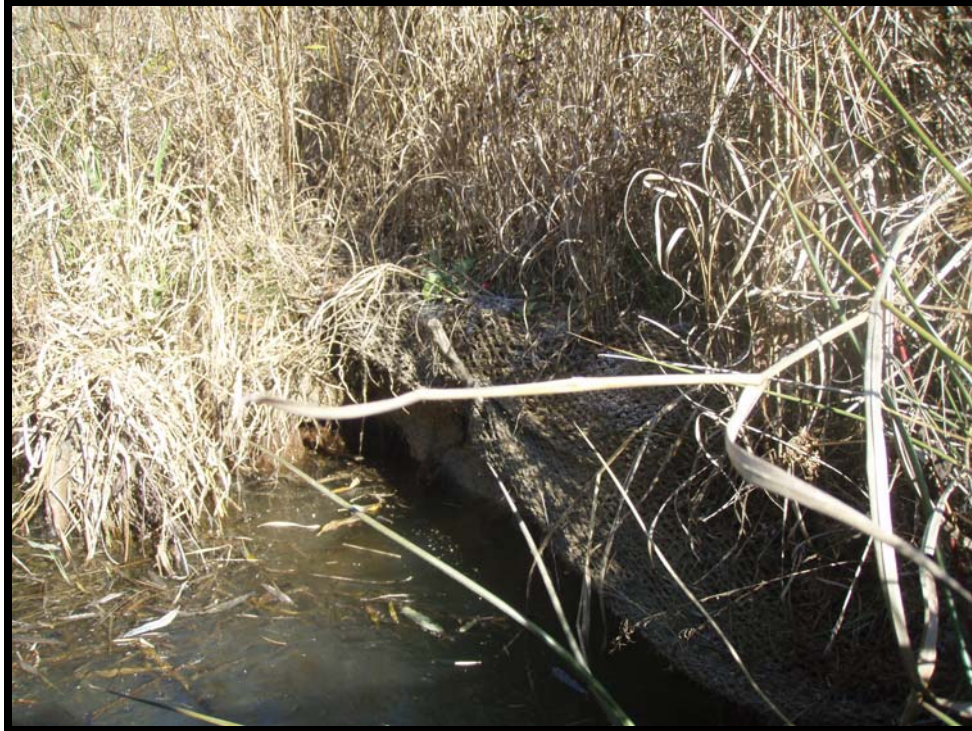
An assessment of channel stability was also performed on November 19<sup>th</sup> and 20<sup>th</sup>, 2008. Areas of concern that were observed and documented included some minor localized bank scour, buried structures, and stressed structures. Detail of such scour is evident in cross-section 6 (pool). These problem areas are shown on Sheets 6 through 9 for Reach 1 and Sheets 14 through 16 for Reach 2 (Problem Area Plan View). The minimal extent of scour and erosion around structures does not warrant repair at this time.

**Photo 1 – Typical Bank Scour – Reach 1 – Year 3 (2008)**

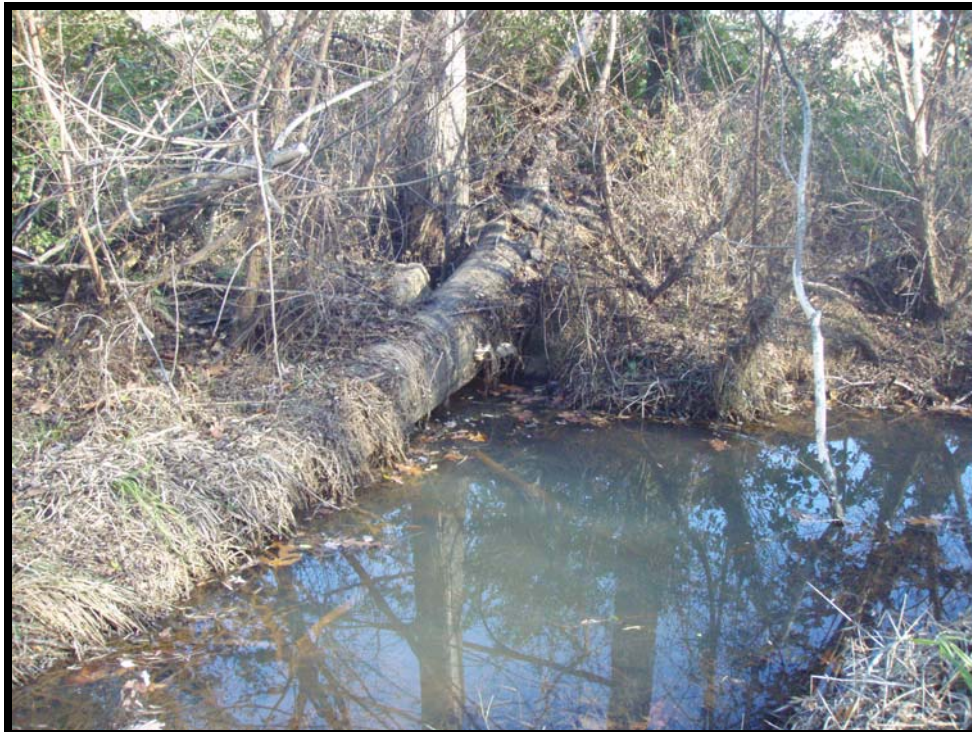
**Photo 2 – Typical Stressed Structure/Bank Scour – Reach 1 – Year 3 (2008)**

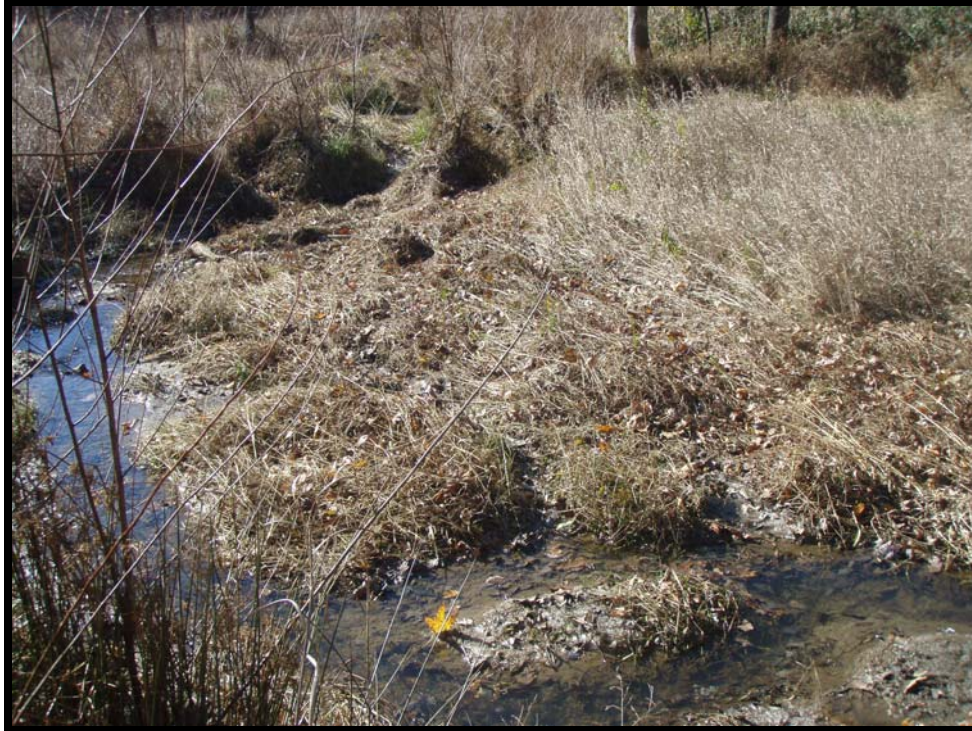
3+00 contains significant sediment, pools have filled, and structures have been buried. From station 3+00 to station 4+50, sediment is present, but less severe, and the riffle-pool sequence is more easily observed. It is important to note that the cattle pasture north of the restoration site is not under the ownership of the Grays.

**Photo 3 – Typical Buried Structure from Off-Site Sediment Source – Reach 1 – Year 3 (2008)**

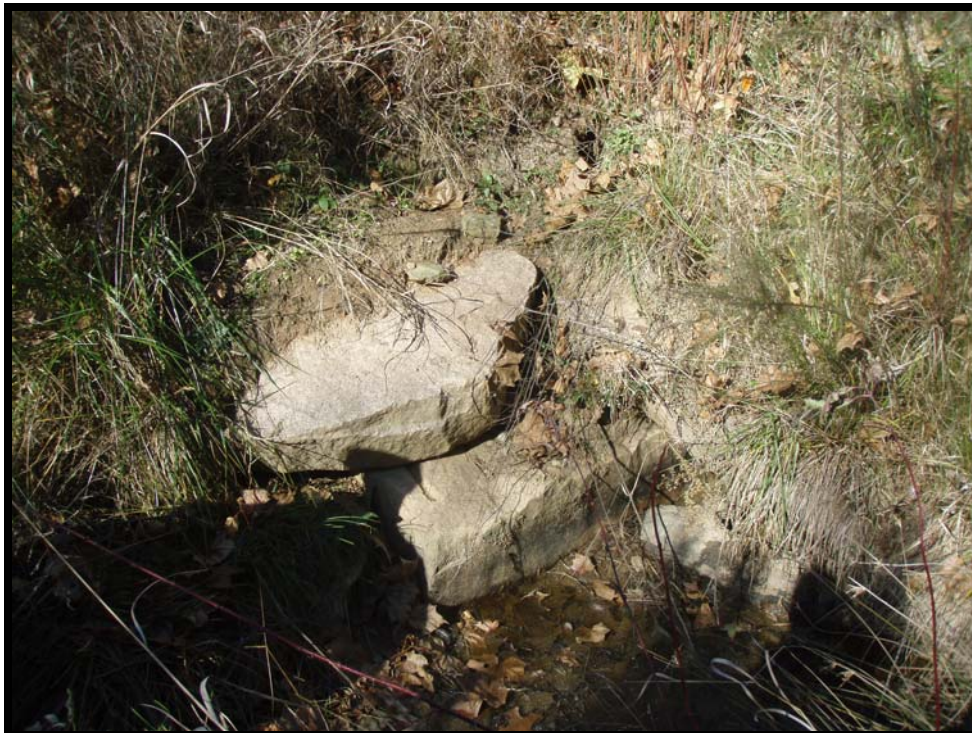
**Photo 4 – Typical Stressed Structure/Bank Scour – Reach 2 – Year 3 (2008)**

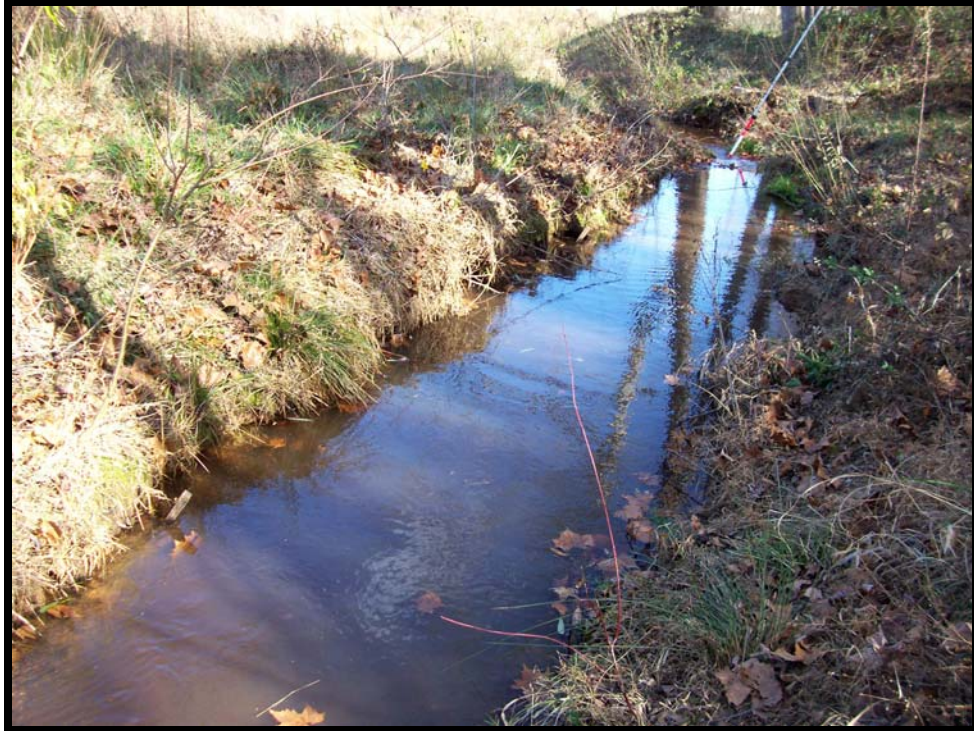
**Photo 5 – Undercut Bank – Reach 1 – Year 3 (2008)**
