Gray Farm Stream Restoration Monitoring Report – Year Four

**Contract # D05016-2
EEP Project # 92219**

Iredell County, North Carolina

December 2009

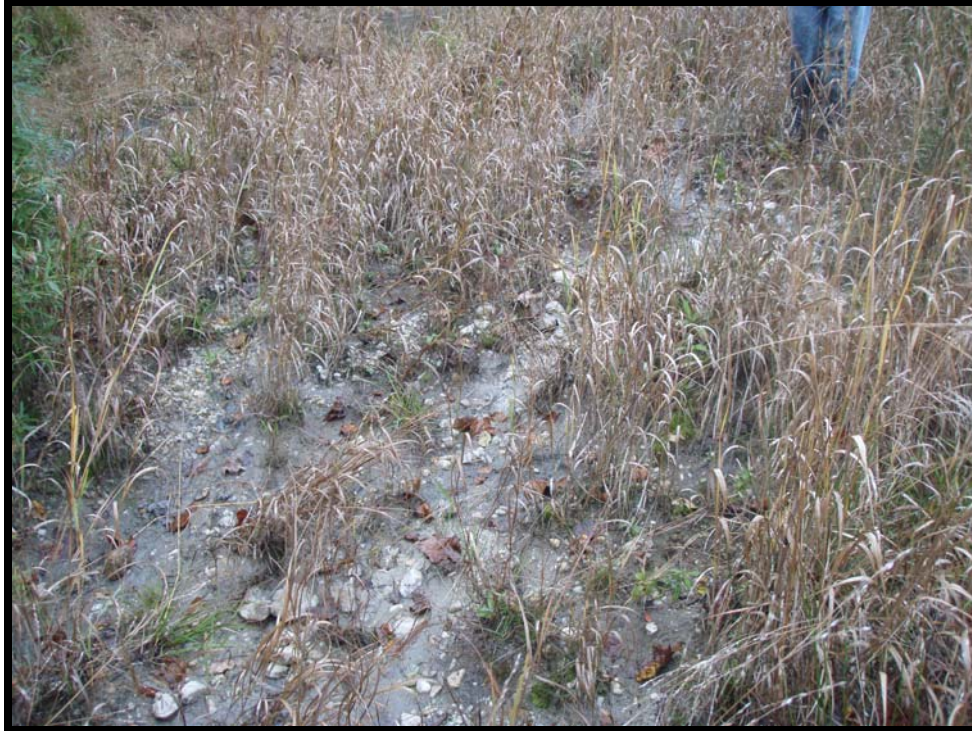
During field inspections on October 27th-29th and November 5th, 2009, a total of six (6) localized areas of bare bank and floodplain were observed on Reach 1. These areas appear to be due primarily to either surface flows or poor soil conditions. Continued revegetation of previously bare areas was observed during Monitoring Year 4, especially within Reach 2. Vegetation Problem Areas are shown on Sheets 6 through 9 (Reach 1). Photos are included in Appendix A.

Photo 1 – Typical Bare Bench/Floodplain – Reach 1 – Year 4 (2009)

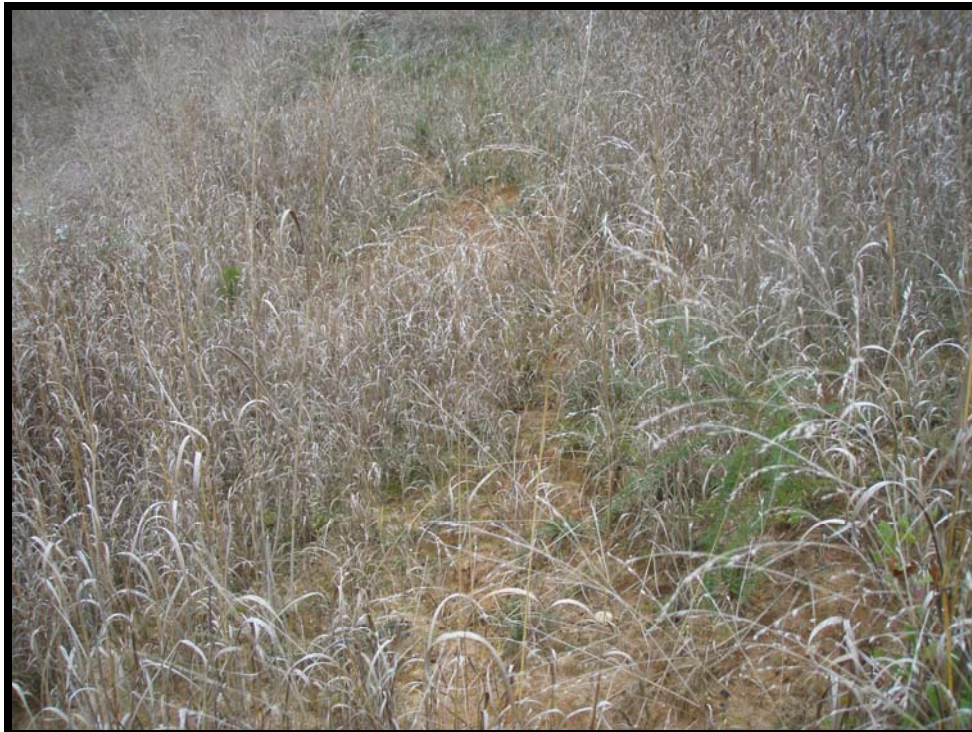
Photo 2 – Typical Bare Bench/Floodplain – Reach 1 – Year 4 (2009)

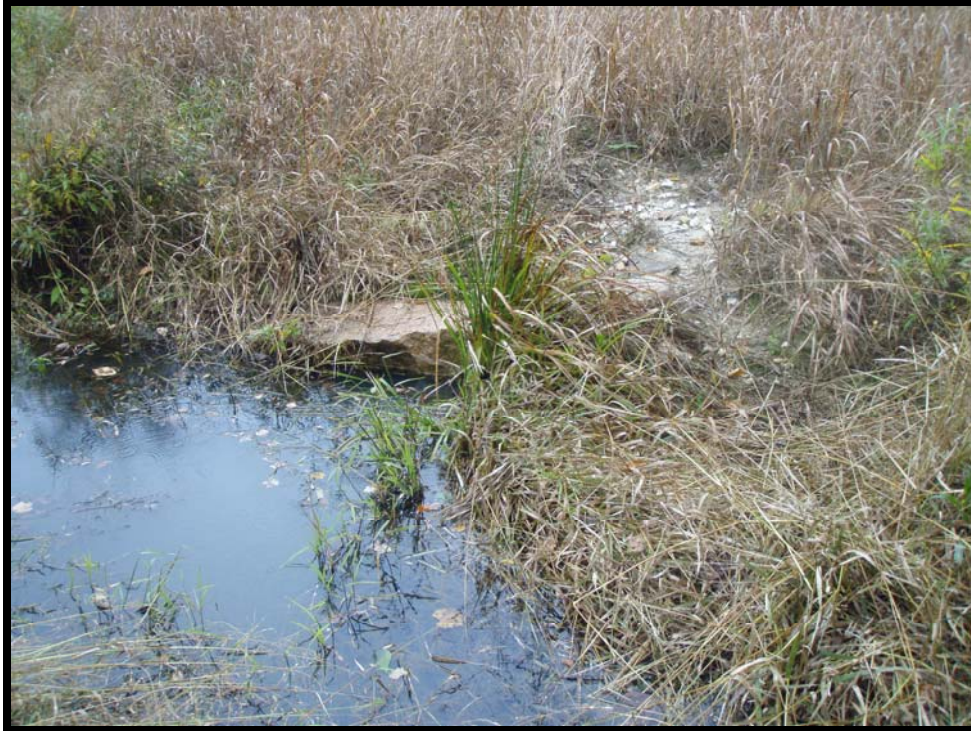
Photo 3 – Typical Bare Bank, Improved from Year 3 – Reach 1 – Year 4 (2009)

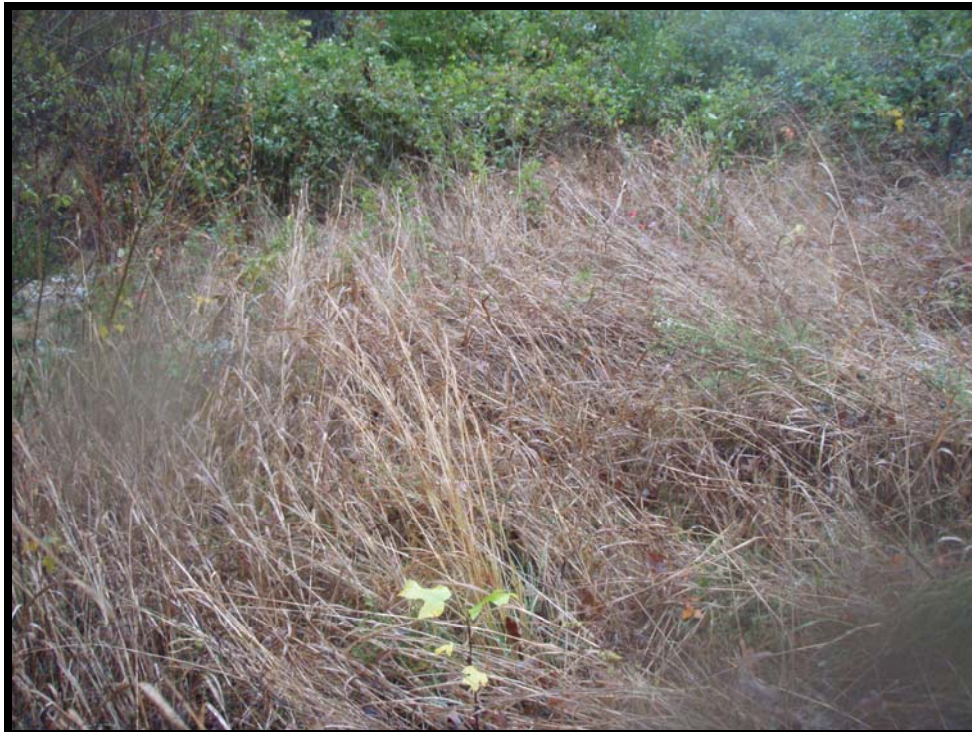
| Reach 2 | | | |
|--|---|---|---|
| Vegetative Problem Areas Improved from Last Year | 21+00 et.al. | Revegetation of previously bare areas | 4 |

Photo 4 – Typical Vegetated Bench/Floodplain, Improved from Year 3 – Reach 2 – Year 4 (2009)

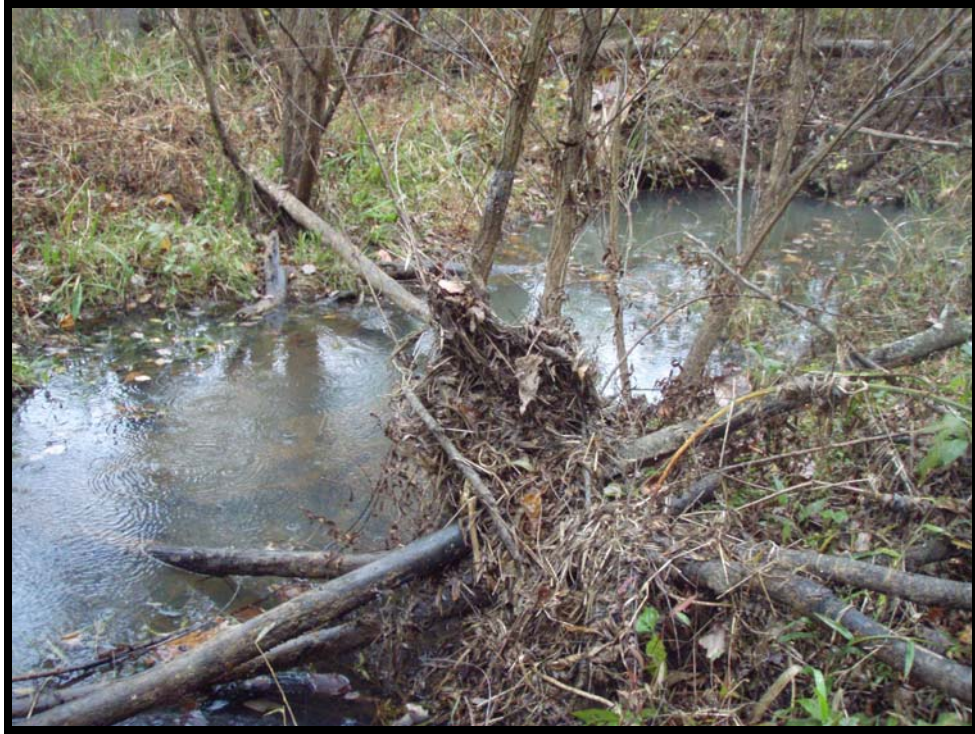
Photo 1 – Reach 1 – Wrack Piles near Cross-section 3

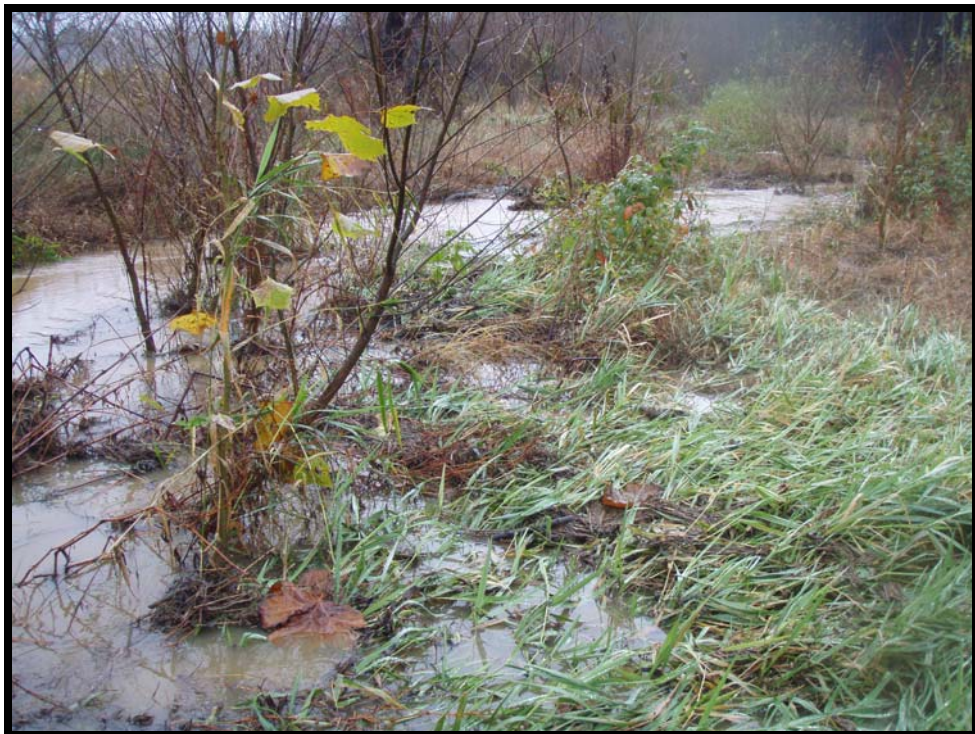
Photo 2 – Reach 1 – Overbank Event 11/11/2009

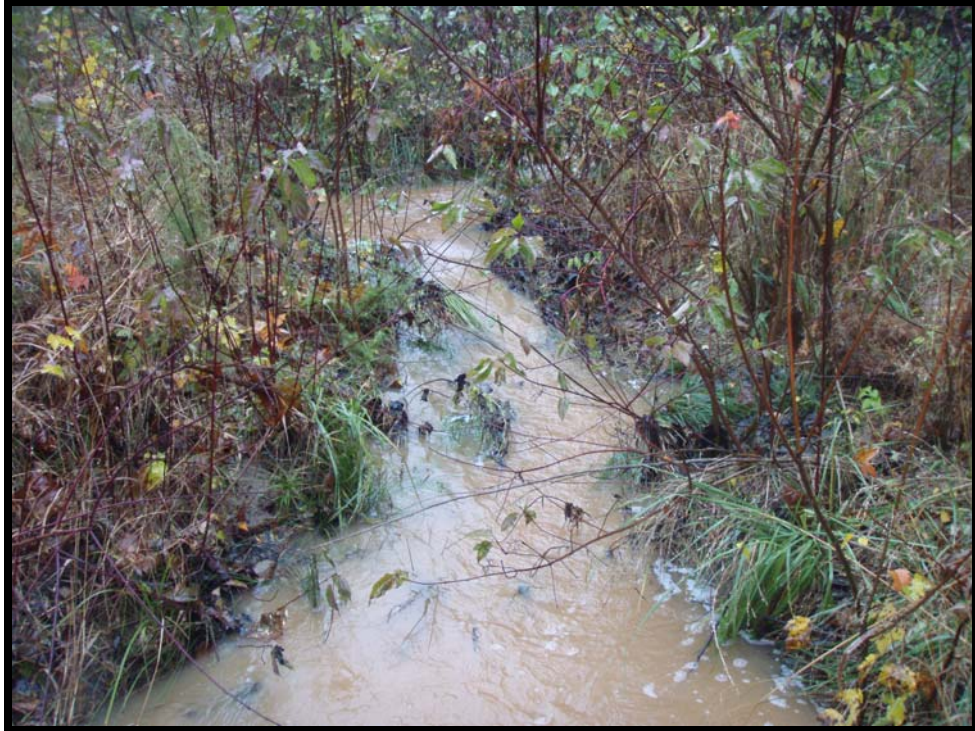
Photo 3 – Reach 2 – Bankfull Event 11/11/2009

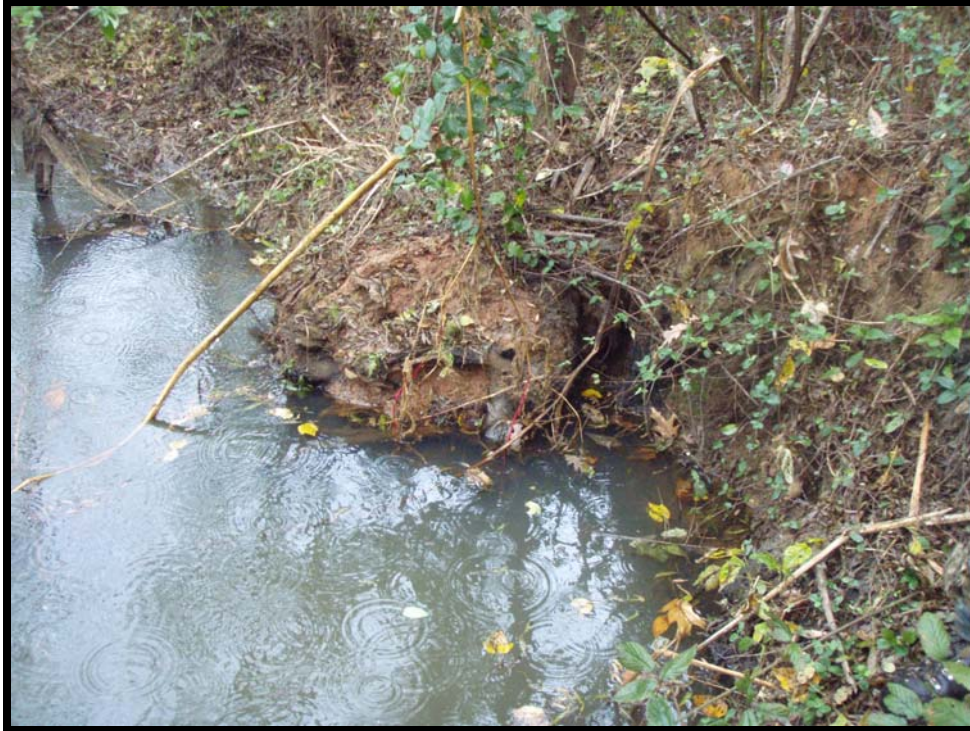
An assessment of channel stability was performed on October 27th, 2009. Areas of concern that were observed and documented included some minor localized bank scour, buried structures, stressed structures, and a single beaver dam. Detail of scour is evident in cross-section 6 (pool). These problem areas are shown on Sheets 6 through 9 for Reach 1 and Sheets 14 through 16 for Reach 2 (Problem Area Plan View). One stressed log J-hook structure at station 41+50 on Reach 1 will need to be repaired and stabilized to fill a scour area behind the structure. With the exception of this structure, the minimal extent of scour and erosion around structures does not warrant repair at this time.

Photo 1 – Typical Stressed Structure/Bank Scour – Reach 1 – Year 4 (2009)

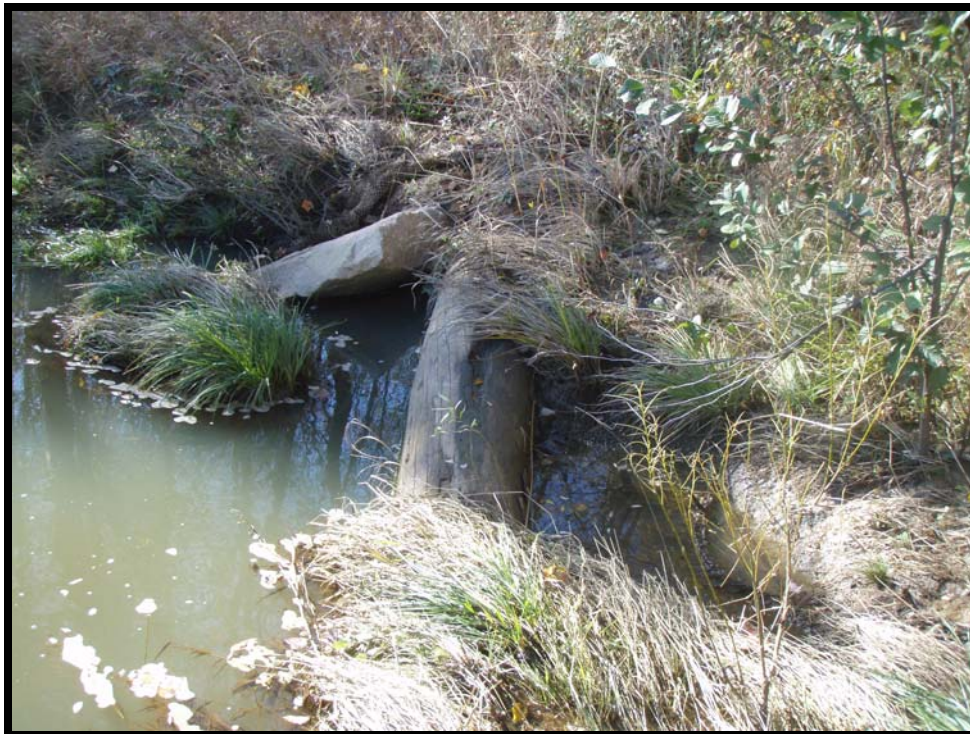
Photo 2 – Typical Stressed Structure/Bank Scour – Reach 1 – Year 4 (2009)

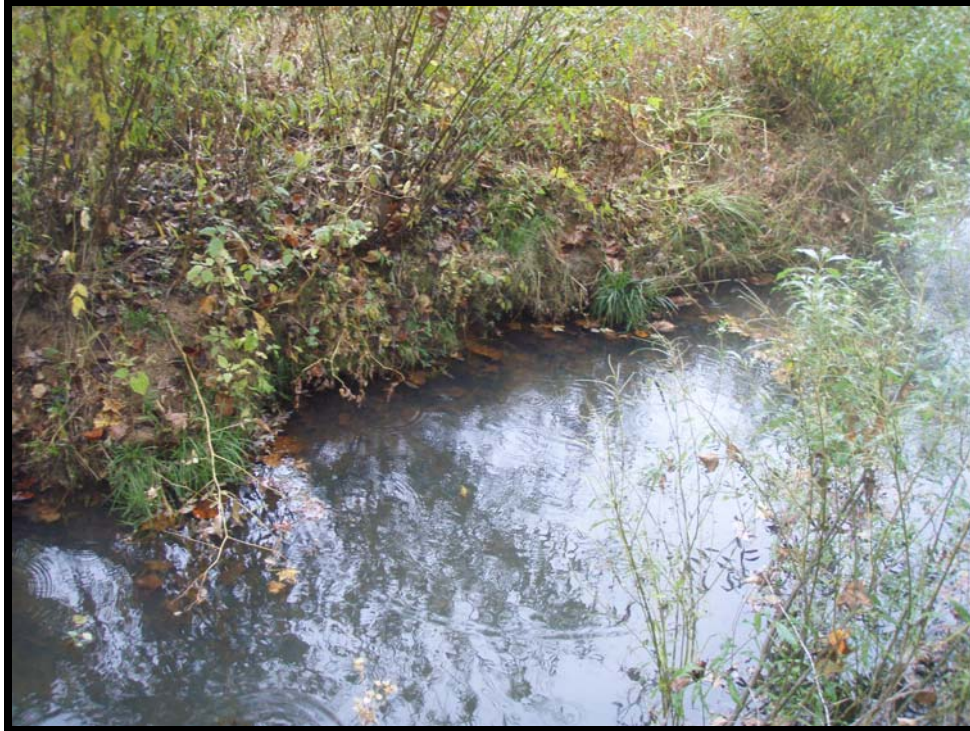
Photo 3 – Typical Undercut Bank – Reach 1 – Year 4 (2009)

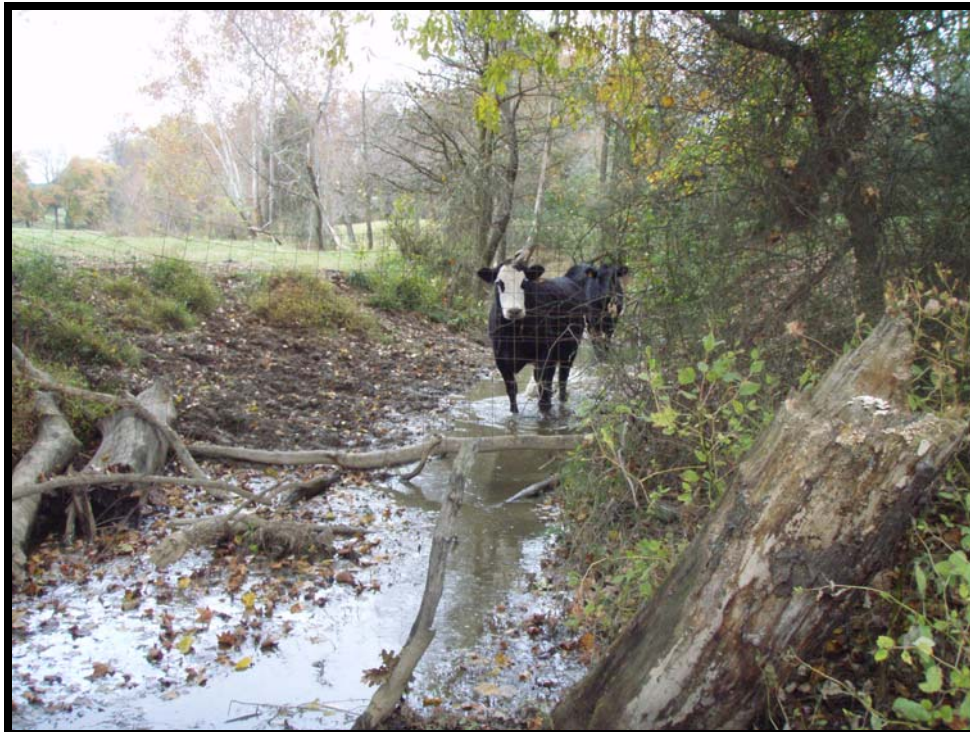
Photo 4 – Sediment from Off-site – Reach 1 near Beginning of Restoration – Year 4 (2009)

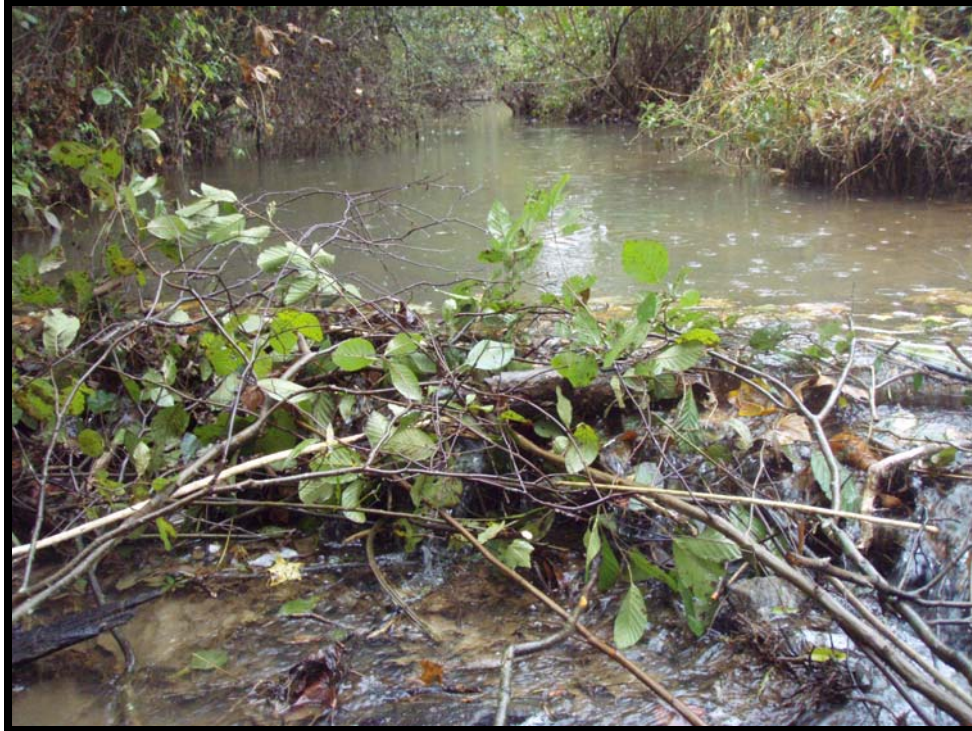
The beaver dam noted on October 27, 2009 at station 56+40 within Reach 1 had raised the water level in the stream to approximately station 53+00, and structures between these two stations were entirely submerged. In order to preserve the restored physical parameters of Reach 1, beavers and their dams will need to be removed from this area.

Photo 5 – Beaver Dam – Reach 1 near End of Restoration – Year 4 (2009)

The above-mentioned structure will be repaired and beavers removed from Reach 1. Other areas will continue to be monitored to ensure that the site continues to exhibit stable conditions and meet the requirements for physical success based on physical success criteria.

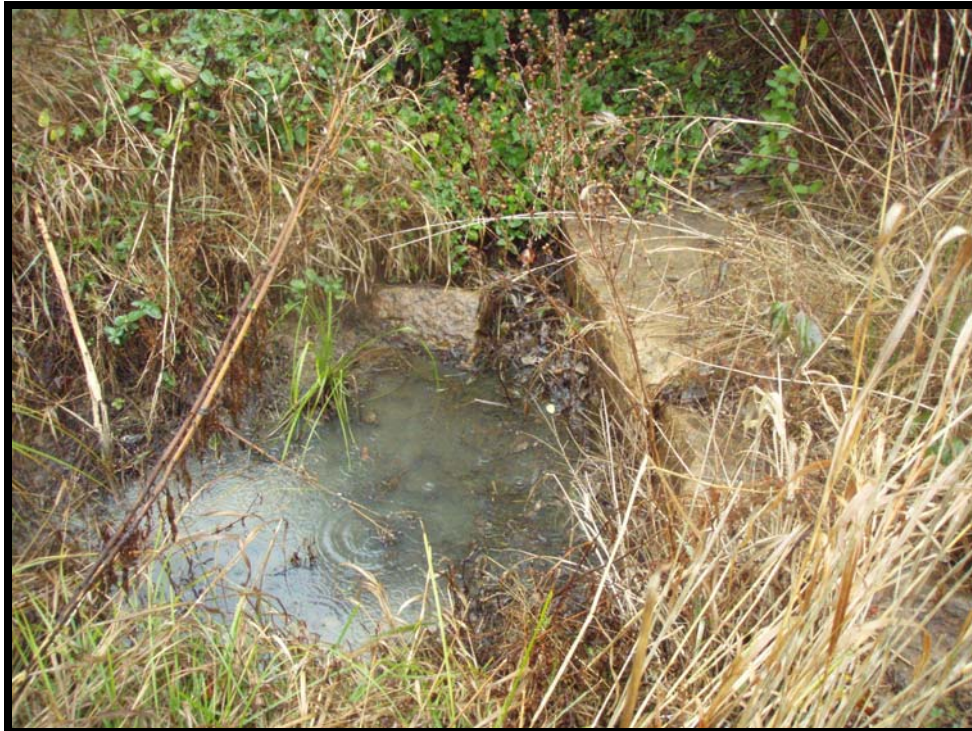
Photo 6 – Typical Stressed Structure/Bank Scour – Reach 2 – Year 4 (2009)

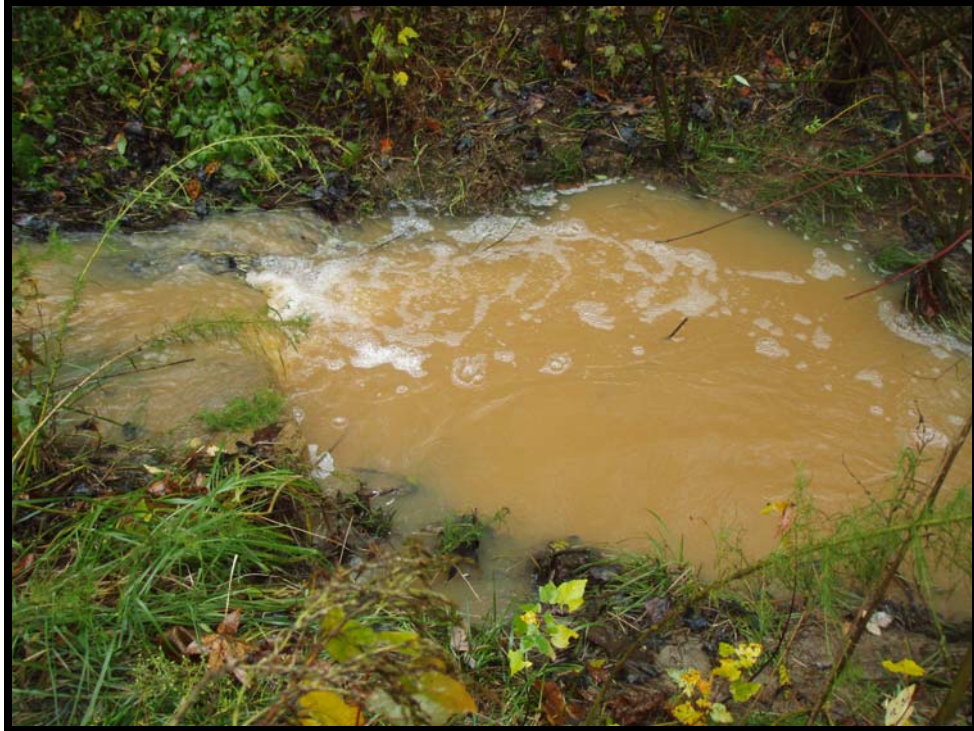
Photo 7 – Area of Channel Scour (Station 16+10 in Long Profile Section 2) – Reach 2 – Year 4 (2009)
