# **Gray Farm Stream Restoration Monitoring Report – Year Five**

**Contract # D05016-2  
EEP Project # 92219**

**Iredell County, North Carolina**

**December 2010**

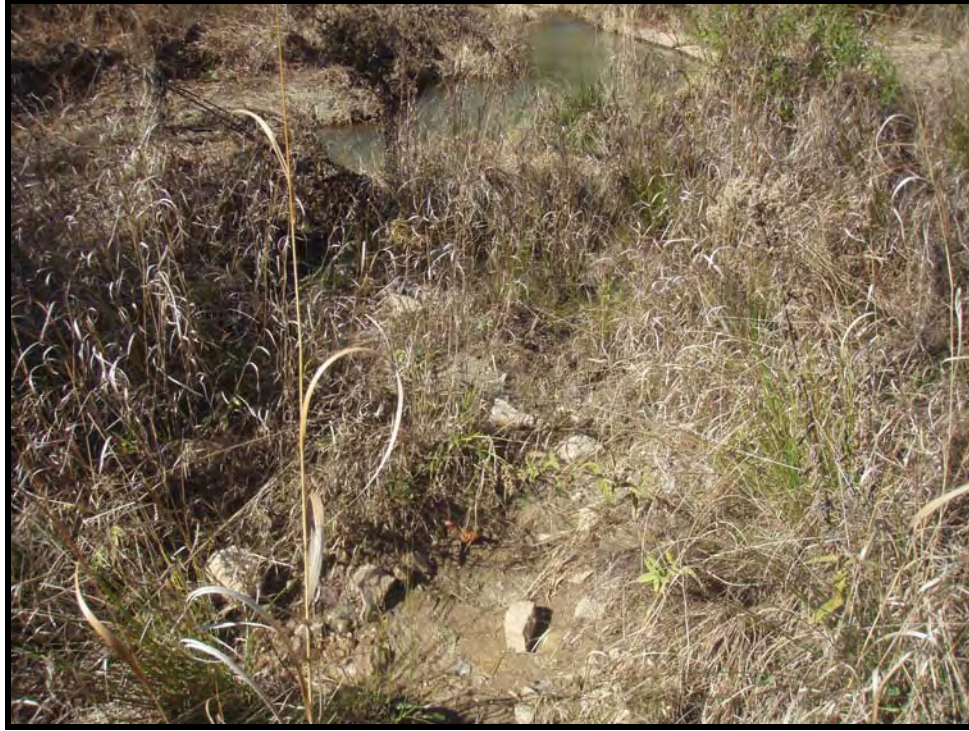
During field inspections on October 25<sup>th</sup>-28<sup>th</sup> and November 10<sup>th</sup>, 2010, a total of one (1) localized area of bare floodplain was observed on Reach 1. This area appears to be due primarily to surface flows. Continued revegetation of previously bare areas within both reaches was observed during Monitoring Year Five. Vegetation Problem Areas are shown on Sheets 6 through 9 (Reach 1). Photos are included in Appendix A.

<b>Reach 1</b>			
<b>Feature/Issue</b>	<b>Station # / Range</b>	<b>Probable Cause</b>	<b>Photo #</b>
Bare Floodplain	42+75 - 43+30	Surface flow / Poor soil quality	1
Vegetative Problem Areas Improved from Last Year	All other previous problem areas	Revegetation of previously bare areas	2

**Photo 1 – Bare Bench/Floodplain – Reach 1 – Year 5 (2010)**

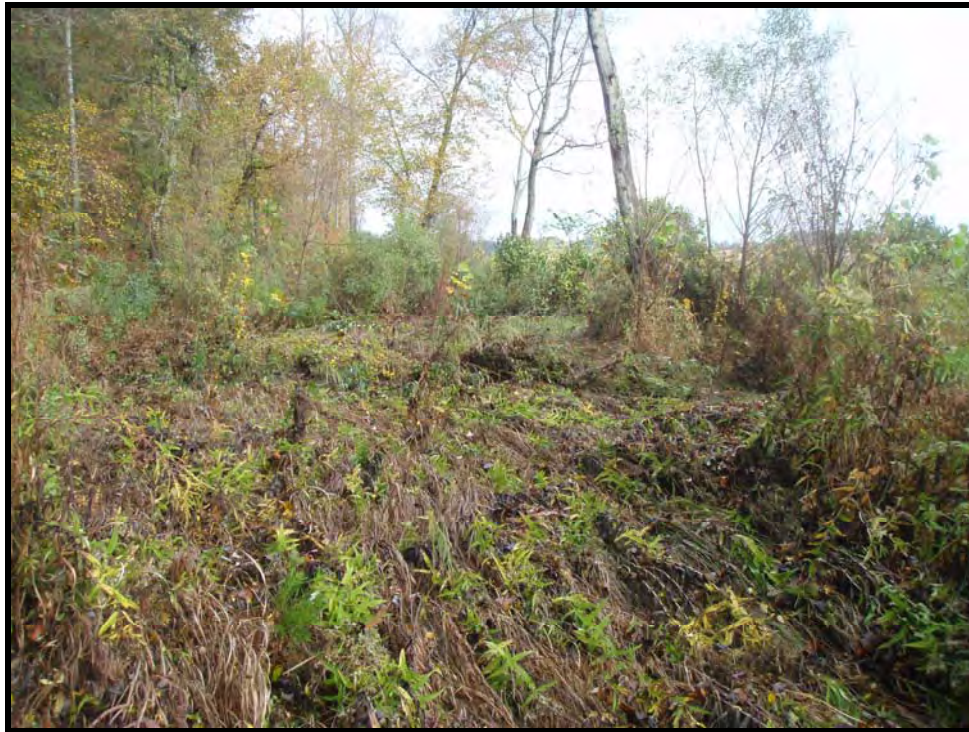
**Photo 2 – Typical Vegetated Bank, Improved from Year 4 – Reach 1 – Year 5 (2010)**

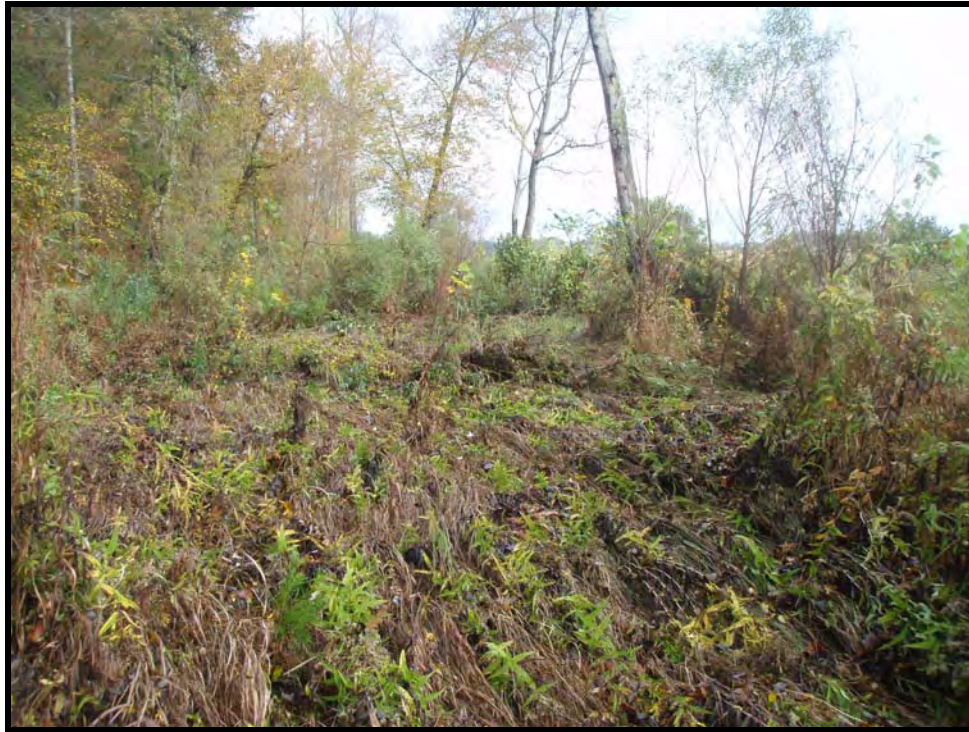
**Photo 1 – Reach 1 – Flattened vegetation near Cross-section 6**

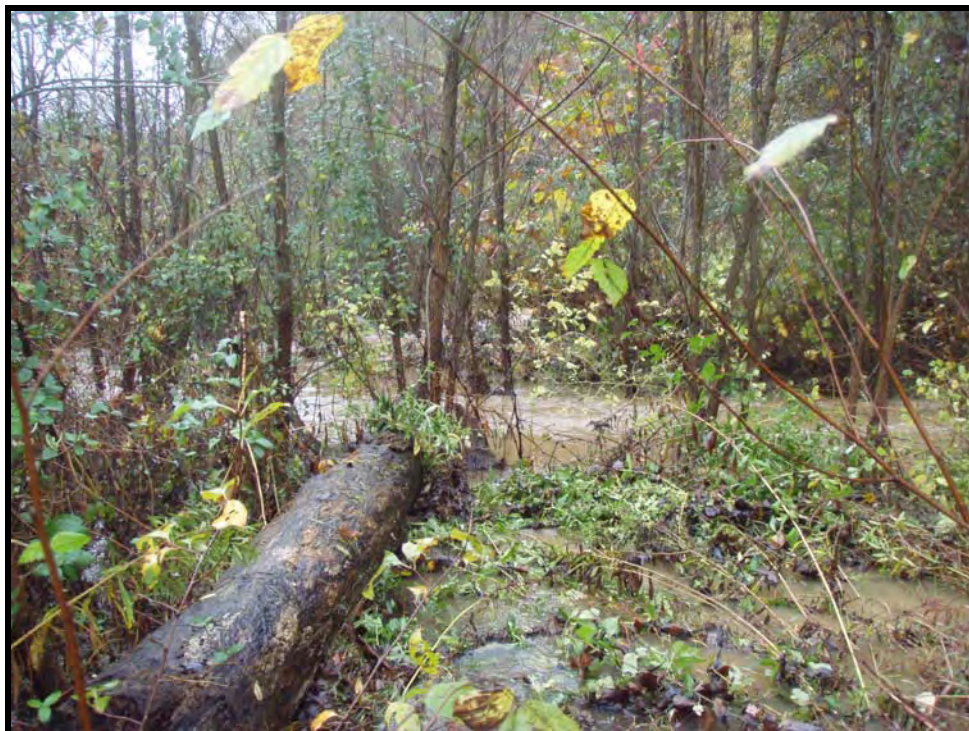
**Photo 2 – Reach 1 – Overbank Event 10/27/2010**

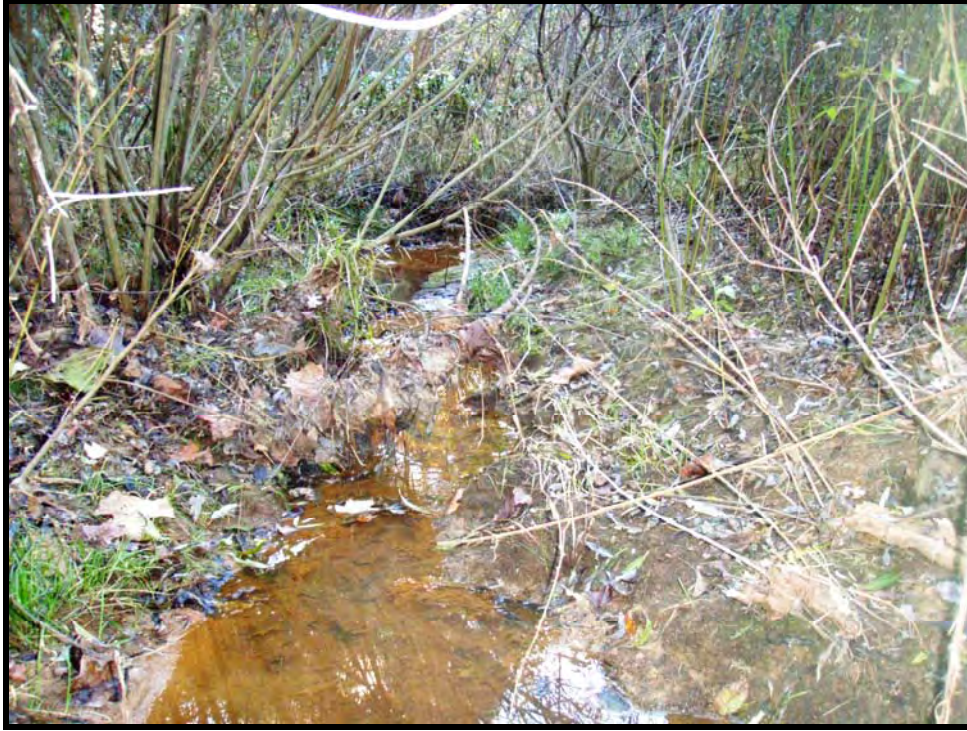
Photo 3 – Reach 2 – Wrack pile above channel

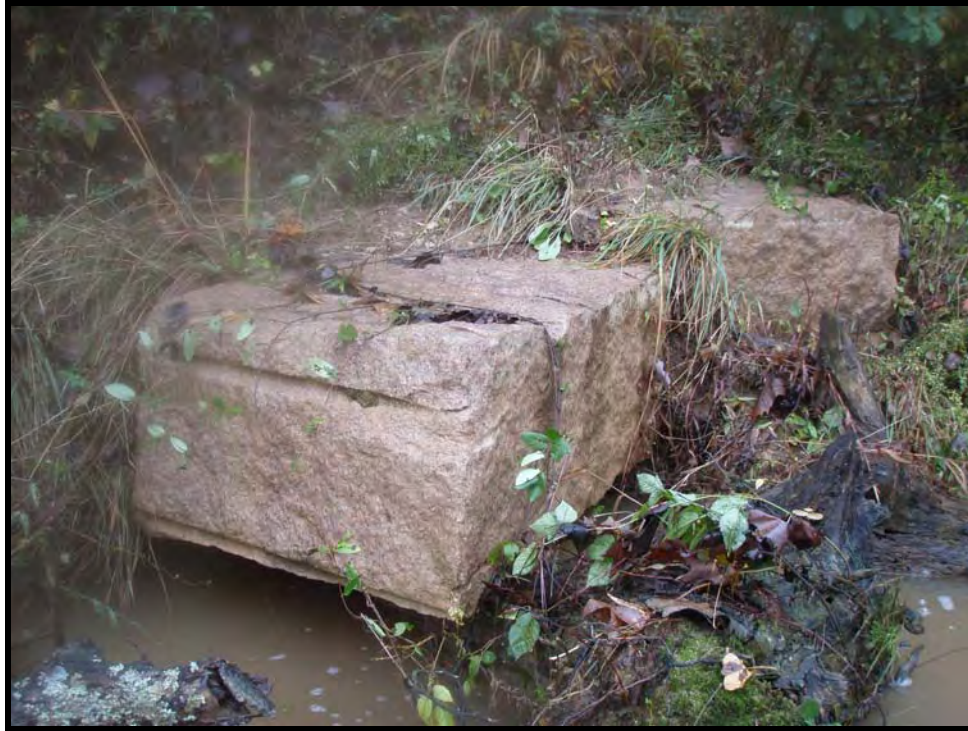
An assessment of channel stability was performed on November 10<sup>th</sup>, 2010. Areas of concern that were observed and documented included some minor localized bank scour, buried structures, and stressed structures. Detail of scour is evident in cross-section 6 (pool). These problem areas are shown on Sheets 6 through 9 for Reach 1 and Sheets 14 through 16 for Reach 2 (Problem Area Plan View). The minimal extent of scour and erosion around structures does not warrant repair at this time.

Photo 1 – Typical Stressed Structure/Bank Scour – Reach 1 – Year 5 (2010)

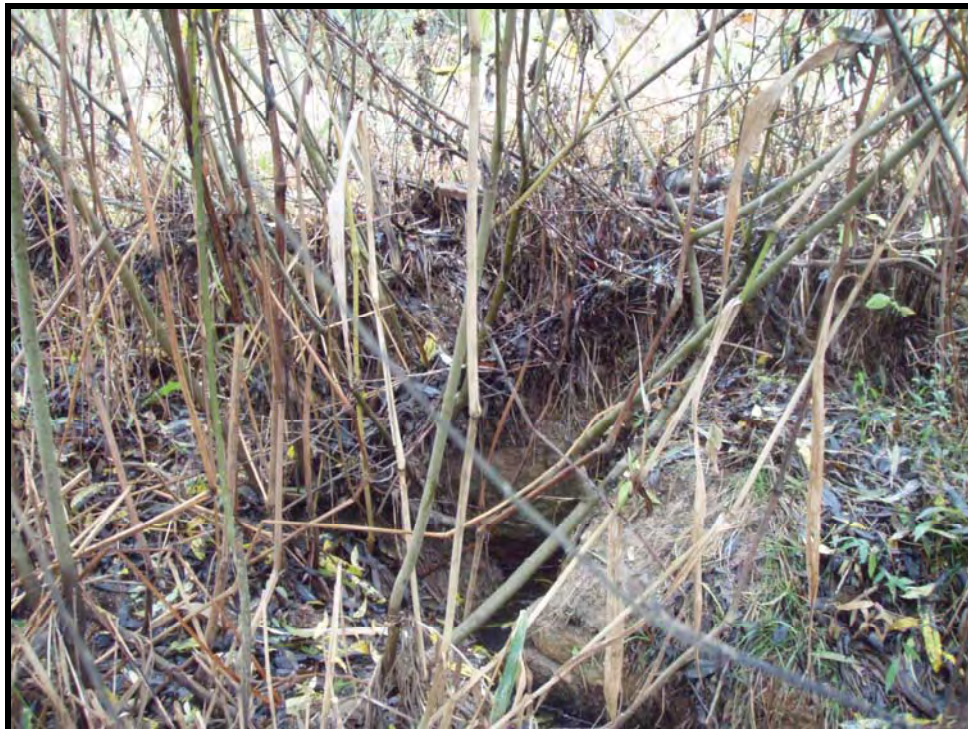
Photo 2 – Typical Stressed Structure/Bank Scour – Reach 1 – Year 5 (2010)

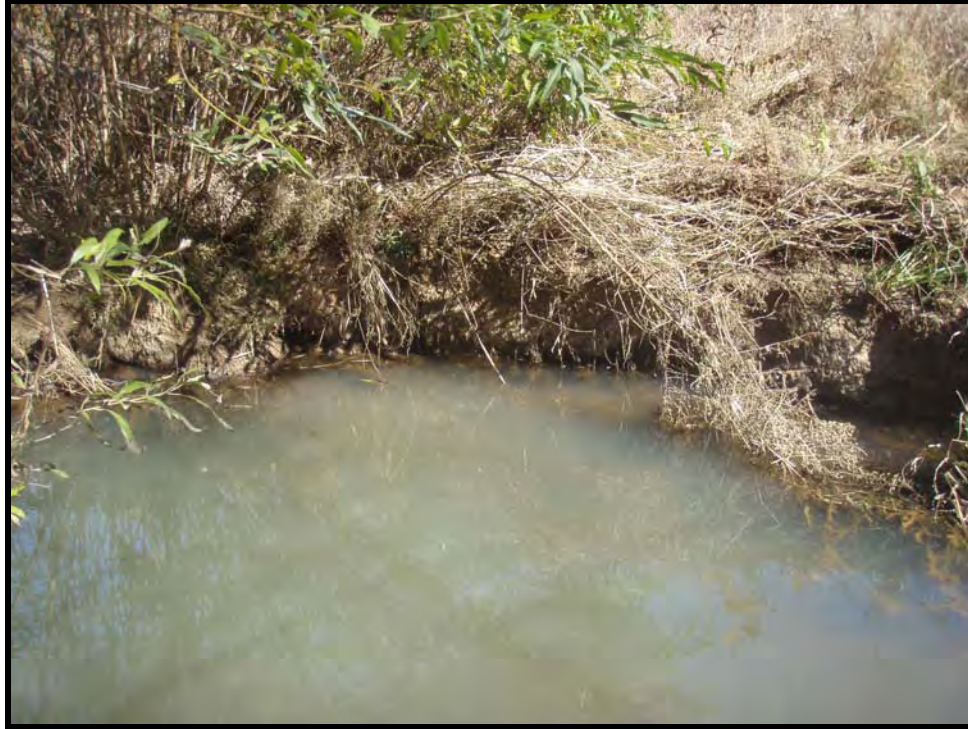
**Photo 3 – Typical Undercut Bank – Reach 1 – Year 5 (2010)**

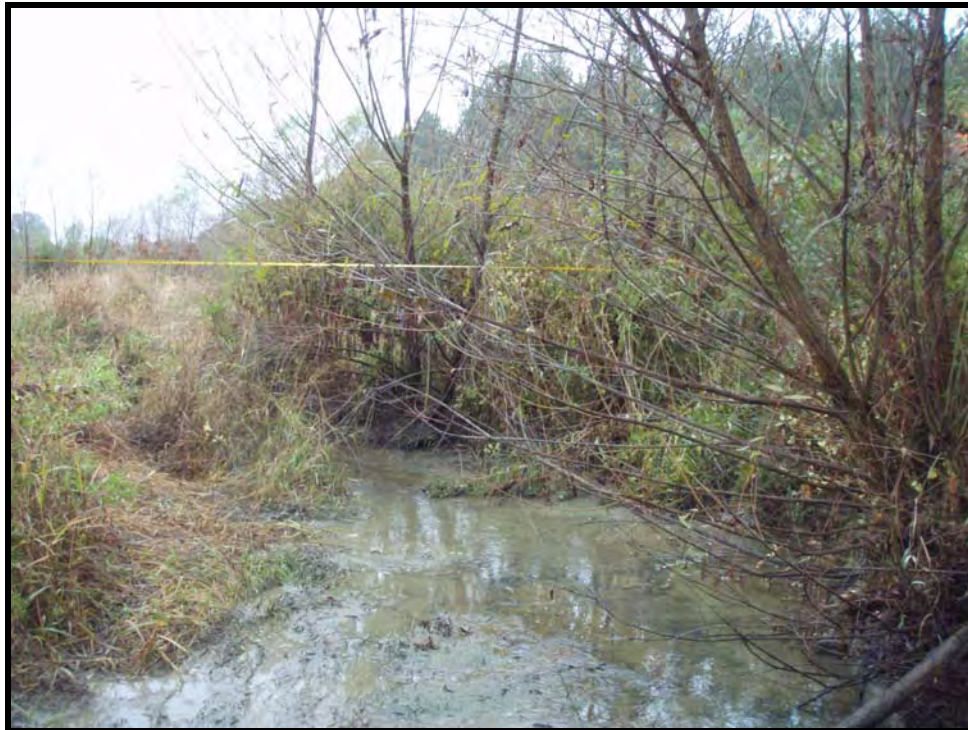
**Photo 4 – Sediment from Off-site – Reach 1 near Beginning of Restoration – Year 5 (2010)**

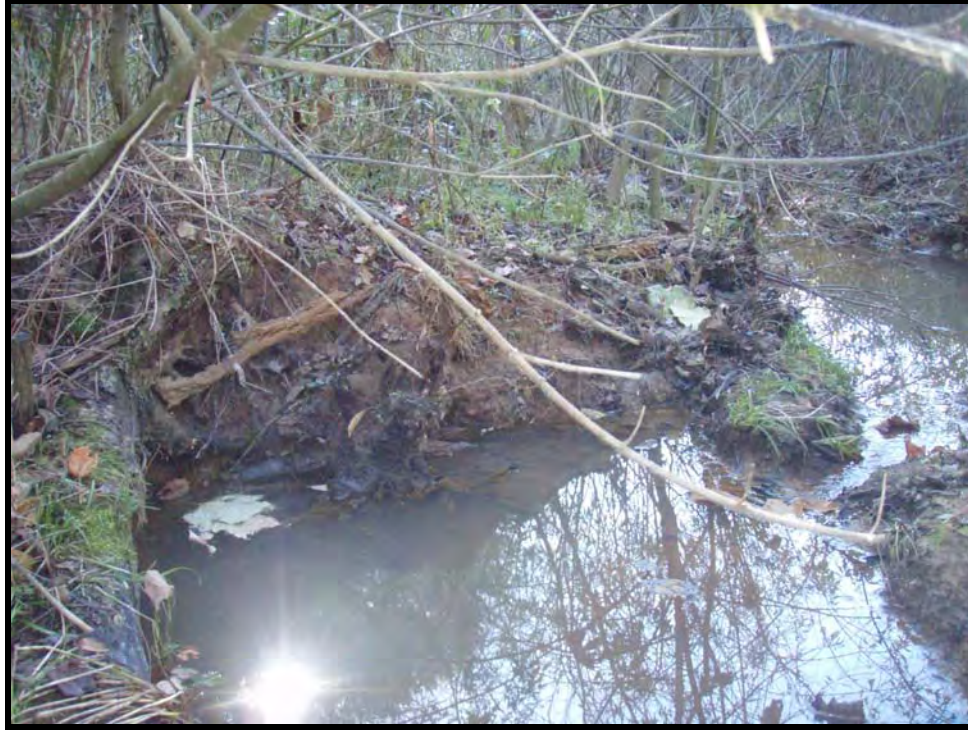
**Photo 5 – Typical Stressed Structure/Bank Scour – Reach 2 – Year 5 (2010)**
