**Year 1 Monitoring Report**  
**FINAL**  
**Greenbrier Stream Mitigation Project**  
**Yadkin County, North Carolina**  
**Monitoring Year 1**

**Data Collection Period:**  
October 2020

**Submission Date:**  
November 2020

NCDEQ Contract No. 7616  
DMS ID No. 100086  
USACE Action ID No. SAW-2018-01755  
NCDWR ID: 20181272  
Yadkin River Basin  
HUC 03040101

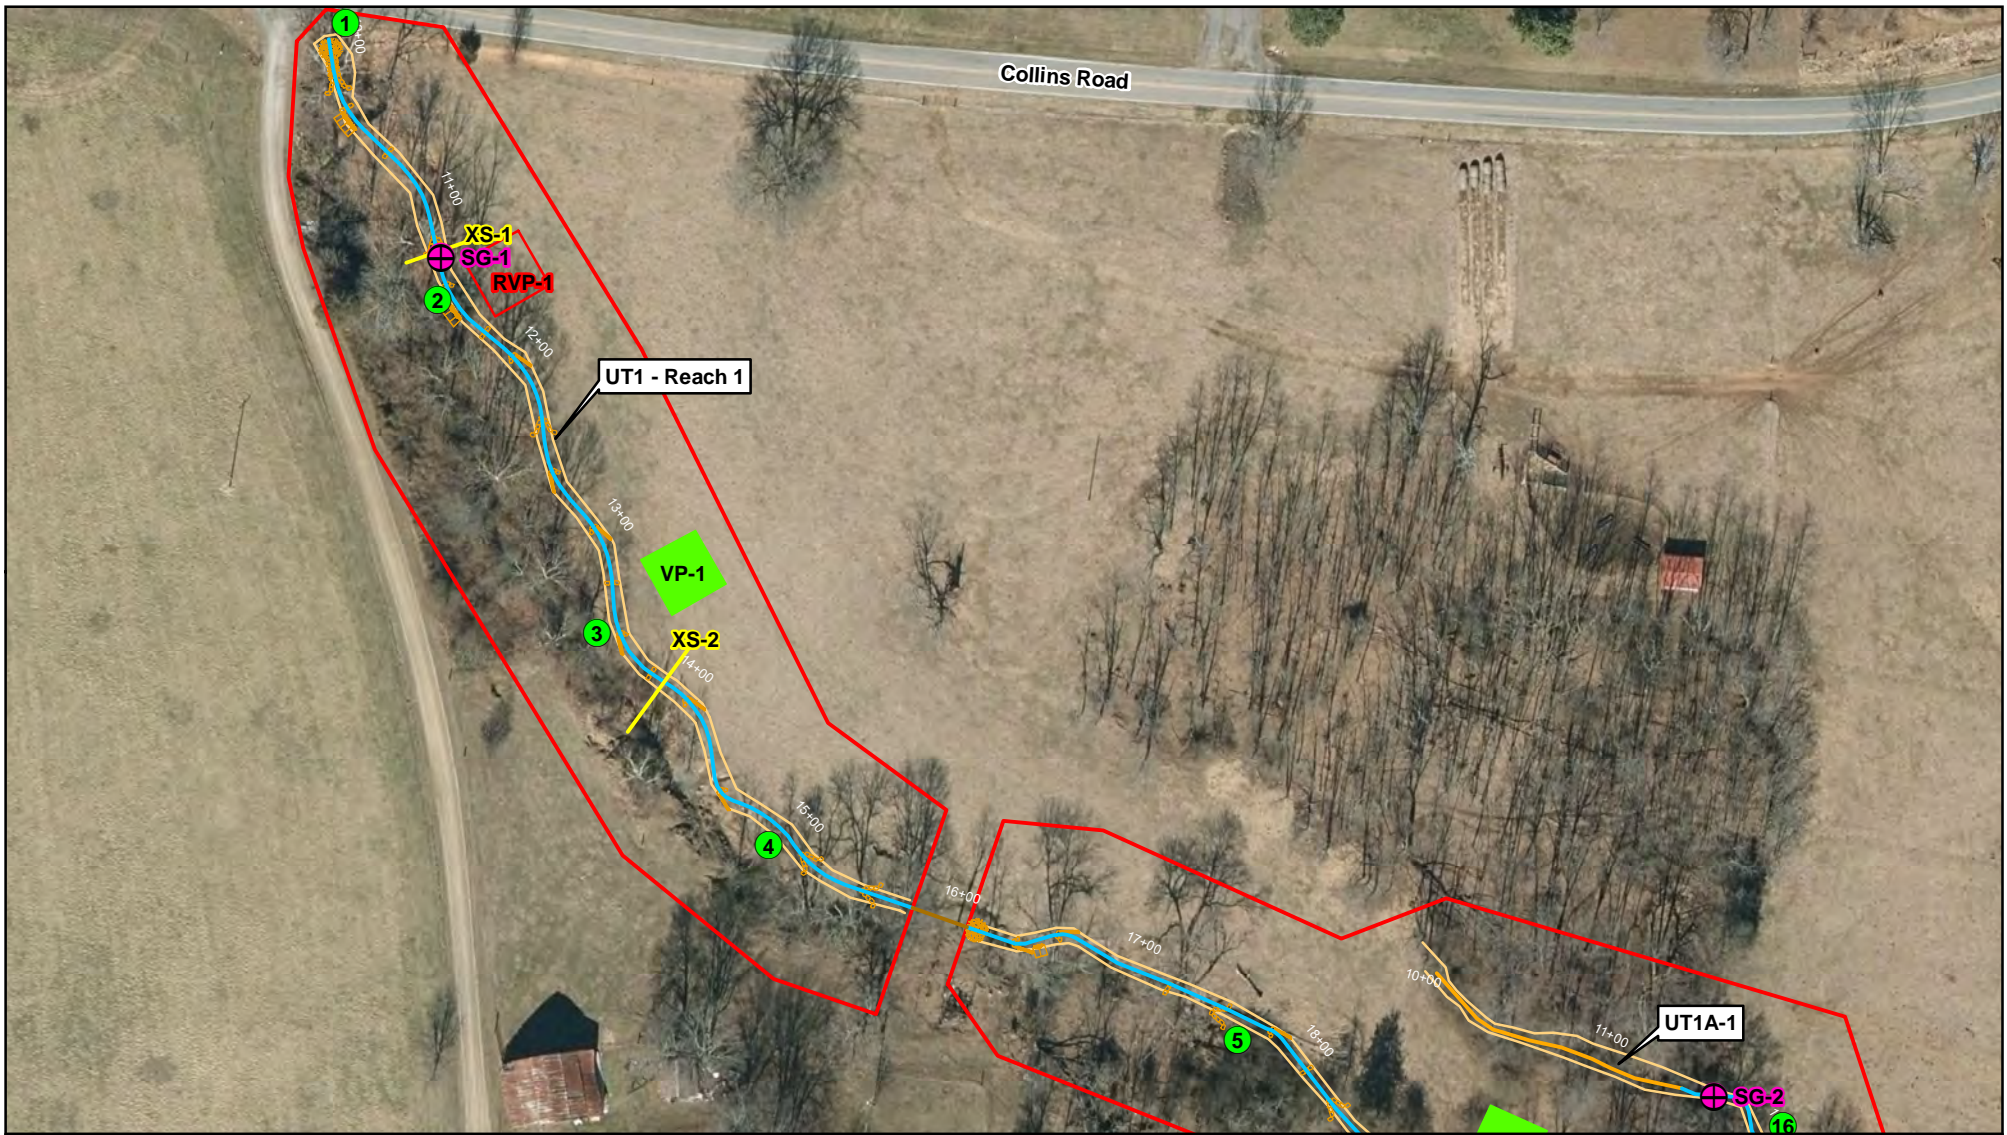
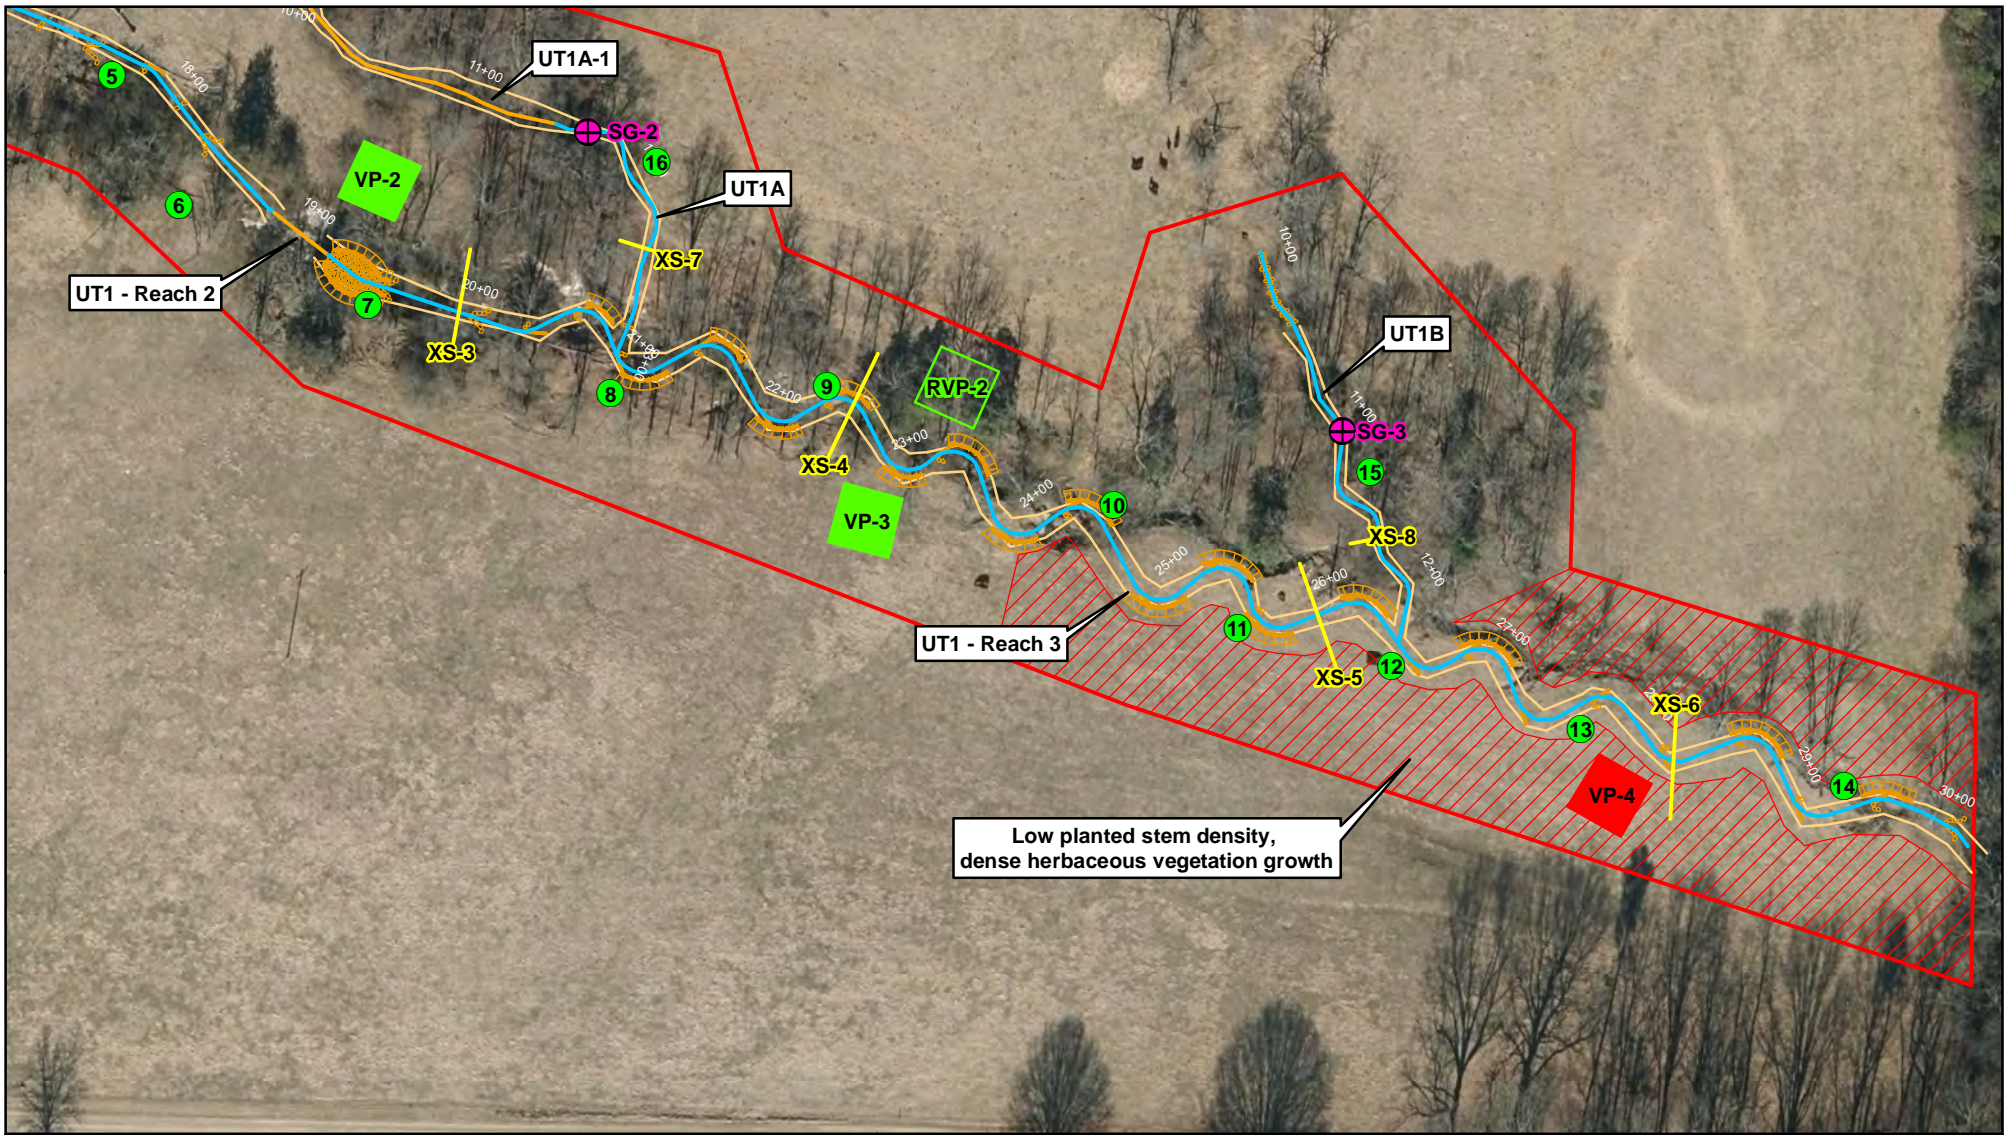
**GREENBRIER STREAM RESTORATION SITE**  
 CURRENT CONDITION PLAN VIEW: ASSET MAP  
 MY1: 2020

- **VP-4 and RVP-1 are now shown as red on the CCPV maps.**
- *Table 6 & Table 7: Recommend showing the VP-4 stems/ acre cells (162 stems/ acre) as orange/ red since it is not meeting the MY3 interim success criteria of 320 stems/acre.*

One vegetation problem area is noted in Figure 2. As indicated by the low stem count in VP-4 F (4 trees), the downstream riparian area of UT1 Reach 3 is covered in dense herbaceous vegetation that seems to have outcompeted the bare root trees that were planted in early 2020. This area covers around 1 acre and will be replanted in 2021. No other vegetation problem areas were noted in MY1. Riparian herbaceous and woody vegetation that was established after construction appears to be flourishing throughout the site. Additionally, no invasive species were noted within the conservation easement.

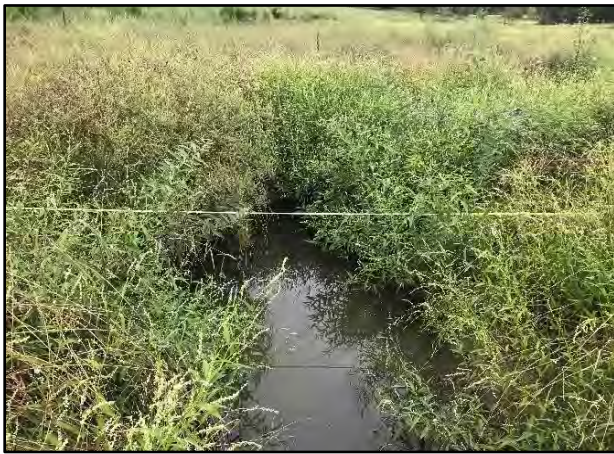
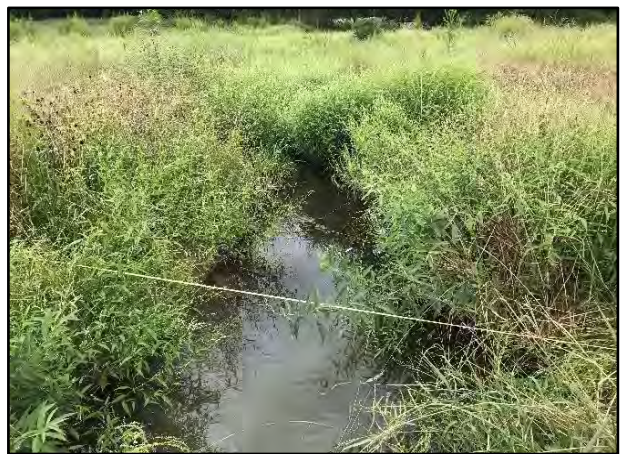
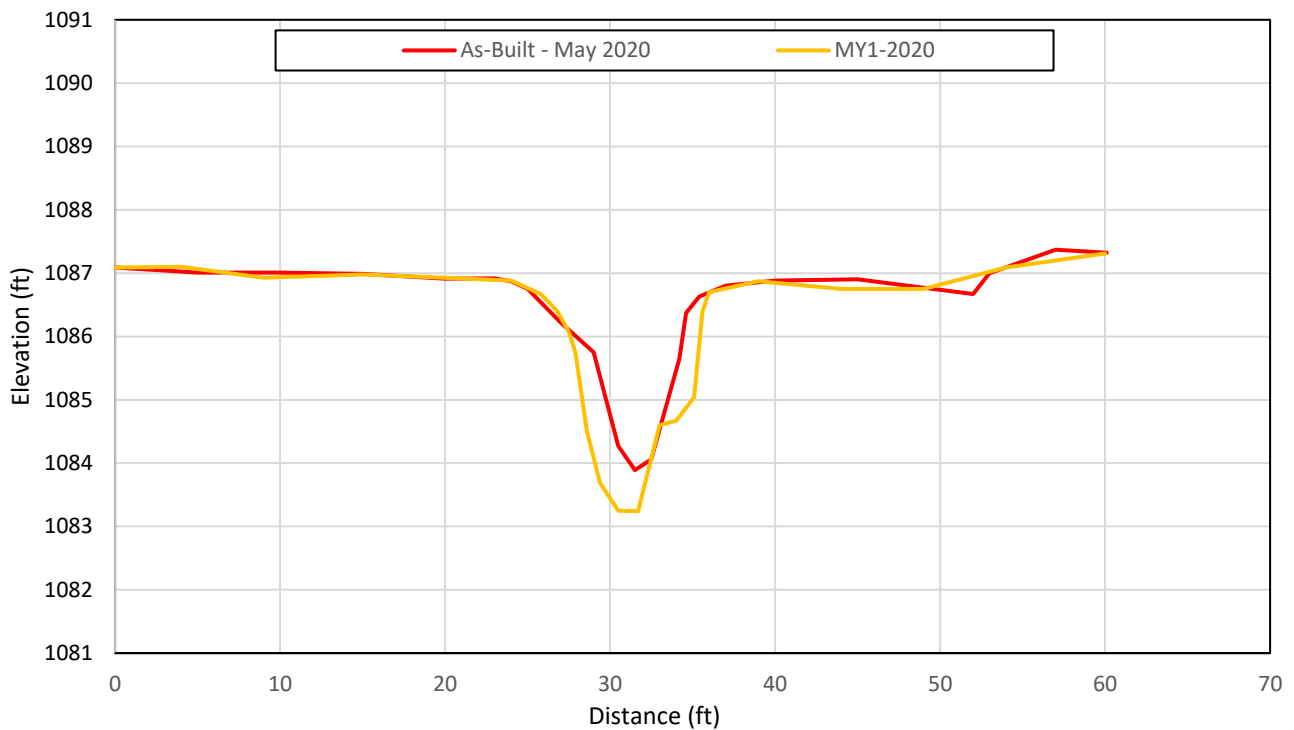
XS6 - UT1 Reach 3

MY0	MY1	MY2	MY3	MY4	MY5	MY+
Bankfull Elevation - Based on AB Bankfull Area	1086.63	1085.85					
Bank Height Ratio - Based on AB-Bankfull Area	1.00	1.32					
Thalweg Elevation	1083.89	1083.24					
LTOB Elevation	1086.63	1086.70					
LTOB Max Depth	2.74	3.46					
LTOB Cross Sectional Area	12.61	19.95					
Entrenchment Ratio	-	-
