Year 2 Monitoring Report
FINAL
Greenbrier Stream Mitigation Project

Yadkin County, North Carolina

Monitoring Year 2

Submission Date:
December 2021

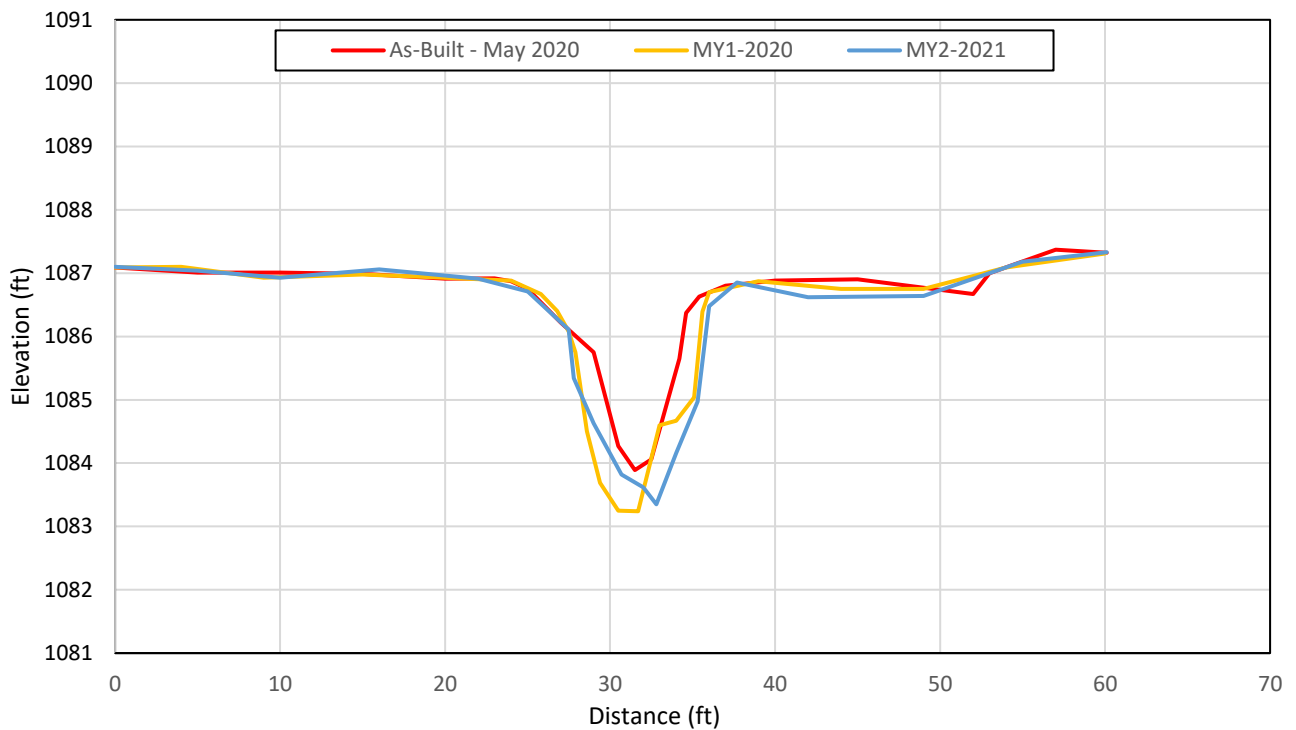
XS6 Pool - 28+30

MY0	MY1	MY2	MY3	MY4	MY5	MY+
Bankfull Elevation - Based on AB Bankfull Area	1086.63	1085.85	1085.82				
Bank Height Ratio - Based on AB-Bankfull Area	1.00	1.32	1.42				
Thalweg Elevation	1083.89	1083.24	1083.35				
LTOB Elevation	1086.63	1086.70	1086.85				
LTOB Max Depth	2.74	3.46	3.50				
LTOB Cross Sectional Area	12.61	19.95	22.83				
Entrenchment Ratio	-	-	-

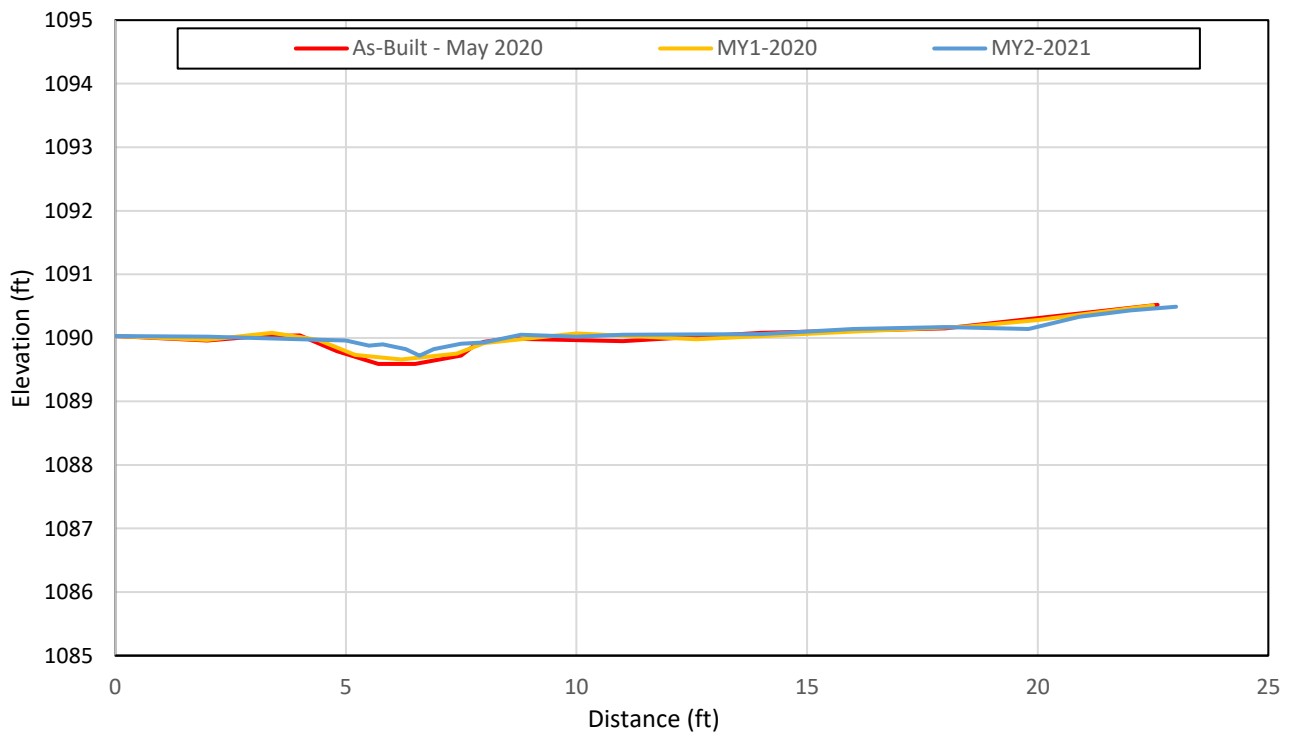
XS8 Riffle- 11+71

MY0	MY1	MY2	MY3	MY4	MY5	MY+
Bankfull Elevation - Based on AB Bankfull Area	1089.94	1090.00	1090.17				
Bank Height Ratio - Based on AB-Bankfull Area	1.00	0.76	0.47				
Thalweg Elevation	1089.59	1089.66	1089.72				
LTOB Elevation	1089.94	1089.92	1089.93				
LTOB Max Depth	0.35	0.26	0.21				
LTOB Cross Sectional Area	0.87	0.59	0.19				
Entrenchment Ratio	>5.26	>5.39	>5.69

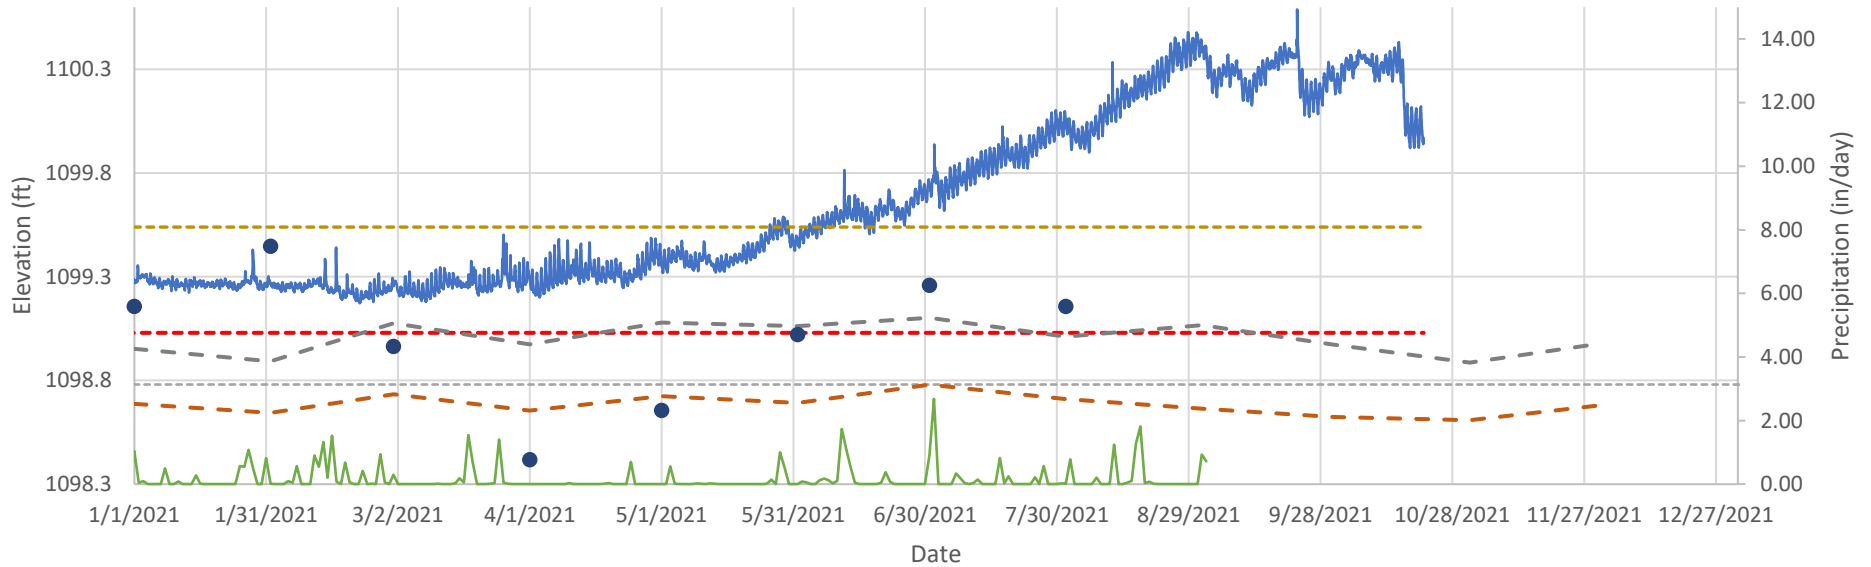
Note: The Meadowbrook rain gauge batteries died on 9/2/21 so no rain data was collected for September and October. GBSG2 became buried in sediment in June 2021 so the water level elevation data from June - October is not accurate.
