Year 3 Monitoring Report
FINAL
Greenbrier Stream Mitigation Project

Yadkin County, North Carolina

Monitoring Year 3

Submission Date:
December 2022

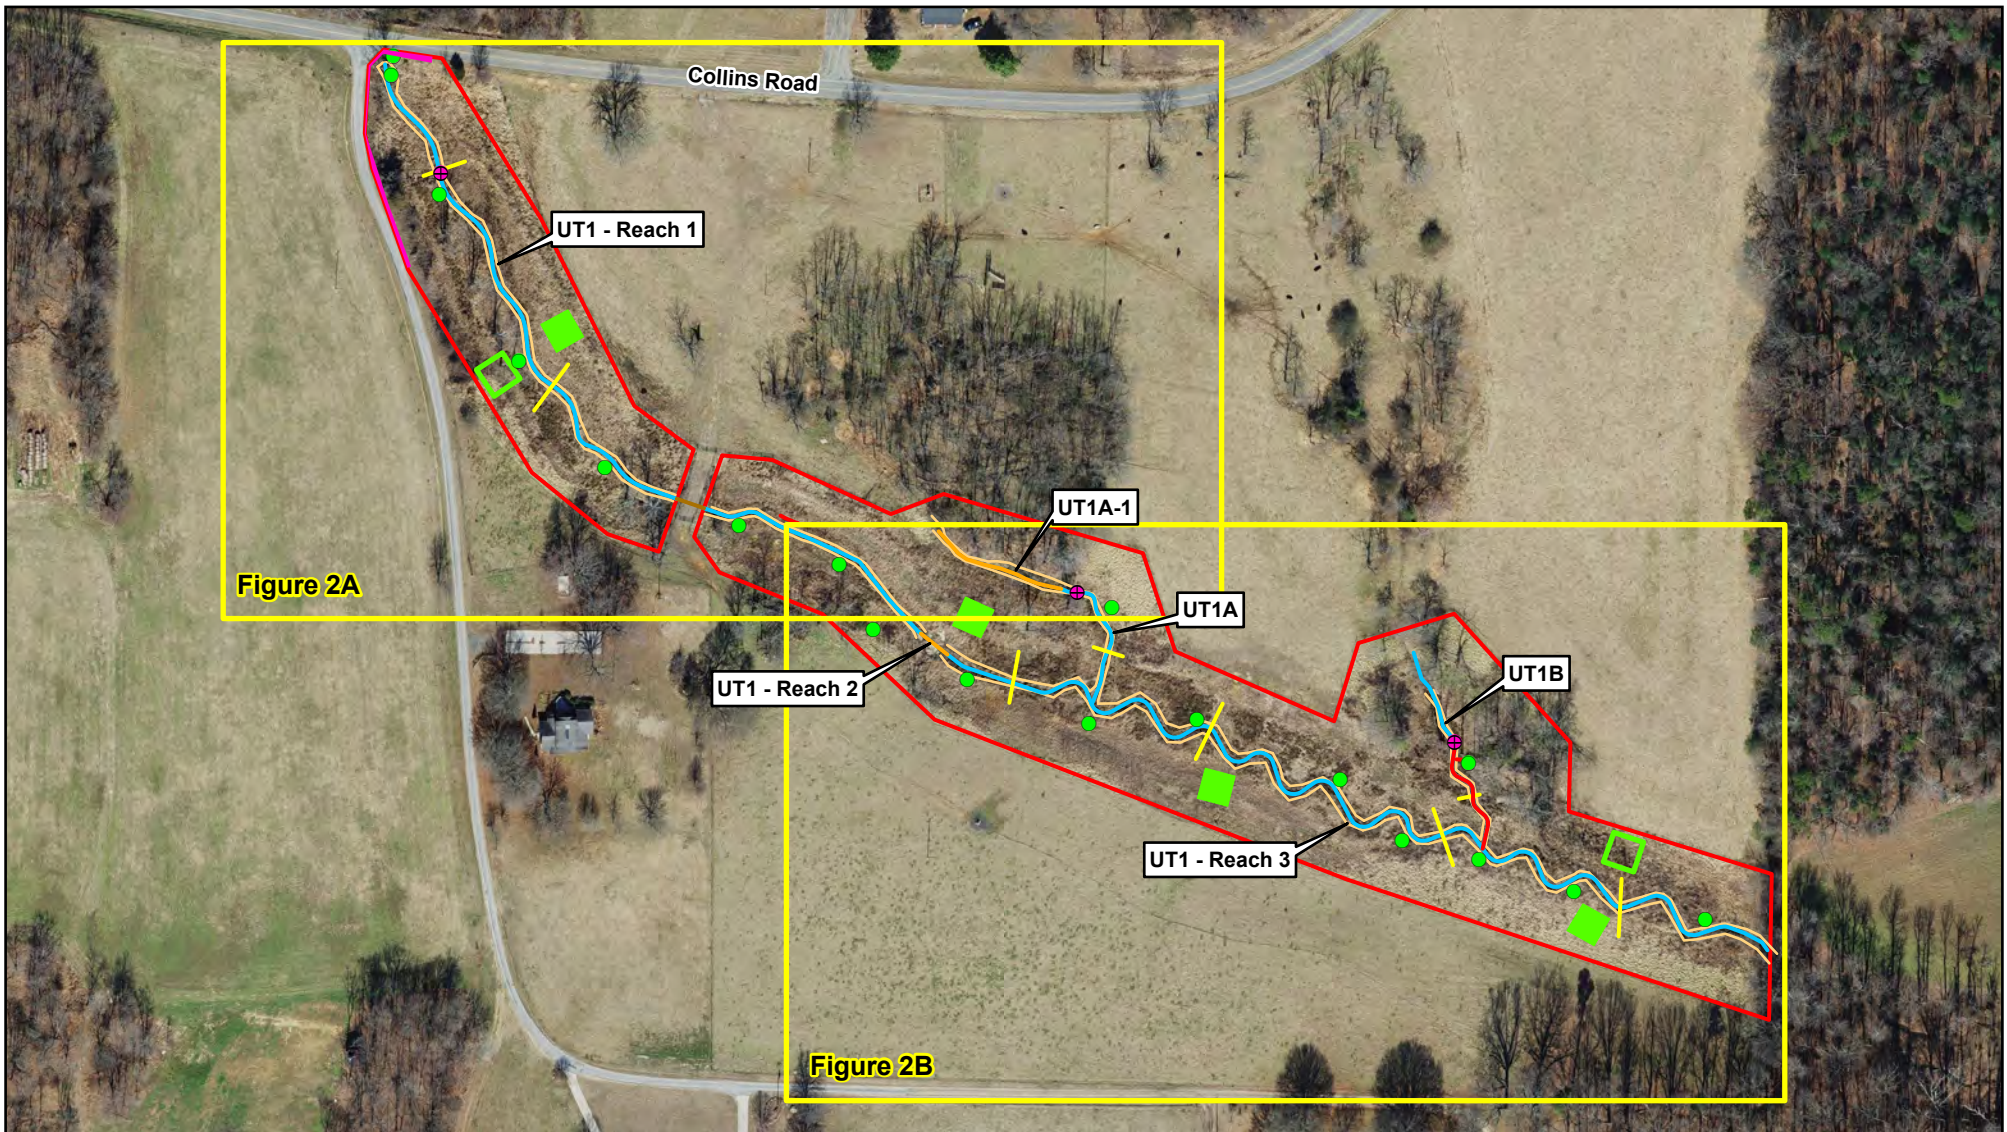
GREENBRIER STREAM RESTORATION SITE
 CURRENT CONDITION PLAN VIEW: OVERVIEW MAP
 MY3: 2022

- **CCPV Maps & Table 5. Vegetation Condition Assessment Table** - *The project encroachment identified on the site on 11/8/22 should be clearly shown on the CCPV maps and reported in the Table 5 vegetation condition assessment table.*
 - **Easement encroachment area has been added to the CCPV and Table 5 has been updated accordingly.**

- **CCPV Maps** – *In the map legend, please update Streams – Enhancement to Streams – Enhancement II. Two (2) small, vegetated overbank side channels were noted in the 11/8/2022 IRT credit release site visit meeting notes. Please show these areas on the CCPV map sheets for reference and briefly discuss them in the report text. EPR committed to taking additional photos of these areas in future project monitoring reports.*
 - **The CCPV maps have been updated to show the Enhancement streams as Enhancement II. The two small overbank side channels have also been added to the CCPV as CPA-1 and CPA-3. A discussion of how they will be monitored in future years has been added to the report in Section 2.1.3.**

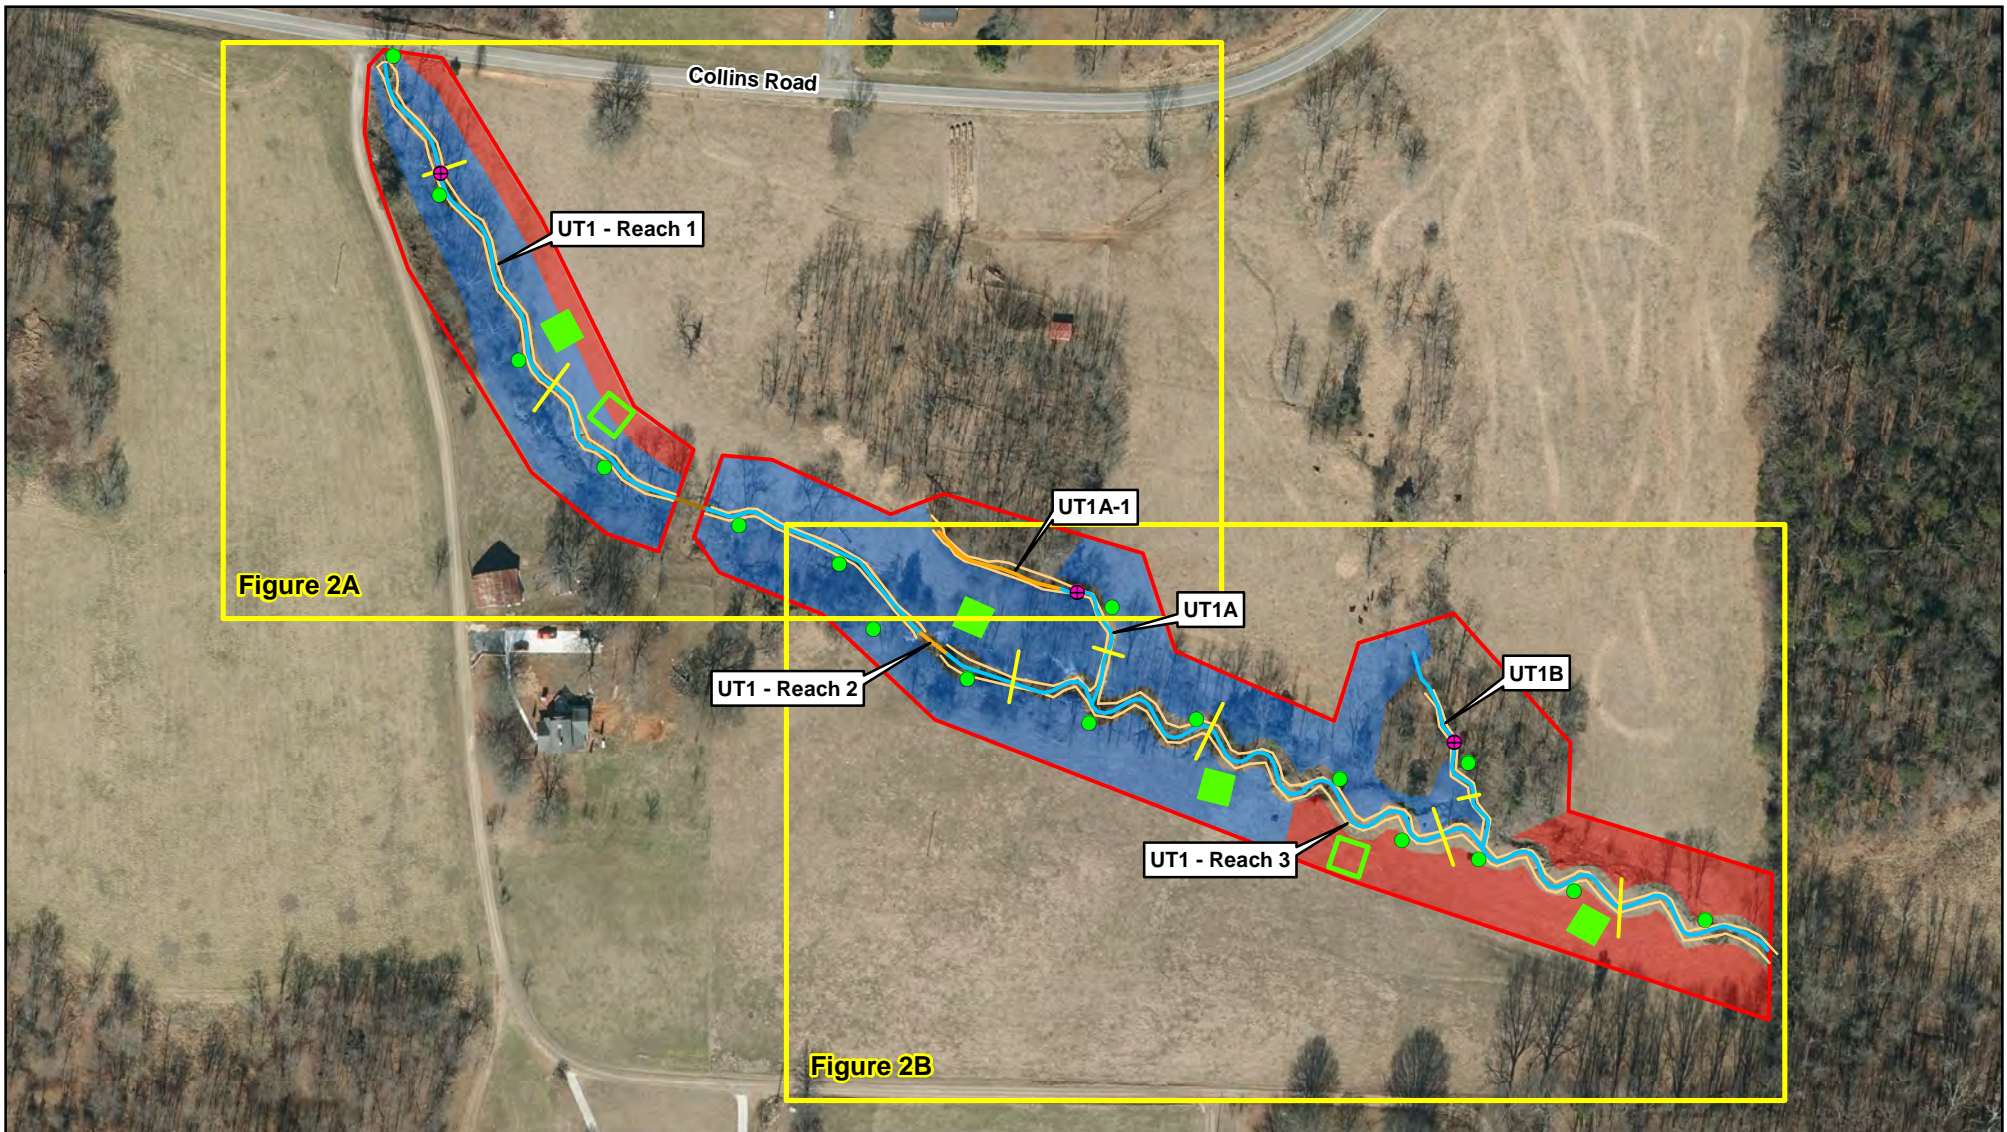
GREENBRIER STREAM RESTORATION SITE
 CURRENT CONDITION PLAN VIEW: OVERVIEW MAP
 MY2: 2021

- **Section 2.2.1 Vegetation Monitoring Data** - *This section indicates that the MY2 (2021) supplemental planting area is shown on the CCPV maps. This is incorrect. DMS recommends adding the 2021 supplemental planting map to Appendix B along with the 2021 supplemental planting list. In addition, the report text regarding the 2021 supplemental planting does not appear to be consistent with the Greenbrier 2021 Supplemental Planting Species List provided in Appendix B. The planting list appears to have discrepancies as well. Please QA/QC the report text and planting list in Appendix B to confirm they are correct and consistent*
 - **Appendix B has been updated to include the correct supplemental planting list. Appendix B now includes Greenbrier MY2 CCPV which shows areas that were supplementally planted in 2021.**

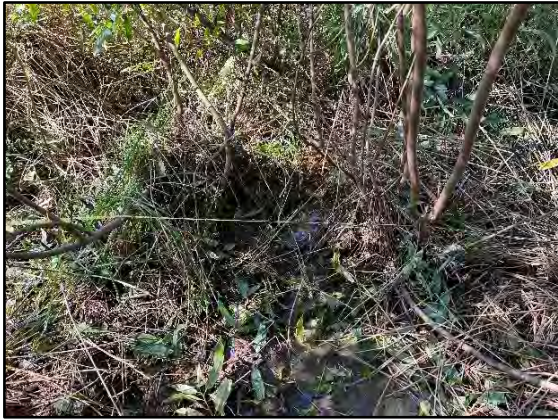
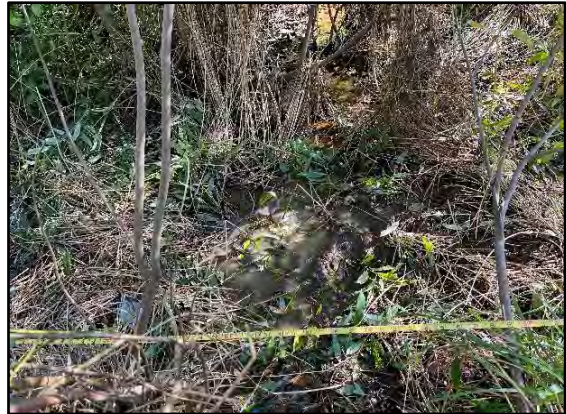
XS8 - UT1B

- **Cross section 8 on UT1B has experienced some growth of channel vegetation in past monitoring years that has resulted in a decrease in bankfull area from year to year. In MY3, it was noted that this cross section is now almost entirely shaded and vegetation should not be as much of an issue in future monitoring years. This is addressed in the Final Report.**
