Year 4 Monitoring Report
Final
Greenbrier Stream Mitigation Project
Yadkin County, North Carolina
Monitoring Year 4

Data Collection Period:
April, September – October 2023

Submission Date:
December 2023

NCDEQ Contract No. 7616
DMS ID No. 100086
USACE Action ID No. SAW-2018-01755
NCDWR ID: 20181272
Yadkin River Basin
HUC 03040101

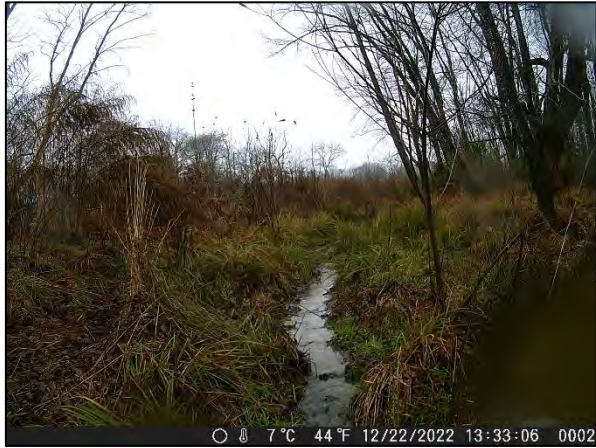
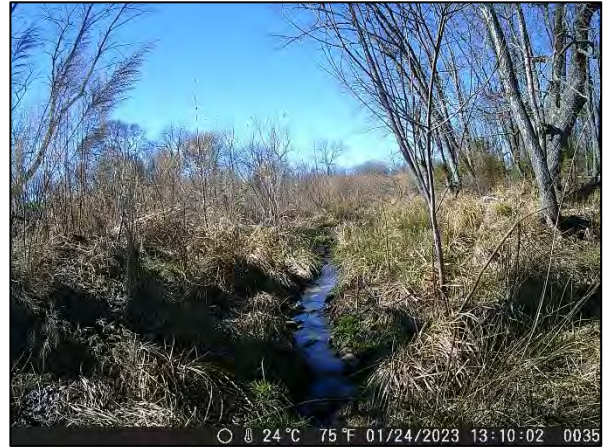
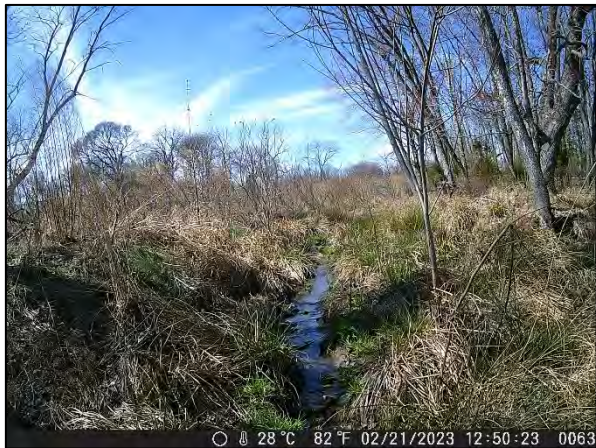
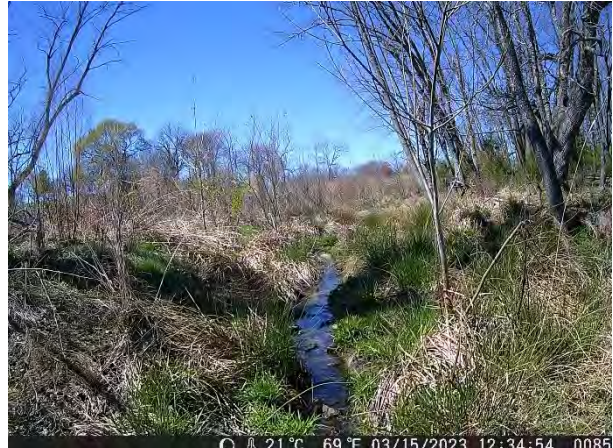
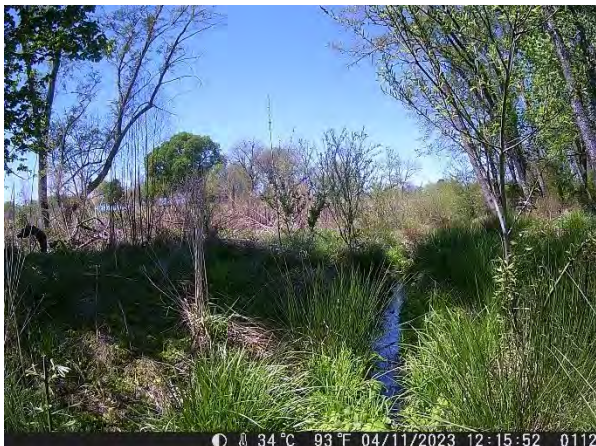
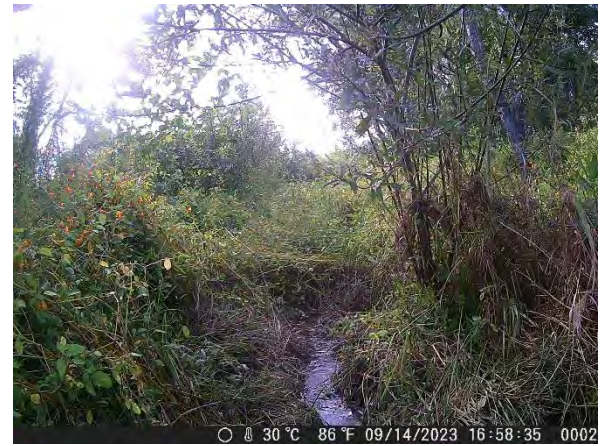
****Note: vegetation blocked game camera view of the stream from 4/21/23-9/13/2023.***

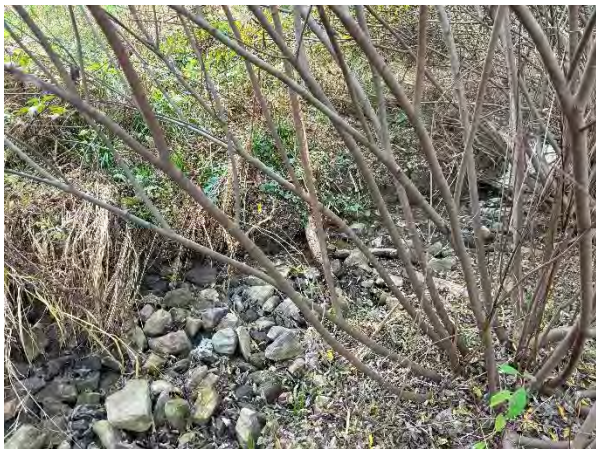
Constructed riffle facing downstream, UT1– 10/31/2023

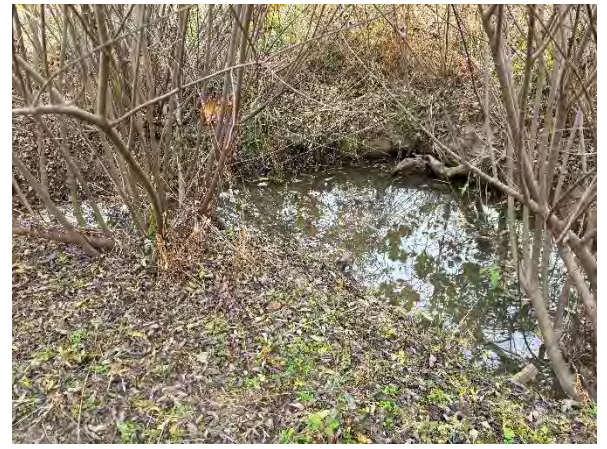
Lateral scour pool, UT1 – 10/31/2023

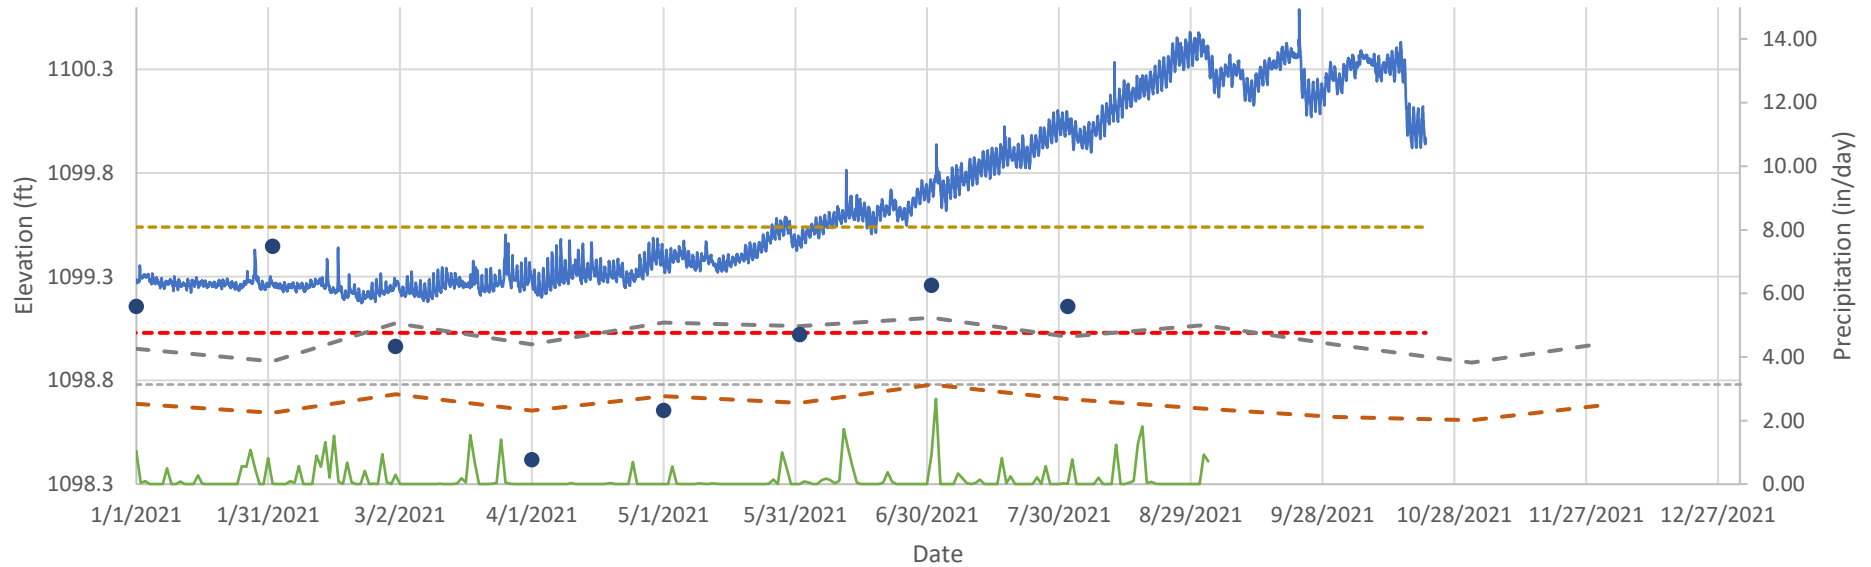
Note: The Meadowbrook rain gauge batteries died on 9/2/21 so no rain data was collected for September and October. GBSG2 became buried in sediment in June 2021 so the water level elevation data from June - October is not accurate.
