**FINAL**  
**ANNUAL MONITORING REPORT**  
**YEAR 1 (2012)**  
**GREENBRIER CREEK STREAM/WETLAND/BUFFER RESTORTION SITE**  
**ALAMANCE AND CHATHAM COUNTIES, NORTH CAROLINA**  
**(EEP Project No. 671, Contract No. 004801)**  
**Construction Completed January 2011**

February 2013

Prepared by:  
Axiom Environmental, Inc.  
218 Snow Avenue  
Raleigh, North Carolina 27603

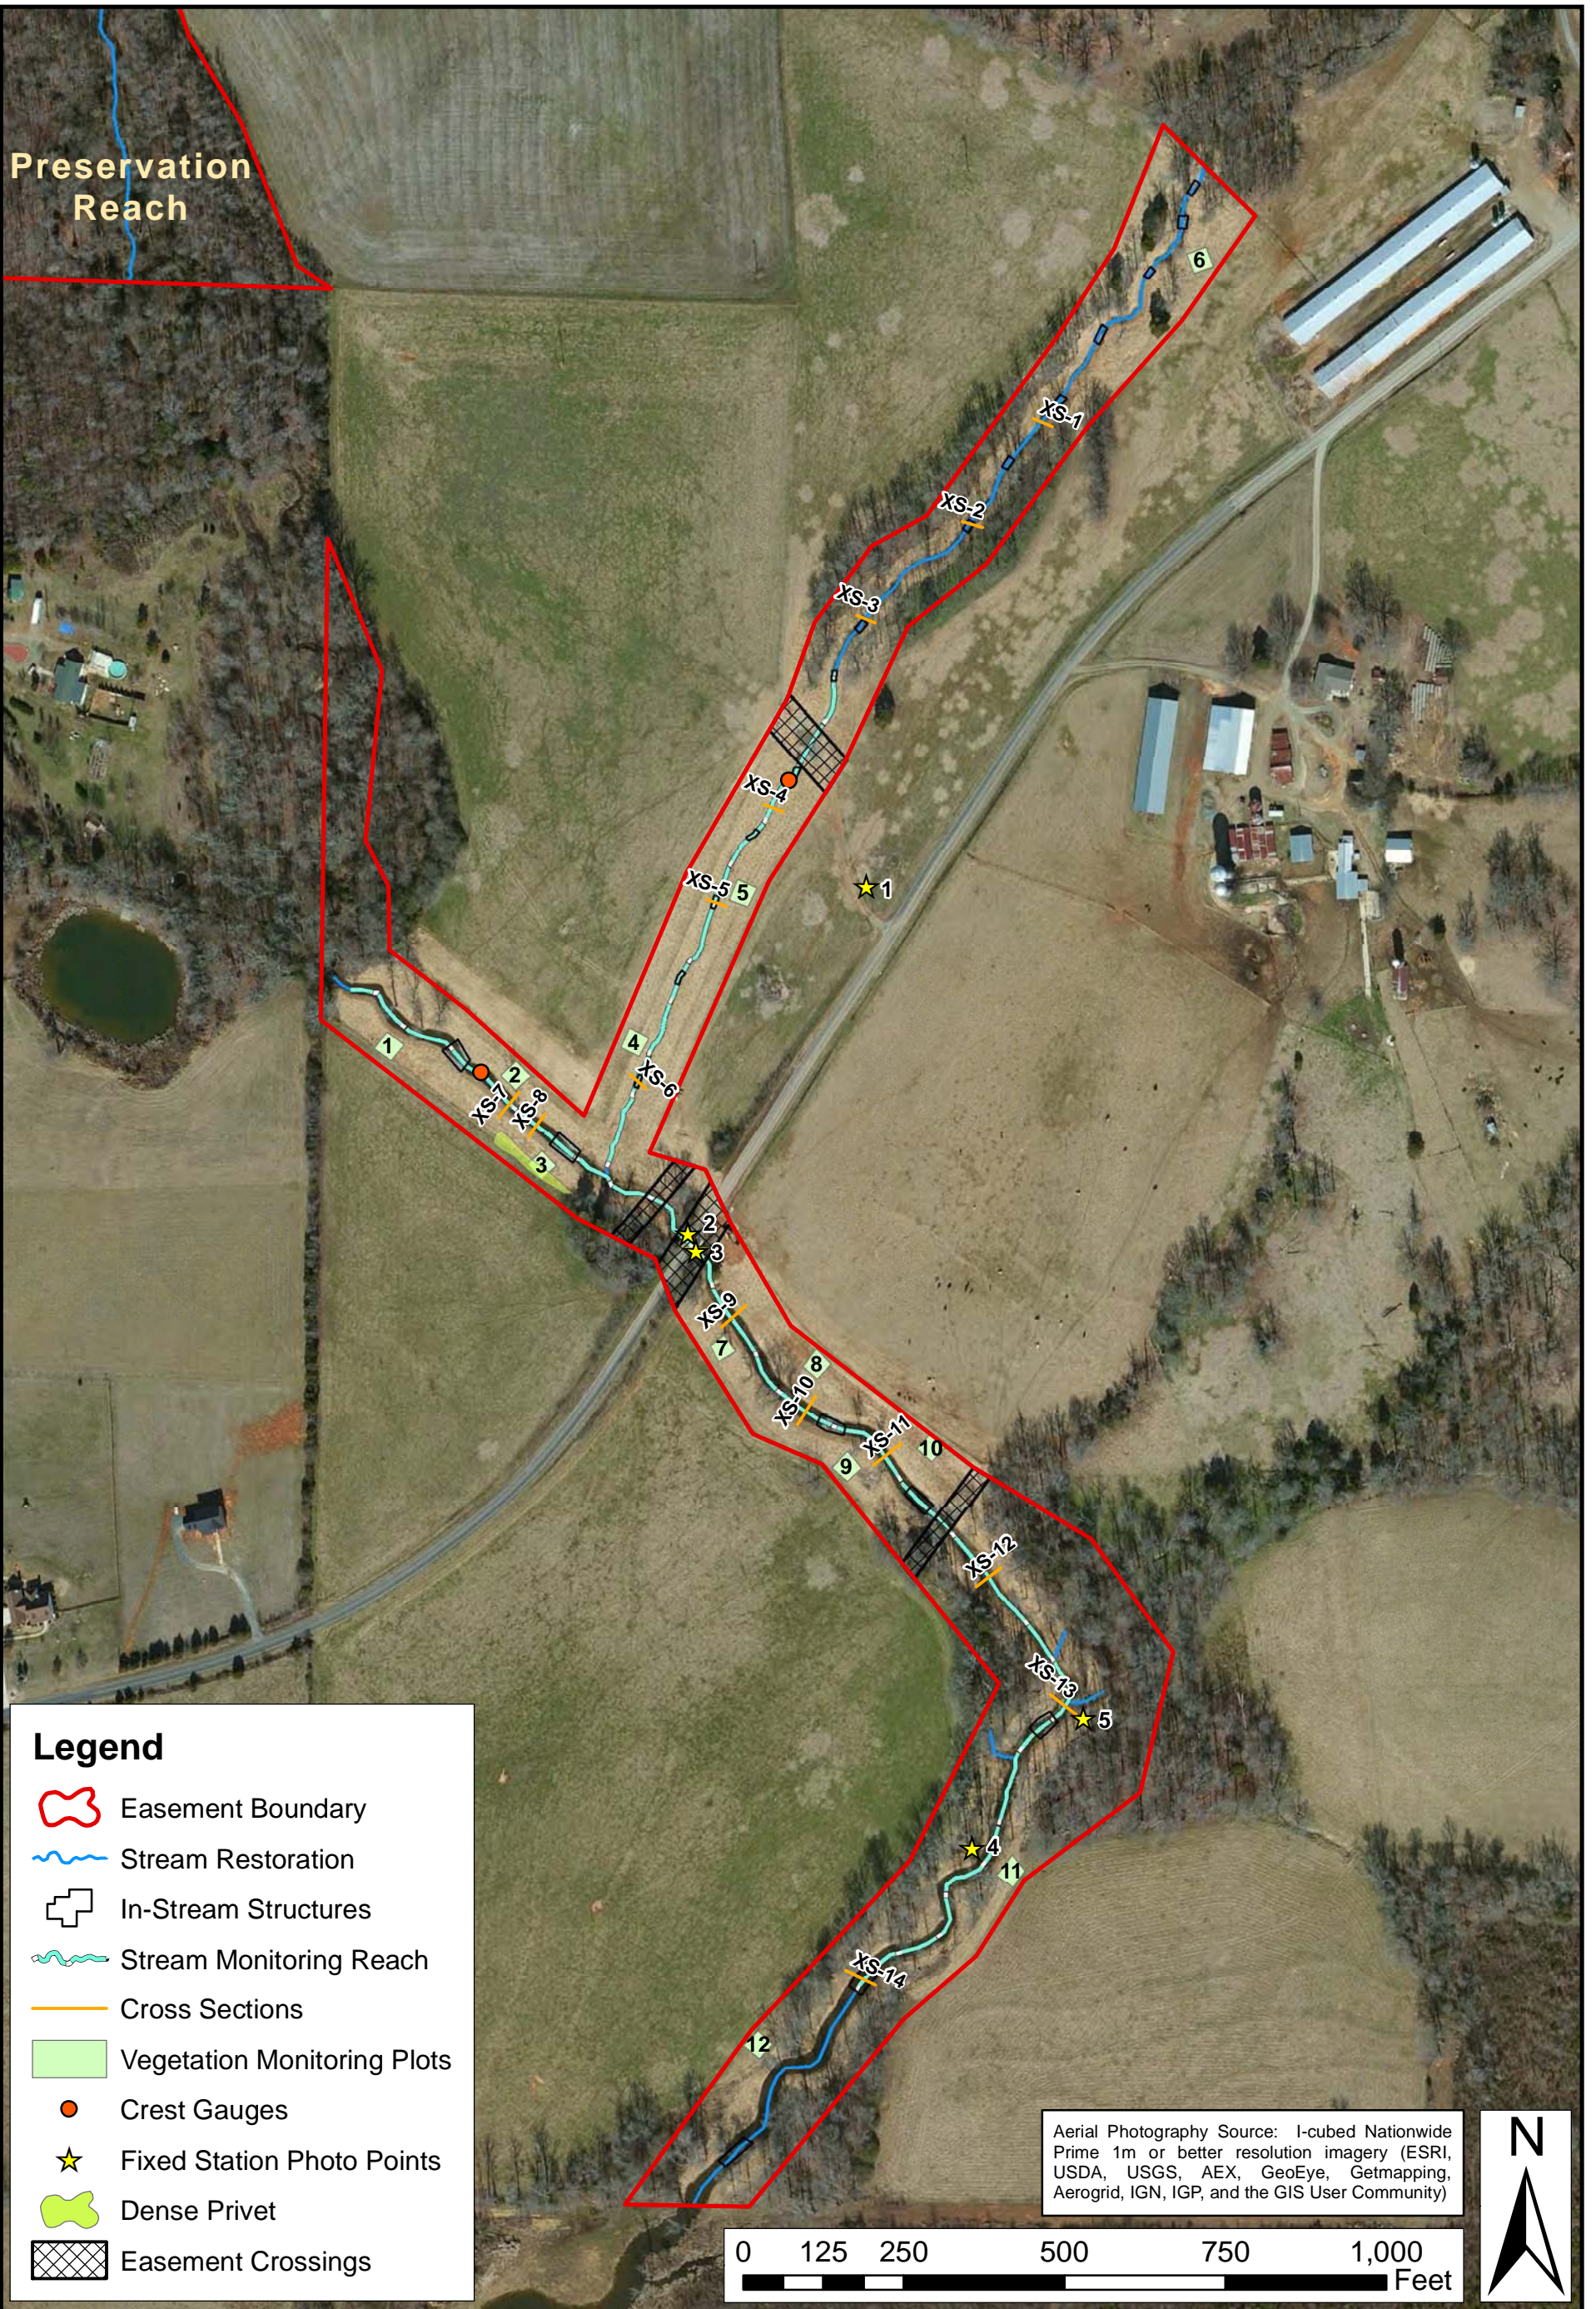
FIGURE  
**2**

Vegetative problem areas were noted above along the main Greenbrier Creek channel near the bridge (upstream of the confluence with the UT [Figure 2, Appendix A]). Prior to construction, Chinese privet was prevalent within the easement. All Chinese privet was removed and/or treated during construction activities, including the preservation reach. Chinese privet continues to occur sporadically throughout the Site; however, upstream of the bridge, the Chinese privet is particularly dense and may require further chemical control.

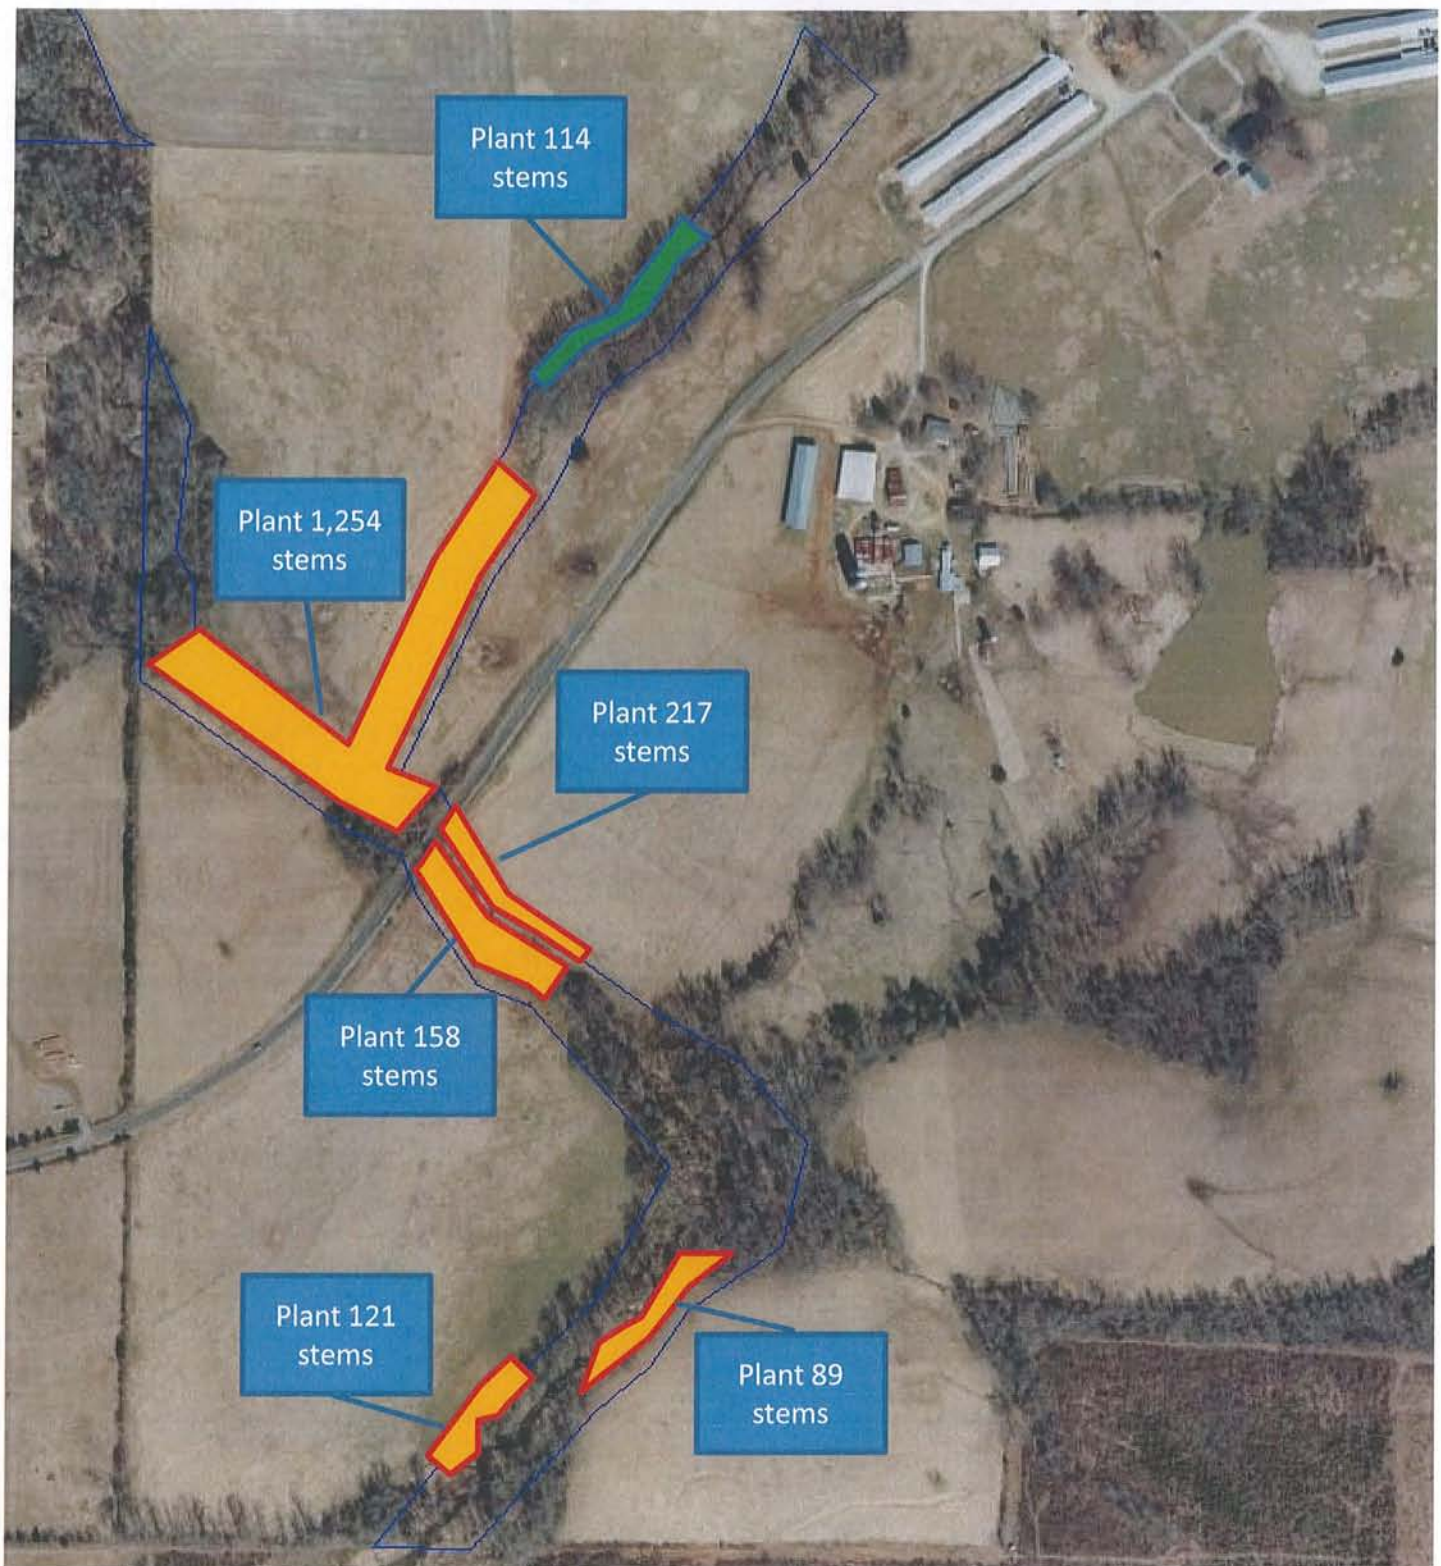
Greenbrier Creek  
Vegetation Warranty Map

In general, some of plant survival in the Zone 4 and Zone 5 planting zones did not meet the warranty requirement. The table below outlines necessary replanting areas. Surviving stems were subtracted from the warranty criteria (544/acre for Zone 4 and 348 per acre for Zone 5) so that the "Total plants needed" column is the number of remaining stems needed get warranty criteria (544/348) stems per acre in areas with deficient vegetation. Planting densities were averaged into planting zones and are identified on the attached Supplemental Planting Map.

Location	Planting Zone	Acres	Total plants needed
Zone 5 (Unnamed Tributary)	Zone 5	0.8	114
Unnamed Tributary (St 400+00 - 407+00) & mainstem (St 106+50 - 100+00)	Zone 4	3	1254
Right, mainstem (St 200+00 - 205+50)	Zone 4	0.6	158
Left, mainstem (St 200+00 - 206+00)	Zone 4	0.7	217
Left, mainstem (St 212+50 - 214+00)	Zone 4	0.2	89
Right, mainstem (St 210+50 - 219+00)	Zone 4	1	121
<b>Total</b>		<b>6.3</b>	<b>1,952</b>
