**FINAL
ANNUAL MONITORING REPORT
YEAR 2 (2013)
GREENBRIER CREEK STREAM/WETLAND/BUFFER RESTORATION SITE
ALAMANCE AND CHATHAM COUNTIES, NORTH CAROLINA
(EEP Project No. 671, Contract No. 004801)
Construction Completed January 2011**

September 2013

Prepared by:
Axiom Environmental, Inc.
218 Snow Avenue
Raleigh, North Carolina 27603

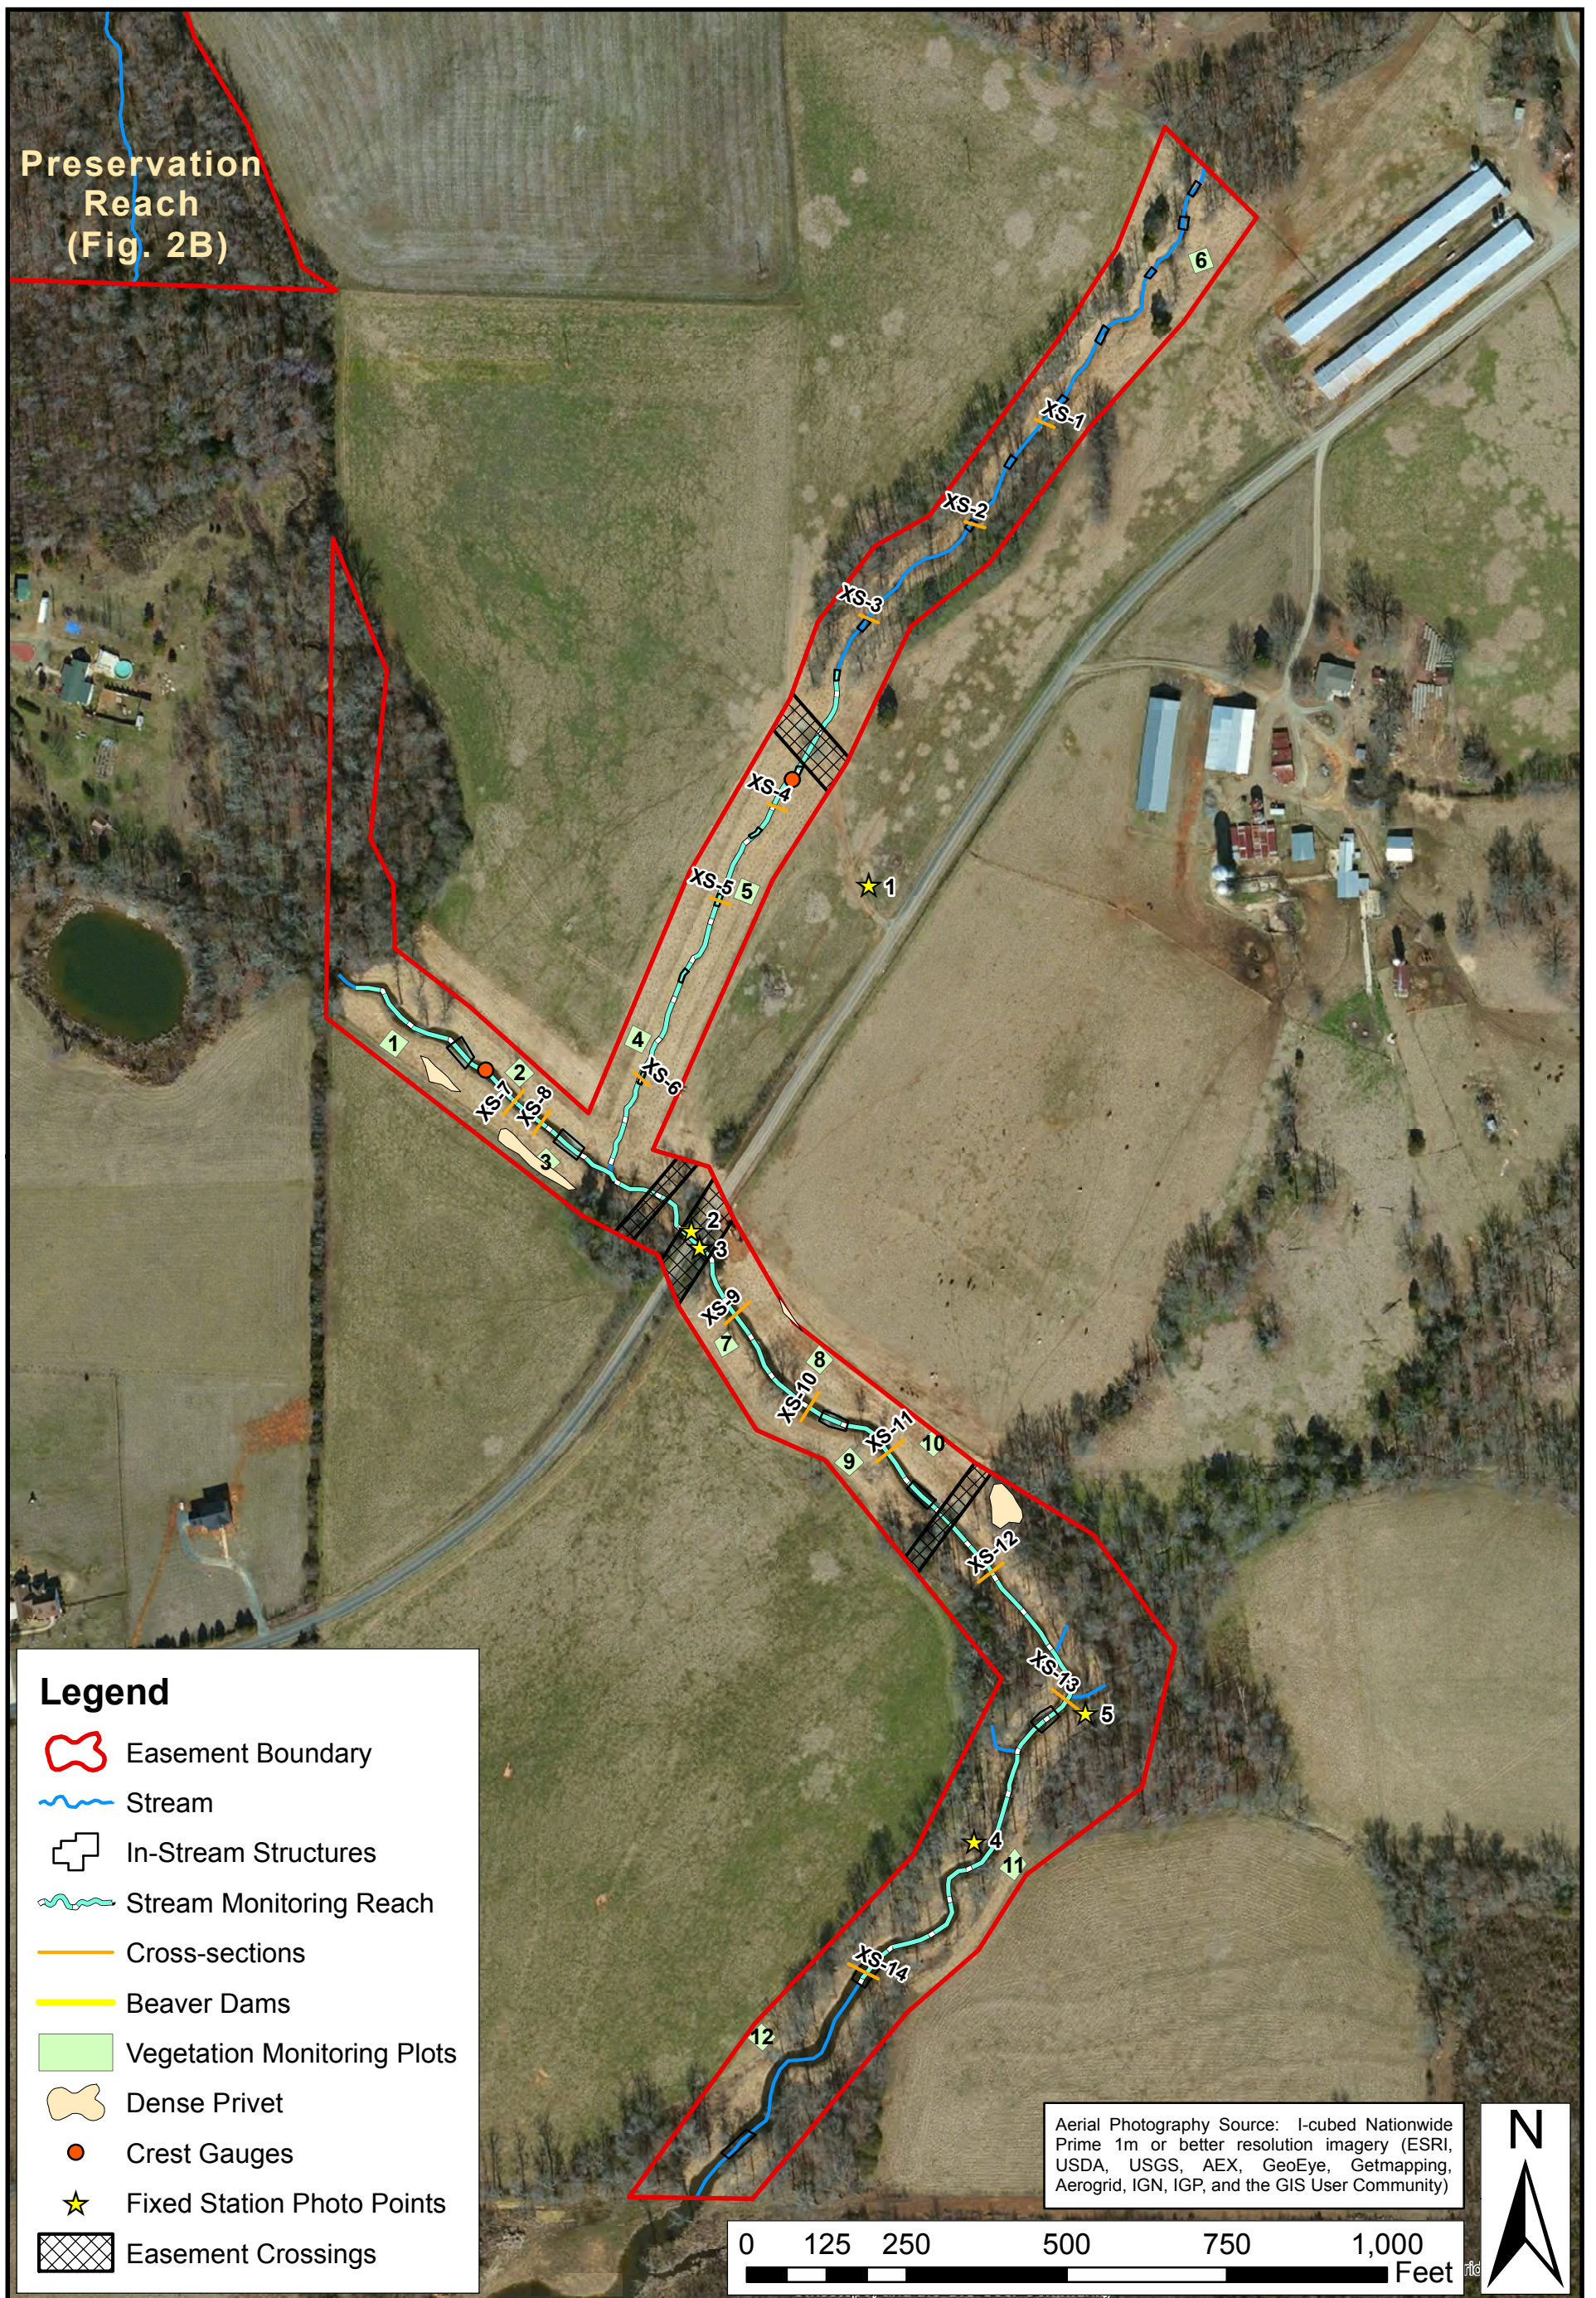
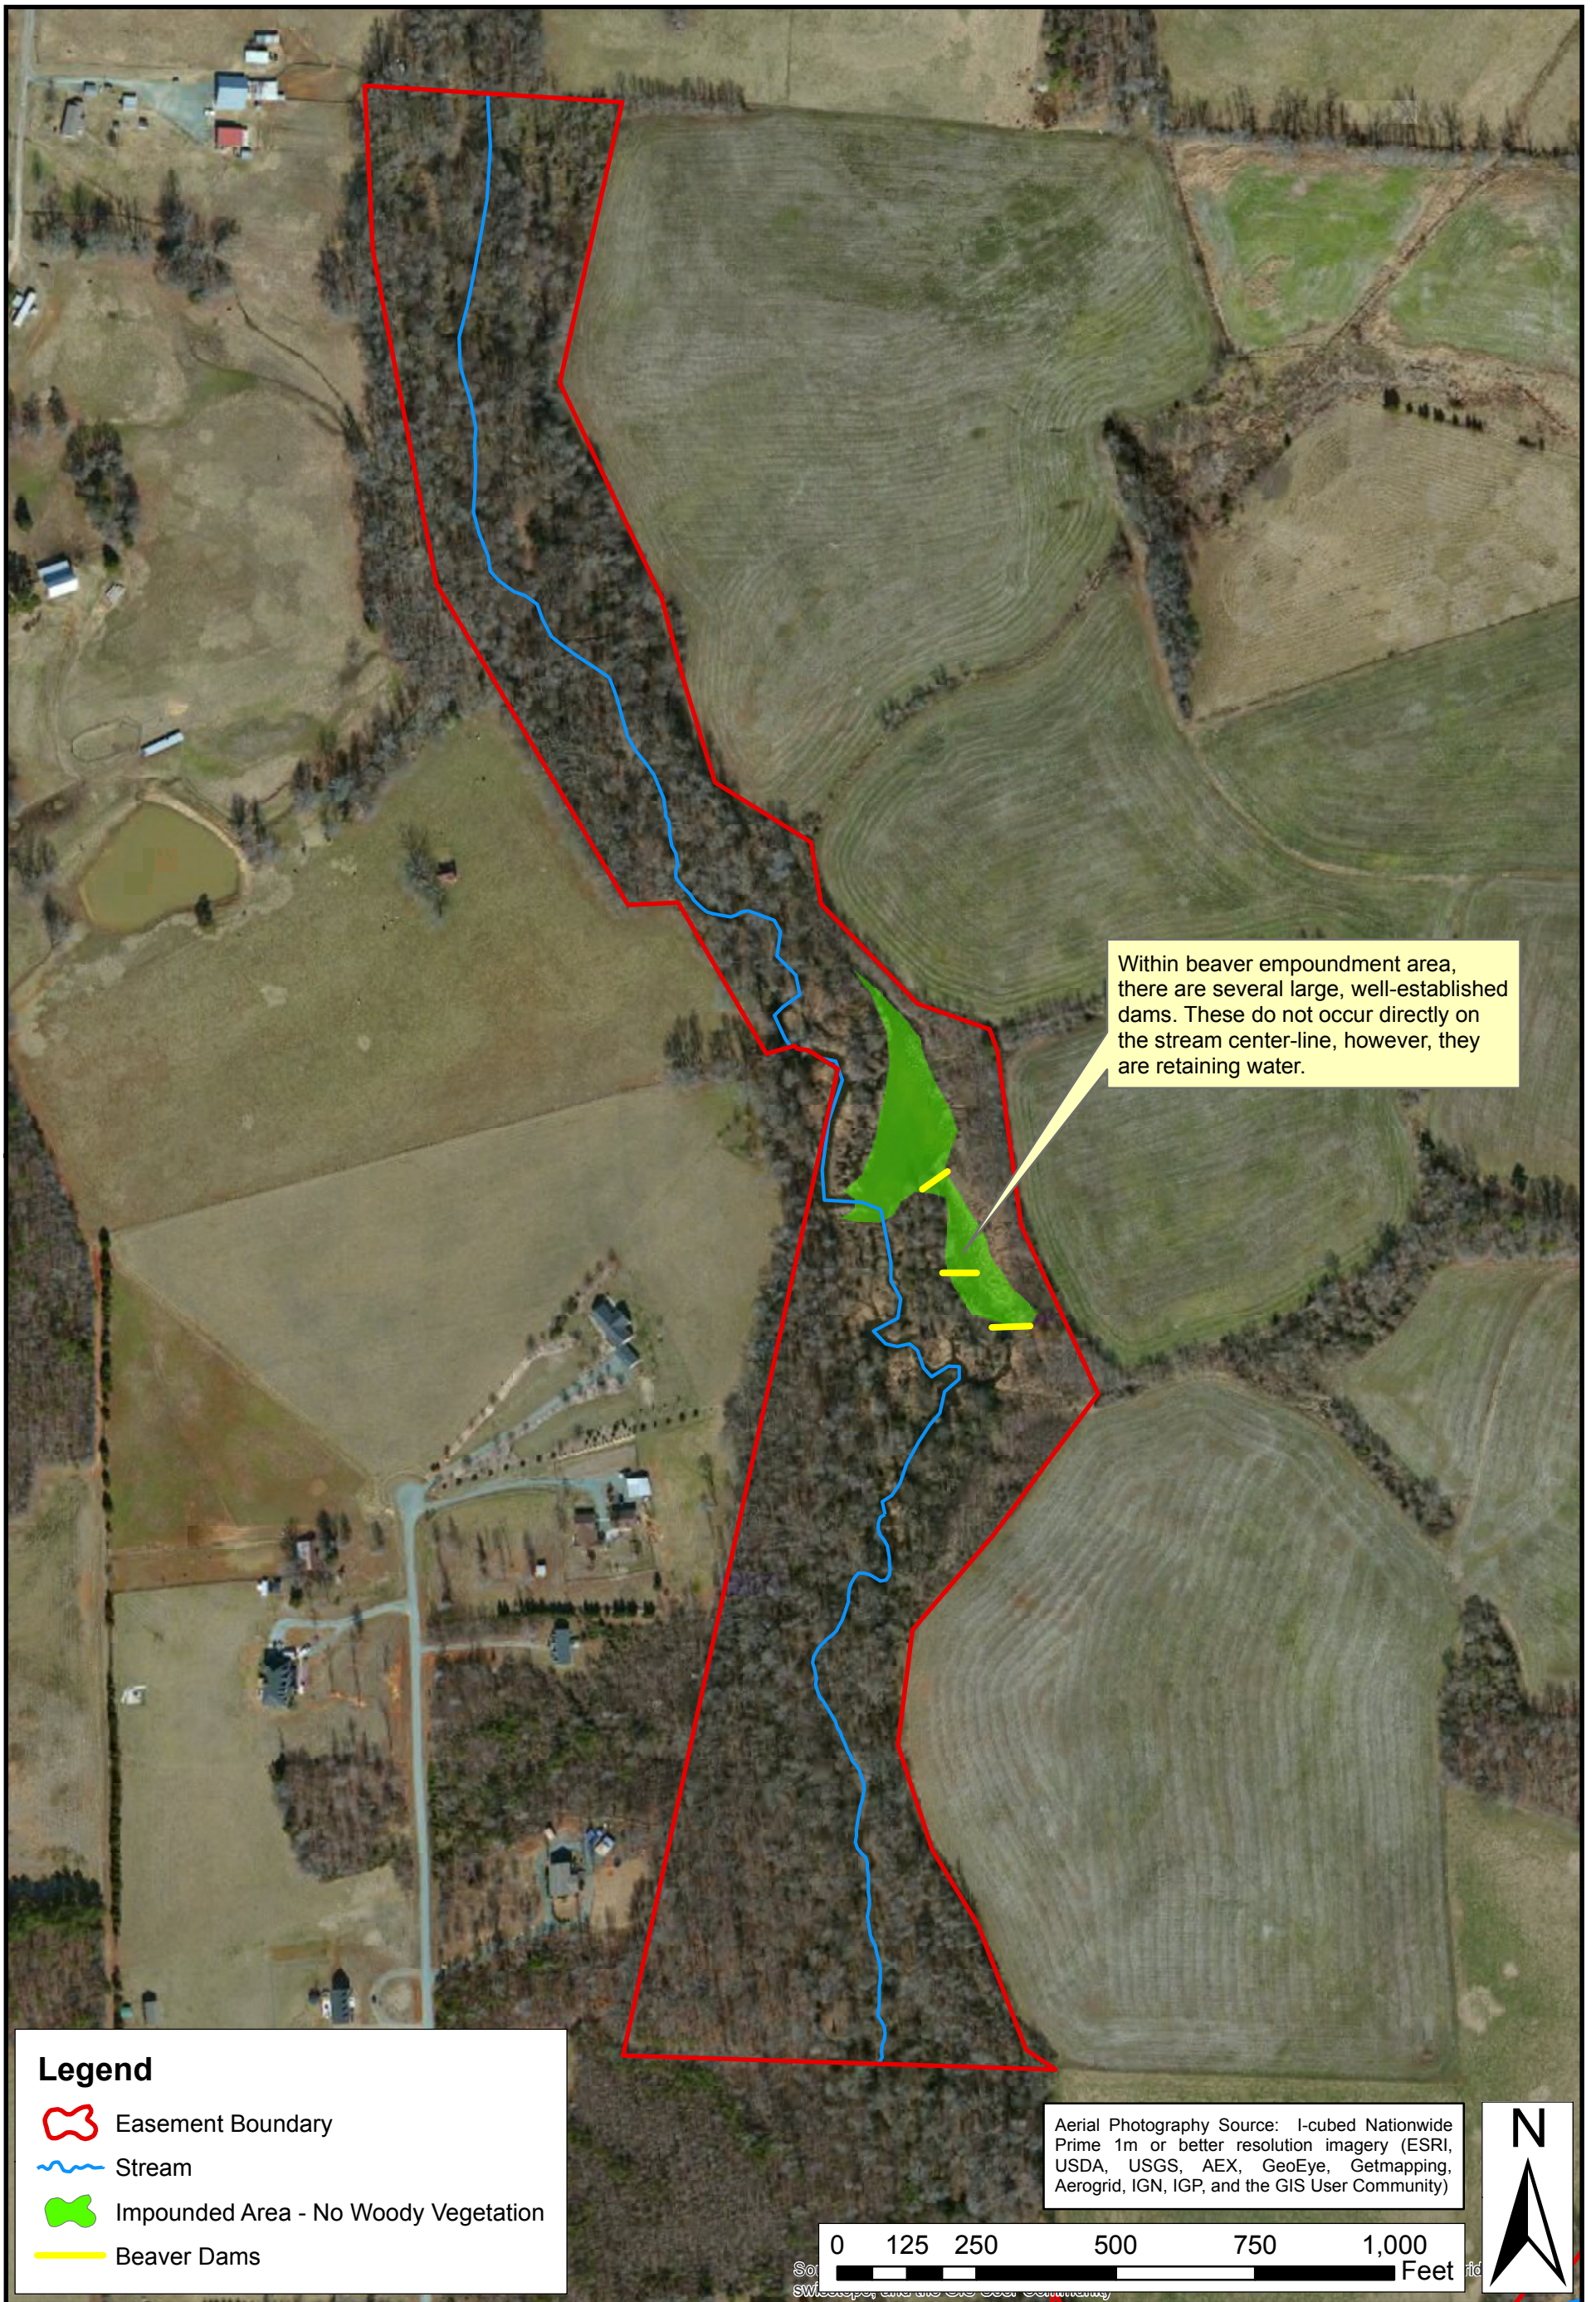
2

Beaver have been an ongoing issue on the Site and are being closely monitored. Three previously noted beaver dams located 1) downstream of the Staley Snow Camp bridge crossing, 2) at Cross-section 12, and 3) at Cross-section 13 were removed by APHIS in May 2013 and were not present during monitoring activities. Currently, one large, well-established impoundment is located on the preservation reach consisting of several beaver dams. One large dam was destroyed in the summer of 2013, but it appears as though the beaver are still active in this area. Few woody stems are surviving in the impoundment footprint, and no natural recruits are becoming established at this time. This impoundment area is shown on the Current Conditions Plan View Map (Figure 2B).

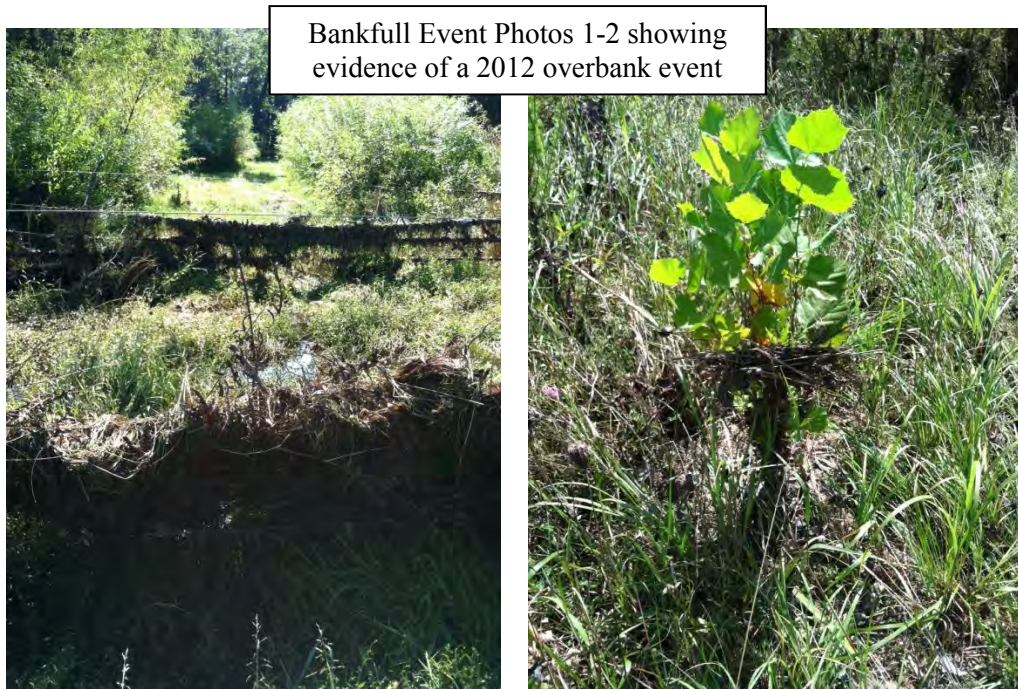
Bankfull Event Photos 1-2 showing evidence of a 2012 overbank event

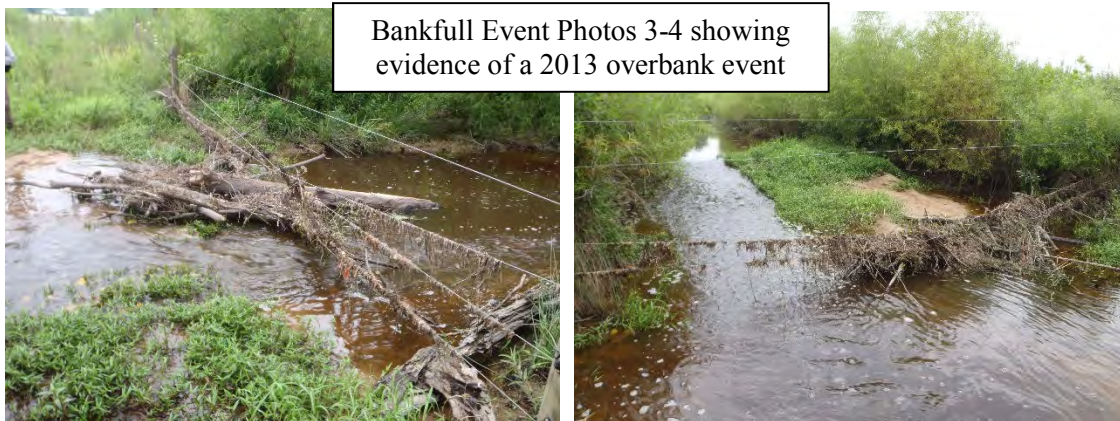
Bankfull Event Photos 3-4 showing evidence of a 2013 overbank event
