**FINAL
ANNUAL MONITORING REPORT
YEAR 3 (2014)
GREENBRIER CREEK STREAM/WETLAND/BUFFER RESTORATION SITE
ALAMANCE AND CHATHAM COUNTIES, NORTH CAROLINA
(EEP Project No. 671, Contract No. 004801)
Construction Completed January 2011**

October 2014

Prepared by:
Axiom Environmental, Inc.
218 Snow Avenue
Raleigh, North Carolina 27603

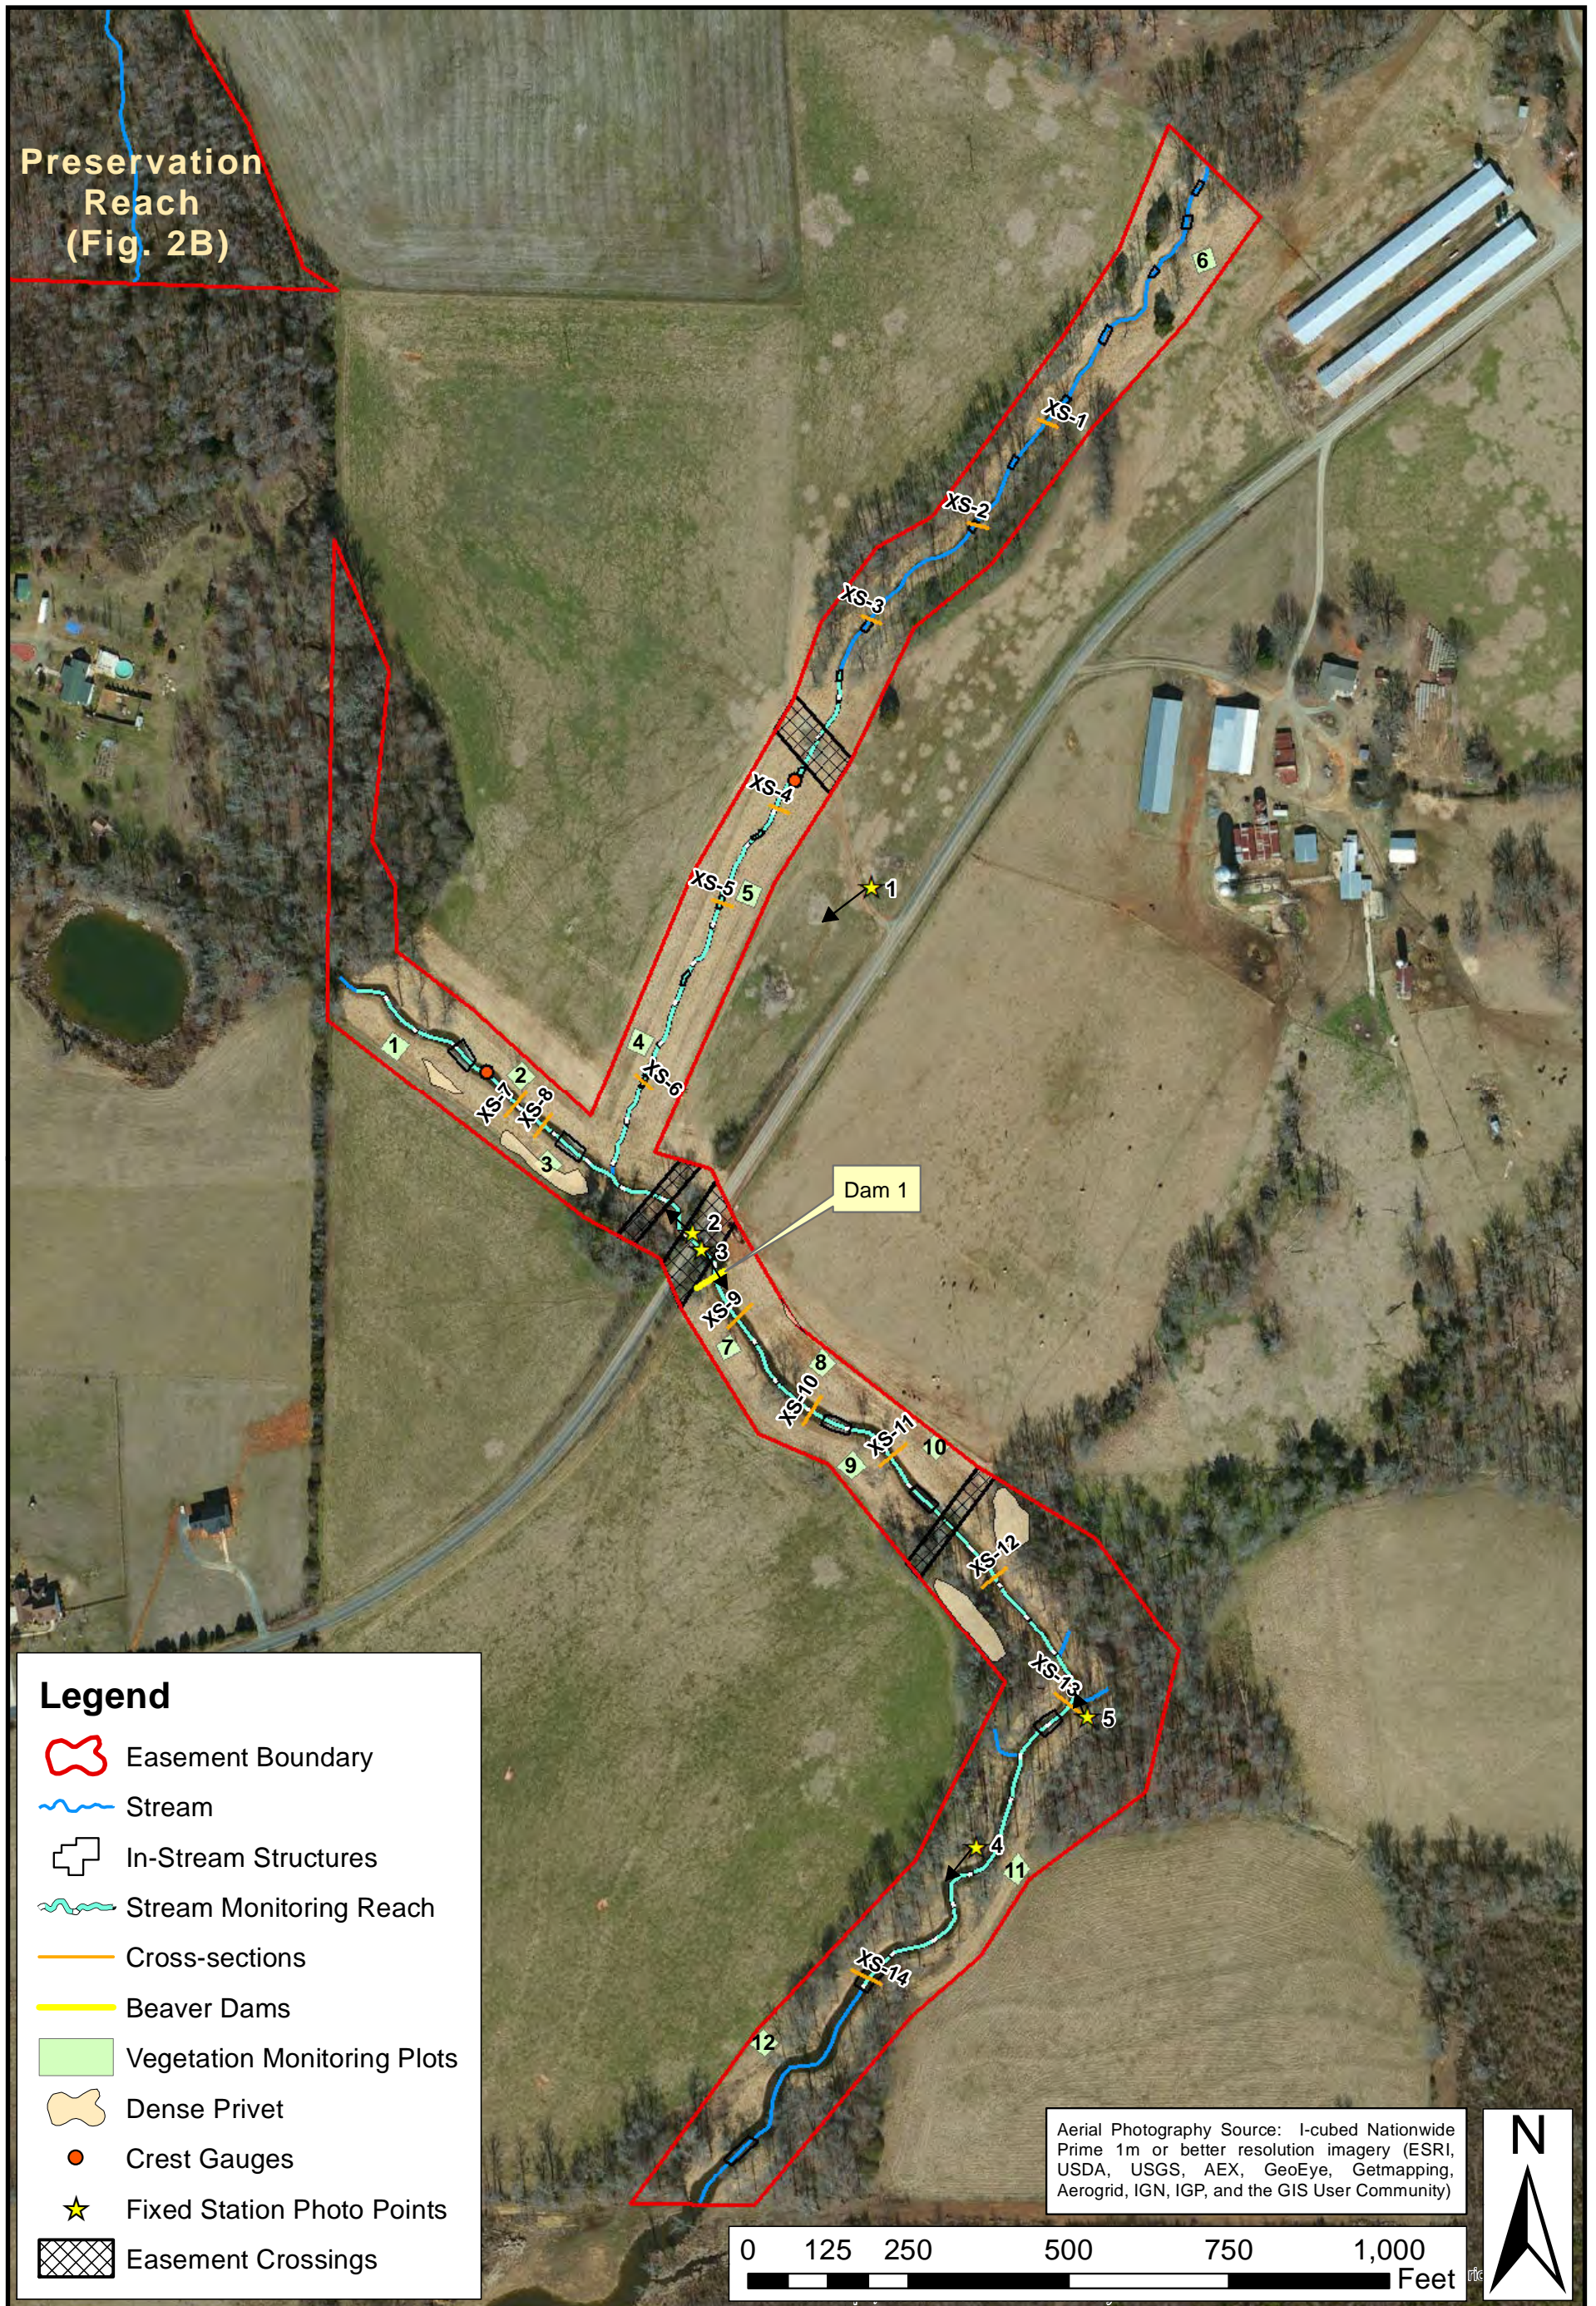
FIGURE

Beaver have been an ongoing issue on the Site and are being closely monitored. One previously noted beaver dam located at Cross-section 8 was removed, likely during a heavy flow event, and was not present during monitoring activities. Another previously noted dam located downstream of the Staley Snow Camp bridge crossing was located and is still intact (Dam 1, Figure 2A, Appendix B). Currently, one large, well-established impoundment is located on the preservation reach consisting of two major beaver dams (Dams 2 and 3, Figure 2B, Appendix B). One large dam was destroyed in the summer of 2013, but it appears as though the beaver are still active in this area. Few woody stems are surviving in the impoundment footprint, which consists of mostly standing water, and no natural recruits are becoming established at this time. This impoundment area is shown on the Current Conditions Plan View Map (Figure 2B, Appendix B).

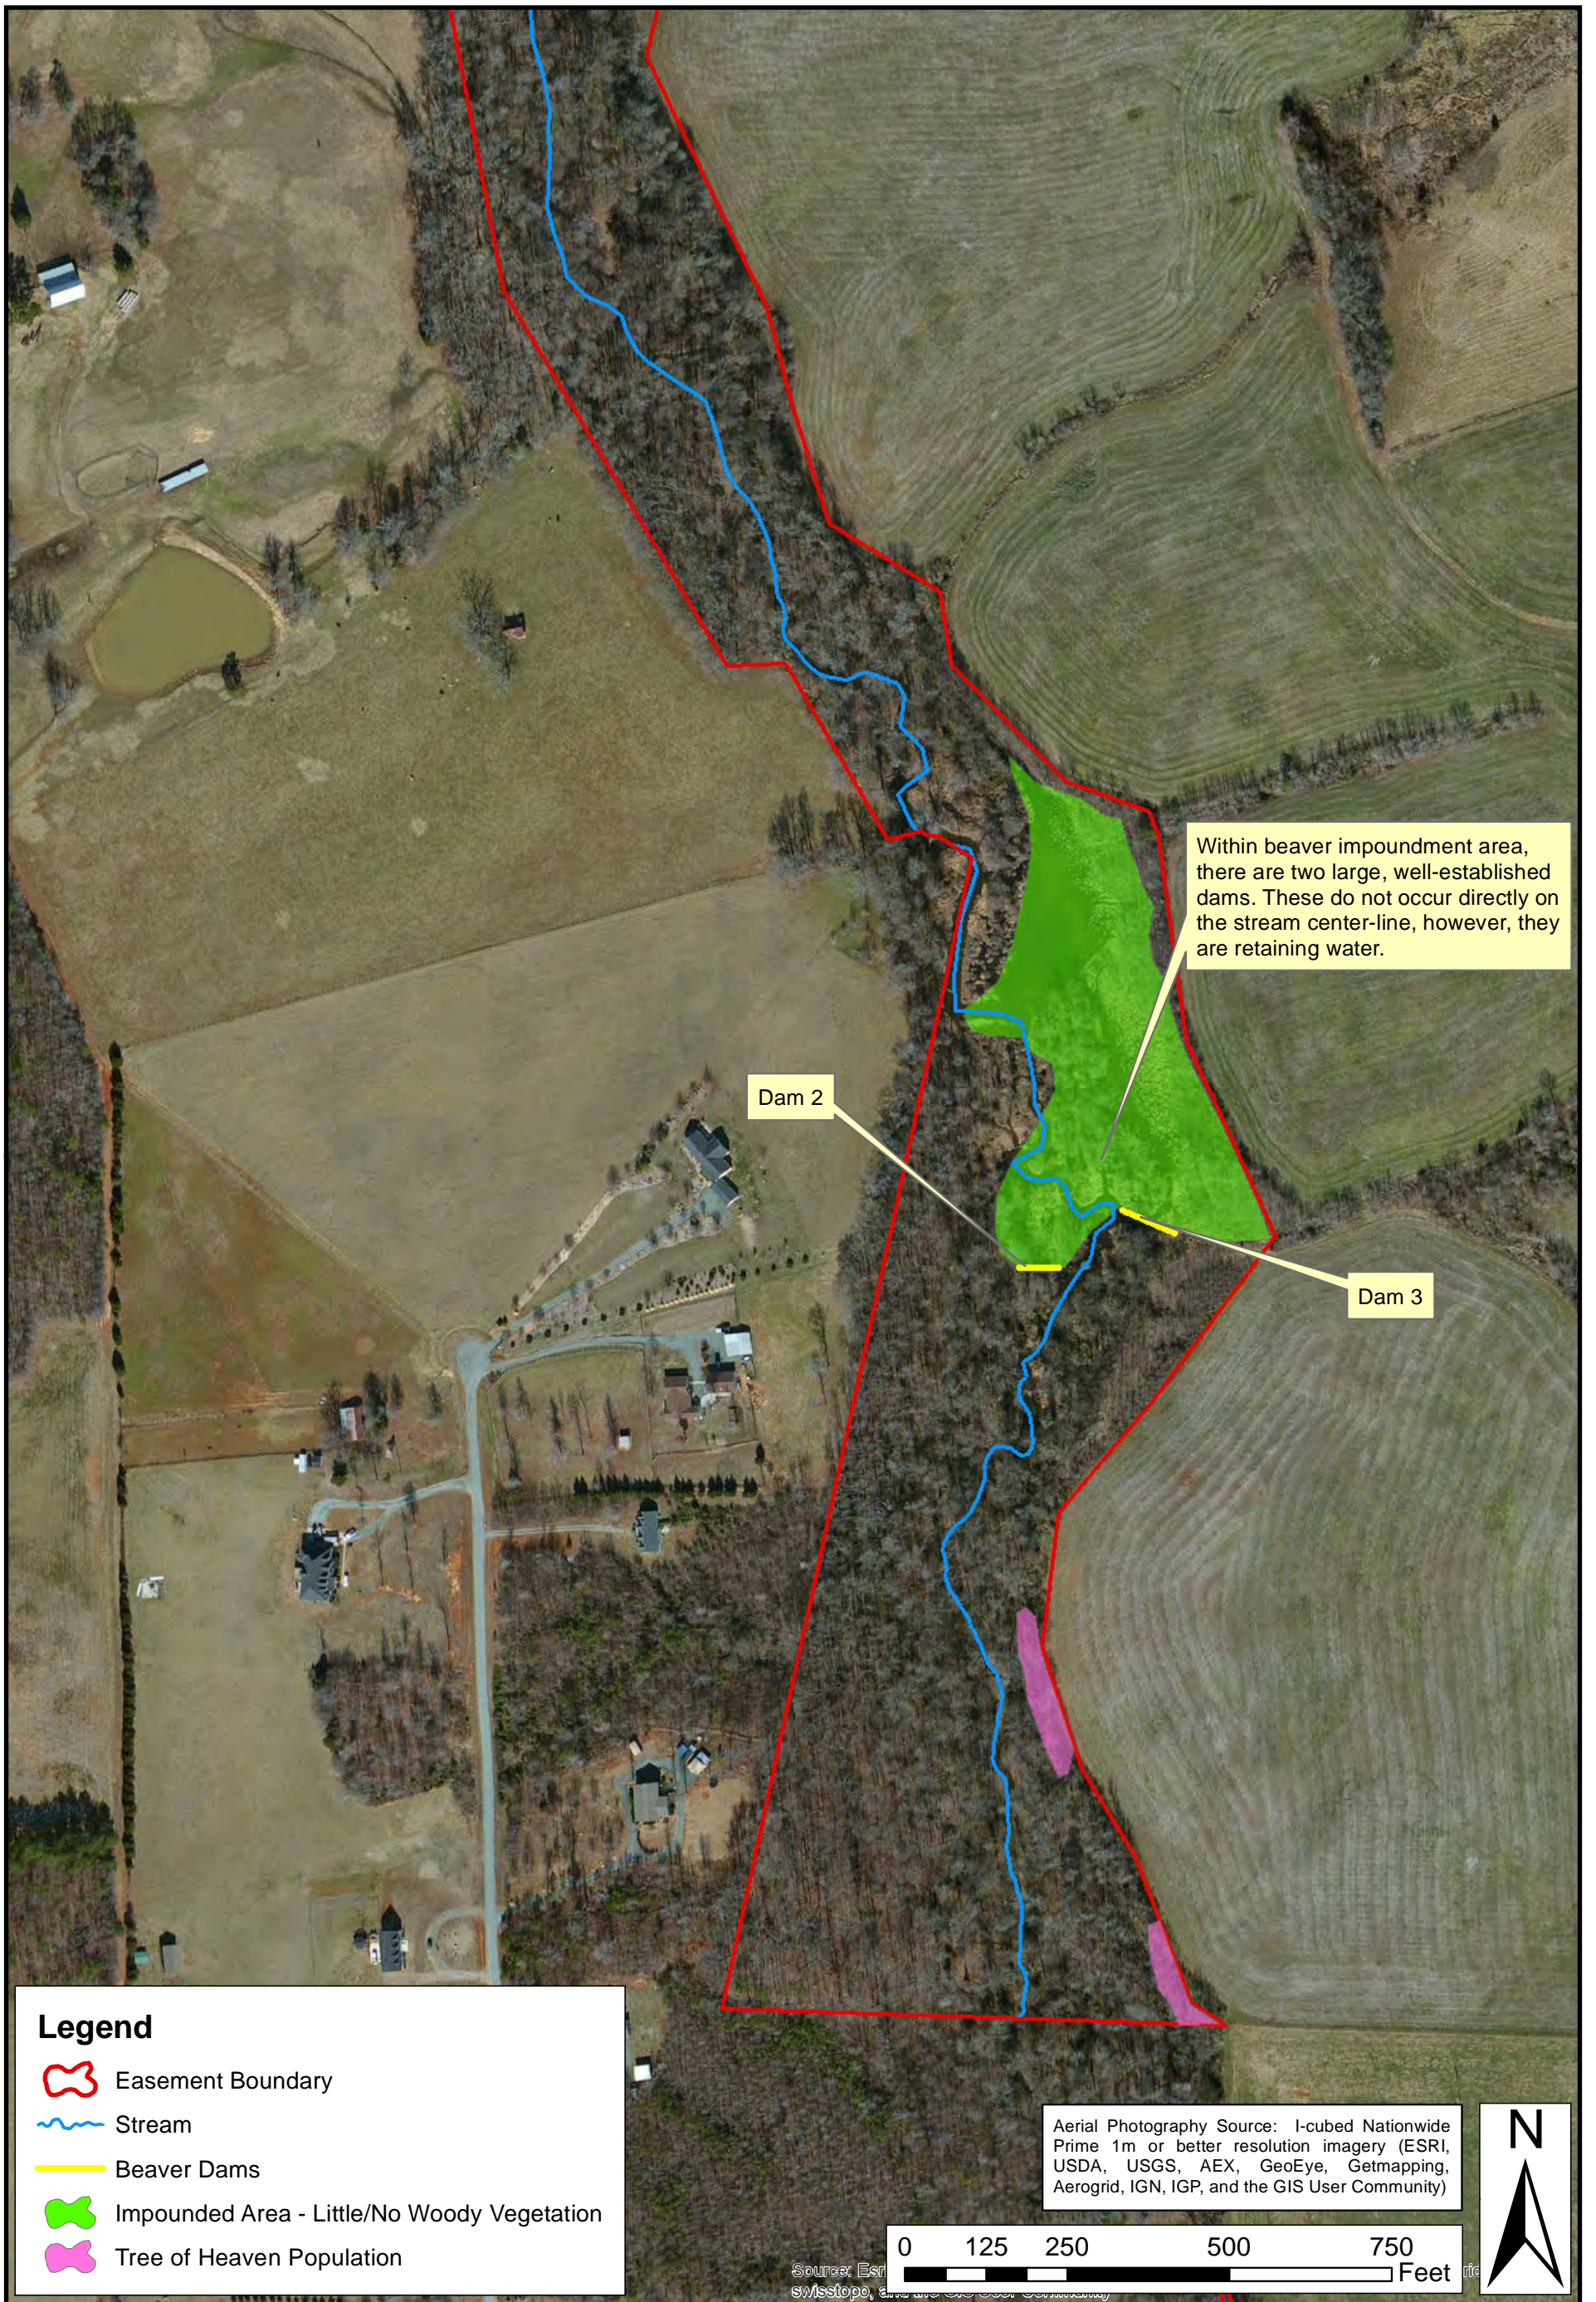
FIGURE
2A

Chinese privet (*Ligustrum sinense*) and Japanese privet (*Ligustrum japonicum*) are scattered throughout the site; however, several occurrences (two areas upstream of the confluence, one smaller area along the easement boundary downstream of the bridge (too small to see on figures), and two areas just downstream

of the ford (near cross-section 12) are particularly dense (Figure 2A, Appendix B). In addition, scattered stems of Bradford pear (*Pyrus calleryana*) and multiflora rose (*Rosa multiflora*) are present in minimal numbers within the Site. Herbaceous species including Japanese stiltgrass (*Microstegium vimineum*) and fescue (*Festuca* sp.) are found across the entire Site. *Microstegium* is found in portions of the Site that are covered by mature canopy along the upstream portion of the unnamed tributary, downstream portions of Greenbrier Creek, and throughout the preservation reach. Fescue is found in open areas previously maintained as pasture.

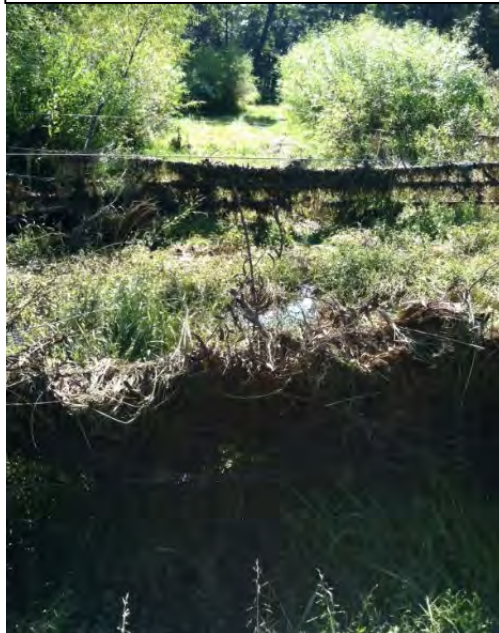
Bankfull Event Photo 1 showing evidence of a 2012 overbank event

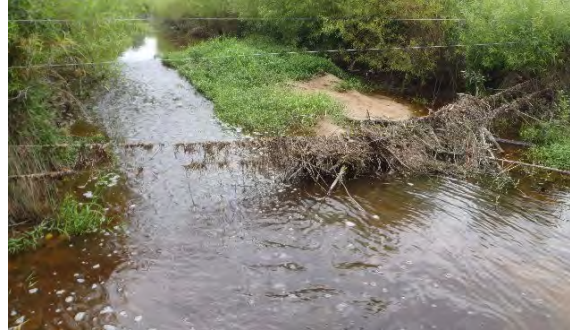
Bankfull Event Photo 2 showing evidence of a 2013 overbank event

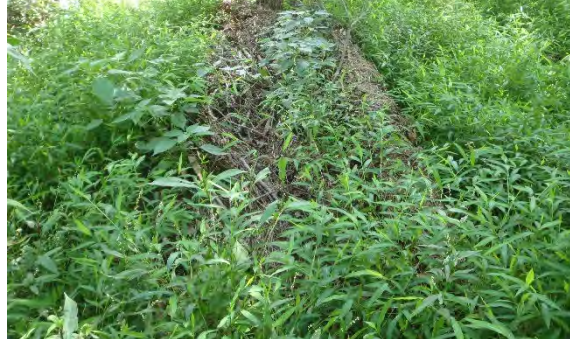
Bankfull Event Photo 3 showing evidence of a 2014 overbank event

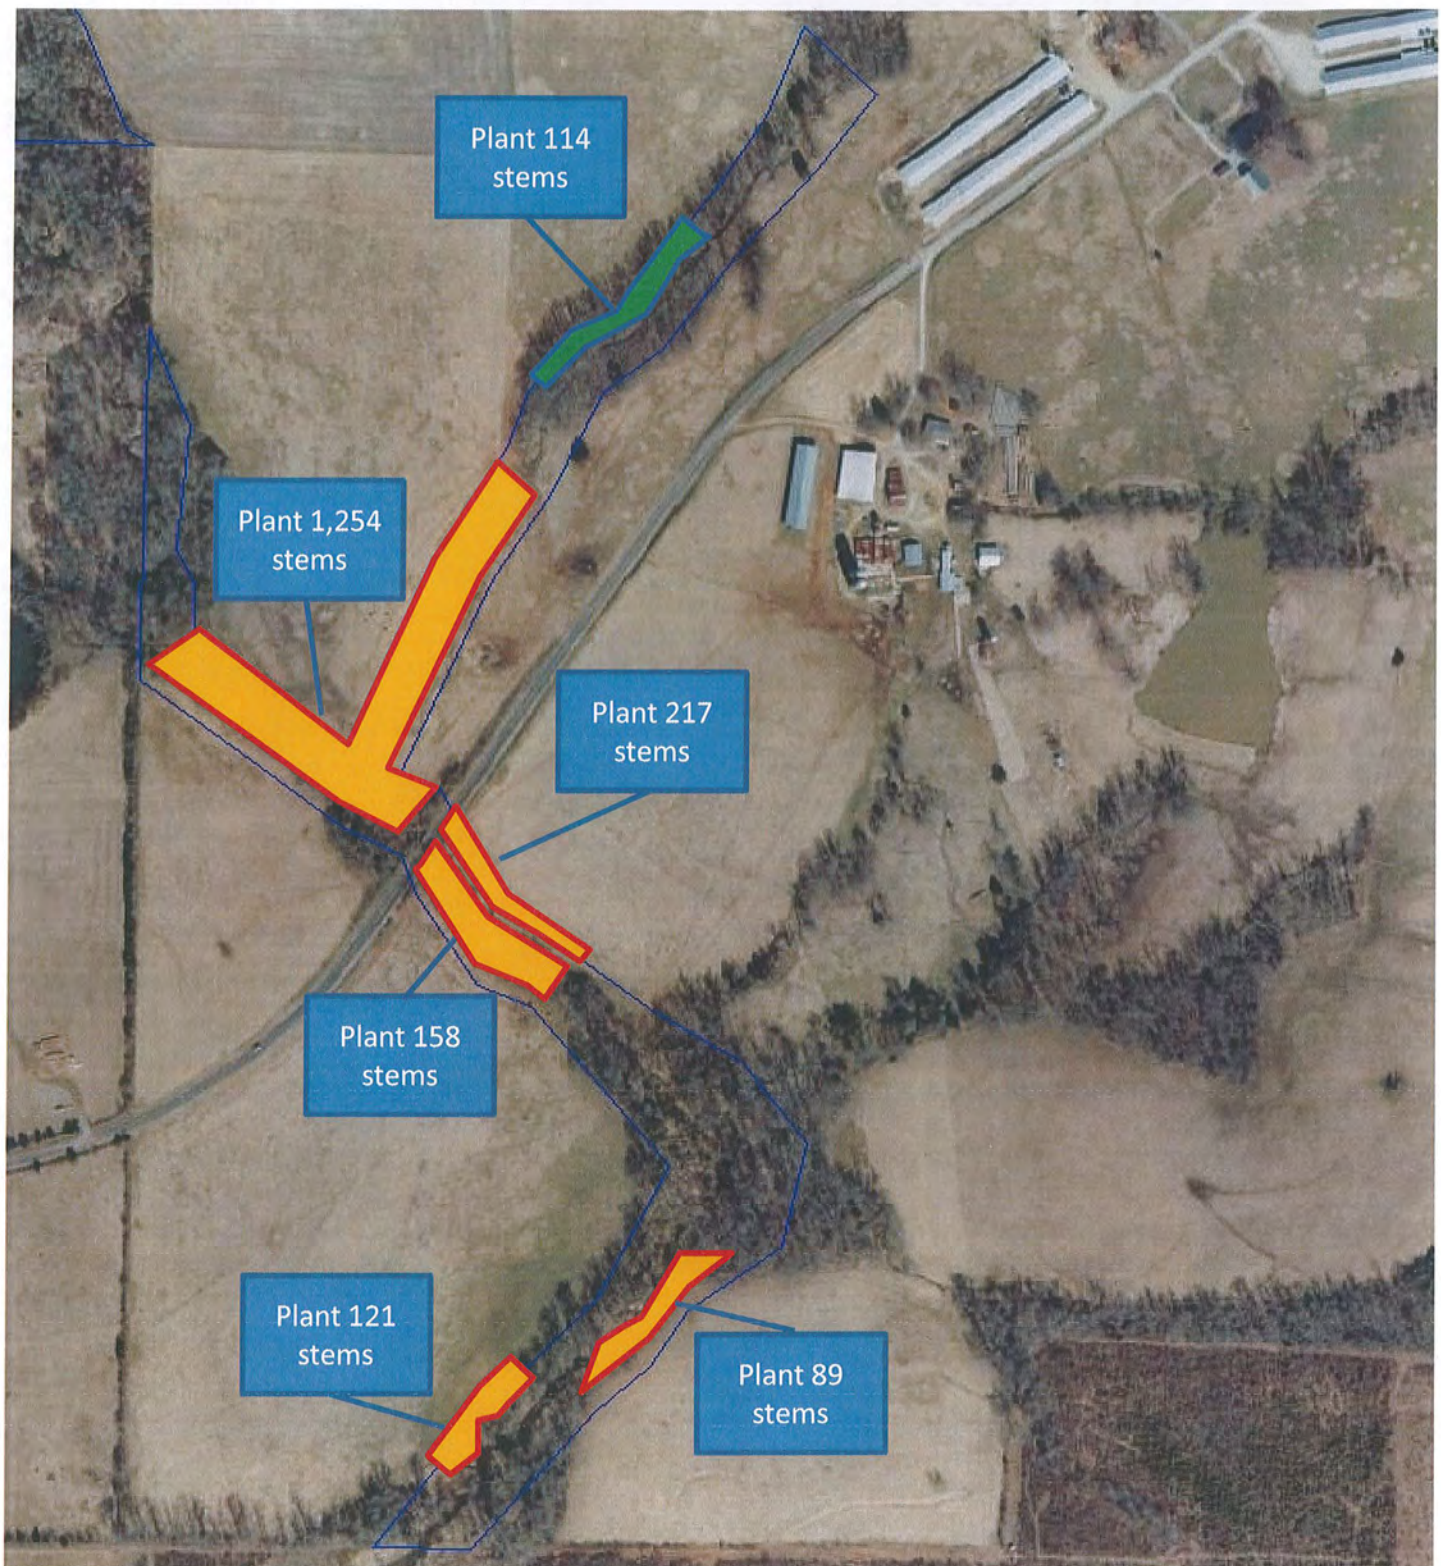
Greenbrier Creek Stream Restoration
Alamance/Chatham Counties
Vegetation Warranty Map

In general, some of plant survival in the Zone 4 and Zone 5 planting zones did not meet the warranty requirement. The table below outlines necessary replanting areas. Surviving stems were subtracted from the warranty criteria (544/acre for Zone 4 and 348 per acre for Zone 5) so that the "Total plants needed" column is the number of remaining stems needed get warranty criteria (544/348) stems per acre in areas with deficient vegetation. Planting densities were averaged into planting zones and are identified on the attached Supplemental Planting Map.

Location	Planting Zone	Acres	Total plants needed
Zone 5 (Unnamed Tributary)	Zone 5	0.8	114
Unnamed Tributary (St 400+00 - 407+00) & mainstem (St 106+50 - 100+00)	Zone 4	3	1254
Right, mainstem (St 200+00 - 205+50)	Zone 4	0.6	158
Left, mainstem (St 200+00 - 206+00)	Zone 4	0.7	217
Left, mainstem (St 212+50 - 214+00)	Zone 4	0.2	89
Right, mainstem (St 210+50 - 219+00)	Zone 4	1	121
Total		6.3	1,952
