**FINAL
ANNUAL MONITORING REPORT
YEAR 4 (2015)
GREENBRIER CREEK STREAM/WETLAND/BUFFER RESTORATION SITE
ALAMANCE AND CHATHAM COUNTIES, NORTH CAROLINA
(DMS Project No. 671, Contract No. 004801)
Construction Completed January 2011**

October 2015

Prepared by:
Axiom Environmental, Inc.
218 Snow Avenue
Raleigh, North Carolina 27603

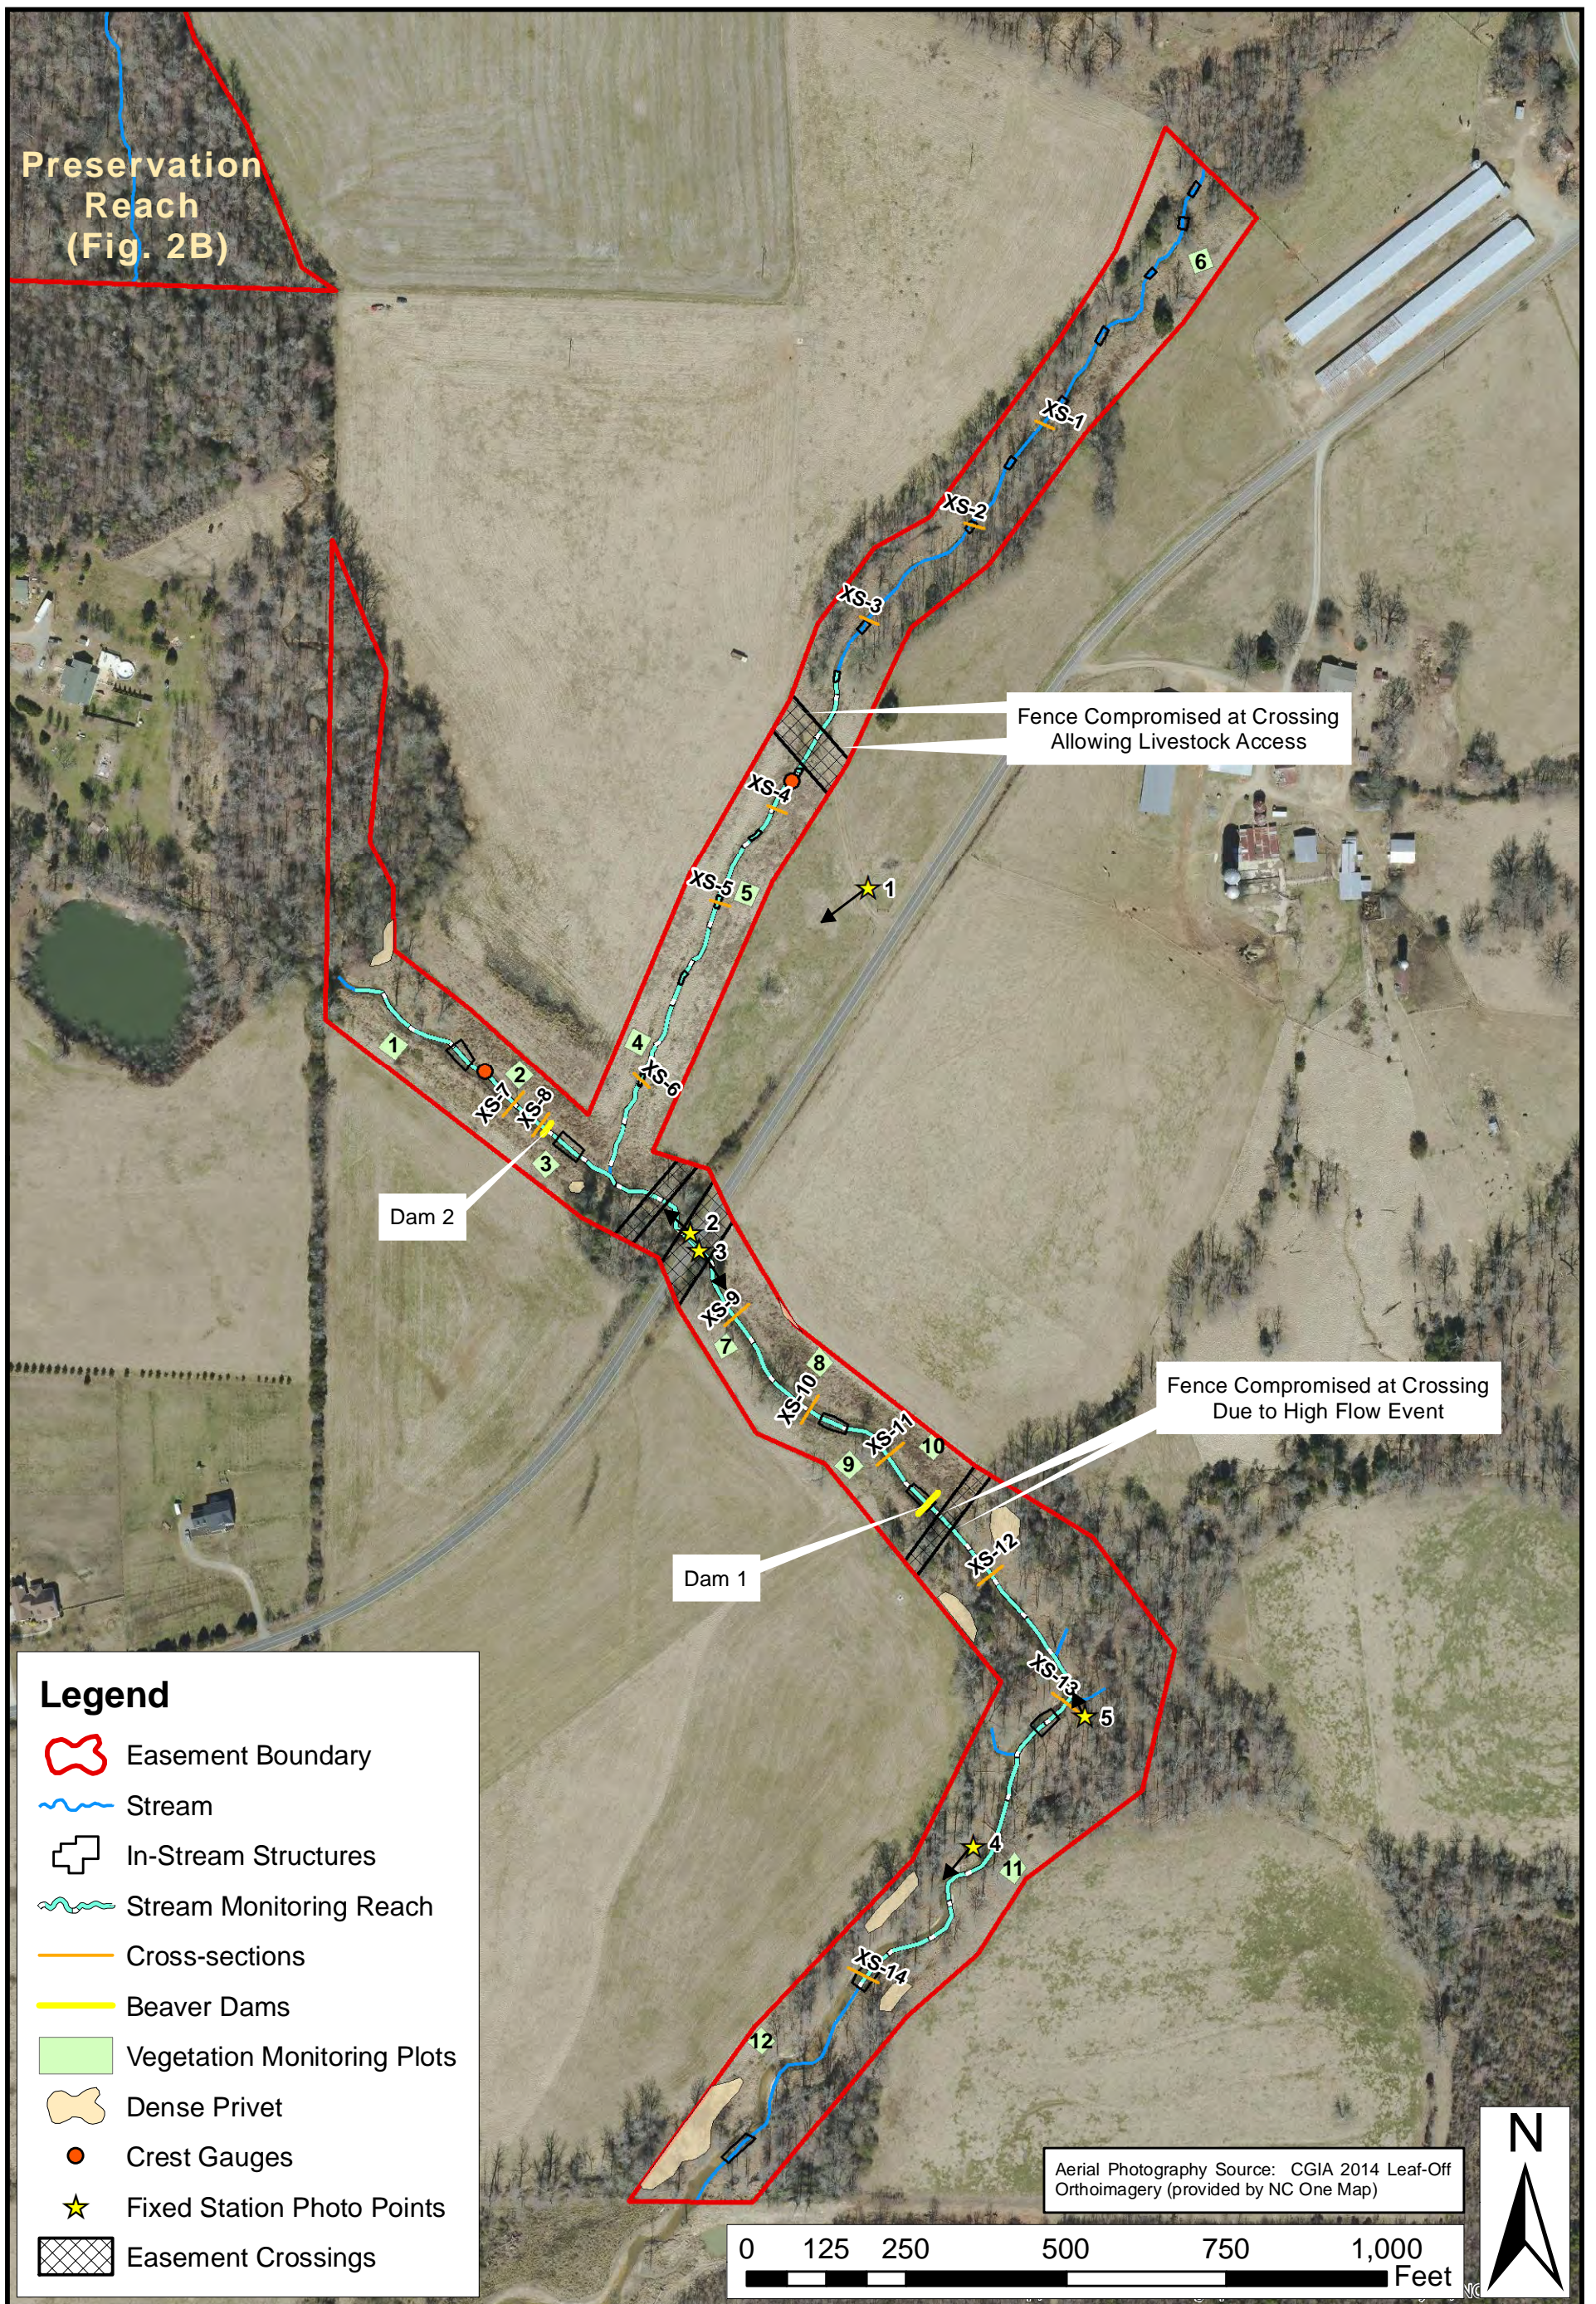
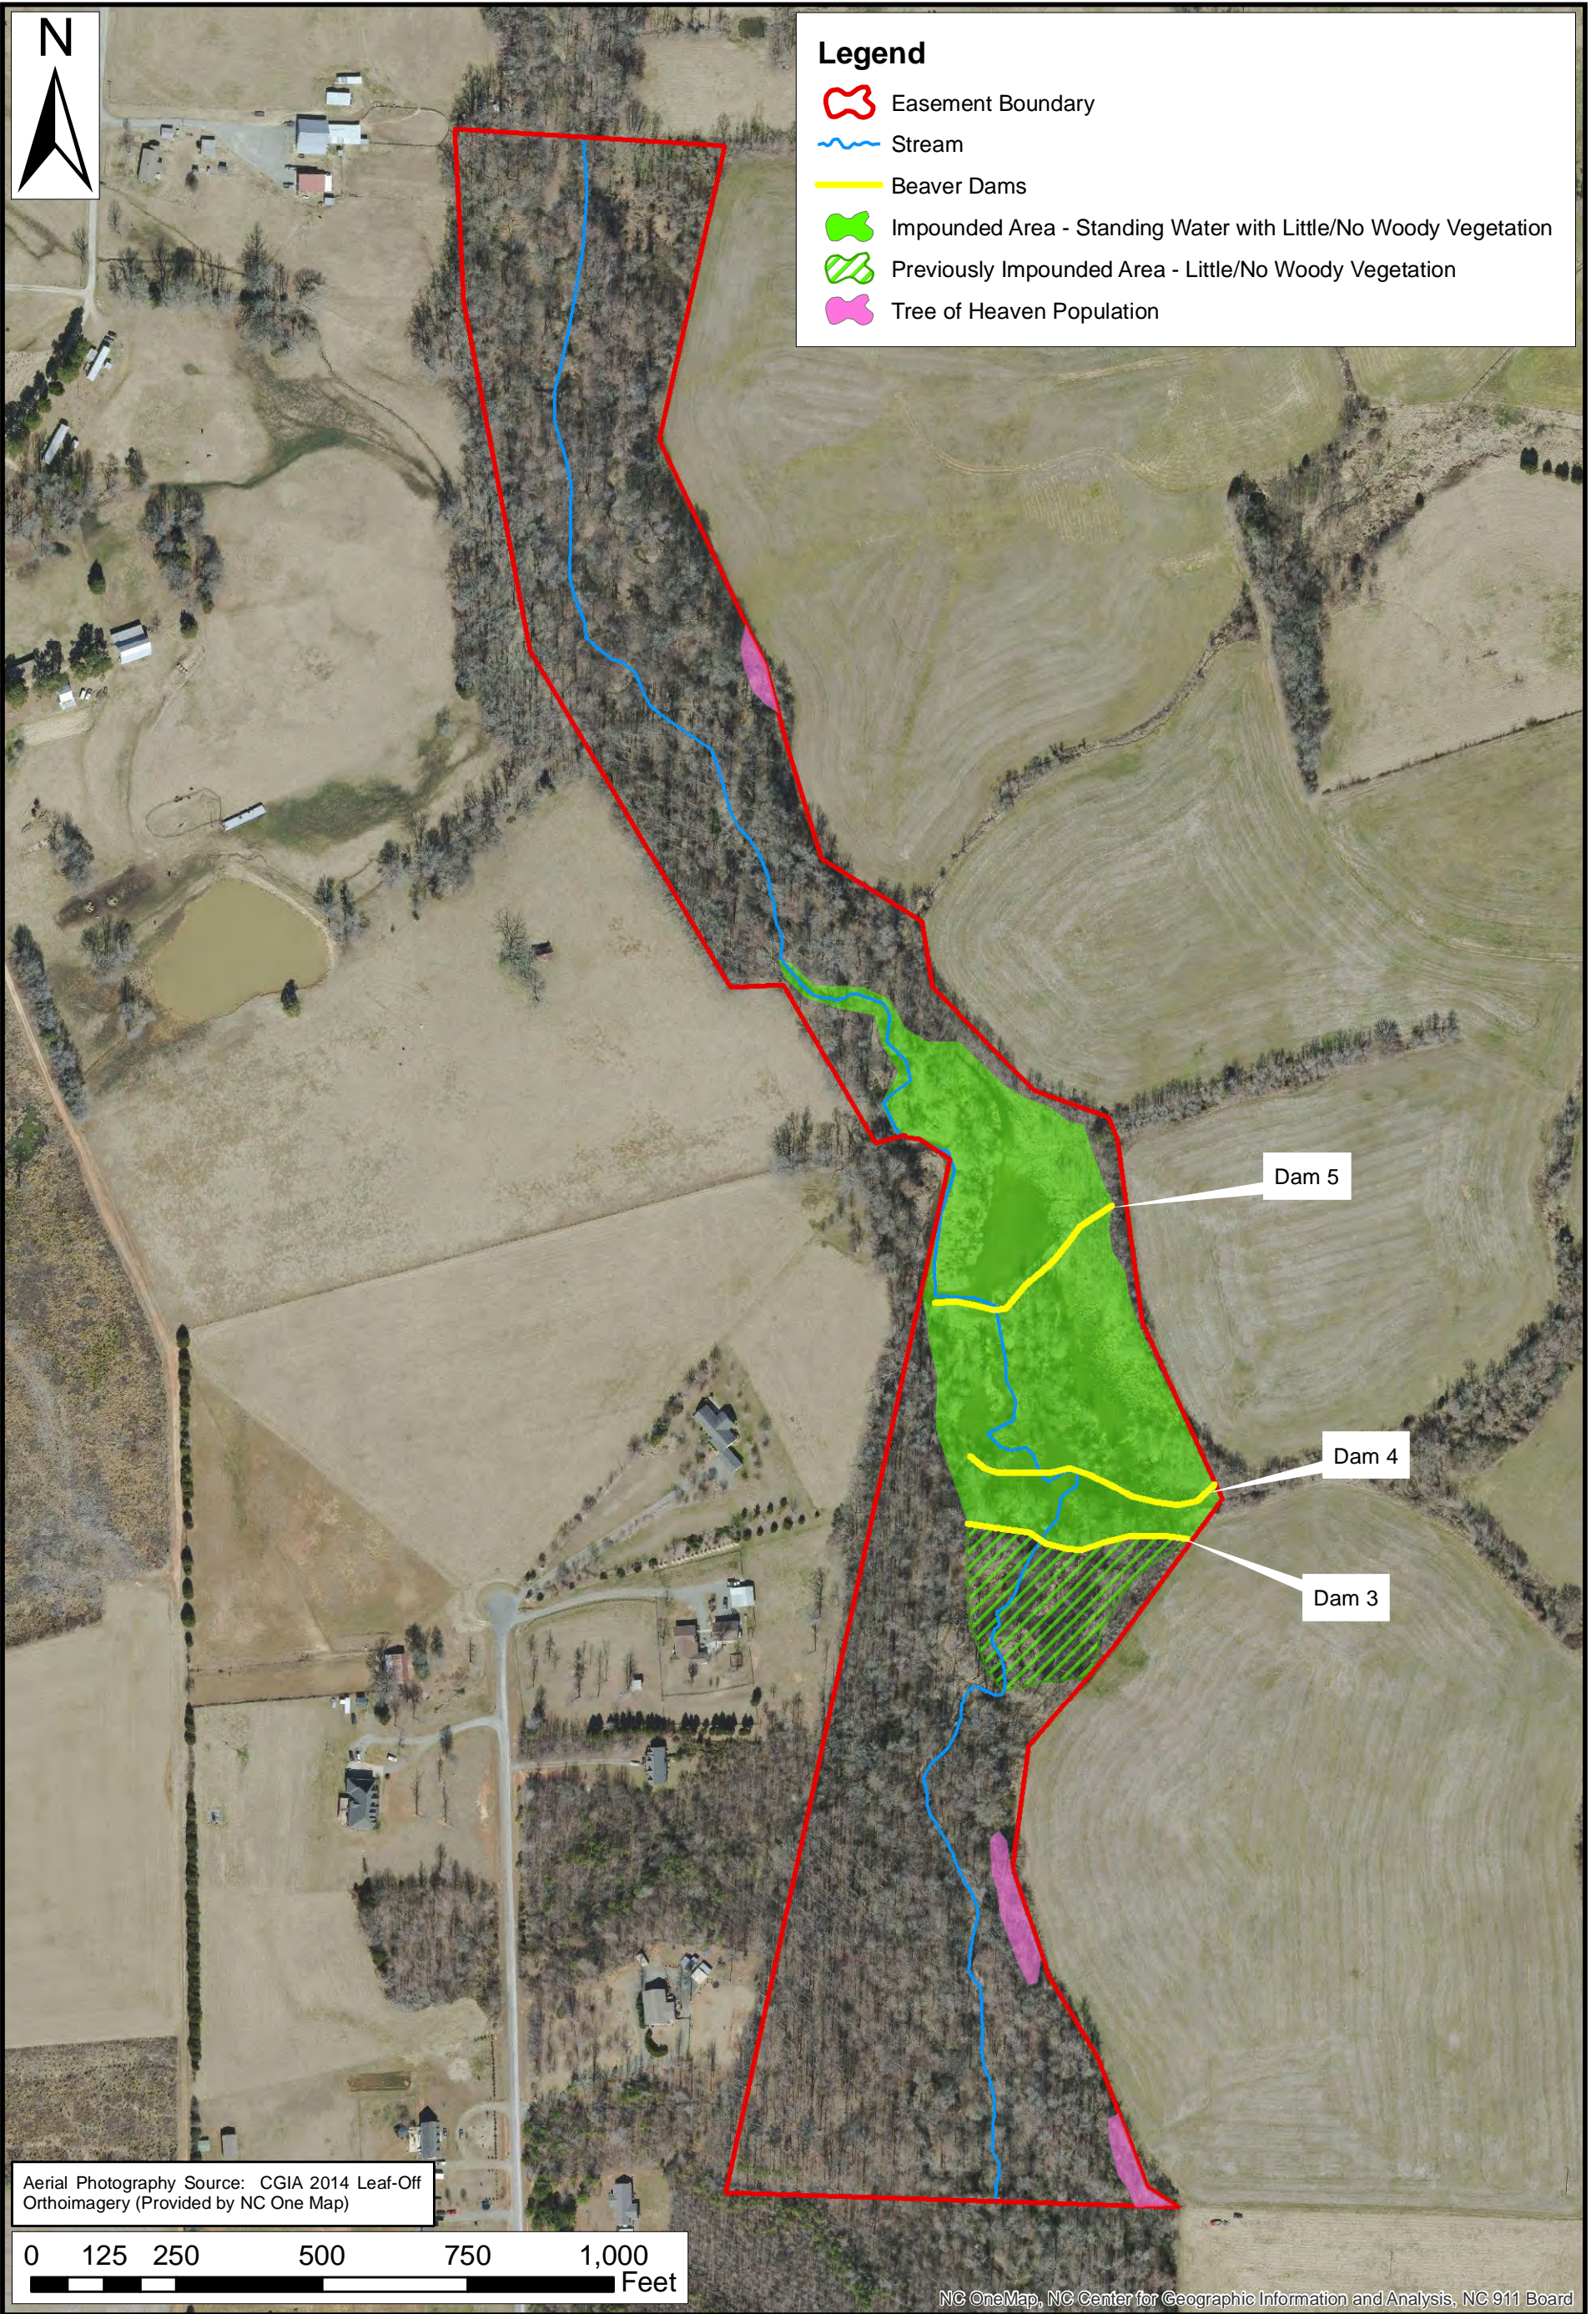
FIGURE
2B

Beaver have been an ongoing issue within the Site and are being closely monitored and trapped when necessary. Two dams were observed on restoration reaches during year 4 (2015) monitoring activities, one in the vicinity of cross section 8 and one near the downstream-most easement crossing. (Dams 1 and 2, Figure 2A, Appendix B). Currently, one large, well-established impoundment is located on the preservation reach consisting of three major beaver dams (Dams 3, 4, and 5, Figure 2B, Appendix B). This impoundment is characterized by standing water and a lack of living woody stems. Several smaller dams were removed during summer 2015, however few woody stems are surviving in the previously impounded footprint. It does not appear that natural recruits are becoming established in these areas at this time. The currently impounded and previously impounded areas are depicted on the Current Conditions Plan View Map (Figure 2B, Appendix B).

Fencing along the downstream ford has been heavily damaged by debris during high flow events. Additionally, a small section of fencing has failed in the ford on the unnamed tributary, and some signs of

livestock activity within the easement at the upstream portion of this tributary were observed (Figure 2A, Appendix B).

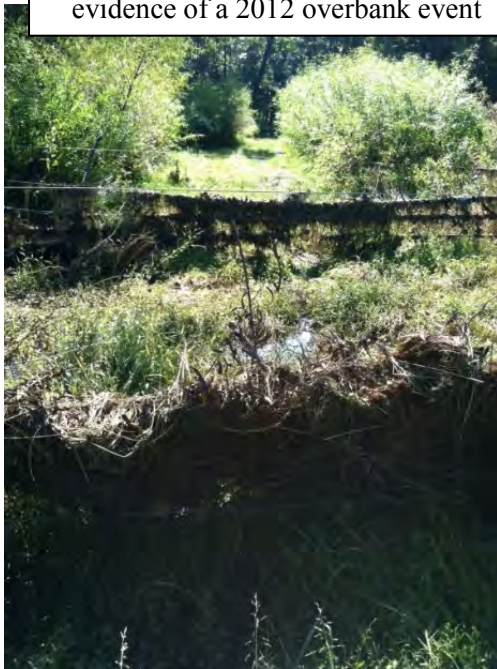
Bankfull Event Photo 1 showing evidence of a 2012 overbank event

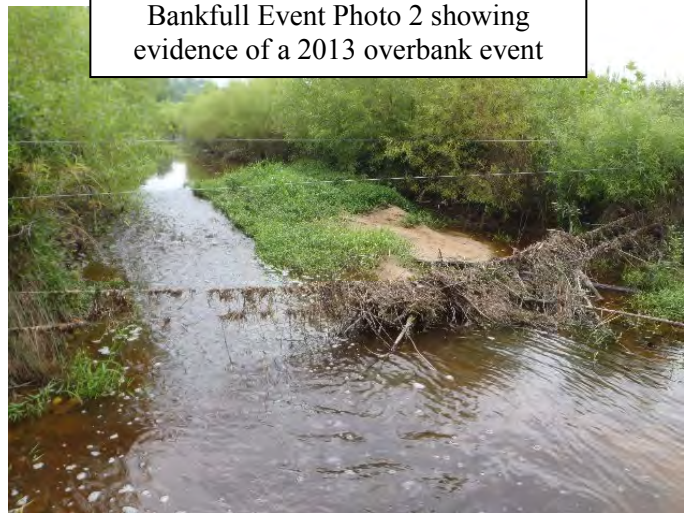
Bankfull Event Photo 2 showing evidence of a 2013 overbank event

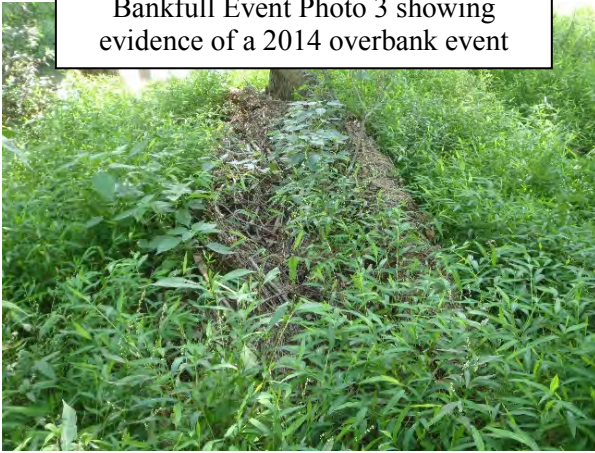
Bankfull Event Photo 3 showing evidence of a 2014 overbank event

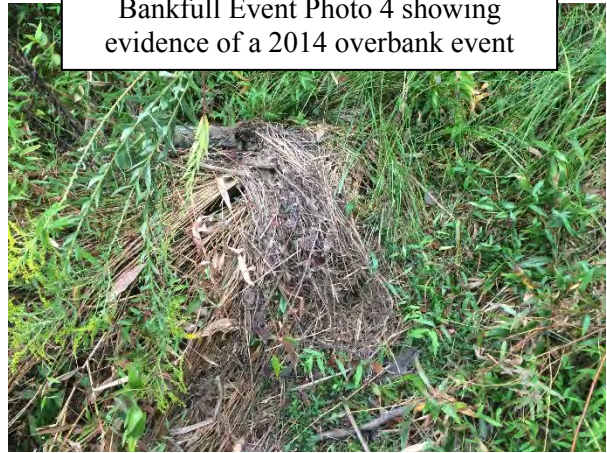
Bankfull Event Photo 4 showing evidence of a 2014 overbank event
