**FINAL
ANNUAL MONITORING REPORT
YEAR 5 (2016)
GREENBRIER CREEK STREAM/WETLAND/BUFFER RESTORATION SITE
ALAMANCE AND CHATHAM COUNTIES, NORTH CAROLINA
(DMS Project No. 671, Contract No. 004801)
Construction Completed January 2011**

November 2016

Prepared by:
Axiom Environmental, Inc.
218 Snow Avenue
Raleigh, North Carolina 27603

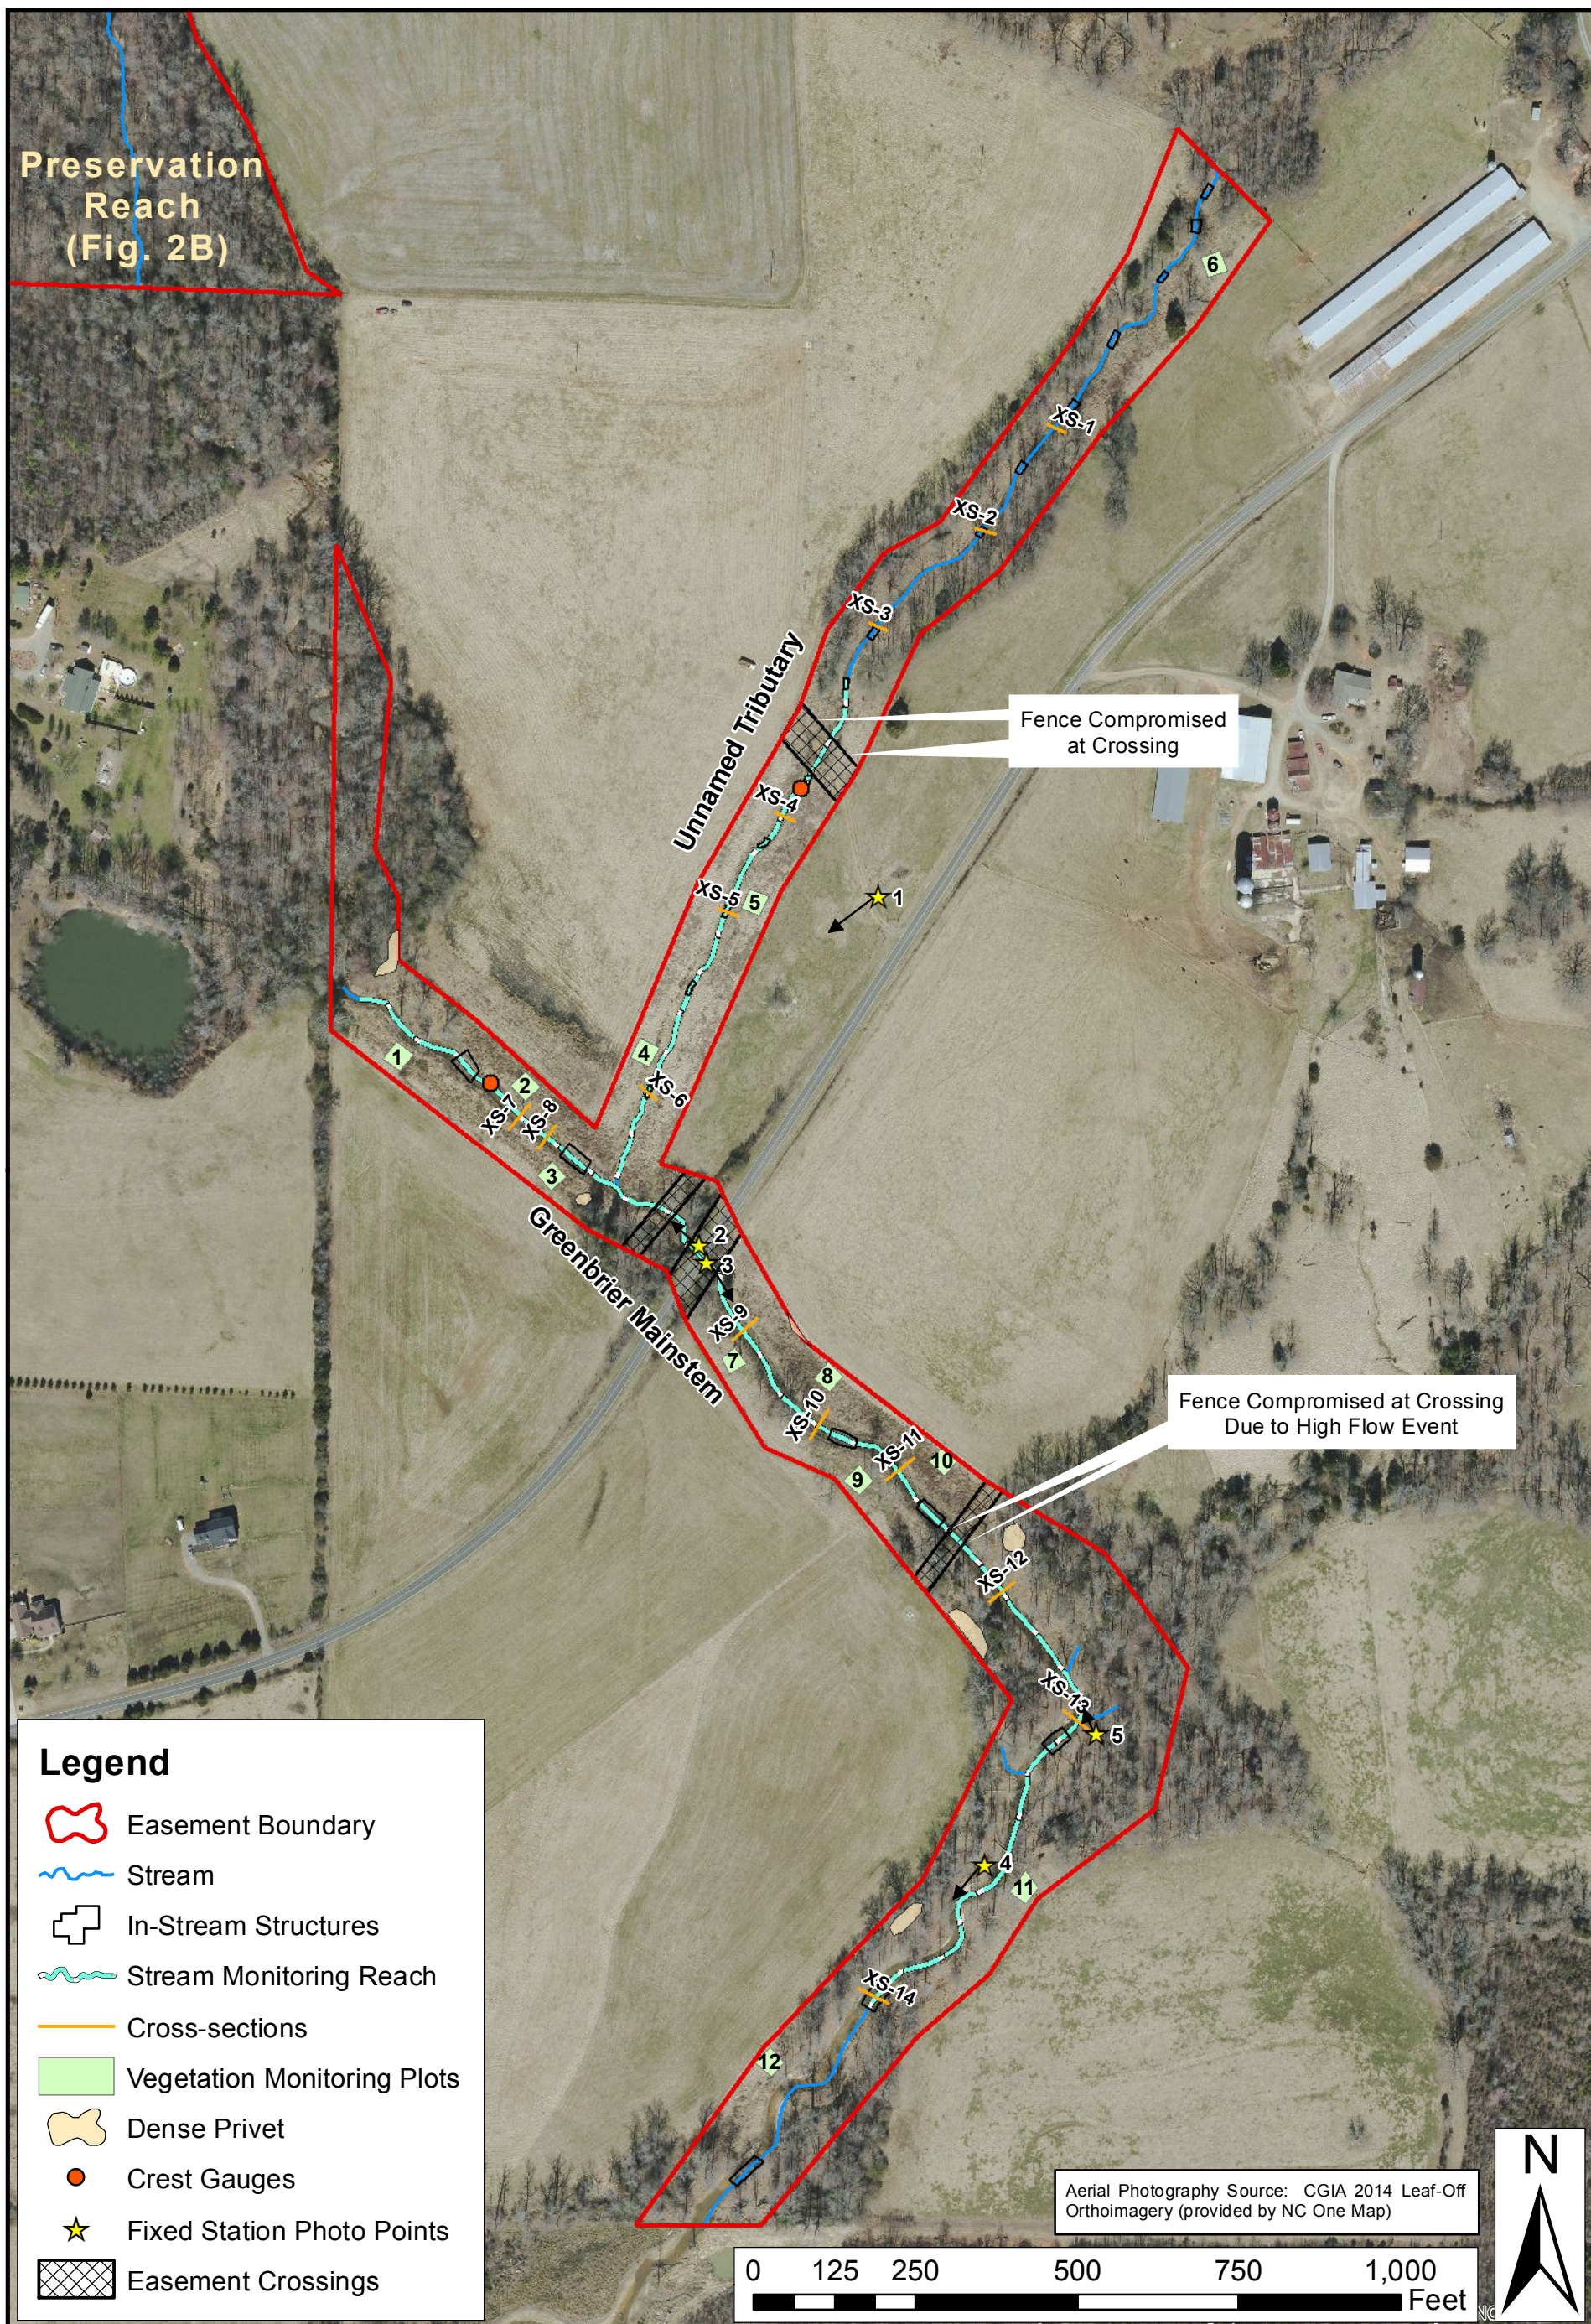
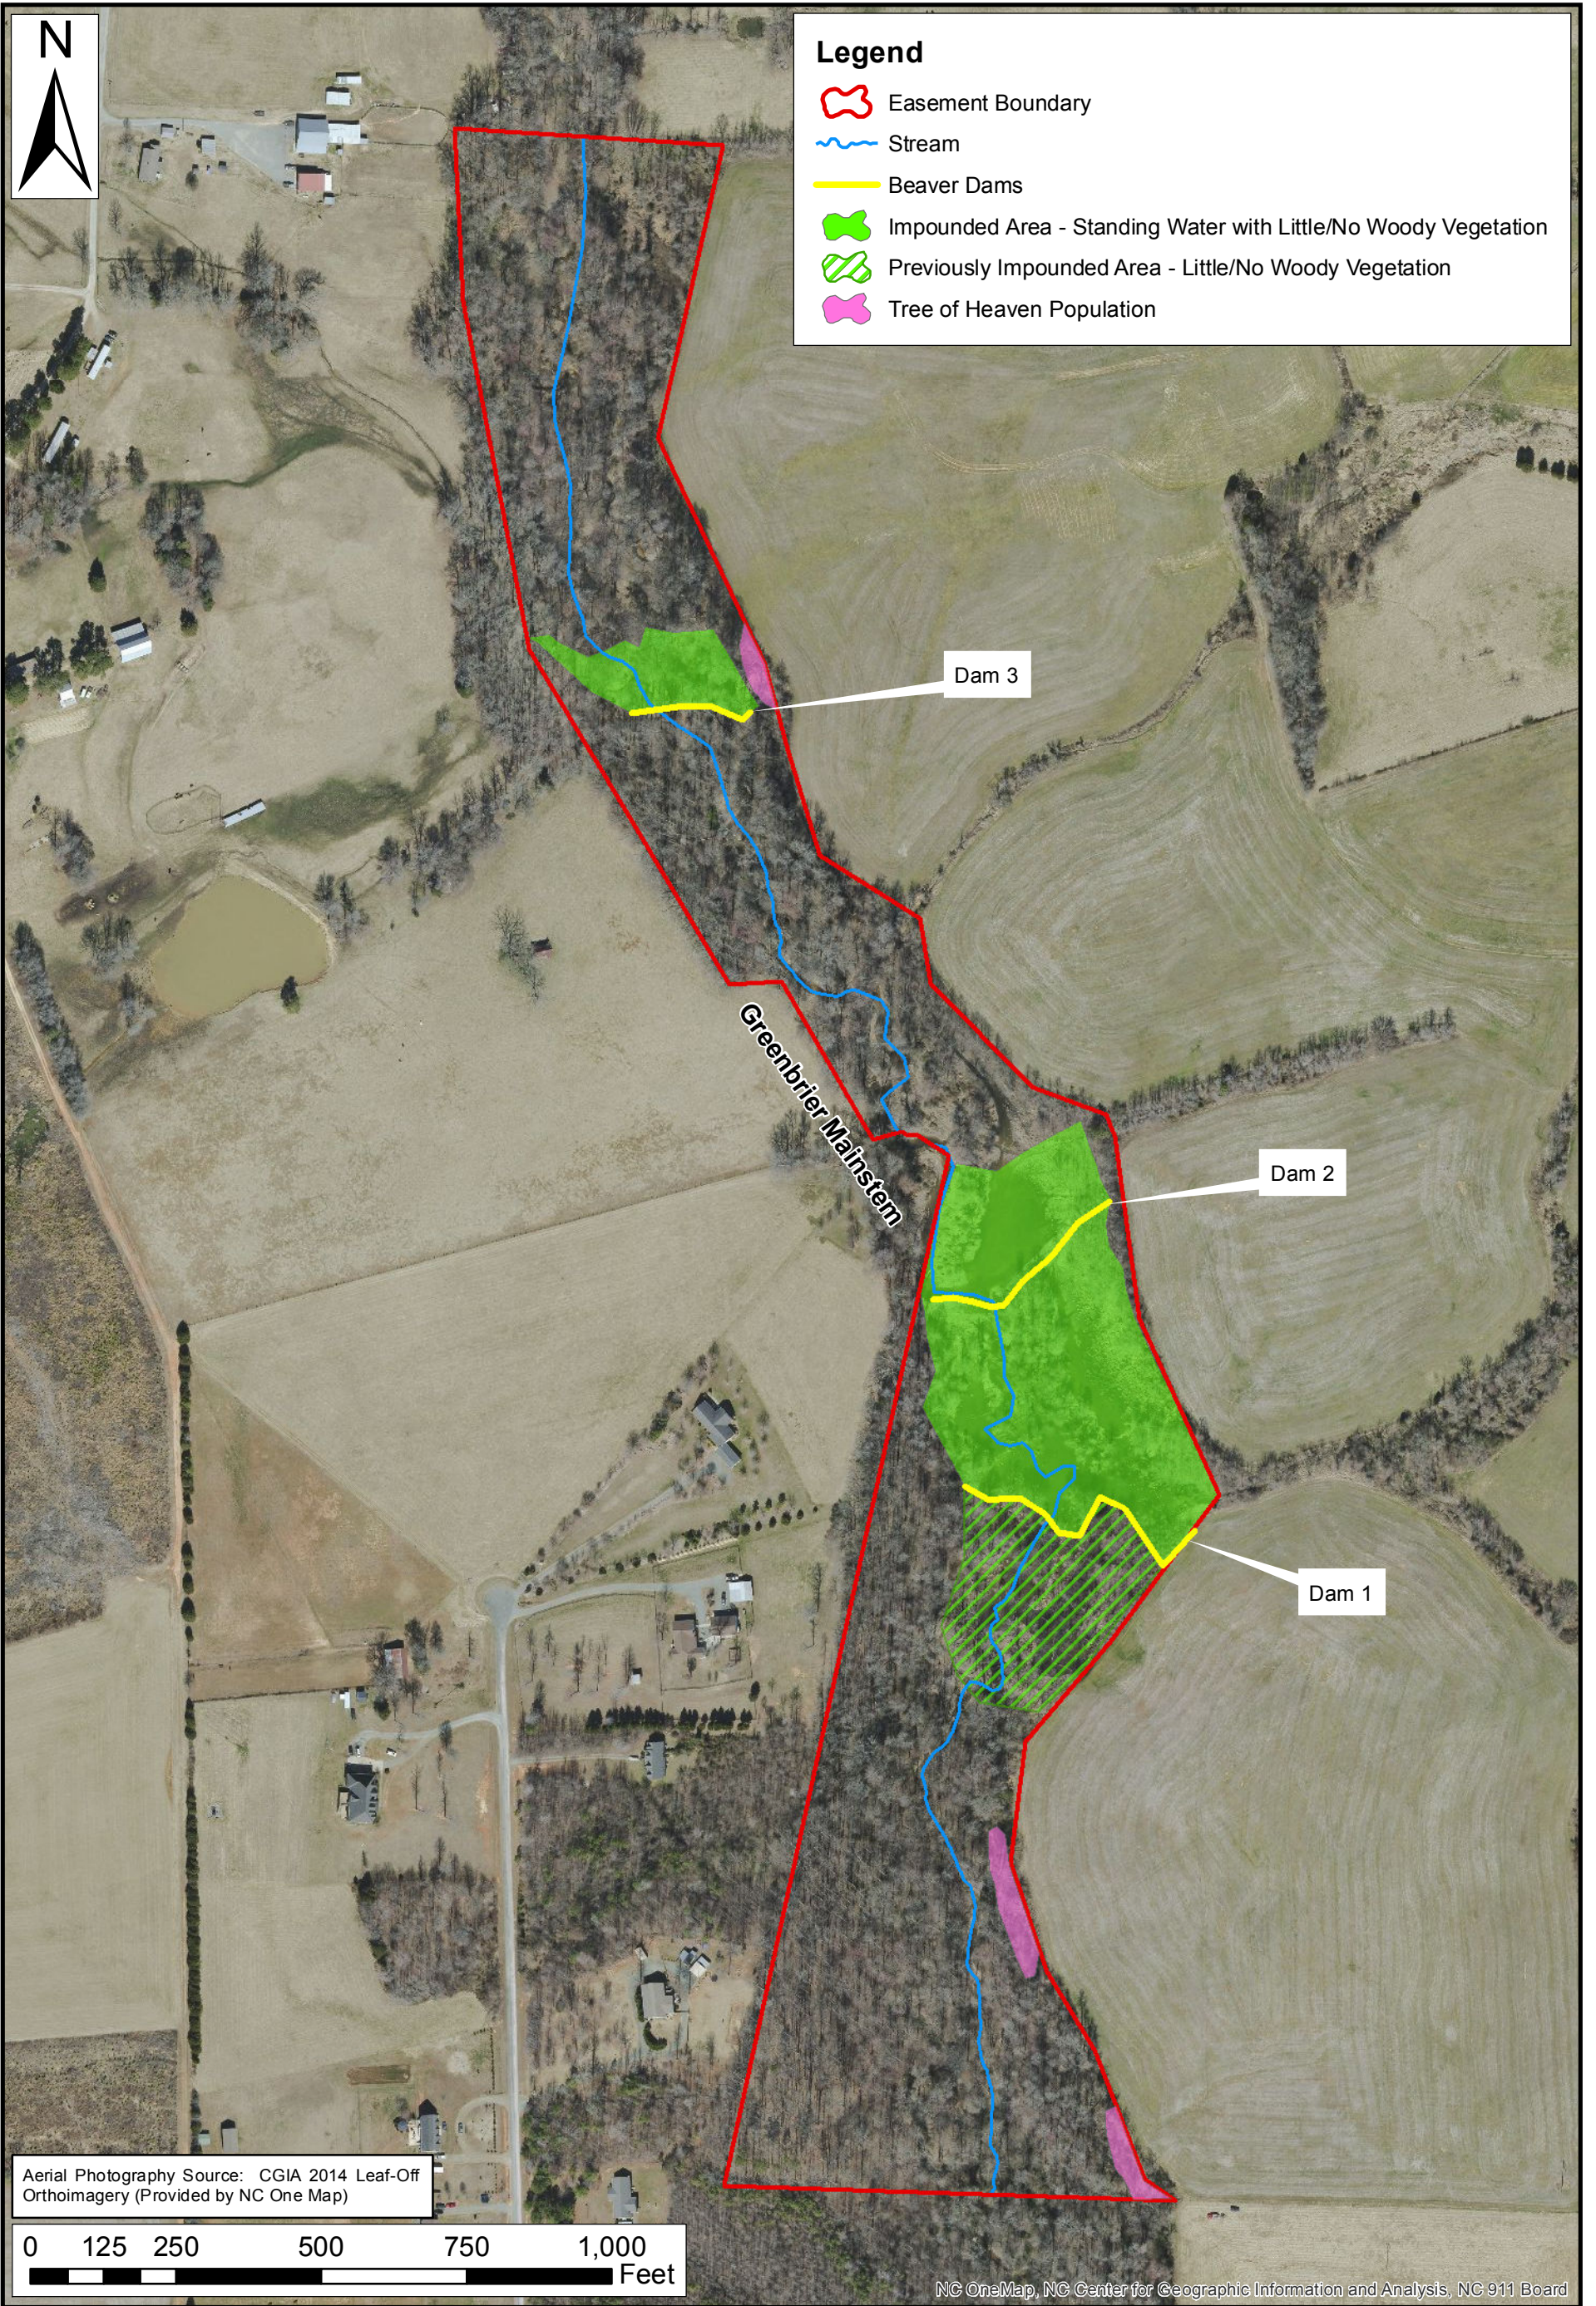
Figures 2A-2B. Current Conditions Plan View

Beaver have been an ongoing issue within the Site and are being closely monitored and trapped when necessary. Currently, one large, well-established impoundment is located on the preservation reach consisting of three major beaver dams (Dams 1, 2, and 3, Figure 2B, Appendix B). This impoundment is characterized by standing water and a lack of living woody stems. The beaver remain active in this area, and few woody stems are surviving in the previously impounded footprint. It does not appear that natural recruits are becoming established in these areas at this time. The currently impounded and previously impounded areas are depicted on the Current Conditions Plan View Map (Figure 2B, Appendix B).

Fencing along the downstream ford has been heavily damaged by debris during high flow events. Additionally, a small section of fencing has failed in the ford on the unnamed tributary, though it appears that the pasture adjacent to this portion of the easement is no longer used for livestock grazing (Figure 2A, Appendix B).

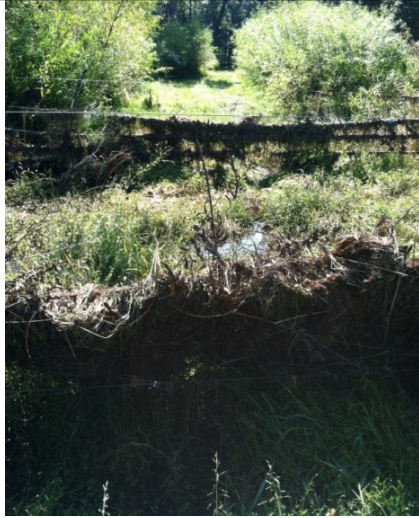
Bankfull Event Photo 1 showing evidence of a 2012 overbank event

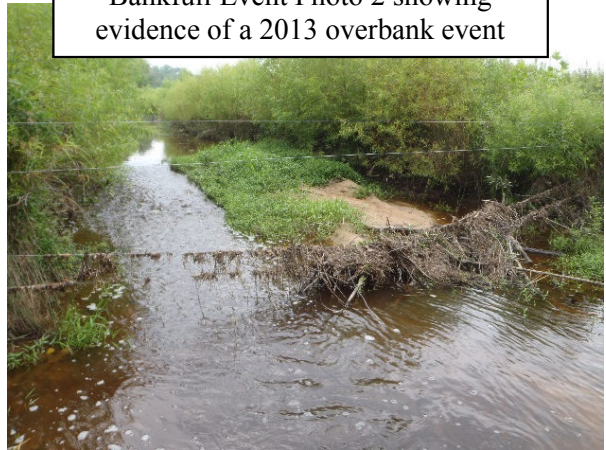
Bankfull Event Photo 2 showing evidence of a 2013 overbank event

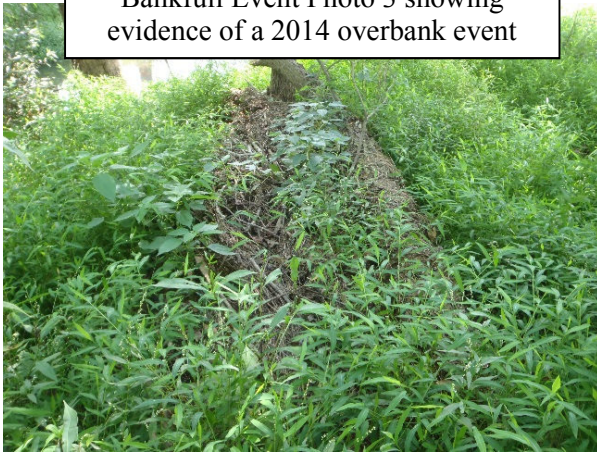
Bankfull Event Photo 3 showing evidence of a 2014 overbank event

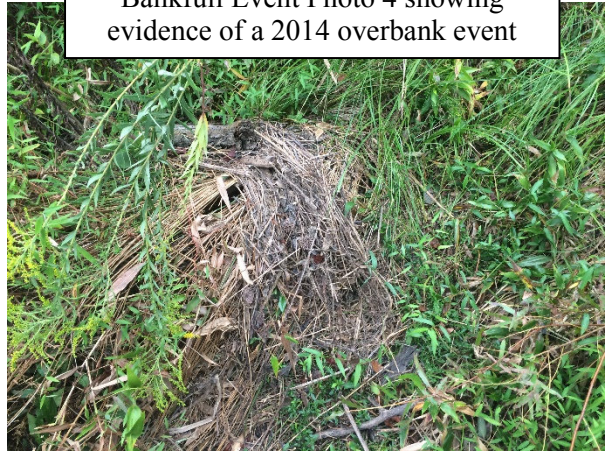
Bankfull Event Photo 4 showing evidence of a 2014 overbank event

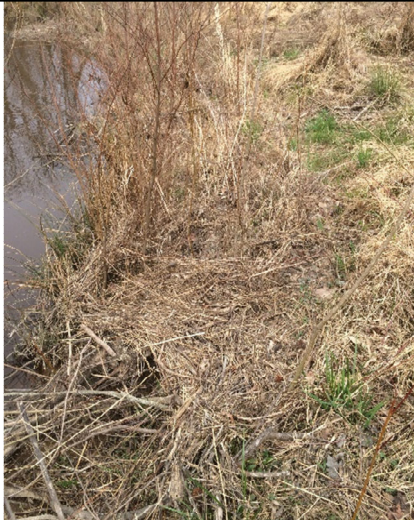
Bankfull Event Photo 5 showing evidence of a 2015 overbank event

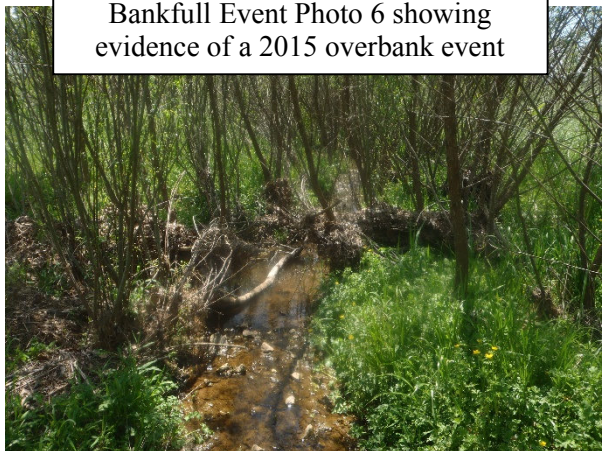
Bankfull Event Photo 6 showing evidence of a 2015 overbank event

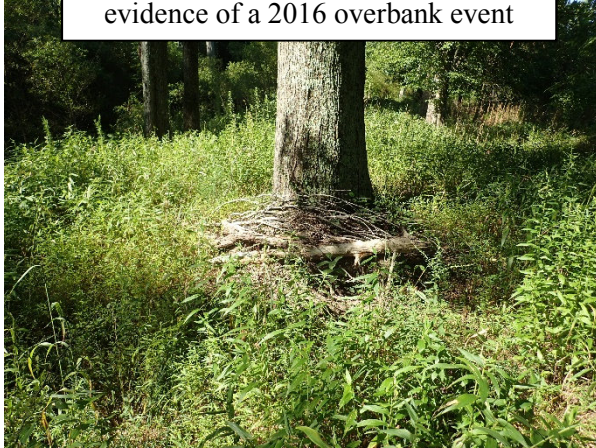
Bankfull Event Photo 7 showing evidence of a 2016 overbank event

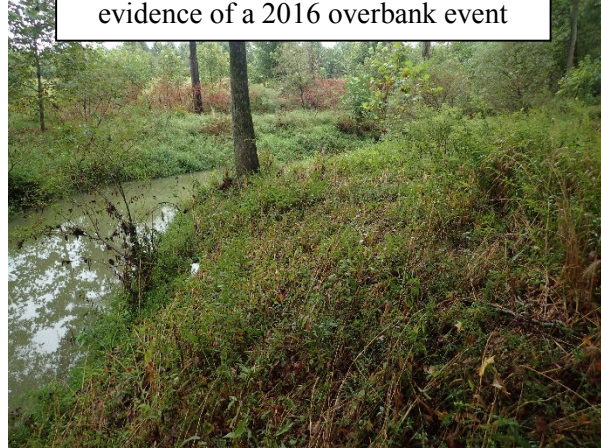
Bankfull Event Photo 8 showing evidence of a 2016 overbank event
